Central Fire Station

Town of Hingham ADA Transition Plan

October 2023

Institute for Human Centered Design

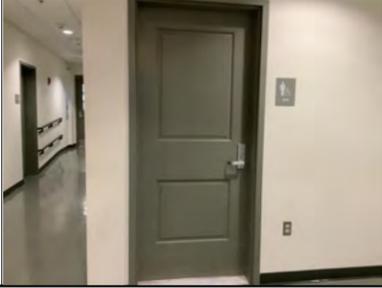
Door requires > 5 lbs. of force to open	8 lbs	Adjust closers so doors do not require more than 5 pounds of force to open.	1	
Signage											
16	By Bays, Safe Haven Sign	Ext.		Signage	Informational

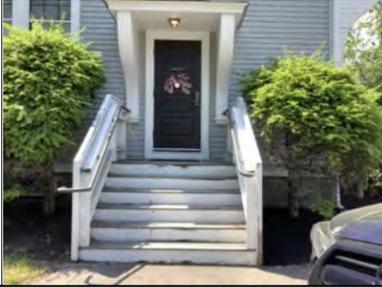
ID	Location	Floor	Room	Element	Type	Photo	Issues	Current Measure	Recommendations	Quantity	Notes
Exterior Stair											
6	Northeast Egress/From Legion Hall	Ext.		Exterior Stair	N/A

Handrails do not extend 12" from stair	-	Bottom: Ensure that the sloped bottom extension extends one tread depth min. beyond last riser nosing in same direction as stair flight.	1	
Entrance											
7	Main Entrance	Ext.		Entrance	Main Entrance

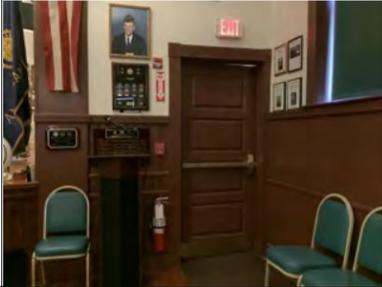
Automatic door opener not operable Clear floor space at opener not provided	- -	Repair or replace the door opener. Relocate automatic door opener to provide 30" x 48" min. clear floor space. Currently, the automatic door opener is located behind a column.	1	
Access to Goods and Services											
Means of Egress											
8	Northeast Egress/From Legion Hall	3		Means of Egress	N/A

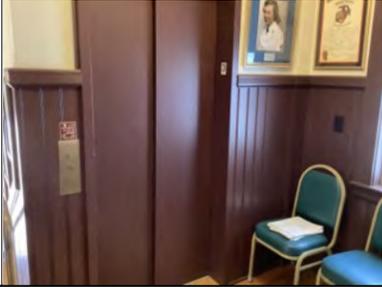
ID	Location	Floor	Room	Element	Type	Photo	Issues	Current Measure	Recommendations	Quantity	Notes
Elevator											
20	Elevator	3		Elevator	Interior

Hoistway signs < 48" > 60"	60.6"	Install hoistway signs on the inside of the door frame 60" above the finished floor.	2	
Signage											
21	Men's Toilet Room	B		Signage	Designation

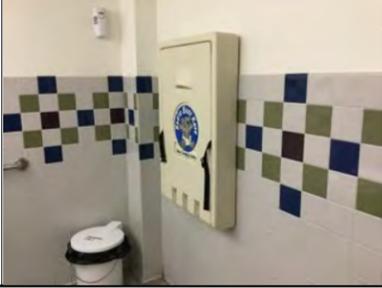
ID	Location	Floor	Room	Element	Type	Photo	Issues	Current Measure	Recommendations	Quantity	Notes
61	All Gender Children's Toilet Room	2		Operable Parts	Other

Side reach > 54"	61"	Relocate baby changing table so that controls are between 15" - 48" above the finished floor.	1	
Dining or Work Surfaces											
62	Courtyard	2		Dining or Work Surfaces	Dining Surface

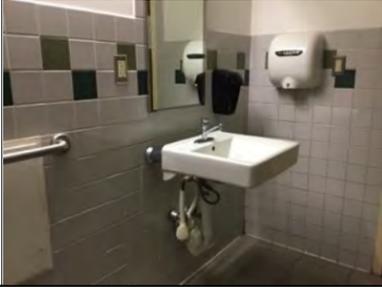
Plumbing underneath is exposed	-	Insulate or otherwise configure pipes to prevent contact at the lavatory.	1	
Single-User Toilet											
67	Women's Toilet Room by Audio Visual Department	2		Single-User Toilet	N/A

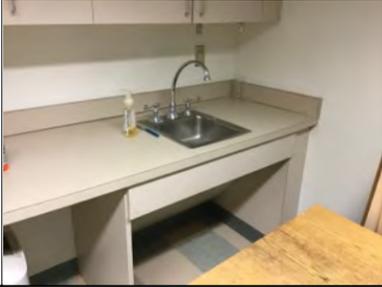
Clear floor space not provided at sink Toe and knee clearances not provided	- 26"	Provide a 30" by 48" clear floor space positioned for a forward approach. Relocate furniture. Ensure there is a 27" min. knee clearance positioned for a forward approach.	1	
77	Story Telling/ Activity Room	2	116A	Sink	Classroom

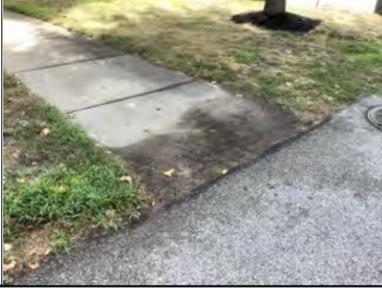
Route not maintained in operable working condition	-	Ensure the accessible route is maintained in operable working condition.	1	
Curb Ramp											
17	Building A, Senior Center, Route to Main Entrance,	Ext.		Curb Ramp	N/A

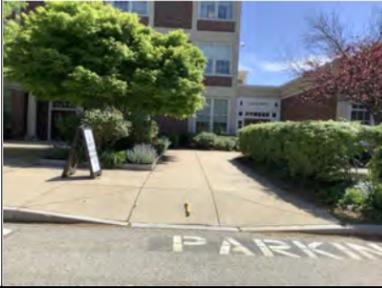
Running slope > 1:12 (8.33%)	11.5%	Reduce running slope to be no steeper than 1:12 (8.33%).	1	
18	North Accessible Parking by Building C, Town Hall, North Egress, Secondary Entrance	Ext.		Curb Ramp	N/A

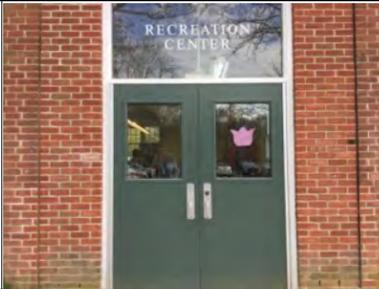
International Symbol of Accessibility not provided	- -	Provide a sign with the International Symbol of Accessibility (ISA). Recommend locating the ISA sign over the tactile designation sign that is required in addition at this door.	1

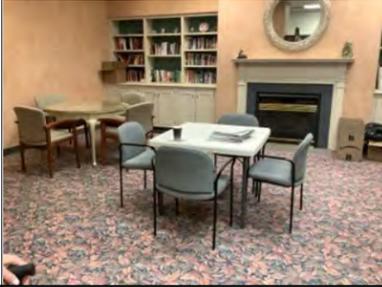
Knee or toe clearance not provided	26.5"	Provide at least one dining or work surface with 27" min. knee and toe clearance.	1	
187	Building A. Senior Center, Large Classroom	1		Dining or Work Surfaces	Work Surface

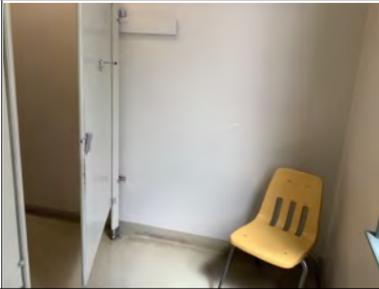
Door has inadequate maneuvering clearance Door pull not provided	- -	Remove the chair to provide maneuvering clearance at the door. Provide a door pull on each side of the door between 34" to 48" above the finished floor that does not require tight grasping, pinching or twisting of the wrist.	2

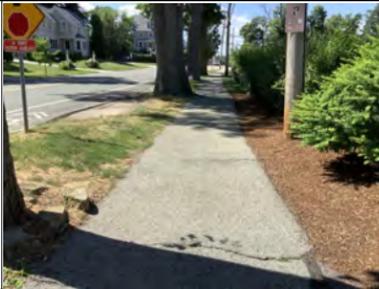
Route not maintained in operable working condition	-	Ensure the accessible route is maintained in operable working condition. Repair damaged pavement.	1	
9	Elm Street Parking to Northwest Entrance/ Egress Door	Ext.		Exterior Access Route	Exterior

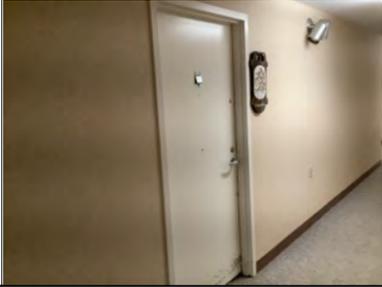
Accessible units not provided in a range of size and amenities	-	Provide a mobility accessible studio and two-bedroom apartment. Distribute accessible dwelling units throughout projects and sites and make such units available in the same ranges of sizes and amenities to provide housing choices for persons with disabilities that are the same as those provided to others. [24 CFR 8.26; 28 CFR 149] Cost will be based on renovation.	1	
Toilet & Bathing Rooms											
Lavatory											
72	Unit 307, Toilet Room	3	307	Lavatory	N/A

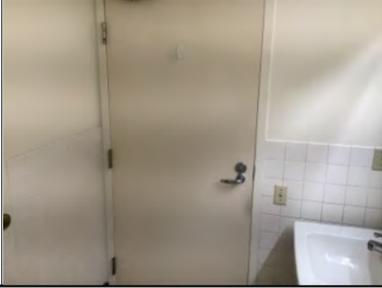
Hook located > 54" high	66"	Locate the coat hook no higher than 48" above the finished floor.	1	
Shower Compartment											
76	Unit 411, Toilet Room	4	411	Shower Compartment	Roll-In Type

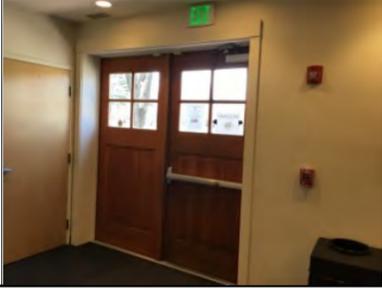
Tactile sign not provided at emergency exit Illuminated International Symbol of Acc. not provided (MAAB 2006)	- -	Provide a sign with raised characters and braille at the emergency exit. Mount signs between 48"-60" above the finished floor located on the latch side of the door. Where a tactile sign is provided at double doors with two active leaves, the sign shall be located to the right of the right hand door. Provide an illuminated sign with the International Symbol of Accessibility (ISA).	1	
Access to Goods and Services											
Ramps											
7	Ramp	Ext.		Ramps	Exterior

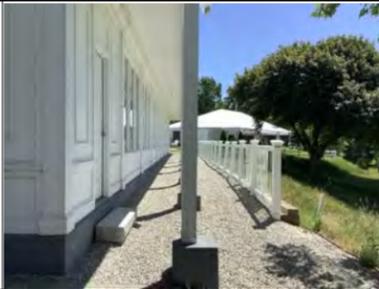
Cross slope > 1:50 (2.00%) Surface is not stable, firm, and slip-resistant	3.5% -	Provide a stable, firm and slip-resistant surface such as stone dust. Reduce cross slope to be no steeper than 1:50 (2.00%).	1	
7	Parking by Events Tent to Lincoln Dining Room, East Egress Door	Ext.		Exterior Access Route	Walkway

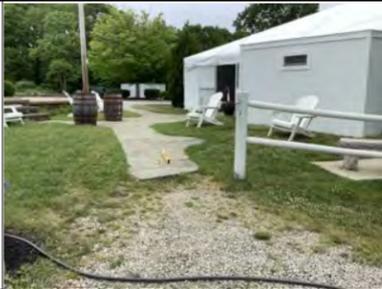
Running slope > 1:20 (5.00%) Level changes > 1/4"	6.9% 3.5"	Reduce running slope to be no steeper than 1:20 (5.00%). Alter change in level to be 1/4" high max.	1	
12	Route From East Parking Lot to Events Tent	Ext.		Exterior Access Route	Walkway

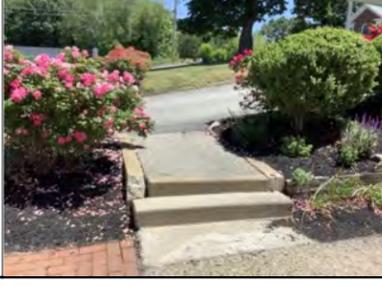
Handrails not provided	-	Provide a handrail on each side of the stair.	1

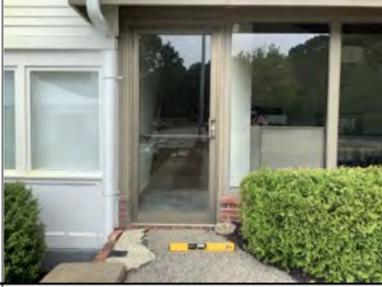
Directional sign to accessible entrance not provided	-	Provide a directional sign indicating the location of the nearest accessible entrance. Recommend providing one sign on the latch side of the door. Where a directional sign is required, it should be located to minimize backtracking. This could mean locating a sign at the beginning of a route, not just at the inaccessible entrances.	1

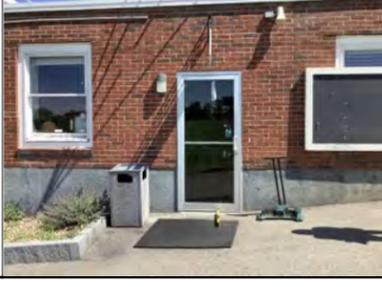
International Symbol of Accessibility not provided	-	After the route to the Pro Shop is brought into compliance, provide a sign with the International Symbol of Accessibility (ISA). Recommend providing the ISA sign above the tactile designation sign that is required at this entrance.	1

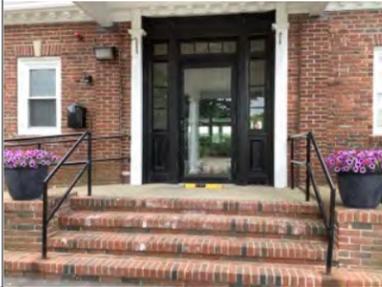
International Symbol of Accessibility not provided	-	Provide a sign with the International Symbol of Accessibility (ISA). Recommend providing sign with the ISA above the tactile designation sign that is required at this door. Recommend providing the ISA sign above the tactile designation sign that is required at the door.	1	
32	North Walkway, Northwest Entrance Door to the Pub	Ext.		Entrance	Secondary Entrance

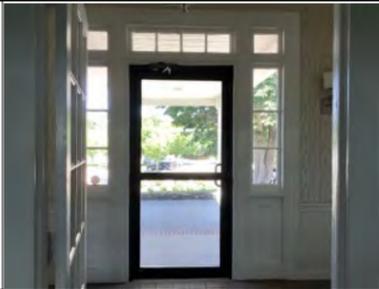
Tactile exit sign not provided	- -	Ensure tactile exit signs with raised characters and braille are provided at exit doors. Mount signs between 48"- 60" above the finished floor located on the latch side of the door.	1	
37	Egress Door to Alley	1		Means of Egress	N/A

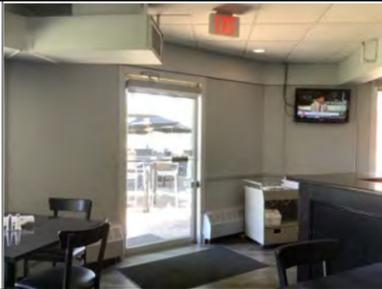
Tactile exit sign not provided Directional sign to accessible emergency exit not provided	- -	Ensure tactile exit signs with raised characters and braille are provided at exit doors. Mount signs between 48"- 60" above the finished floor located on the latch side of the door. Provide a directional sign indicating the location of the nearest accessible emergency exit.	1	
42	Upper Function Room, to East Egress Door	2		Means of Egress	N/A

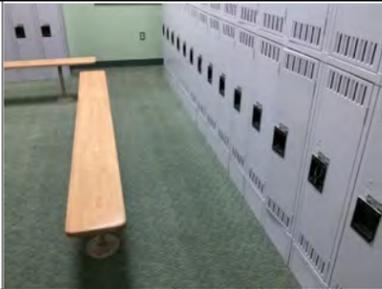
Route < 36" wide	31.2"	Relocate bench to ensure that a clear width of 36" min. is maintained at the accessible route.	1	
52	Women's Locker Room	1		Interior Access Route	N/A

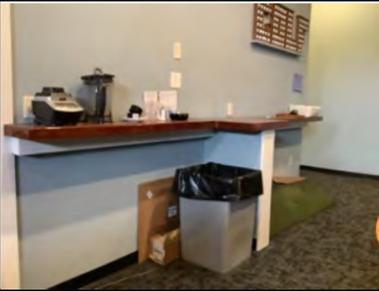
Obstructed by protruding objects	-	Provide a cane-detectable barrier under the shelves.	2	
57	Route Between the First Floor and Second Floor of the East Building	1, 2		Interior Access Route	N/A

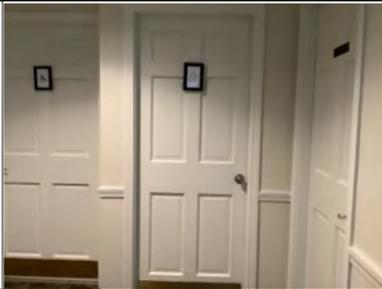
Clear width at door < 32"	29.4"	Provide signage directing users to an accessible toilet room. Locate the sign above the room designation sign.	1	
62	Upper Function Room Women's Toilet Room	2		Doors, Doorways, & Gates	Toilet Room

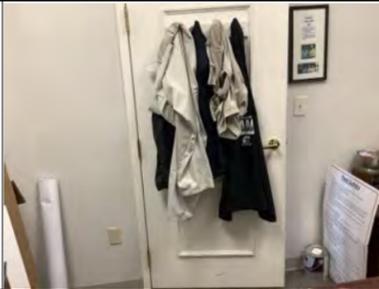
Maneuvering clearance(s) not provided	-	Relocate furniture so that there is 18" clear on the latch side of the door and 60" clear in front of the door. Relocate the desk, paint can and other furniture.	1	
67	Single-User Toilet Room and Women's Single-User Toilet Room by the Locker Rooms	1		Doors, Doorways, & Gates	Toilet Room

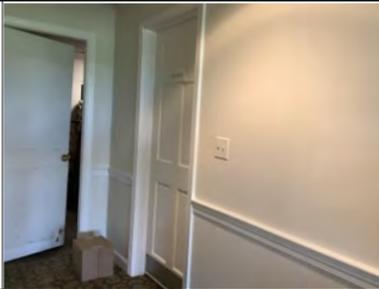
<p>Raised characters not provided on sign Raised characters < 48" or > 60" above ground Braille not provided on sign Sign not located on the latch side of the door</p>	<ul style="list-style-type: none"> - - - 	<p>Provide text with raised characters duplicated in braille on sign. Mount signs so that the baseline of the lowest tactile character is 48" min. above finished floor and the baseline of the highest tactile character is 60" max. above the finished floor. Locate the sign at permanent rooms alongside the door on the latch side.</p>	1	
77	Lincoln Dining Room, Women's Toilet Room	1		Signage	Designation

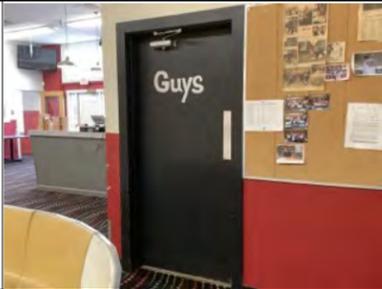
<p>Raised characters not provided on sign</p> <p>Braille not provided on sign</p> <p>Sign not located on the latch side of the door</p> <p>Raised characters < 48" or > 60" above ground</p> <p>International Symbol of Acc. not provided</p>	<ul style="list-style-type: none"> - - - - - 	<p>Provide text with raised characters duplicated in braille on sign. Mount signs so that the baseline of the lowest tactile character is 48" min. above finished floor and the baseline of the highest tactile character is 60" max. above the finished floor. Locate the sign at permanent rooms alongside the door on the latch side.</p> <p>Replace the sign with a sign containing the International Symbol of Accessibility (ISA).</p>	1	
82	Bowling Alley, Women's Toilet Room	1		Signage	Designation

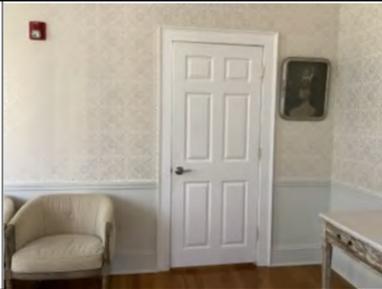
International Symbol of Acc. not provided	-	After this room is brought into full compliance, provide a sign with a sign containing the International Symbol of Accessibility (ISA). Locate the side on the latch side of the door.	1	
Service Counter											
97	Greenside Grille, Hostess	1		Service Counter	N/A
