0 Station Street Parking Lot

Town of Hingham ADA Transition Plan

October 2023

Institute for Human Centered Design

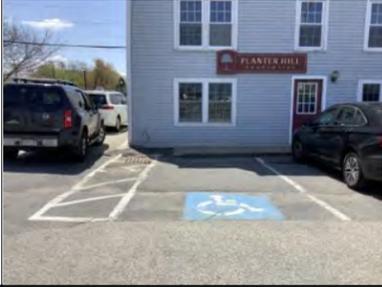
ID	Location	Floor	Room	Element	Type	Photo	Issues	Current Measure	Recommendations	Quantity	Notes
Off-Street Parking Lot or Garage											
5	8 North Street Parking Area - Accessible Space	Ext.		Off-Street Parking Lot or Garage	Visitor

Total # of parking Van space < 132" or < 96" wide Access aisle not compliant Access aisle does not adjoin an accessible route Sign not provided Sign does not have the designation "Van Accessible"	8 108" 52" - - -	Provide a van accessible space that is 132" wide min. with a marked access aisle that is 60" wide min. or provide a space and access aisle that are both 96" wide min. Ensure the access aisle adjoins an accessible route. Provide a sign with the International Symbol of Accessibility (ISA). Add the designation "Van Accessible" to the sign located at the van accessible space.	1	
6	8 North Street Parking Area - Parking Lot	Ext.		Off-Street Parking Lot or Garage	Visitor

Surface not stable, firm, and slip-resistant	-	Repair surface. (Note: Some recommendations for the 6 Mill Street parking area are provided in the Best Practice section of the narrative report.)	1

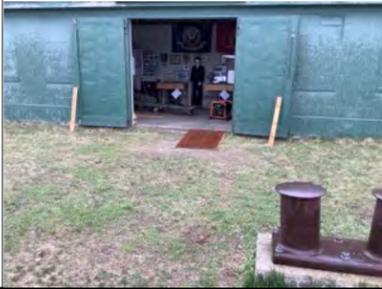
ID	Location	Floor	Room	Element	Type	Photo	Issues	Current Measure	Recommendations	Quantity	Notes
6	Green Dock House Military Museum Main Entrance	Ext.		Exterior Access Route	Exterior

Accessible route not provided Threshold > 1/2" high	- 2"	Ensure an accessible route is provided to the Green Dock House Military Museum main entrance. Alter the threshold to be 1/2" high max.	1	
Curb Ramp											
7	Carlson Athletic Fields	Ext.		Curb Ramp	Parallel

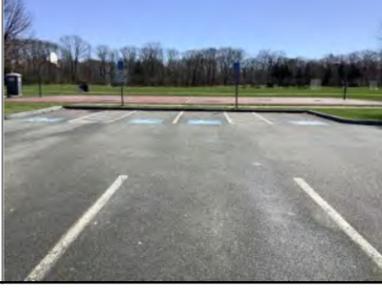
Total # of parking Total # of designated accessible parking spaces Total # of designated van accessible spaces Sign not provided	186 4 0 -	Five car accessible parking spaces and one van accessible parking space are required. Provide one additional car and one van accessible parking space. Provide a sign with the International Symbol of Accessibility (ISA) with the bottom of the sign 60" min. above the ground and the top 96" max. above the ground. (Two signs with the ISA are missing at the parking spaces in the picture).	1

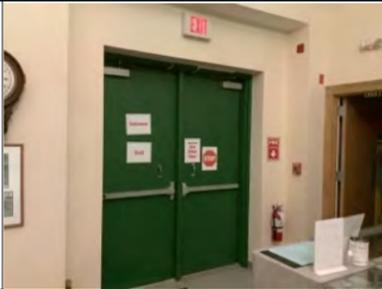
ID	Location	Floor	Room	Element	Type	Photo	Issues	Current Measure	Recommendations	Quantity	Notes
16	Railway Museum, Main Egress	1		Emergency Exit	N/A

Tactile sign not provided at emergency exit Illuminated International Symbol of Acc. not provided (MAAB 2006)	- -	Provide a sign with raised characters and braille at the emergency exit. Mount signs between 48"-60" above the finished floor located on the latch side of the door. Where a tactile sign is provided at double doors with two active leaves, the sign shall be located to the right of the right hand door. Provide an illuminated sign with the International Symbol of Accessibility (ISA).	1	
Access to Goods and Services											
Interior Access Route											
17	Fire Museum Garage	1		Interior Access Route	Interior

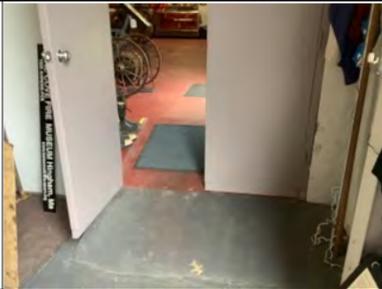
ID	Location	Floor	Room	Element	Type	Photo	Issues	Current Measure	Recommendations	Quantity	Notes
21	Fire Museum Garage to Men's Toilet Room	1		Doors, Doorways, & Gates	Other

Hardware not operable with a closed fist	-	Provide hardware that can be operable with one hand and not require tight grasping, pinching, or twisting of the wrist.	1	
22	Fire Museum Main Room	1		Doors, Doorways, & Gates	Toilet Room

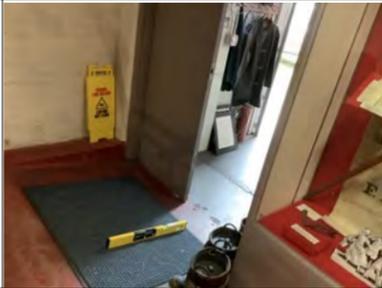
Running slope >1:12 (8.33%)	14.5%	Reduce running slope to be no steeper than 1:12 (8.33%). (Repair to this ramp might be technically infeasible. If that is the case, ensure there is an accessible route to alternate accessible entry points at both sides of the building)	1

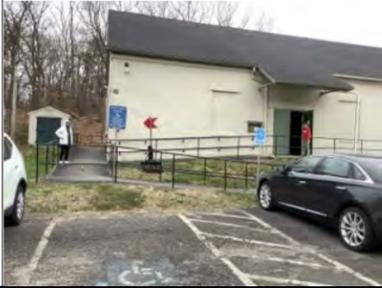
25	Railway Museum Parking	1		Ramps	Exterior

Running slope >1:12 (8.33%) Landing has a slope > 1:50 (2.00%) (MAAB)	10.2% 3.5%	Rebuild the ramp. Reduce running slope to be no steeper than 1:12 (8.33%). Ensure that the slope in all directions is no greater than 1:50 (2.00%).	1

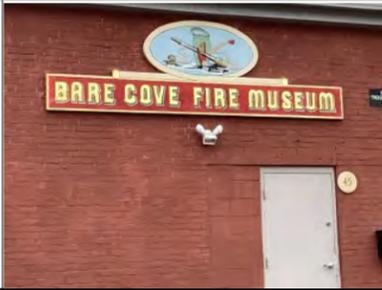
ID	Location	Floor	Room	Element	Type	Photo	Issues	Current Measure	Recommendations	Quantity	Notes
Signage											
26	Fire Museum	Ext.		Signage	Designation

<ul style="list-style-type: none"> Raised characters not provided Raised characters < 48" or > 60 " above ground Braille not provided Sign not located on the latch side of the door 	-	<ul style="list-style-type: none"> Provide text with raised characters duplicated in braille. Mount signs so that the baseline of the lowest tactile character is 48" min. above the finished floor and the baseline of the highest tactile character is 60" max. above the finished floor. Locate signs at permanent rooms alongside the door on the latch side on the wall. 	1	
27	Fire Museum, Women's Toilet Room	1		Signage	Designation

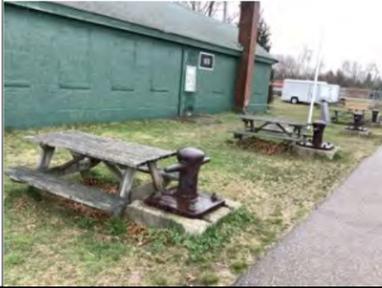
ID	Location	Floor	Room	Element	Type	Photo	Issues	Current Measure	Recommendations	Quantity	Notes
Picnic Tables											
31	Green Dock House Military Museum	Ext.		Picnic Tables	N/A

<ul style="list-style-type: none"> Number of seating spaces at picnic tables Number of accessible seating spaces Clear floor space not provided Surface not firm and stable Toe or knee clearance at table not provided Picnic table not on an accessible route 	<ul style="list-style-type: none"> 4 0 - - - 	Provide at least one picnic table with top between 28"- 34" above the ground and 27" clear height underneath. Ensure that the accessible picnic table is connected to an accessible route. Ensure that at a 30" by 48" clear floor space positioned for a forward approach is provided at an accessible picnic table. Ensure surface is firm, stable and slip-resistant.	1	
Benches											
32	Green Dock House Military Museum	Ext.		Benches	N/A

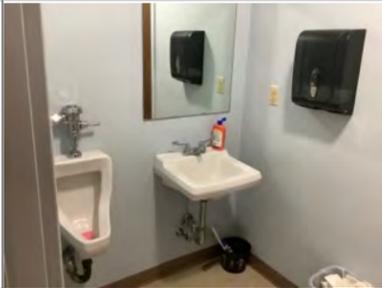
ID	Location	Floor	Room	Element	Type	Photo	Issues	Current Measure	Recommendations	Quantity	Notes
Lavatory											
35	Fire Museum Men's Toilet Room	1		Lavatory	N/A

Exposed plumbing underneath Mirror above lavatory w/reflective surface > 40"	- 41.5"	Insulate or otherwise configure pipes to prevent contact at the lavatory. Lower mirror so that the bottom surface is at 40" max. above the finished floor.	1	
Toilet Compartment											
36	Fire Museum Men's Toilet Room	1		Toilet Compartment	Accessible Compartment

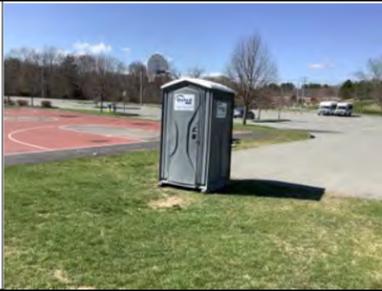
ID	Location	Floor	Room	Element	Type	Photo	Issues	Current Measure	Recommendations	Quantity	Notes
40	Carlson Athletic Fields, near Basketball Court	Ext.		Portable Toilet	N/A

Not located on an accessible route Accessible portable toilets not provided	- -	Ensure that at least 5% of portable toilets (with a minimum of one) are accessible. Locate the accessible portable toilet on an accessible route.	1	
Play and Sport Areas											
Field											
41	Carlson Athletic Fields Baseball Bleacher	Ext.		Field	Baseball

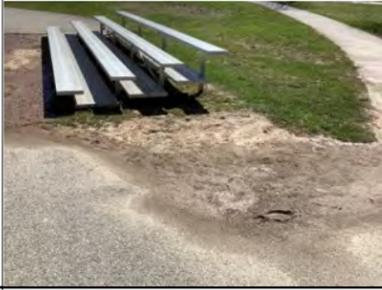
Accessible spaces not provided at sidelines seating	-	Provide a 36" x 60" clear floor space along each side of the bleacher. Clear the dirt from the area and ensure that it is maintained in operable working condition.	1	
42	Carlson Athletic Fields, Batting Cage	Ext.		Field	Baseball

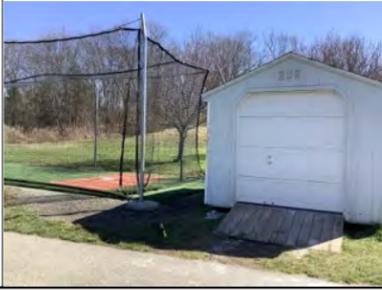
Practice areas are not on an accessible route	7.4%	Provide an accessible route to practice areas. Ensure that the slope is no steeper than 5%.	1

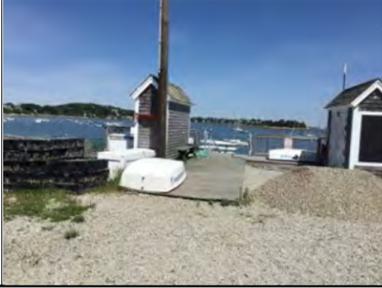
ID	Location	Floor	Room	Element	Type	Photo	Issues	Current Measure	Recommendations	Quantity	Notes
6	Walkway to Gangway	Ext.		Exterior Access Route	Exterior

Accessible route not provided Level changes > 1/4"	2"	Alter the change in level to be 1/4" high max. Ensure an accessible route is provided.	1	
Off-Street Parking Lot or Garage											
7	Parking Lot	Ext.		Off-Street Parking Lot or Garage	Visitor

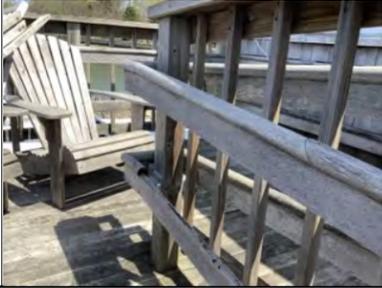
The ramp to the boathouse lacks continuous handrails (the lower handrail is not in operable working condition in multiple locations). Additionally, the bottom landing has a running slope that is steeper than allowed.

Handrails not continuous where required	-	Provide continuous handrails for the length of ramp runs. (Lower handrails are not in operable working condition in multiple locations.)	1

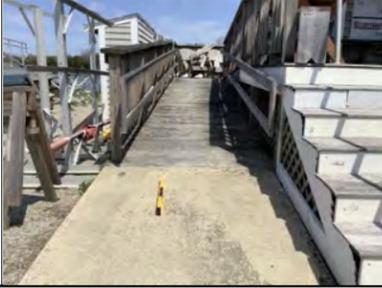
ID	Location	Floor	Room	Element	Type	Photo	Issues	Current Measure	Recommendations	Quantity	Notes
10	Boathouse	Ext.		Ramps	Exterior

Landing has a slope > 1:50 (2.00%) (MAAB)	8%	Rebuild the ramp bottom landing to ensure that the slope of the landing does not exceed 1:50 (2.00%).	1	
Picnic Tables											
11	Boathouse	Ext.		Picnic Tables	N/A

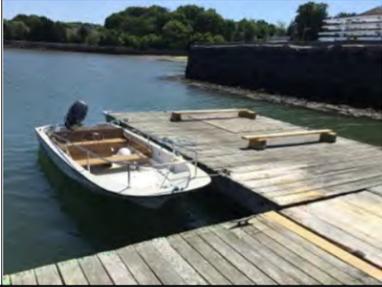
ID	Location	Floor	Room	Element	Type	Photo	Issues	Current Measure	Recommendations	Quantity	Notes
Boating											
14	Row Boat Area	Ext.		Boating	N/A

Edge protection at dock not provided		Provide detectable warnings that comply with 521 CMR on all sides of the dock.	1	
15	Dock	Ext.		Boating	N/A

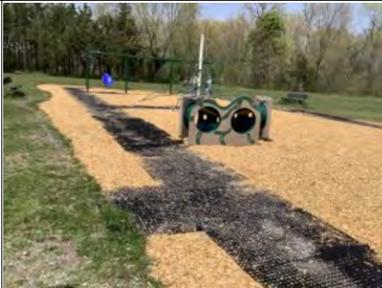
ID	Location	Floor	Room	Element	Type	Photo	Issues	Current Measure	Recommendations	Quantity	Notes
5	Playground	Ext.		Play Areas	N/A

Surface not maintained in operable working condition	-	Ensure that the accessible route is kept clear of engineered wood fiber chips.	1	
Field											
6	Soccer Field	Ext.		Field	Soccer

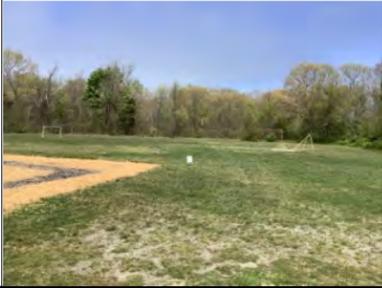
Not connected to an accessible-route No accessible route to all areas of sport activity	- -	Install a stable, firm and slip-resistant accessible route to the boundary of sport activity at the soccer field. Also ensure there is an accessible route connecting all areas of sport activity in the park. Ensure the route is 48" wide min. If the route is less than 60" wide, provide a 60" x 60" passing space every 200 feet.	1	
Court											
7	Basketball Court	Ext.		Court	Basketball

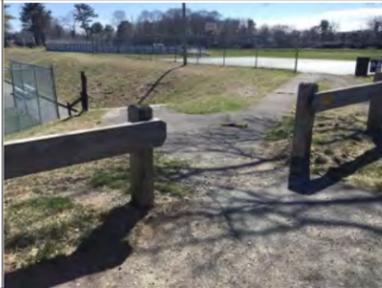
Cross slope > 1:50 (2.00%)	8.9%	Reduce the cross slope to be no steeper than 1:50 (2.00%).	1	
2	Playground	Ext.		Exterior Access Route	Walkway

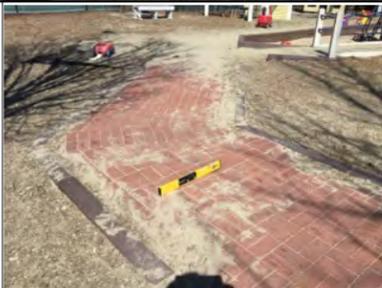
Cross slope > 1:50 (2.00%) Route not maintained in operable working condition	5.7% -	Reduce the cross slope to be no steeper than 1:50 (2.00%). Ensure that the accessible route is maintained in operable working condition.	1	
3	Route to Tennis Court Near Playground	Ext.		Exterior Access Route	Exterior

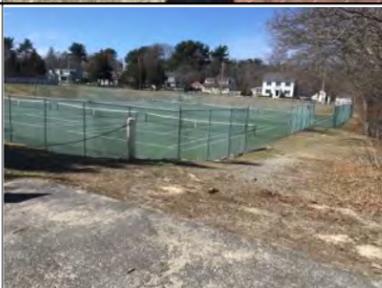
Running slope > 1:20 (5.00%)	15%	It may not be technically feasible to provide an accessible route to the tennis court. Recommend providing program access by informing visitors about another park in Hingham where tennis courts are available on an accessible route and including this information on municipal web sites.	1

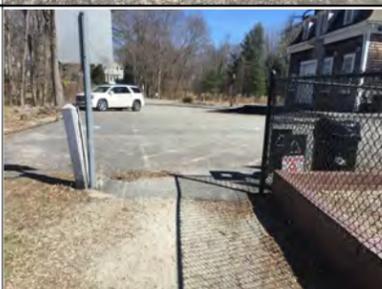
Level changes > 1/4"	-	Alter the change in level to be 1/4" high max.	1	
5	Playground	Ext.		Exterior Access Route	Exterior

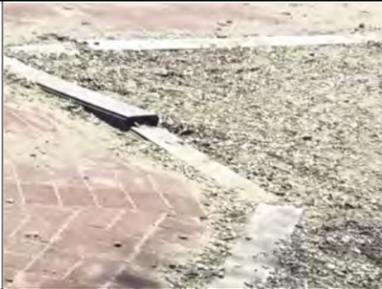
Level changes > 1/4"	-	Alter the change in level to be 1/4" high max.	1	
7	Playground Walkway Transition to Ramp	Ext.		Exterior Access Route	Walkway

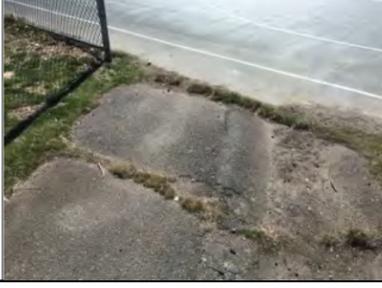
Route not maintained in operable working condition	-	Ensure that the accessible route is maintained in operable working condition.	1

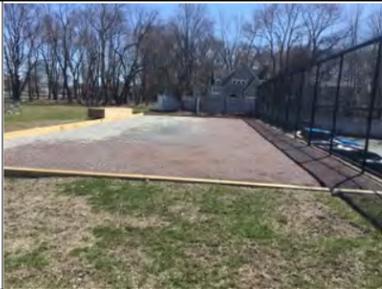
Accessible route not provided	-	Ensure an accessible route is provided.	1	
12	Old Batting Cage Near Baseball Field	Ext.		Exterior Access Route	Exterior

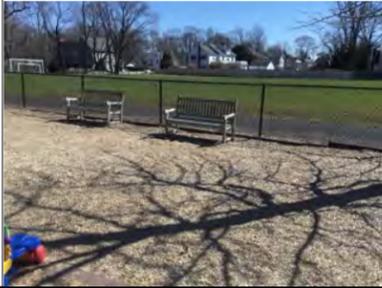
No accessible route to one bench in this area	-	Provide an accessible route to at least one bench in this area or relocate bench to an accessible route.	1	
Trash / Recycling											
22	Baseball Field - Southwest Dugout	Ext.		Trash / Recycling	N/A

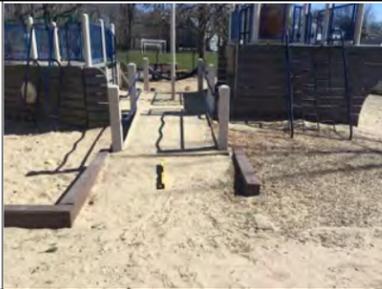
Running slope of ramps at ground level > 1:16 (6.25%)	9.6%	Rebuilding the ramp so that the ramp run is no steeper than 1:16 (6.25%) might be technically infeasible.	1	
26	Playground	Ext.		Play Areas	N/A

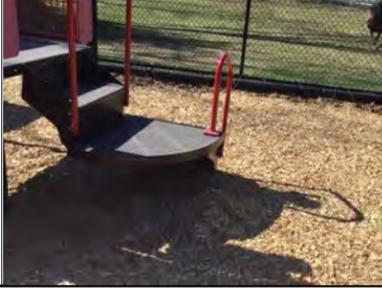
No compliant transfer system	-	Alteration might not be technically feasible until the component is replaced. Transfer platforms must be 24" min. wide and 14" min. deep.	1	
Field											
10	Baseball Field - Dugouts	Ext.		Field	Baseball

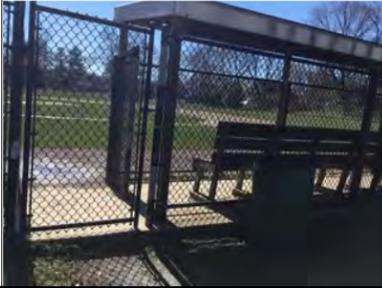
Accessible spaces are not provided at team seating Not connected to an accessible-route	- -	Provide a 36" x 48" clear floor space at team seating. Provide an accessible route to the field.	2	
11	Baseball Field	Ext.		Field	Baseball

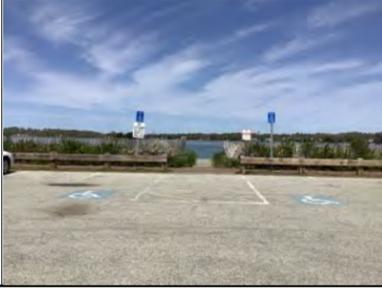
Recommend providing a sign indicating the location of the nearest accessible beach access point.	1
