East Elementary School

Town of Hingham ADA Transition Plan

October 2023

Institute for Human Centered Design

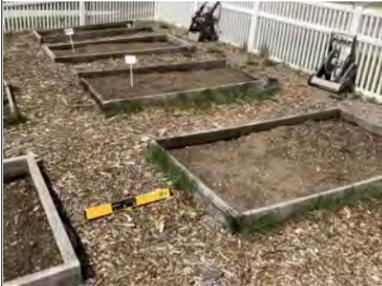
ID	Location	Floor	Room	Element	Type	Photo	Issues	Current Measure	Recommendations	Quantity	Notes
Approach and Entrance											
Exterior Access Route											
1	Garden	Ext.		Exterior Access Route	Exterior

Exterior route < 36" wide Cross slope > 1:50 (2.00%) Running slope > 1:20 (5.00%) Surface is not stable, firm, and slip-resistant Accessible route not provided	35" 5% 7% - -	Ensure that a clear width of 36" min. is maintained at the accessible route. Reduce cross slope to be no steeper than 1:50 (2.00%). Reduce running slope to be no steeper than 1:20 (5.00%). Ensure the surface is a stable, firm and slip-resistant material such as stone dust. Ensure an accessible route is provided to each bed.	1	
2	Northwest Exit Door by Rooms 113 and 114	Ext.		Exterior Access Route	Walkway

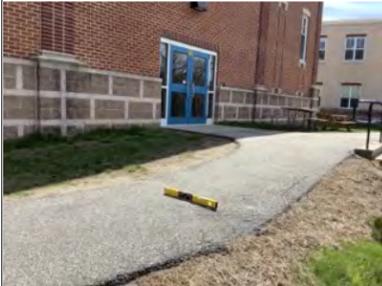
Cross slope > 1:50 (2.00%) Running slope > 1:20 (5.00%)	3% 7%	Reduce cross slope to be no steeper than 1:50 (2.00%). Reduce running slope to be no steeper than 1:20 (5.00%).	1

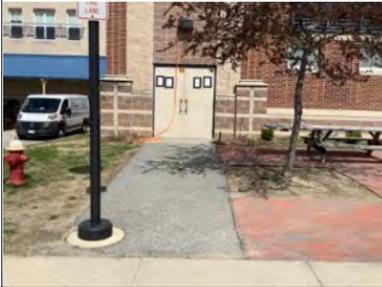
3	Exit Door From Stairs by the Kitchen	Ext.		Exterior Access Route	Walkway

Running slope > 1:20 (5.00%)	7%	Reduce running slope to be no steeper than 1:20 (5.00%).	1	
4	Bench at Playground South of School by the Gym Parking Lot	Ext.		Exterior Access Route	Exterior

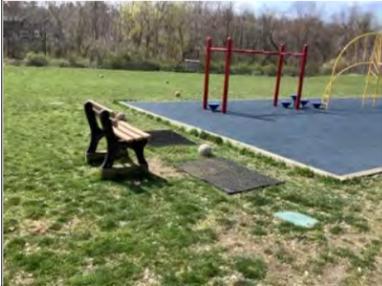
Accessible route not provided	-	Ensure an accessible route is provided to one (1) bench by the playground.	1	
5	Garden	Ext.		Exterior Access Route	Exterior

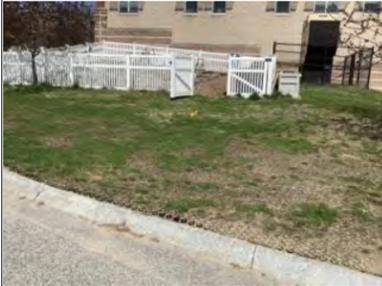
Accessible route not provided	-	Ensure an accessible route is provided to the garden.	1

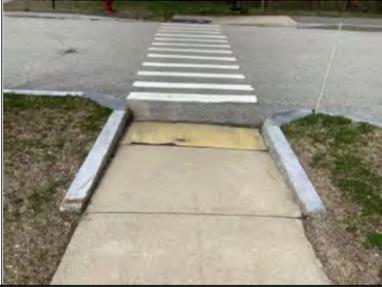
Surface not stable, firm and slip-resistant	-	Repair surface. The detectable warning is damaged and peeling.	1	
Off-Street Parking Lot or Garage											
7	Northwest Parking Area by Main Entrance			Off-Street Parking Lot or Garage	Visitor

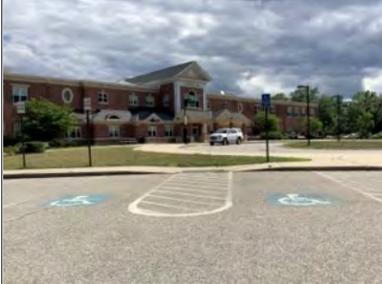
Total # of parking Total # of designated accessible parking spaces Total # of designated van accessible spaces Sign not provided Sign does not have the designation "Van Accessible"	52 2 1 - -	Provide a sign with the International Symbol of Accessibility (ISA) with the bottom of the sign 60" min. above the ground and the top 96" max. above the ground at each parking space. (It is not provided at two (2) of the spaces.) Add the designation "Van Accessible" to the sign located at the van accessible space.	3

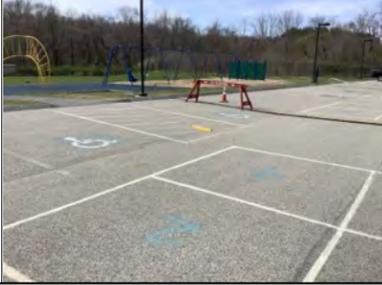
8	Parking by Drop-Off Area on South Side of School	Ext.		Off-Street Parking Lot or Garage	Visitor

Total # of parking Total # of designated accessible parking spaces Total # of designated van accessible spaces Running or cross slope at space > 1:50 (2.00%) Sign not provided Sign does not have the designation "Van Accessible"	74 1 1 3.0% - -	Provide one additional standard accessible parking space in this area. Reduce running or cross slope to be no steeper than 1:50 (2.00%). Provide a sign with the International Symbol of Accessibility at the front of both parking spaces. Add the designation "Van Accessible" to the sign located at the van accessible space.	1	
Passenger Loading Zones											
9	Drop-Off Area by Gym	Ext.		Passenger Loading Zones	N/A

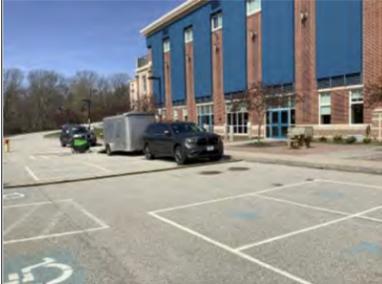
Marking not provided at access aisle Sign with ISA not provided (MAAB)	- -	Ensure access aisles are marked so as to discourage parking in them. Provide a sign that includes the International Symbol of Accessibility (ISA) at the head of the space. Locate the sign so that the bottom is 60" min. above the ground and the top is 96" max. above the ground.	1

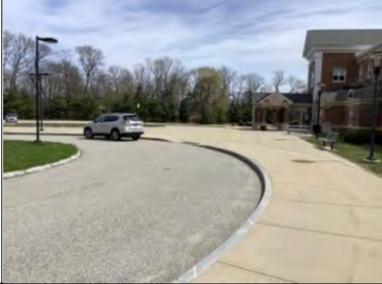
10	West Drop-Off Area by Main Entrance	Ext.		Passenger Loading Zones	N/A

Marking not provided at access aisle Sign with ISA not provided (MAAB)	- -	Ensure access aisles are marked so as to discourage parking in them. Provide a sign that includes the International Symbol of Accessibility (ISA) at the head of the space. Locate the sign so that the bottom is 60" min. above the ground and the top is 96" max. above the ground.	1

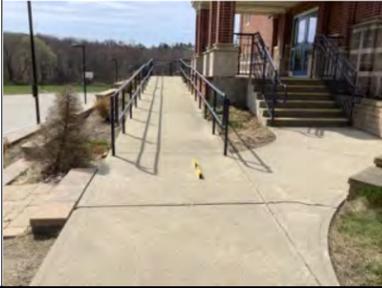
Landing has a slope > 1:50 in either direction	3.5%	Rebuild the ramp to ensure that the slope of the landing does not exceed 1:50 (2.00%).	1	
Emergency Exit											
13	Northeast Egress Door to Exterior by Classroom 109	1		Emergency Exit	N/A

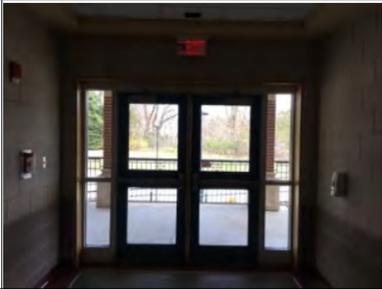
Tactile sign not provided at exit	-	Provide tactile exit signs with raised characters and braille at exit doors. Mount signs between 48"- 60" above the finished floor located on the latch side of the door.	1

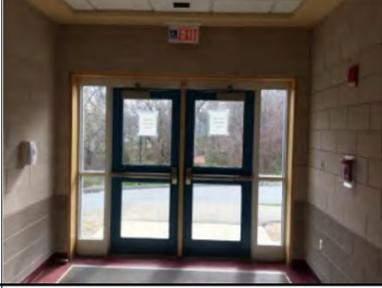
14	Egress Door 14	1		Emergency Exit	N/A

Tactile sign not provided at exit	-	Provide tactile exit signs with raised characters and braille at exit doors. Mount signs between 48"- 60" above the finished floor located on the latch side of the door.	1	
15	Stage Exit Door to Stairs	LL	3	Emergency Exit	N/A

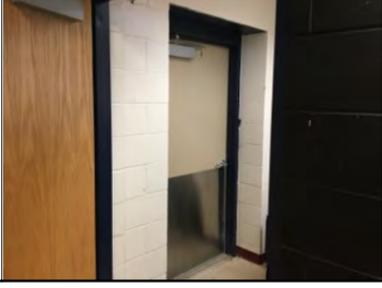
Tactile sign not provided at exit Directional sign to accessible emergency exit not provided	- -	Provide tactile exit signs with raised characters and braille at exit doors. Mount signs between 48"- 60" above the finished floor located on the latch side of the door. Provide a directional sign indicating the location of the nearest accessible emergency exit.	1

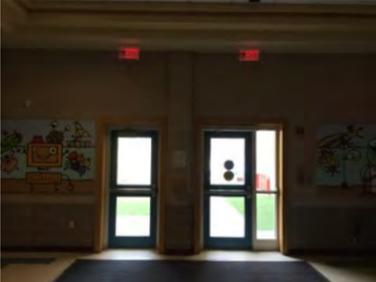
ID	Location	Floor	Room	Element	Type	Photo	Issues	Current Measure	Recommendations	Quantity	Notes
16	Exit doors From Southeast Corridor by the Cafeteria	LL		Emergency Exit	N/A

Tactile sign not provided at exit Illuminated Int. Symbol of Acc. not provided (MAAB 2006)	- -	Provide tactile exit signs with raised characters and braille at exit doors. Mount signs between 48"- 60" above the finished floor located on the latch side of the door. Provide an illuminated sign with the International Symbol of Accessibility (ISA).	2	
17	Cafeteria Exit Doors	LL	3	Emergency Exit	N/A

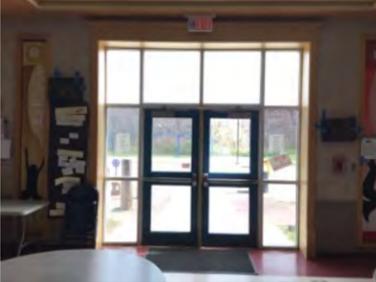
Tactile sign not provided at exit Illuminated Int. Symbol of Acc. not provided (MAAB 2006)	- -	Provide tactile exit signs with raised characters and braille at exit doors. Mount signs between 48"- 60" above the finished floor located on the latch side of the door. Provide an illuminated sign with the International Symbol of Accessibility (ISA).	2

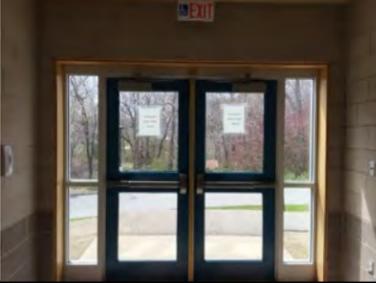
18	Egress Exit Door to Exterior by Room 126 and 127	1		Emergency Exit	N/A

Tactile sign not provided at exit Door requires > 15 lbs. of force to open	- 18 lbs	Provide tactile exit signs with raised characters and braille at exit doors. Mount signs between 48"- 60" above the finished floor located on the latch side of the door. Adjust closers of exterior doors so doors do not require more than 15 pounds of force.	1	
Access to Goods and Services											
Means of Egress											
19	Main Entrance/ Egress	1		Means of Egress	N/A

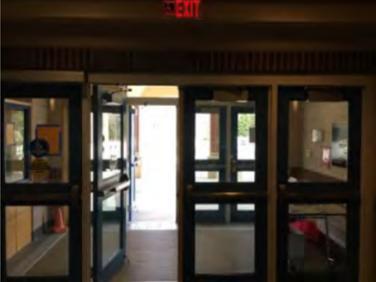
Tactile exit sign not provided	-	Ensure tactile exit signs with raised characters and braille are provided at exit doors. Mount signs between 48"- 60" above the finished floor located on the latch side of the door.	1	
20	Egress Door 14	1		Means of Egress	N/A

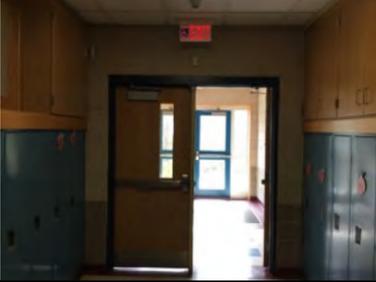
Tactile exit sign not provided		Ensure tactile exit signs with raised characters and braille are provided at exit doors. Mount signs between 48"- 60" above the finished floor located on the latch side of the door.	1

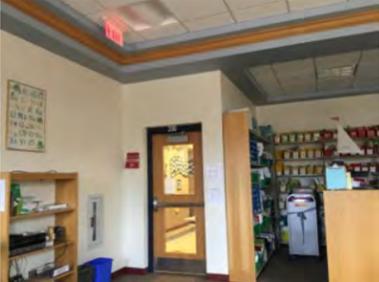
ID	Location	Floor	Room	Element	Type	Photo	Issues	Current Measure	Recommendations	Quantity	Notes
21	Library Egress 2	2	200	Means of Egress	N/A

Tactile exit sign not provided	-	Ensure tactile exit signs with raised characters and braille are provided at exit doors. Mount signs between 48"- 60" above the finished floor located on the latch side of the door.	1	
22	Main Entrance/ Egress	1		Means of Egress	N/A

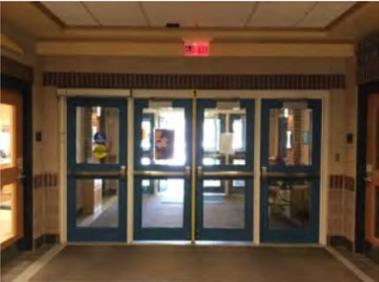
Tactile exit sign not provided Illuminated ISA symbol not provided (MAAB)	- -	Ensure tactile exit signs with raised characters and braille are provided at exit doors. Mount signs between 48"- 60" above the finished floor located on the latch side of the door. Provide an illuminated sign with the International Symbol of Accessibility (ISA).	1	
23	Stage Exit Door to Stairs	LL	3	Means of Egress	N/A

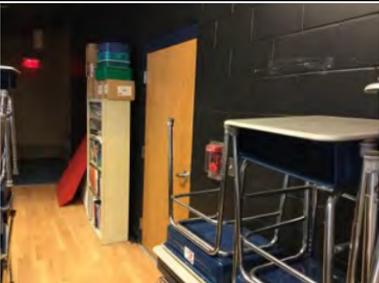
Tactile exit sign not provided Directional sign to accessible emergency exit not provided	- -	Ensure tactile exit signs with raised characters and braille are provided at exit doors. Mount signs between 48"- 60" above the finished floor located on the latch side of the door. Provide a directional sign indicating the location of the nearest accessible emergency exit.	1

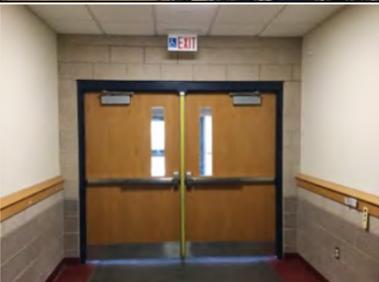
24	Northeast Egress Door to Vestibule by Classroom 109	1		Means of Egress	N/A

Illuminated ISA symbol not provided (MAAB)	- -	Provide an illuminated sign with the International Symbol of Accessibility (ISA).	1	
25	Egress Exit Door to Vestibule by Room 126 and 127	1		Means of Egress	N/A

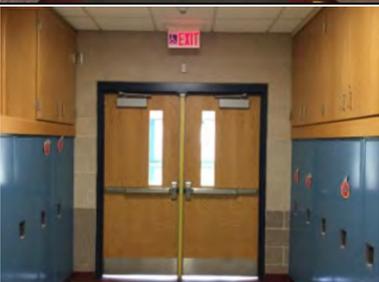
Illuminated ISA symbol not provided (MAAB)	- -	Provide an illuminated sign with the International Symbol of Accessibility (ISA).	1

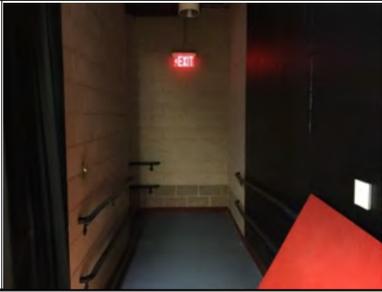
ID	Location	Floor	Room	Element	Type	Photo	Issues	Current Measure	Recommendations	Quantity	Notes
26	Stage	LL	3	Means of Egress	N/A

Illuminated ISA symbol not provided (MAAB)	-	Provide an illuminated sign with the International Symbol of Accessibility (ISA).	1	
Interior Access Route											
27	Small Group Room	1	106A	Interior Access Route	N/A

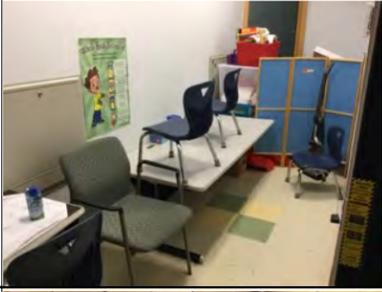
Route < 36" wide	29.5"	Ensure that a clear width of 36" min. is maintained at the accessible route.	1	
28	Kindergarten Classroom	1	111	Interior Access Route	N/A

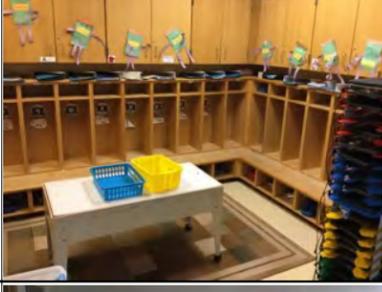
Route < 36" wide	27"	Ensure that a clear width of 36" min. is maintained at the accessible route.	1	
29	Library	2	200	Interior Access Route	N/A

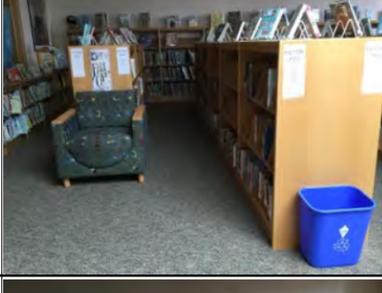
Route < 36" wide	31"	Ensure that a clear width of 36" min. is maintained at the accessible route.	1	
30	Library	2	200	Interior Access Route	N/A

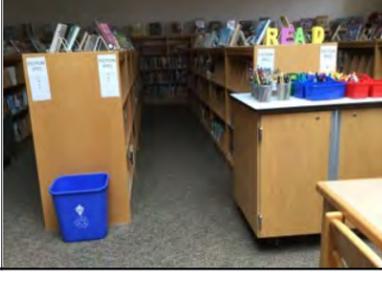
Route < 36" wide	29"	Ensure that a clear width of 36" min. is maintained at the accessible route.	1

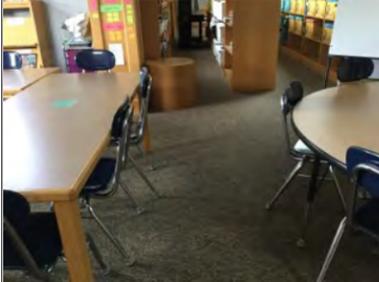
ID	Location	Floor	Room	Element	Type	Photo	Issues	Current Measure	Recommendations	Quantity	Notes
31	Library	2	200	Interior Access Route	N/A

Route < 36" wide	31"	Ensure that a clear width of 36" min. is maintained at the accessible route.	1	
32	Small Group Room	2	215B	Interior Access Route	N/A

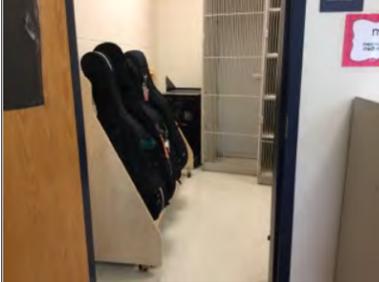
Route < 36" wide	26"	Ensure that a clear width of 36" min. is maintained at the accessible route.	1	
33	Corridor by Multipurpose Room	1	115	Interior Access Route	N/A

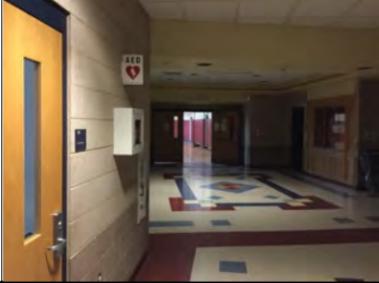
Obstructed by protruding objects	6.2"	Relocate defibrillator out of the circulation path.	1	
Doors, Doorways, & Gates											
34	Assistant Principal's Office	1	100 B	Doors, Doorways, & Gates	Office

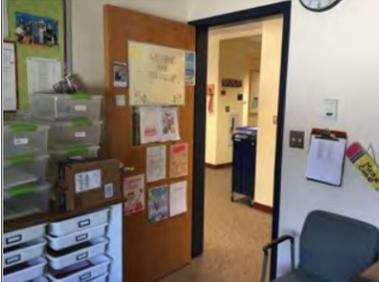
Maneuvering clearance(s) not provided	-	Relocate furniture to provide maneuvering clearance at the door.	1	
35	Principal's Office	1	100 C	Doors, Doorways, & Gates	Office

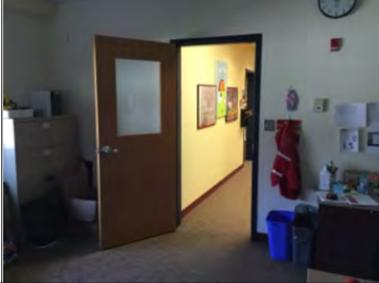
Maneuvering clearance(s) not provided	-	Relocate items on the latch side of the door to ensure that there is 18" clear min.	1

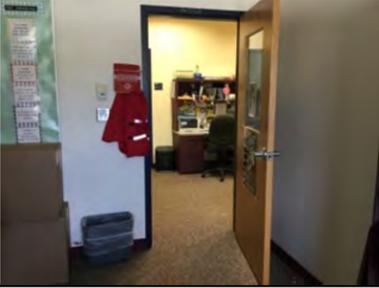
ID	Location	Floor	Room	Element	Type	Photo	Issues	Current Measure	Recommendations	Quantity	Notes
36	Counselor's Office	1	101B	Doors, Doorways, & Gates	Office

Maneuvering clearance(s) not provided	-	Relocate items on the latch side of the door to ensure that there is 18" clear min.	1	
37	Conference Room	1	101F	Doors, Doorways, & Gates	Meeting Room

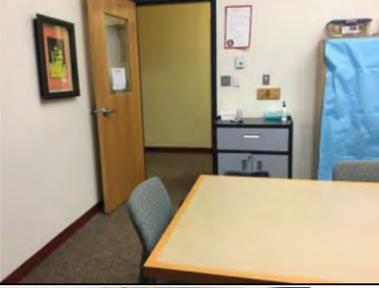
Maneuvering clearance(s) not provided	-	Relocate the furniture so that there is 18" on the latch side of the door.	1	
38	Secondary Entrance to Health Office	1	103	Doors, Doorways, & Gates	Office

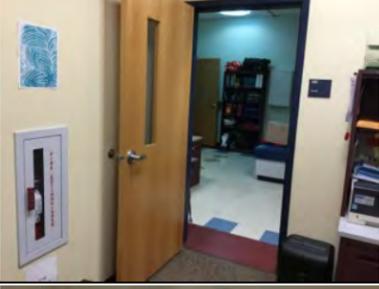
Maneuvering clearance(s) not provided	16"	Relocate items on the latch side of the door to ensure that there is 18" clear min.	1	
39	Special Education English Classroom	2	202	Doors, Doorways, & Gates	Office

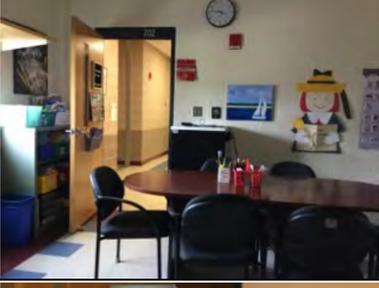
Maneuvering clearance(s) not provided	-	Relocate the table so that there is 18" clear on the latch side of the door.	1	
40	Special Education Math Classroom	2	211A	Doors, Doorways, & Gates	Classroom

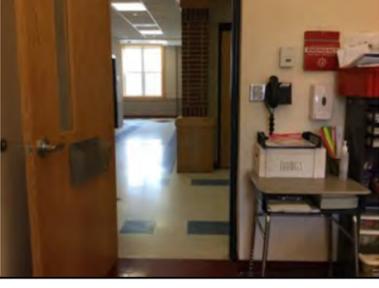
Maneuvering clearance(s) not provided	-	Relocate desk.	1

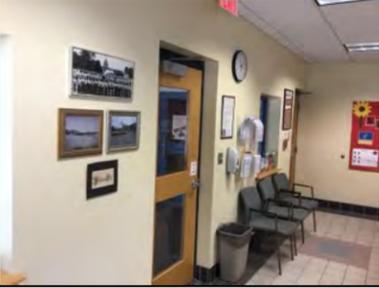
ID	Location	Floor	Room	Element	Type	Photo	Issues	Current Measure	Recommendations	Quantity	Notes
41	Main Office	1	100	Doors, Doorways, & Gates	Office

Maneuvering clearance(s) not provided Door requires > 5 lbs. of force to open	- 8 lbs	Relocate trash bin to provide maneuvering clearance alongside the door. Adjust closers so doors do not require more than 5 pounds of force to open.	1	
42	Staff and Public Toilet Room by Classroom 110	1		Doors, Doorways, & Gates	Toilet Room

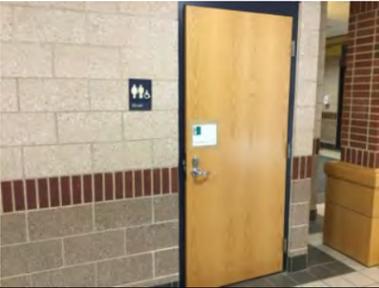
Door requires > 5 lbs. of force to open	10 lbs	Adjust closers so doors do not require more than 5 pounds of force to open.	1	
43	Staff and Public Toilet Room (Facing Classroom 102)	1		Doors, Doorways, & Gates	Other

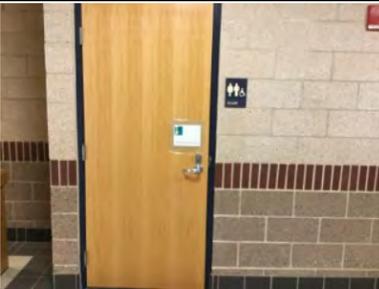
Door requires > 5 lbs. of force to open	8 lbs	Adjust closers so doors do not require more than 5 pounds of force to open.	1	
44	Student Services Entrance From Corridor	1	101	Doors, Doorways, & Gates	Office

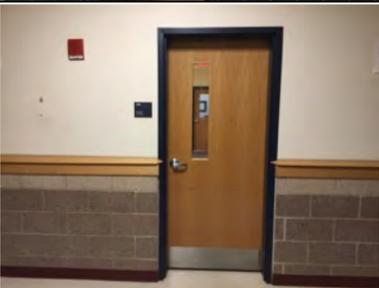
Door requires > 5 lbs. of force to open	12 lbs	Adjust closers so doors do not require more than 5 pounds of force to open.	1

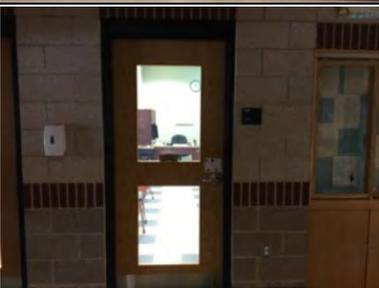
45	Nurse's Office	1	103	Doors, Doorways, & Gates	Office

Door requires > 5 lbs. of force to open	10 lbs	Adjust closers so doors do not require more than 5 pounds of force to open.	1

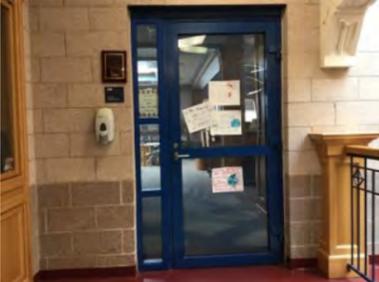
Door requires > 5 lbs. of force to open	9 lbs	Adjust closers so doors do not require more than 5 pounds of force to open.	1	
47	Staff and Public Toilet Room	LL		Doors, Doorways, & Gates	Toilet Room

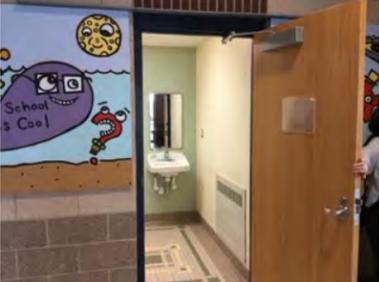
Door requires > 5 lbs. of force to open	10 lbs	Adjust closers so doors do not require more than 5 pounds of force to open.	1	
Ramps											
48	Ramp to Stage	LL	3	Ramps	Interior

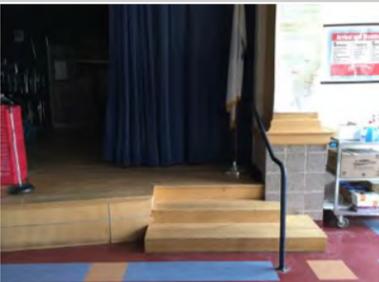
Handrail not provided on both sides	-	Provide handrails on both sides.	1	
50	Stage	LL	3	Stairways	Other

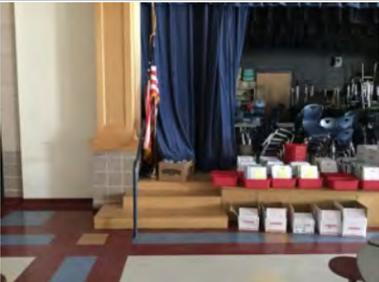
Handrail not provided on both sides	-	Provide handrails on both sides.	1

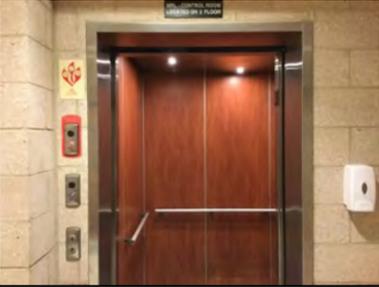
Hoistway signs not on both jambs	-	Provide hoistway signs on both sides of jambs.	2	
52	Elevator	LL		Elevator	Interior

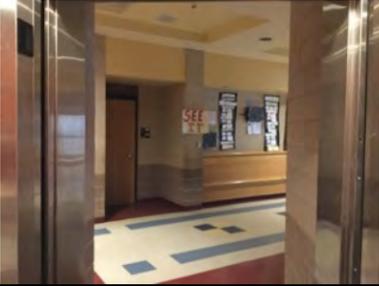
Hoistway signs not on both jambs	-	Provide hoistway signs on both sides of jambs.	2	
Signage											
53	Main Office	1	100	Signage	Designation

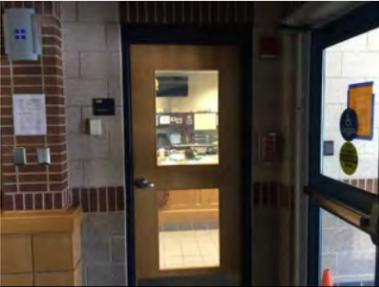
Raised characters < 48" or > 60" above ground	64"	Mount signs so that the baseline of the lowest tactile character is 48" min. above finished floor and the baseline of the highest tactile character is 60" max. above the finished floor.	1	
54	Principal's Office	1	100 C	Signage	Designation

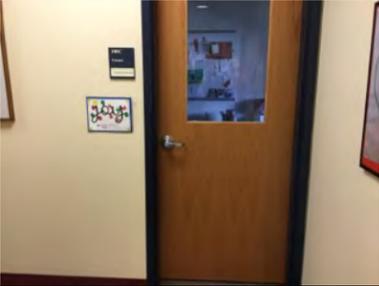
Raised characters < 48" or > 60" above ground	62"	Mount signs so that the baseline of the lowest tactile character is 48" min. above finished floor and the baseline of the highest tactile character is 60" max. above the finished floor.	1

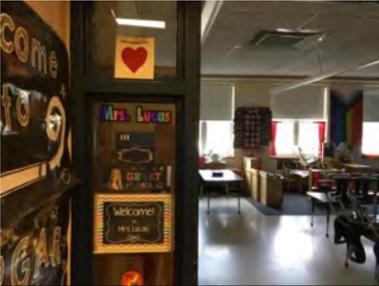
55	Kindergarten Classroom	1	111	Signage	Designation

Raised characters < 48" or > 60" above ground	61.5"	Mount signs so that the baseline of the lowest tactile character is 48" min. above finished floor and the baseline of the highest tactile character is 60" max. above the finished floor.	1

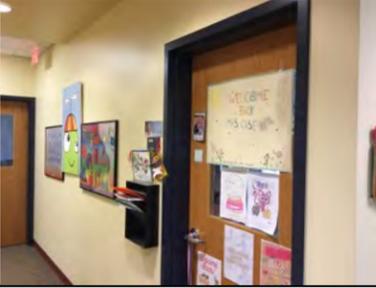
Raised characters < 48" or > 60" above ground Signage lacks 18" by 18" clear floor space	62" -	Mount signs so that the baseline of the lowest tactile character is 48" min. above finished floor and the baseline of the highest tactile character is 60" max. above the finished floor. Relocate the black box to provide a clear floor space of 18" min. by 18" min. at the designation sign.	1	
57	Counselor's Office	1	101A	Signage	Designation

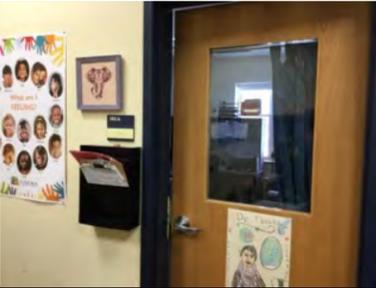
Raised characters < 48" or > 60" above ground Signage lacks 18" by 18" clear floor space	62" -	Mount signs so that the baseline of the lowest tactile character is 48" min. above finished floor and the baseline of the highest tactile character is 60" max. above the finished floor. Relocate the black file folder to provide a clear floor space of 18" min. by 18" min. at the designation sign.	1

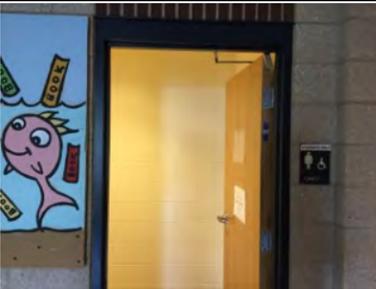
58	Girls' Toilet Room	LL		Signage	Designation

Sign not located on the latch side of the door	-	Locate the sign at permanent rooms alongside the door on the latch side.	1	
59	Staff and Public Toilet Room	LL		Signage	Designation

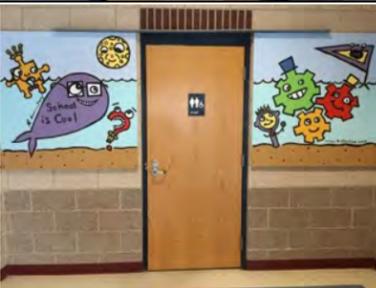
Sign not located on the latch side of the door	-	Locate the sign at permanent rooms alongside the door on the latch side.	1	
60	Director, Pre-Kindergarten and Special Education Office	1	101D	Signage	Designation

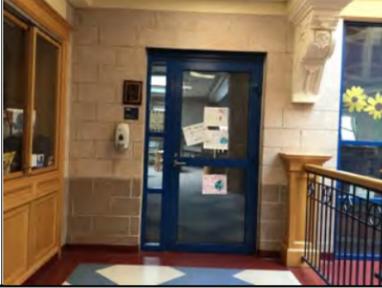
Signage lacks 18" by 18" clear floor space	-	Relocate soap dispenser to provide a clear floor space of 18" min. by 18" min. at the designation sign.	1	
Operable Parts											
62	Main Office	1	100	Operable Parts	Other

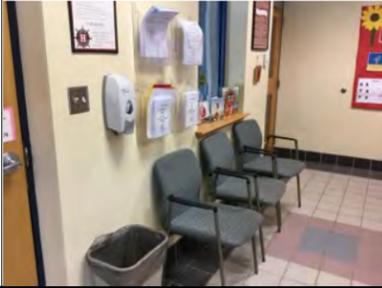
Reach < 15" or > 48"(forward/side approach)	64.5"	Ensure that some of each type of flyer are located no higher than 48" and not obstructed by chairs.	1	
Dining or Work Surfaces											
63	Reading Special Education for Pre-Kindergarten and Kindergarten Office	1	101C	Dining or Work Surfaces	Work Surface

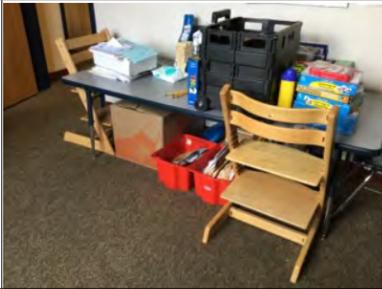
At least one or 5% accessible tables not provided Knee or toe clearance not provided	- 21"	Ensure that at least one (1) work surface is accessible. Provide at least one (1) work surface with 24" min. knee and toe clearance.	1	
64	Director Pre-K and Special Education Office	1	101D	Dining or Work Surfaces	Work Surface

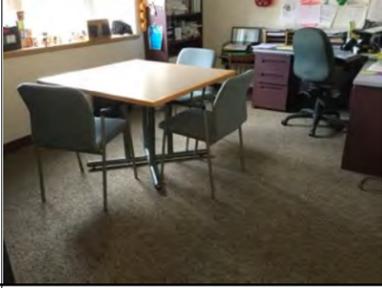
Knee or toe clearance not provided	Toe	Provide at least one (1) work surface with toe clearance.	1

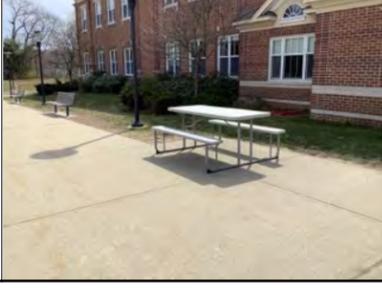
65	By Main Entrance	Ext.		Dining or Work Surfaces	Dining Surface

Knee or toe clearance not provided	-	Provide at least one (1) picnic table with 24" min. knee and toe clearance that is 19" deep min.	1

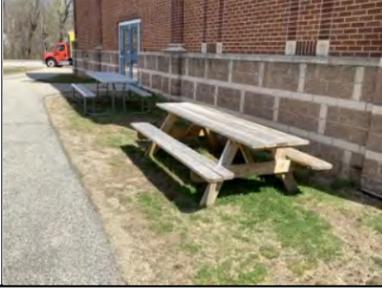
Knee or toe clearance not provided Surface not stable, firm, and slip-resistant Not on a accessible route At least one or 5% accessible tables not provided	- - - -	Ensure at least one (1) picnic table is located on an accessible route. Provide at least one (1) dining or work surface with 24" min. knee and toe clearance.	1	
Locker Room											
67	Corridor by Stair 4	2	223	Locker Room	N/A

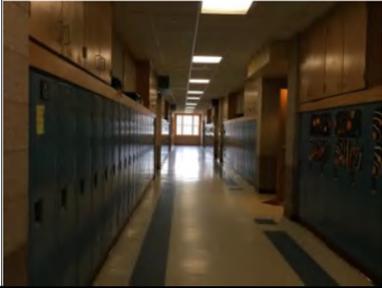
5% of lockers are not accessible	-	Provide at least one accessible locker (or ensure 5% of all lockers are accessible) .	1	
Toilet & Bathing Rooms											
Lavatory											
68	Staff and Public Toilet Room by Classroom 110	1		Lavatory	N/A

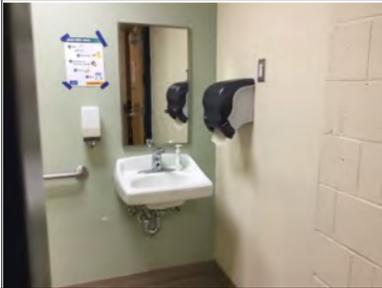
Plumbing underneath is exposed	-	Insulate or otherwise configure pipes to prevent contact at lavatory.	1

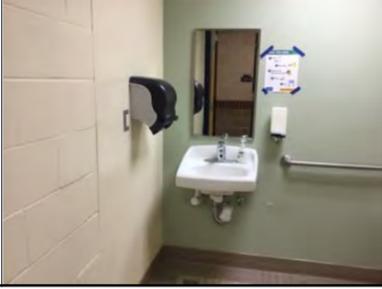
69	Staff and Public Toilet Room (Facing Classroom 102)	1		Lavatory	N/A

Plumbing underneath is exposed		Insulate or otherwise configure pipes to prevent contact at lavatory.	1

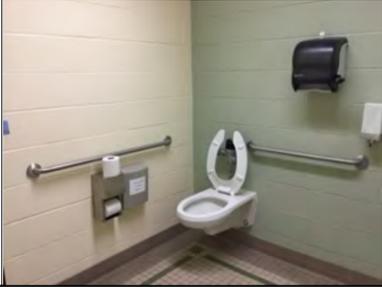
Paper towel dispenser mounted over the grab bar	-	Ensure that no dispensers are mounted over the grab bars.	1	
Toilet Compartment											
71	Boys' Toilet Room	LL		Toilet Compartment	Accessible Compartment

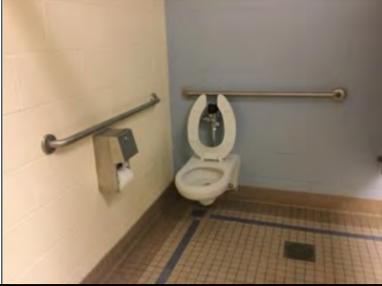
Toilet seat <17" or > 19" high Centerline < or > 18" (MAAB)	15" 14.5"	Install a toilet with a seat height 17"- 19" above the finished floor. Relocate toilet so the centerline is 18" from the side wall.	1	
72	Girls' Toilet Room	LL		Toilet Compartment	Accessible Compartment

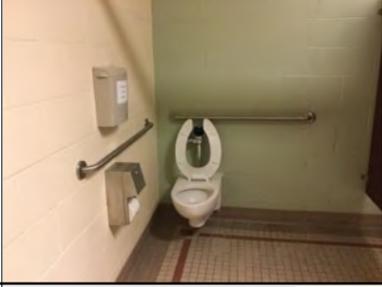
Object mounted over the grab bar	-	Ensure that nothing is mounted over the grab bars.	1	
73	Boys' Toilet Room	LL		Toilet Compartment	Accessible Compartment

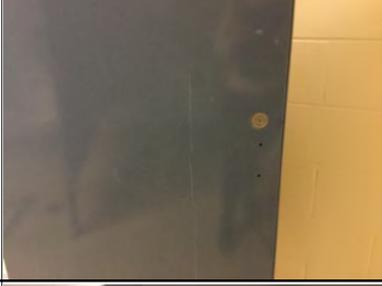
Door pull not provided		Provide a door pull on each side of the door between 34" to 48" above the finished floor that does not require tight grasping, pinching or twisting of the wrist.	1

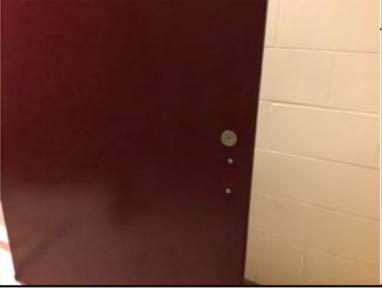
Door pull not provided	-	Provide a door pull on each side of the door between 34" to 48" above the finished floor that does not require tight grasping, pinching or twisting of the wrist.	1	
Urinal											
76	Boys' Toilet Room	LL		Urinal	N/A

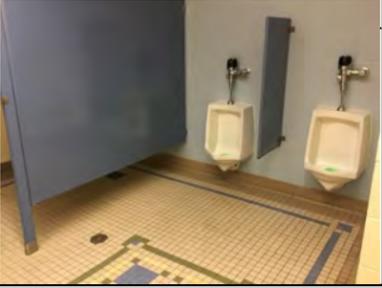
Flush control too high or not properly located	47.5"	Mount flush control at 44" max. above the finished floor.	1	
Dispensers											
77	Staff and Public Toilet Room by Rooms 110 and 102	1		Dispensers	Paper Towel Dispenser

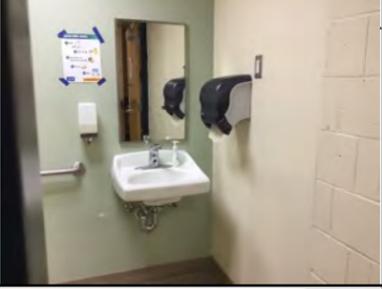
Dispenser acts as a protruding object	-	Relocate paper towel dispenser out of the circulation path.	2	
78	Boys' Toilet Room	LL		Dispensers	Paper Towel Dispenser

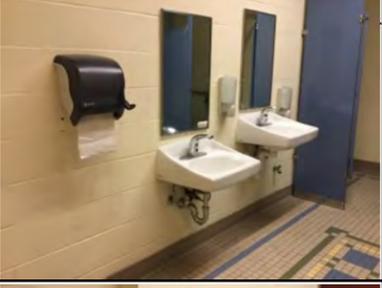
Dispenser acts as a protruding object	8"	Relocate dispenser out of the circulation path.	1	
79	Girls' Toilet Room	LL		Dispensers	Paper Towel Dispenser

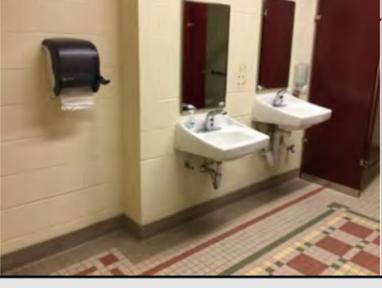
Dispenser acts as a protruding object	8"	Relocate dispenser out of the circulation path.	1

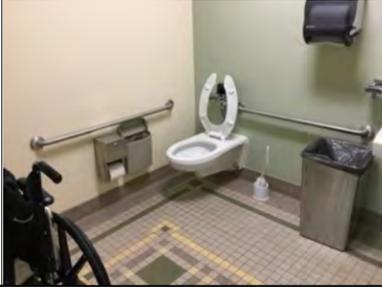
Paper towel dispenser mounted over the grab bar		Ensure that no dispensers are mounted over the grab bars.	1	
81	Pre-K Classroom Toilet Room	1	107	Single-User Toilet (Children)	N/A

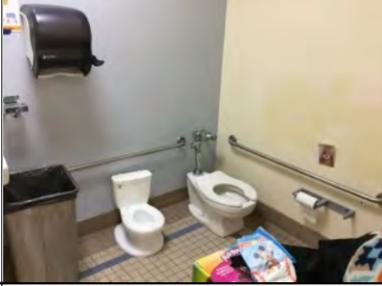
Paper towel dispenser mounted over the grab bar	-	Ensure that no dispensers are mounted over the grab bars.	1	
82	RISE Program Classroom Toilet Room	1	110	Single-User Toilet (Children)	N/A

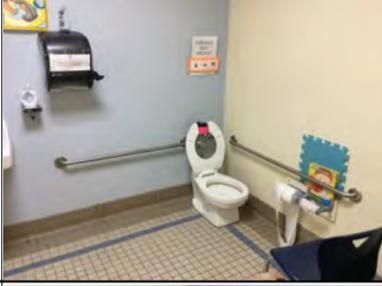
Paper towel dispenser mounted over the grab bar	-	Ensure that no dispensers are mounted over the grab bars.	1	
83	Kindergarten Classroom Toilet Room	1	111	Single-User Toilet (Children)	N/A

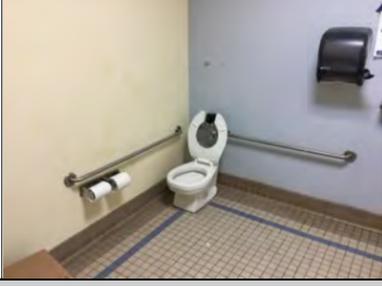
Paper towel dispenser mounted over the grab bar	-	Ensure that no dispensers are mounted over the grab bars.	1	
Toilet Compartment (Children)

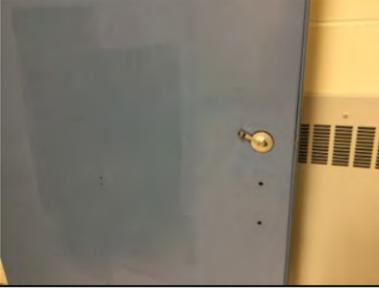
Door with malfunctioning self-closing hinge Door pull not provided	- -	Repair self-closing hinge. Provide a door pull on each side of the door between 34" to 48" above the finished floor that does not require tight grasping, pinching or twisting of the wrist.	1	
86	Boys' Toilet Room by Classroom 202 (Exterior of Compartment)	2		Toilet Compartment (Children)	Accessible Compartment

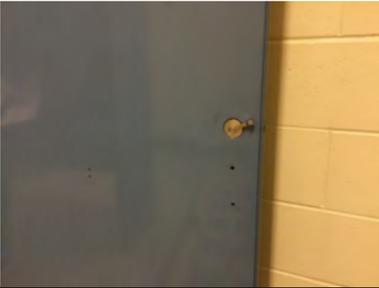
Door with malfunctioning self-closing hinge Door pull not provided	- -	Repair self-closing hinge. Provide a door pull on each side of the door between 34" to 48" above the finished floor that does not require tight grasping, pinching or twisting of the wrist.	1	
87	Girls' Toilet Room by Gym	1		Toilet Compartment (Children)	Accessible Compartment

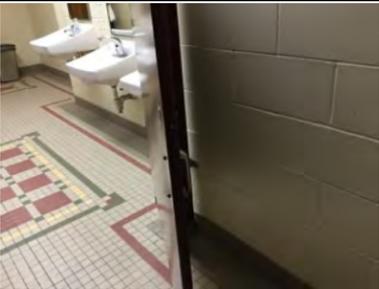
Door pull not provided	- -	Provide a door pull on each side of the door between 34" to 48" above the finished floor that does not require tight grasping, pinching or twisting of the wrist.	1

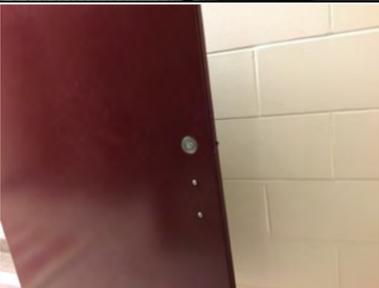
88	Girls' Toilet Room by Elevator (Exterior of Compartment)	2		Toilet Compartment (Children)	Accessible Compartment

Door pull not provided	-	Provide a door pull on each side of the door between 34" to 48" above the finished floor that does not require tight grasping, pinching or twisting of the wrist.	1	
89	Boys' Toilet Room by Elevator (Exterior of Compartment)	2		Toilet Compartment (Children)	Accessible Compartment

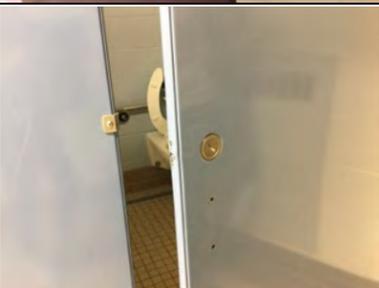
Door pull not provided	-	Provide a door pull on each side of the door between 34" to 48" above the finished floor that does not require tight grasping, pinching or twisting of the wrist.	1

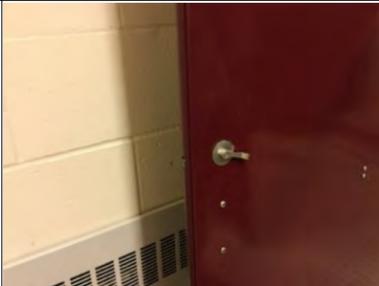
ID	Location	Floor	Room	Element	Type	Photo	Issues	Current Measure	Recommendations	Quantity	Notes
90	Girls' Toilet Room by Classroom 210 (Interior of Compartment)	2		Toilet Compartment (Children)	Accessible Compartment

Door pull not provided	-	Provide a door pull on each side of the door between 34" to 48" above the finished floor that does not require tight grasping, pinching or twisting of the wrist.	1	
91	Boys' Toilet Room by Classroom 202 (Interior of Compartment)	2		Toilet Compartment (Children)	Accessible Compartment

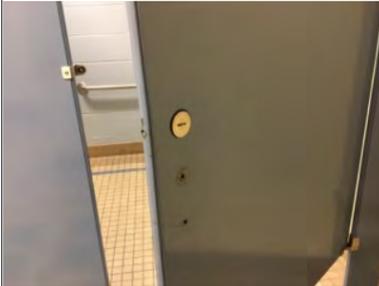
Door pull not provided	-	Provide a door pull on each side of the door between 34" to 48" above the finished floor that does not require tight grasping, pinching or twisting of the wrist.	1	
92	Girls' Toilet Room by Elevator	2		Toilet Compartment (Children)	Accessible Compartment

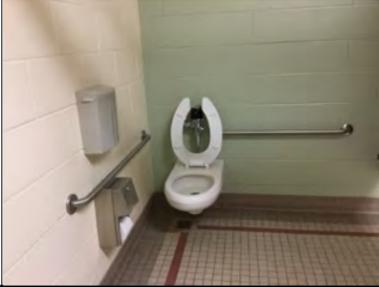
Object mounted over the grab bar		Ensure that nothing is mounted over the grab bars, including the sanitary napkin disposal bin.	1

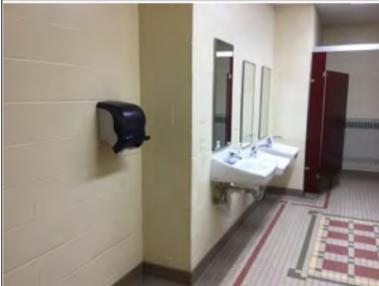
Lavatory (Children)											
93	Girls' Toilet Room by Gym	1		Lavatory (Children)	N/A

Lavatory rim or counter > 30" Mirror above lavatory w/reflective surface > 31"	33" 39"	Relocate lavatory with the front of the rim or counter no higher than 30" above the finished floor. Lower mirror so that the bottom surface is at 31" above the finished floor.	1	
94	Boys' Toilet Room by Gym	1		Lavatory (Children)	N/A

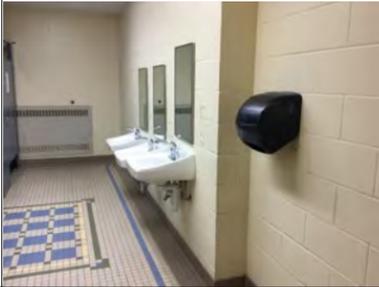
Lavatory rim or counter > 30" Mirror above lavatory w/reflective surface > 31"	33" 40"	Relocate lavatory with the front of the rim or counter no higher than 30" above the finished floor. Lower mirror so that the bottom surface is at 31" above the finished floor.	1

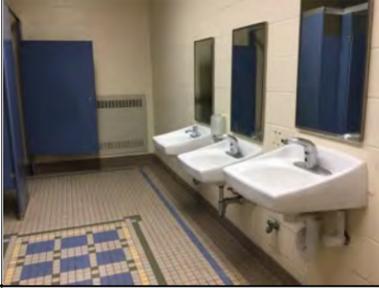
ID	Location	Floor	Room	Element	Type	Photo	Issues	Current Measure	Recommendations	Quantity	Notes
95	Boys' Toilet Room by Elevator	2		Lavatory (Children)	N/A

Lavatory rim or counter > 30" Mirror above lavatory w/reflective surface > 31"	33.5" 40"	Relocate lavatory with the front of the rim or counter no higher than 30" above the finished floor. Lower mirror so that the bottom surface is at 31" above the finished floor.	1	
96	Girls' Toilet Room by Classroom 210	2		Lavatory (Children)	N/A

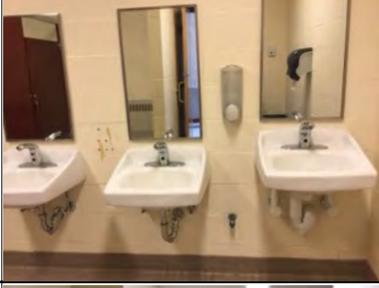
Lavatory rim or counter > 30" Mirror above lavatory w/reflective surface > 31"	32.5" 40"	Relocate lavatory with the front of the rim or counter no higher than 30" above the finished floor. Lower mirror so that the bottom surface is at 31" above the finished floor.	1	
97	Girls' Toilet Room by Elevator	2		Lavatory (Children)	N/A

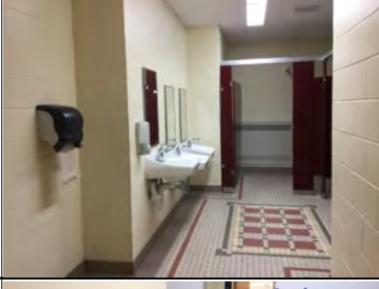
Lavatory rim or counter > 30" Mirror above lavatory w/reflective surface > 31"	33.5" 39.7"	Relocate lavatory with the front of the rim or counter no higher than 30" above the finished floor. Lower mirror so that the bottom surface is at 31" above the finished floor.	1

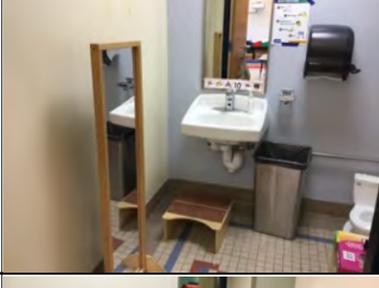
98	Pre-K Classroom Toilet Room	1	107	Lavatory (Children)	N/A

Faucet not operable with a closed fist	-	Provide a faucet that can be operable with one hand and not require tight grasping, pinching or twisting of the wrist for at least one lavatory.	1	
99	Nurse's Office Toilet Room	1	103	Lavatory (Children)	N/A

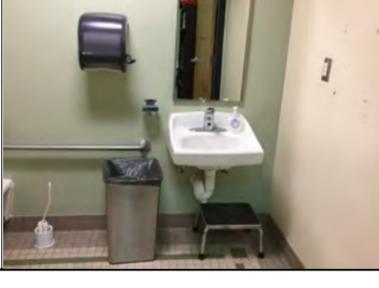
Mirror above lavatory w/reflective surface > 31"	36.5"	Lower mirror so that the bottom surface is at 31" above the finished floor.	1

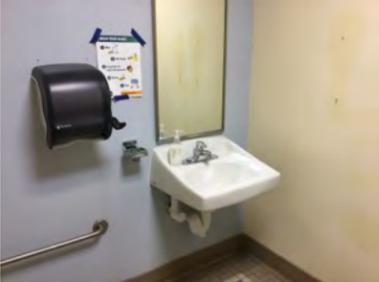
ID	Location	Floor	Room	Element	Type	Photo	Issues	Current Measure	Recommendations	Quantity	Notes
100	Kindergarten Classroom Toilet Room	1	111	Lavatory (Children)	N/A

Mirror above lavatory w/reflective surface > 31"	35"	Lower mirror so that the bottom surface is at 31" above the finished floor.	1	
101	Boys' Toilet Room by Classroom 202	2		Lavatory (Children)	N/A

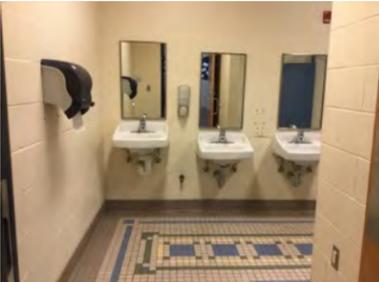
Mirror above lavatory w/reflective surface > 31" Exposed plumbing underneath	- 39"	Insulate or otherwise configure pipes to prevent contact, for at least one lavatory (that has a counter or rim no higher than 30" above the finished floor. Lower mirror so that the bottom surface is at 31" above the finished floor.	1	
Dispensers (Children)											
102	Girls' Toilet Room by Gym	1		Dispensers (Children)	Paper Towel Dispenser

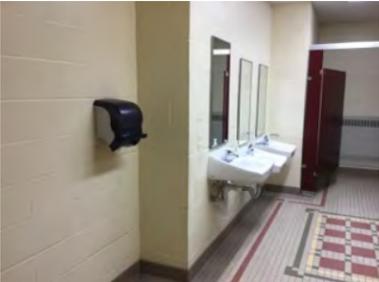
Dispenser is a protruding object	-	Relocate the paper towel dispenser out of the circulation path.	1

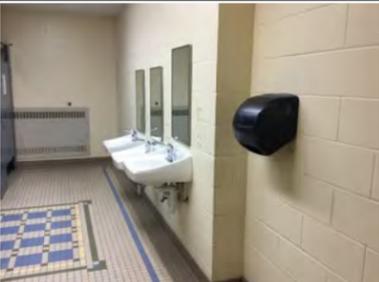
103	Boys' Toilet Room by Gym	1		Dispensers (Children)	Paper Towel Dispenser

Dispenser is a protruding object	-	Relocate the paper towel dispenser out of the circulation path.	1	
104	Girls' Toilet Room by Elevator	2		Dispensers (Children)	Paper Towel Dispenser

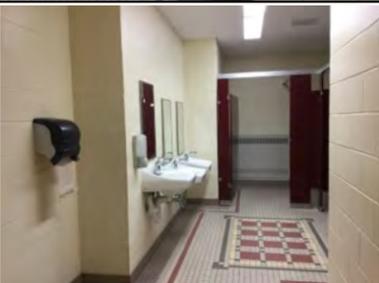
Dispenser is a protruding object	8"	Relocate the paper towel dispenser out of the circulation path.	1

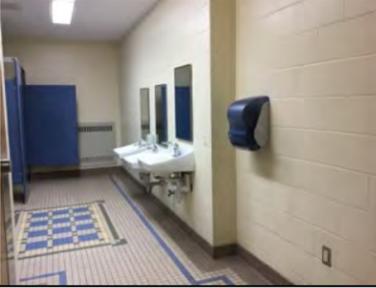
ID	Location	Floor	Room	Element	Type	Photo	Issues	Current Measure	Recommendations	Quantity	Notes
105	Boys' Toilet Room by Elevator	2		Dispensers (Children)	Paper Towel Dispenser

Dispenser is a protruding object	9"	Relocate the paper towel dispenser out of the circulation path.	1	
106	Girls' Toilet Room by Classroom 210	2		Dispensers (Children)	Paper Towel Dispenser

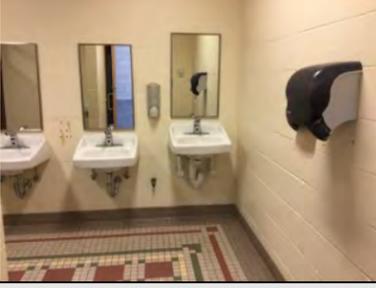
Dispenser is a protruding object	8.3"	Relocate the paper towel dispenser out of the circulation path.	1	
Additional Access											
Drinking Fountains											
107	Drinking Fountain by Elevator	2		Drinking Fountains	Hi-Lo

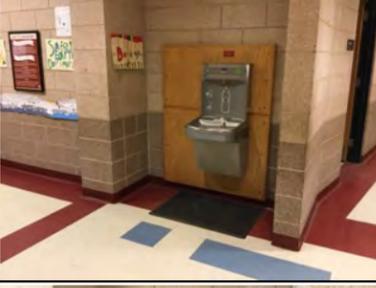
No drinking fountain provided for standing users	-	Provide an additional drinking fountain for standing users.	1	
109	By Classroom 211A	2		Drinking Fountains	Low

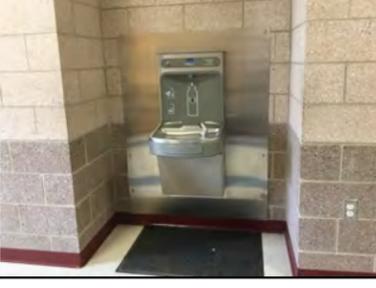
No drinking fountain provided for standing users	-	Provide an additional drinking fountain for standing users.	1

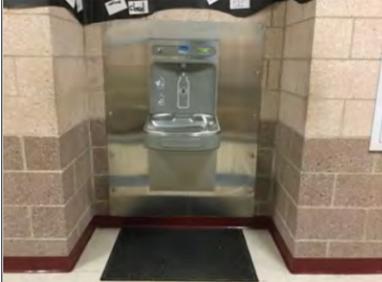
ID	Location	Floor	Room	Element	Type	Photo	Issues	Current Measure	Recommendations	Quantity	Notes
110	Drinking Fountain by Classroom 202	2		Drinking Fountains	Low

No drinking fountain provided for standing users No drinking fountain provided for seated users	23.3" knee 30" spout	Install a Hi-Lo drinking fountain.	1	
111	By Cafeteria	LL		Drinking Fountains	Hi-Lo

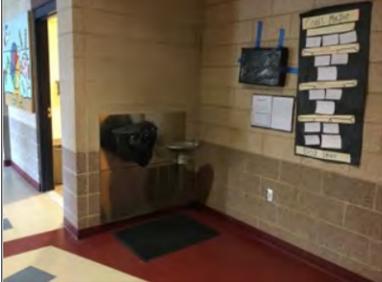
Standing height fountain does not have cane protection	-	Provide a cane-detectable barrier skirt under the high unit.	1	
Sink											
112	Nurse's Office	1	103	Sink	Other

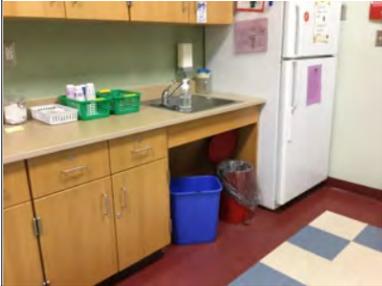
Toe and knee clearances not provided	-	Relocate the bins and items stored under all accessible sinks.	1	
Play and Sport Areas											
Play Areas											
113	Playground South of School by the Gym Parking Lot	Ext.		Play Areas	N/A

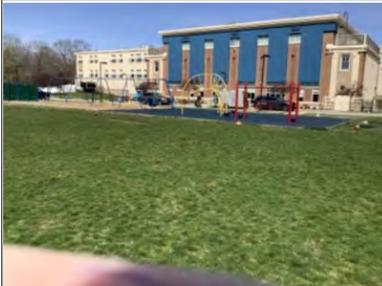
Accessible route not provided to playground Accessible route not provided around playground	- -	On the day of survey there was no accessible route to or around the playground. Ensure that an accessible route is provided to and around the playground.	1

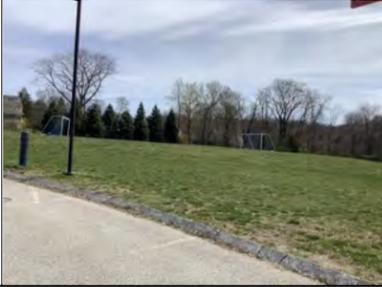
Field not connected to an accessible route	-	Provide an accessible route to the boundary of sport activity at the soccer field.	1	
Best Practice											
115	Staircase 3	1

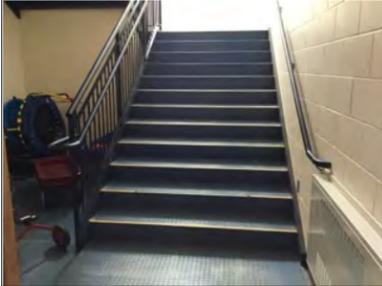
Recommend repairing contrast strips as they are beginning to peel off.	1	
116	Kindergarten Classroom	1	111

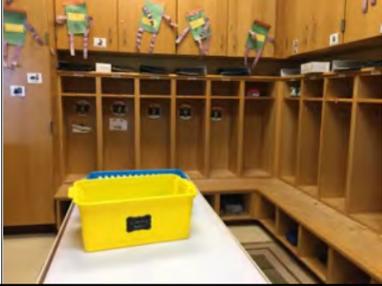
41"	Recommend providing storage at an accessible height for kindergarten-aged children based on the ADA 2010 Standards, between 20" and 36" above the finished floor.	1	
117	By Main Entrance	Ext.

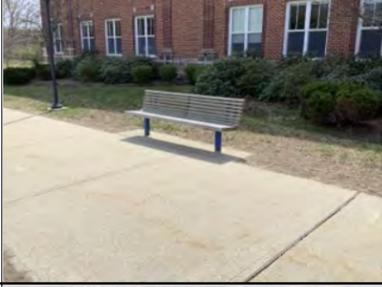
Recommend providing a 36" min. by 48" min. stable, firm and slip-resistant surface adjacent to at least one bench in the park in a manner that is substantially similar to what is shown in Figure 1 in the narrative report.	1	
118	Picnic Tables by Exit Door From Stairs by the Kitchen	Ext.

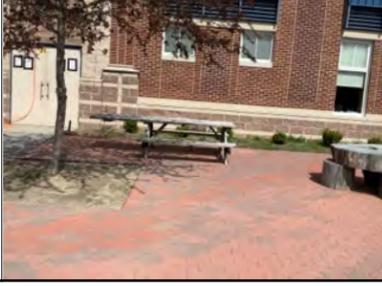
Recommend rotating the accessible picnic table on the south side of the school so that it is easier to get around all sides.	1

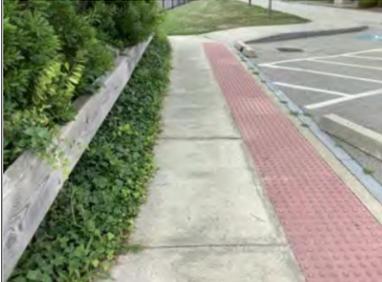
ID	Location	Floor	Room	Element	Type	Photo	Issues	Current Measure	Recommendations	Quantity	Notes
Approach and Entrance											
Exterior Access Route											
1	North Lot Parking Near Multi-Purpose Field B	Ext.		Exterior Access Route	Walkway

Exterior route < 36" wide	33"	Ensure that a clear width of 36" min. is maintained at the accessible route by trimming the bushes.	1	
2	Ramp to Egress Door 21, 22, 23, 24	Ext.		Exterior Access Route	Exterior

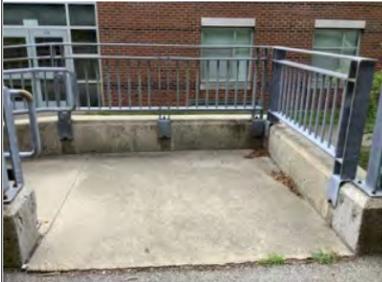
Surface openings > 1/2"	2"	Repair the surface between concrete and asphalt.	1	
3	To Egress Door 21 and 22	Ext.		Exterior Access Route	Walkway

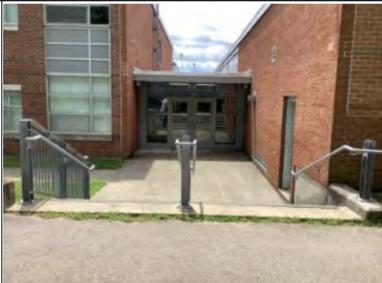
Surface openings > 1/2" Level changes > 1/4"	2" 0.5"	Repair surface between concrete and asphalt. Alter change in level to be 1/4" high max.	1	
4	Courtyard Near Cafeteria - Greenhouse	Ext.		Exterior Access Route	Exterior

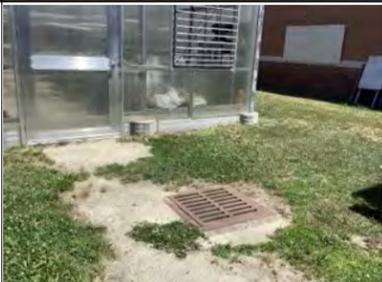
Surface openings > 1/2" Accessible route not provided	1.5" -	Ensure an accessible route is provided to the greenhouse. Replace or reposition so that openings are 1/2" max. and the long opening dimension is perpendicular to the dominant direction of travel.	1

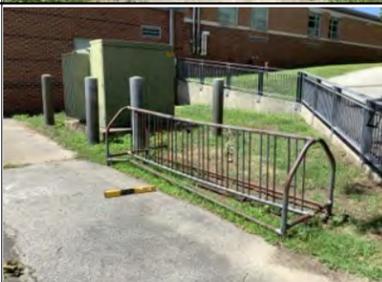
5	By Egress Door 28 and 29	Ext.		Exterior Access Route	Exterior

Cross slope > 1:50 (2.00%)	4%	Reduce cross slope to be no steeper than 1:50 (2.00%).	1

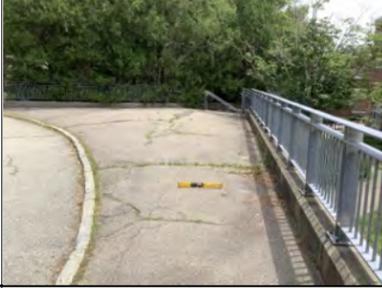
Cross slope > 1:50 (2.00%) Route not maintained in operable working condition	3% -	Reduce cross slope to be no steeper than 1:50 (2.00%). Ensure the accessible route is maintained in operable working condition by repairing the cracks in the asphalt.	1	
7	To Fields L, M, N, O, P, Q	Ext.		Exterior Access Route	Exterior

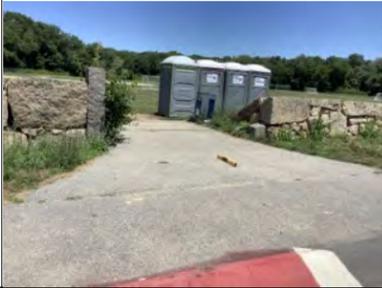
Running slope > 1:20 (5.00%)	7%	Reduce running slope to be no steeper than 1:20 (5.00%).	1	
8	To Fields L, M, N, O, P, Q	Ext.		Exterior Access Route	Walkway

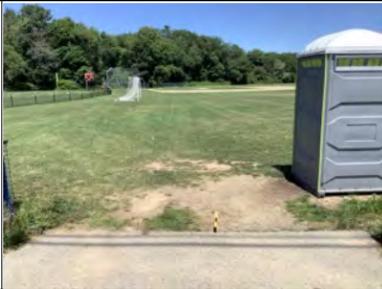
Running slope > 1:20 (5.00%)	10%	Reduce running slope to be no steeper than 1:20 (5.00%).	1	
9	Baseball Field L, 3rd Base Seating	Ext.		Exterior Access Route	Exterior

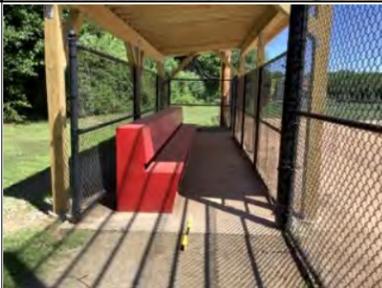
Running slope > 1:20 (5.00%)	9.5%	Reduce running slope to be no steeper than 1:20 (5.00%).	1

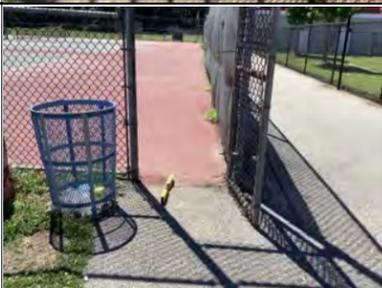
10	To Tennis Court	Ext.		Exterior Access Route	Exterior

Running slope > 1:20 (5.00%)	8%	Reduce running slope to be no steeper than 1:20 (5.00%).	1

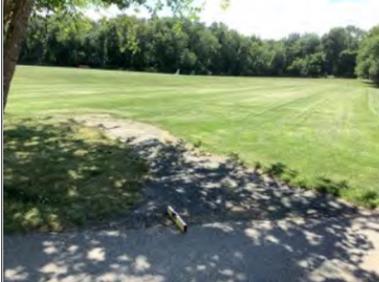
ID	Location	Floor	Room	Element	Type	Photo	Issues	Current Measure	Recommendations	Quantity	Notes
11	Baseball Field E to Soccer Field G	Ext.		Exterior Access Route	Exterior

Running slope > 1:20 (5.00%) Surface is not stable, firm, and slip-resistant Accessible route not provided	11.6% - -	Ensure an accessible route is provided to Baseball Field E and Soccer Field G. Reduce running slope to be no steeper than 1:20 (5.00%). Ensure that the surface is stable, firm and slip-resistant.	1	
12	Egress Door 13	Ext.		Exterior Access Route	Exterior

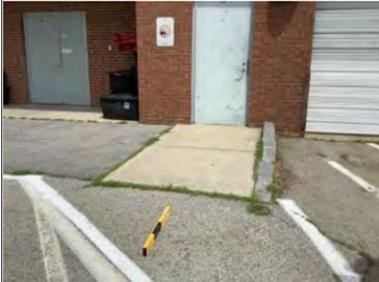
Running slope > 1:20 (5.00%) Route not maintained in operable working condition	7% -	Reduce running slope to be no steeper than 1:20 (5.00%). Ensure the accessible route is maintained in operable working condition.	1	
13	To Lacrosse Field I and H	Ext.		Exterior Access Route	Exterior
