East Elementary School

Town of Hingham ADA Transition Plan

October 2023

Institute for Human Centered Design

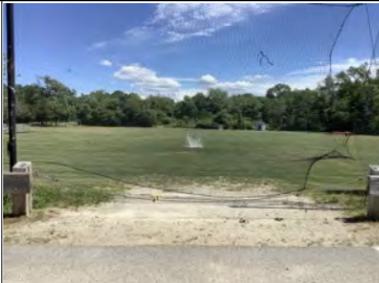
Running slope > 1:20 (5.00%) Accessible route not provided	11.2% -	Reduce running slope to be no steeper than 1:20 (5.00%). Ensure an accessible route is provided.	1

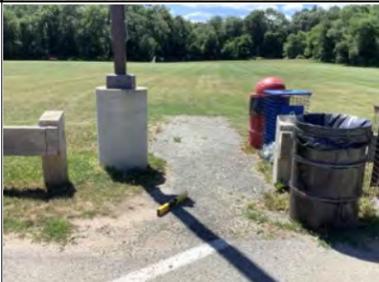
14	To Soccer Field G	Ext.		Exterior Access Route	Exterior

Running slope > 1:20 (5.00%) Accessible route not provided	7.5% -	Reduce running slope to be no steeper than 1:20 (5.00%). Ensure an accessible route is provided.	1	
15	Courtyard Near Gym	Ext.		Exterior Access Route	Exterior

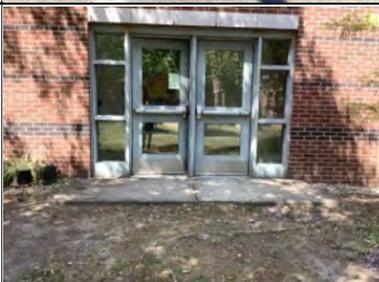
Level changes > 1/4" Accessible route not provided	2.5" -	Alter change in level to be 1/4" high max. Ensure an accessible route is provided.	2

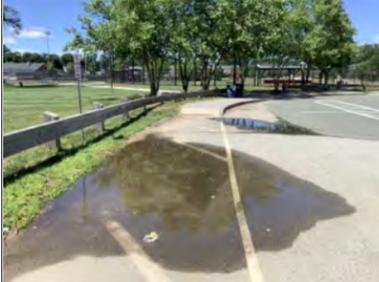
Does not prevent accumulation of water	-	Repair surface to prevent accumulation of water in the path of travel.	1	
17	By Egress Door 2	Ext.		Exterior Access Route	Walkway

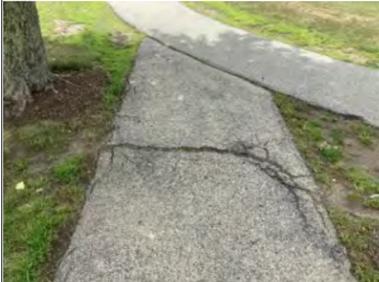
Route not maintained in operable working condition	-	Ensure the accessible route is maintained in operable working condition by repairing the crack in the walkway.	1	
18	Towards Softball Field A	Ext.		Exterior Access Route	Walkway

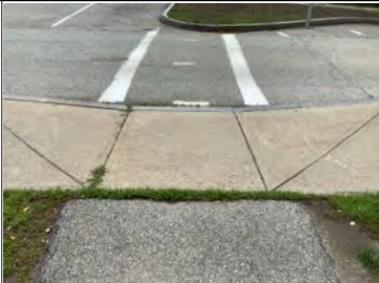
Route not maintained in operable working condition	-	Ensure the accessible route is maintained in operable working condition by removing the grass to ensure a flush transition in the path of travel between the concrete and asphalt.	1	
19	Route by Egress Door 7, Egress Door 4	Ext.		Exterior Access Route	Walkway

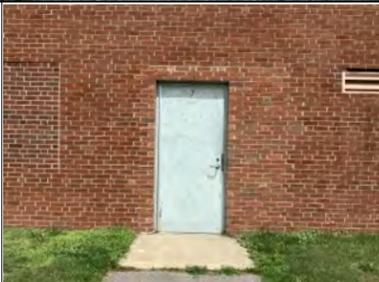
Route not maintained in operable working condition	-	Ensure the accessible route is maintained in operable working condition. Repair the route at the transition between materials.	2

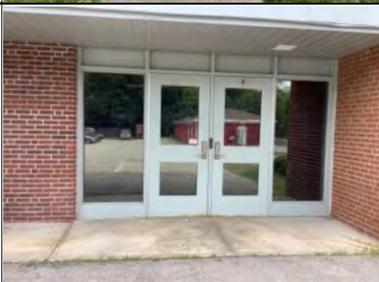
20	Egress Door 8	Ext.		Exterior Access Route	Exterior

Route not maintained in operable working condition	-	Ensure the accessible route is maintained in operable working condition by patching the transition in the path between the concrete and asphalt.	1

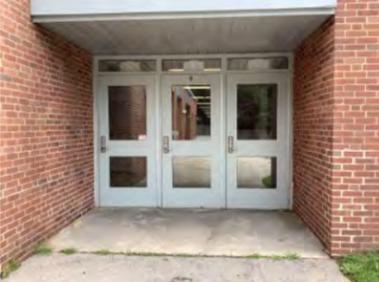
Route not maintained in operable working condition	-	Ensure the accessible route is maintained in operable working condition by patching the transition in the path between the concrete and asphalt.	1	
22	Egress Door 14	Ext.		Exterior Access Route	Walkway

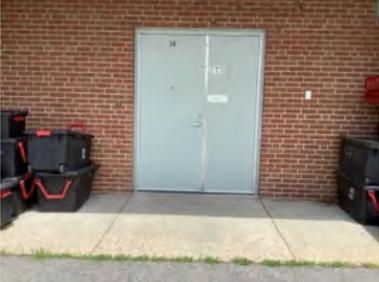
Route not maintained in operable working condition	-	Ensure the accessible route is maintained in operable working condition by patching the transition in the path between the concrete and asphalt.	1	
23	Egress Door 14	Ext.		Exterior Access Route	Walkway

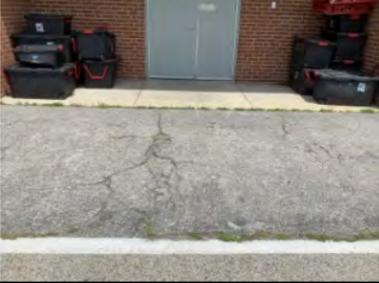
Route not maintained in operable working condition	-	Repair the cracks in the asphalt.	1	
24	To Egress Door 18	Ext.		Exterior Access Route	Walkway

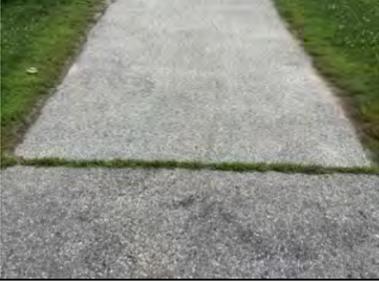
Route not maintained in operable working condition	-	Ensure the accessible route is maintained in operable working condition by patching the transition.	1

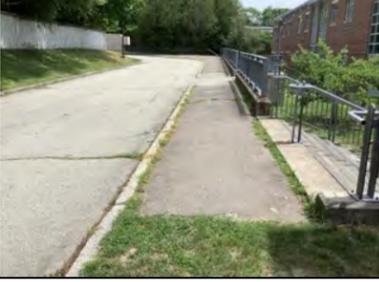
25	To Egress Door 24 and 25	Ext.		Exterior Access Route	Walkway

Route not maintained in operable working condition	-	Ensure the accessible route is maintained in operable working condition by repairing the cracks in the walkway.	1

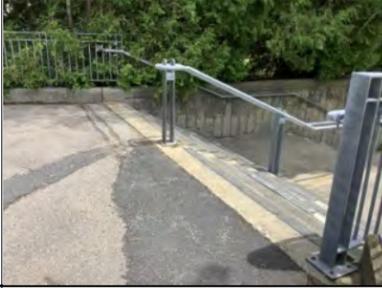
Route not maintained in operable working condition	-	Ensure the accessible route is maintained in operable working condition by repairing the asphalt.	1	
27	Tennis Court to Shot Put	Ext.		Exterior Access Route	Exterior

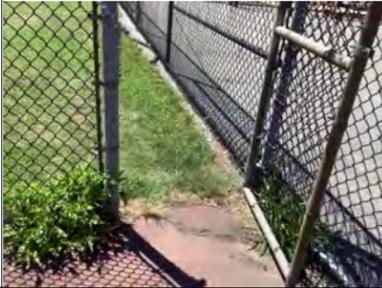
Route not maintained in operable working condition	-	Ensure the accessible route is maintained in operable working condition by removing the grass in the accessible walkway.	1	
28	By Playground	Ext.		Exterior Access Route	Exterior

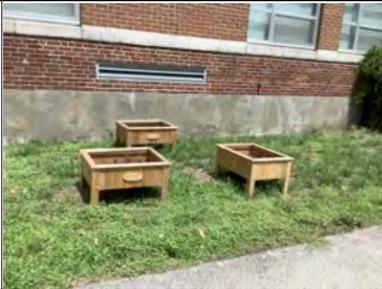
Accessible route not provided	-	Ensure an accessible route is provided to the garden beds.	1	
Curb Ramp											
29	To Egress Door 19 and 20	Ext.		Curb Ramp	N/A

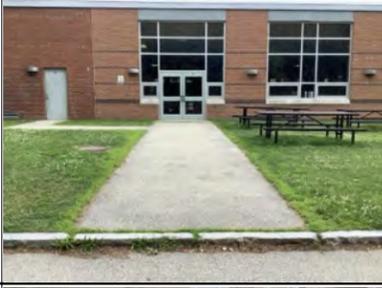
Curb ramp not provided	4"	Provide a curb ramp.	1	
30	North Lot Parking Near Egress Door 2	Ext.		Curb Ramp	N/A

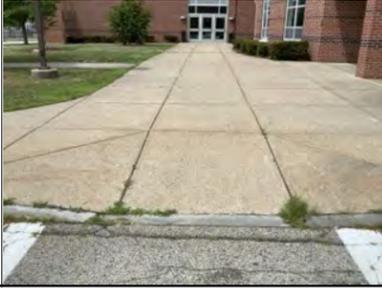
Transition from curb ramp to street not flush	-	Ensure transition from curb ramp to street is flush or free of changes in level.	1

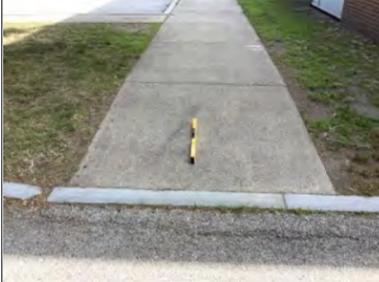
Transition from curb ramp to street not flush	-	Ensure transition from curb ramp to street is flush or free of changes in level.	1	
32	By Egress Door 33	Ext.		Curb Ramp	Parallel

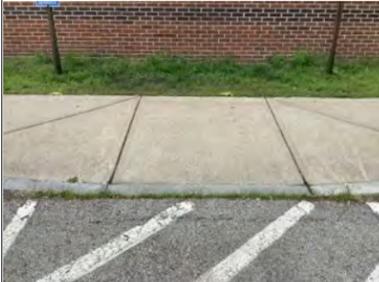
Transition from curb ramp to street not flush Landing not provided at top of curb ramp	- -	Ensure transition from curb ramp to street is flush or free of changes in level. Provide landing at top of curb ramp or reconfigure ramp.	1	
33	North Lot Parking Near Egress Door 2	Ext.		Curb Ramp	Blended Transition

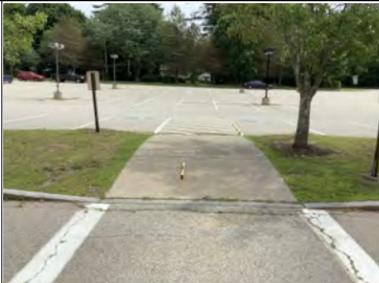
Landing not provided at top of curb ramp	-	Provide landing at top of curb ramp or reconfigure ramp.	1	
34	Soccer Field G to Baseball Field E	Ext.		Curb Ramp	N/A

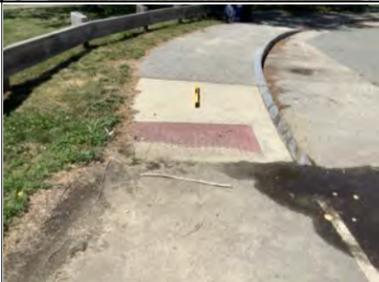
Surface not stable, firm and slip-resistant	-	Repair surface at the base of the curb ramp.	1	
Off-Street Parking Lot or Garage

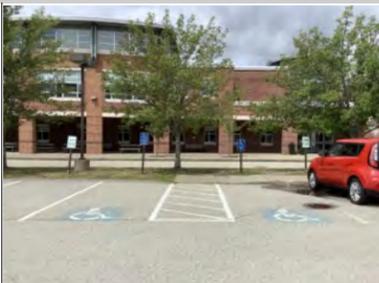
35	North Lot Parking by Main Entrance, Egress Door 1	Ext.		Off-Street Parking Lot or Garage	Visitor

Total # of parking Total # of designated accessible parking spaces Total # of designated van accessible spaces Sign bottom < 60" above finished grade	189 9 3 38"	Ensure signs at both the accessible spaces are located with the sign bottom 60" above the ground min.	2

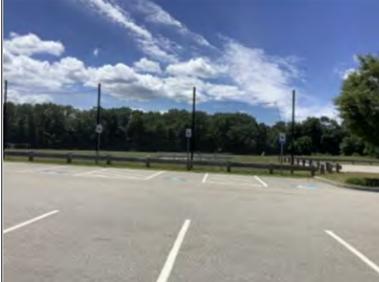
Total # of parking Total # of designated accessible parking spaces Total # of designated van accessible spaces	289 6 1	Provide one (1) additional van accessible space. Ensure that the access aisle and van accessible parking space are each 96" min. wide. Add the designation "Van Accessible" to the sign located at the van accessible space. Locate signs with the bottom of the sign 60" above the ground min.	1	
37	North Lot Parking Near Egress Door 2	Ext.		Off-Street Parking Lot or Garage	Visitor

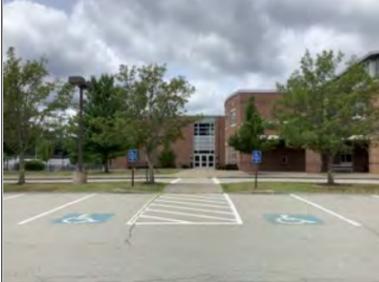
Sign does not have the designation "Van Accessible" Sign bottom < 60" above finished grade	- 41"	Add the designation "Van Accessible" to the sign located at the van accessible space. Ensure signs at both the car and van accessible spaces are located with the sign bottom 60" above the ground min.	2

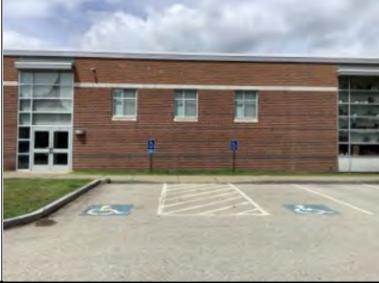
38	North Lot Parking by Egress Door 33	Ext.		Off-Street Parking Lot or Garage	Visitor

Sign bottom < 60" above finished grade	36"	Ensure signs at both the car and van accessible spaces are located with the sign bottom 60" above the ground min.	2	
Exterior Ramp											
39	Ramp To Egress Door 21, 22, 23, 24	Ext.		Exterior Ramp	N/A

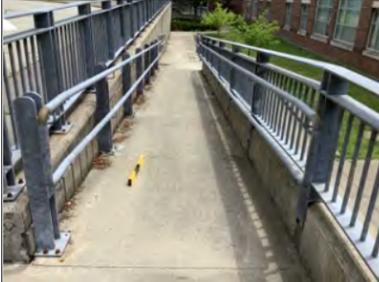
Handrails do not extend 12" past top & bottom	-	Alter handrails to extend horizontally above the landing for 12" min. beyond the top and bottom of ramp runs.	1	
40	Ramp To Egress Door 21, 22, 23, 24	Ext.		Exterior Ramp	N/A

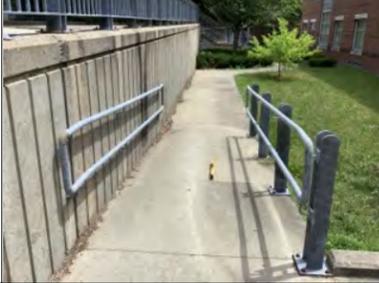
Handrails do not extend 12" past top & bottom	-	Alter handrails to extend horizontally above the landing for 12" min. beyond the top and bottom of ramp runs.	1

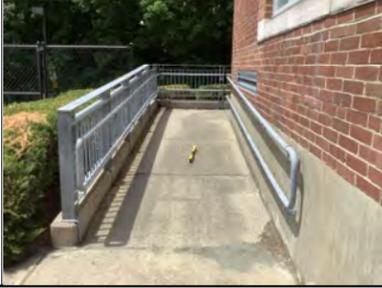
Surface is not stable, firm, and slip-resistant	-	Repair the damaged surface at the base of the ramp.	1	
Exterior Stair											
42	Stairs by Egress Doors 5 and 6	Ext.		Exterior Stair	N/A

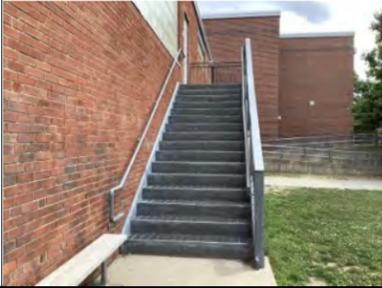
Handrails do not extend 12" from stair	- -	Bottom: Ensure that the sloped bottom extension extends one tread depth min. beyond last riser nosing in same direction as stair flight on the right side.	1	
43	Stairs From Egress Doors 24 and 25	Ext.		Exterior Stair	N/A

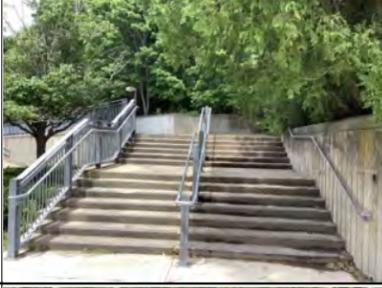
Does not prevent accumulation of water	-	Repair stairs to prevent accumulation of water.	1	
44	Stairs From Egress Doors 24 and 25	Ext.		Exterior Stair	N/A

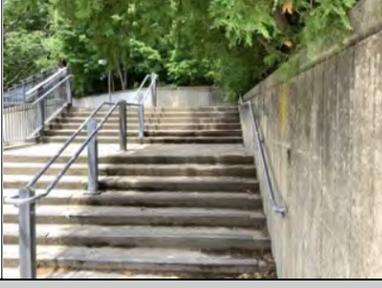
Vertical clearance < 80" above ground	58"	Trim low hanging tree branches to provide vertical clearance in the circulation route.	1

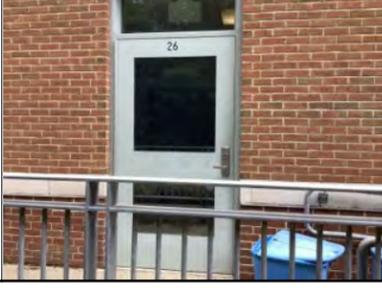
Emergency Exit											
45	Egress Door 26	Ext.		Emergency Exit	N/A

Maneuvering clearance(s) not provided	-	Remove the trash can to provide 18" min. maneuvering clearance on the latch side of the door (24" min. would be preferable).	1

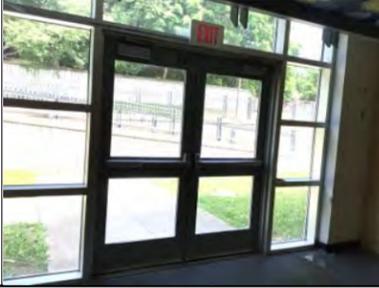
Door requires > 15 lbs. of force to open	23 lbs.	Adjust closers of exterior doors so doors do not require more than 15 pounds of force. Recommendation applies to all exterior doors.	1	
Access to Goods and Services											
Means of Egress											
47	Egress Door 3	1		Means of Egress	N/A

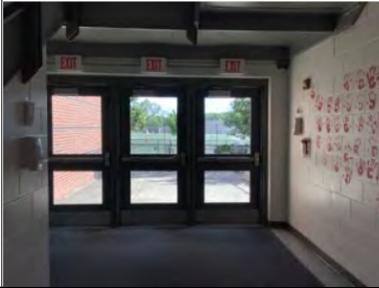
Tactile exit sign not provided	-	Ensure tactile exit signs with raised characters and braille are provided at exit doors. Mount signs between 48"- 60" above the finished floor located on the latch side of the door.	1	
48	Autoshop - Workshop - Exit 13	1	159	Means of Egress	N/A

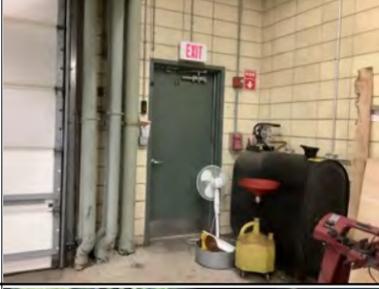
Tactile exit sign not provided	-	Ensure tactile exit signs with raised characters and braille are provided at exit doors. Mount signs between 48"- 60" above the finished floor located on the latch side of the door.	1

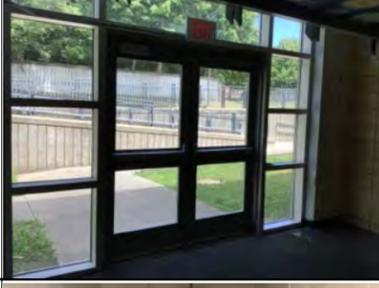
49	Egress Doors 23 and 25	1	159	Means of Egress	N/A

Tactile exit sign not provided	-	Ensure tactile exit signs with raised characters and braille are provided at exit doors. Mount signs between 48"- 60" above the finished floor located on the latch side of the door.	2	
50	Girls' Lacrosse Team Room - Egress 6	2		Means of Egress	N/A

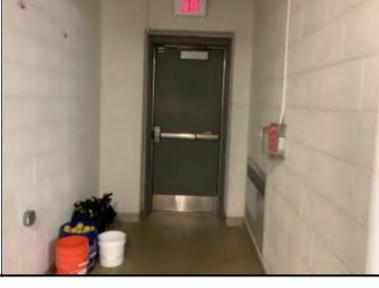
Tactile exit sign not provided	-	Ensure tactile exit signs with raised characters and braille are provided at exit doors. Mount signs between 48"- 60" above the finished floor located on the latch side of the door.	1

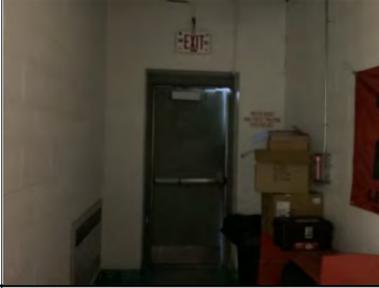
Tactile exit sign not provided	-	Ensure tactile exit signs with raised characters and braille are provided at exit doors. Mount signs between 48"- 60" above the finished floor located on the latch side of the door.	1	
52	Stair Near 288, Stair Near 285, Stair Near 282	2		Means of Egress	N/A

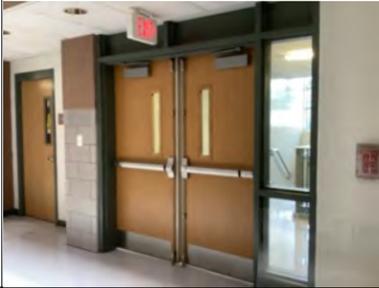
Tactile exit sign not provided	-	Ensure tactile exit signs with raised characters and braille are provided at exit doors. Mount signs between 48"- 60" above the finished floor located on the latch side of the door.	3	
53	Main Entrance/ Egress 1	1		Means of Egress	N/A

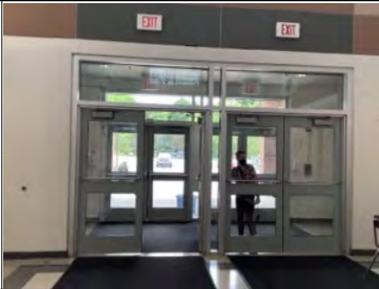
Tactile exit sign not provided Illuminated ISA symbol not provided (MAAB)	- -	Ensure tactile exit signs with raised characters and braille are provided at exit doors. Mount signs between 48"- 60" above the finished floor located on the latch side of the door. Where a tactile sign is provided at double doors with two active leaves, the sign shall be located to the right of the right hand door. Provide an illuminated sign with the International Symbol of Accessibility (ISA).	1

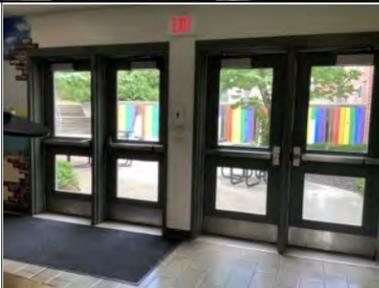
54	Egress Doors 24 and 22	1		Means of Egress	N/A

Tactile exit sign not provided Illuminated ISA symbol not provided (MAAB)	- -	Ensure tactile exit signs with raised characters and braille are provided at exit doors. Mount signs between 48"- 60" above the finished floor located on the latch side of the door. Where a tactile sign is provided at double doors with two active leaves, the sign shall be located to the right of the right hand door. Provide an illuminated sign with the International Symbol of Accessibility (ISA).	2	
55	Egress Door 32	1		Means of Egress	N/A

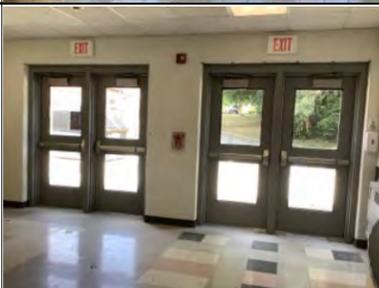
Tactile exit sign not provided Illuminated ISA symbol not provided (MAAB)	- -	Ensure tactile exit signs with raised characters and braille are provided at exit doors. Mount signs between 48"- 60" above the finished floor located on the latch side of the door. Where a tactile sign is provided at double doors with two active leaves, the sign shall be located to the right of the right hand door. Provide an illuminated sign with the International Symbol of Accessibility (ISA).	2

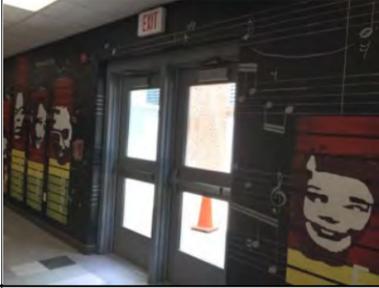
Tactile exit sign not provided Illuminated ISA symbol not provided (MAAB)	- -	Ensure tactile exit signs with raised characters and braille are provided at exit doors. Mount signs between 48"- 60" above the finished floor located on the latch side of the door. Where a tactile sign is provided at double doors with two active leafs, the sign shall be located to the right of the right hand door. Provide an illuminated sign with the International Symbol of Accessibility (ISA).	3	
57	Music Room 2 - Egress Door 33	1	193	Means of Egress	N/A

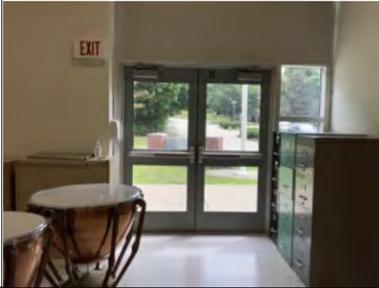
Tactile exit sign not provided Illuminated ISA symbol not provided (MAAB)	- -	Ensure tactile exit signs with raised characters and braille are provided at exit doors. Mount signs between 48"- 60" above the finished floor located on the latch side of the door. Where a tactile sign is provided at double doors with two active leafs, the sign shall be located to the right of the right hand door. Provide an illuminated sign with the International Symbol of Accessibility (ISA).	1

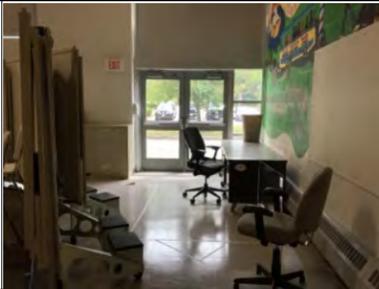
58	Music Room 1 - Egress Door 34	1	197	Means of Egress	N/A

Tactile exit sign not provided Illuminated ISA symbol not provided (MAAB)	- -	Ensure tactile exit signs with raised characters and braille are provided at exit doors. Mount signs between 48"- 60" above the finished floor located on the latch side of the door. Where a tactile sign is provided at double doors with two active leafs, the sign shall be located to the right of the right hand door. Provide an illuminated sign with the International Symbol of Accessibility (ISA).	1	
59	Cafeteria - Egress Doors 19 and 18	1		Means of Egress	N/A

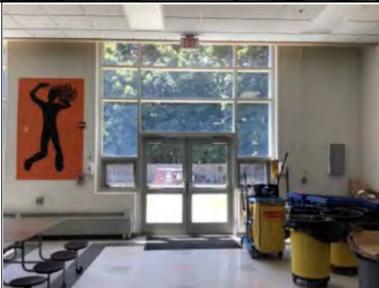
Tactile exit sign not provided Illuminated ISA symbol not provided (MAAB)	- -	Ensure tactile exit signs with raised characters and braille are provided at exit doors. Mount signs between 48"- 60" above the finished floor located on the latch side of the door. Where a tactile sign is provided at double doors with two active leafs, the sign shall be located to the right of the right hand door. Provide an illuminated sign with the International Symbol of Accessibility (ISA).	2

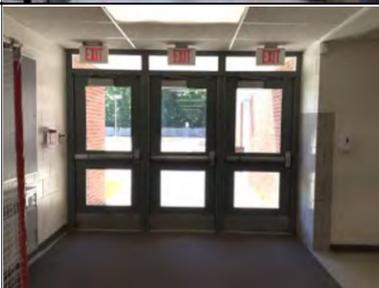
60	Secondary Entrance/ Egress Door 9	1		Means of Egress	N/A

Tactile exit sign not provided Illuminated ISA symbol not provided (MAAB)	- -	Ensure tactile exit signs with raised characters and braille are provided at exit doors. Mount signs between 48"- 60" above the finished floor located on the latch side of the door. Where a tactile sign is provided at double doors with two active leafs, the sign shall be located to the right of the right hand door. Provide an illuminated sign with the International Symbol of Accessibility (ISA).	1

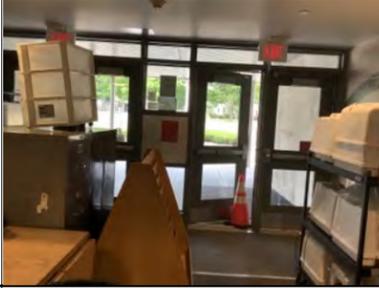
ID	Location	Floor	Room	Element	Type	Photo	Issues	Current Measure	Recommendations	Quantity	Notes
61	Secondary Student/ Staff Entrance and Egress Door 27	2		Means of Egress	N/A

Tactile exit sign not provided Illuminated ISA symbol not provided (MAAB)	- -	Ensure tactile exit signs with raised characters and braille are provided at exit doors. Mount signs between 48"- 60" above the finished floor located on the latch side of the door. Where a tactile sign is provided at double doors with two active leafs, the sign shall be located to the right of the right hand door. Provide an illuminated sign with the International Symbol of Accessibility (ISA).	1	
62	Press Box, East	Ext.		Means of Egress	N/A

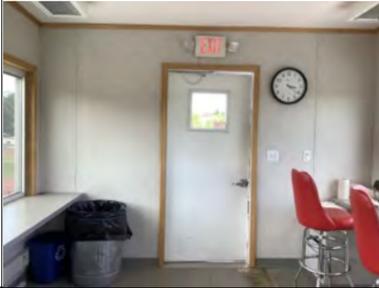
Tactile exit sign not provided Illuminated ISA symbol not provided (MAAB)	- -	Ensure tactile exit signs with raised characters and braille are provided at exit doors. Mount signs between 48"- 60" above the finished floor located on the latch side of the door. Provide an illuminated sign with the International Symbol of Accessibility (ISA).	1

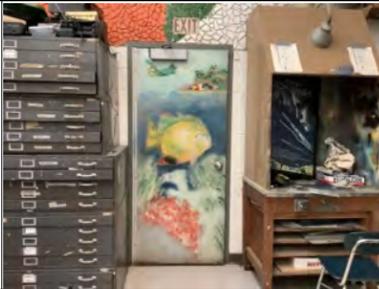
63	Egress Door 21	1	163	Means of Egress	N/A

Tactile exit sign not provided Directional sign to accessible emergency exit not provided	- -	Ensure tactile exit signs with raised characters and braille are provided at exit doors. Mount signs between 48"- 60" above the finished floor located on the latch side of the door. Provide a directional sign indicating the location of the nearest accessible emergency exit.	1	
64	Weight Room - Egress Door 4	1		Means of Egress	N/A

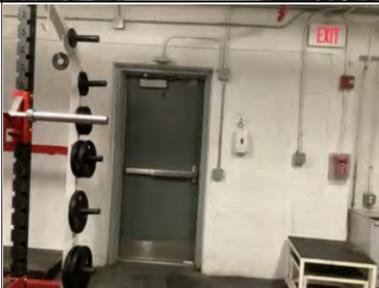
Tactile exit sign not provided Directional sign to accessible emergency exit not provided	- -	Ensure tactile exit signs with raised characters and braille are provided at exit doors. Mount signs between 48"- 60" above the finished floor located on the latch side of the door. Provide a directional sign indicating the location of the nearest accessible emergency exit.	1	
65	Health Classroom - Egress Door 7	1	146	Means of Egress	N/A

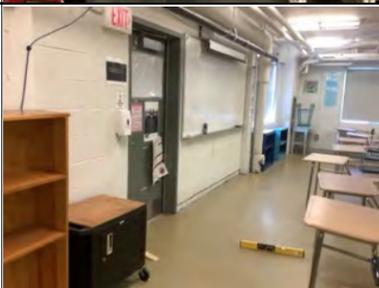
Tactile exit sign not provided Directional sign to accessible emergency exit not provided	- -	Ensure tactile exit signs with raised characters and braille are provided at exit doors. Mount signs between 48"- 60" above the finished floor located on the latch side of the door. Provide a directional sign indicating the location of the nearest accessible emergency exit.	1

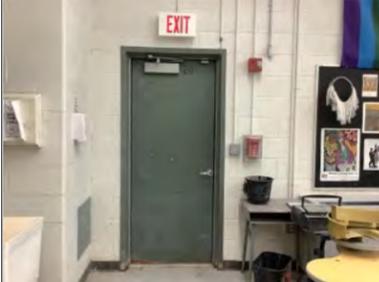
ID	Location	Floor	Room	Element	Type	Photo	Issues	Current Measure	Recommendations	Quantity	Notes
66	Art - Pottery - Egress Door 20	1	165	Means of Egress	N/A

Tactile exit sign not provided Directional sign to accessible emergency exit not provided	- -	Ensure tactile exit signs with raised characters and braille are provided at exit doors. Mount signs between 48"- 60" above the finished floor located on the latch side of the door. Provide a directional sign indicating the location of the nearest accessible emergency exit.	1	
67	Child Lab - Egress Door 26	2	298	Means of Egress	N/A

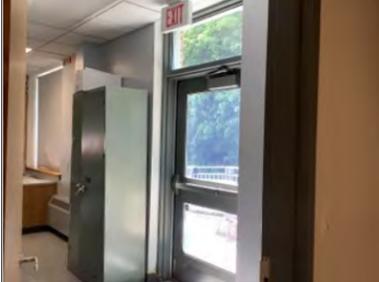
Tactile exit sign not provided Directional sign to accessible emergency exit not provided	- -	Ensure tactile exit signs with raised characters and braille are provided at exit doors. Mount signs between 48"- 60" above the finished floor located on the latch side of the door. Provide a directional sign indicating the location of the nearest accessible emergency exit.	1

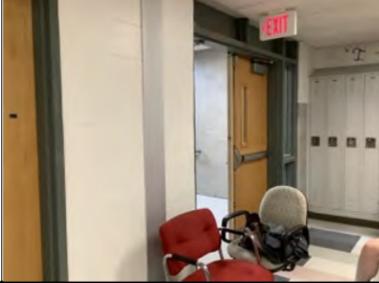
68	Stair and Egress Door 25	1		Means of Egress	N/A

Illuminated ISA symbol not provided (MAAB)	-	Provide an illuminated sign with the International Symbol of Accessibility (ISA).	1	
69	Stair and Egress Door 23	1		Means of Egress	N/A

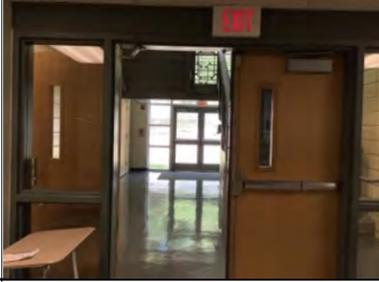
Illuminated ISA symbol not provided (MAAB)	-	Provide an illuminated sign with the International Symbol of Accessibility (ISA).	1	
70	To Egress Door 3 and Stair 3	1		Means of Egress	N/A

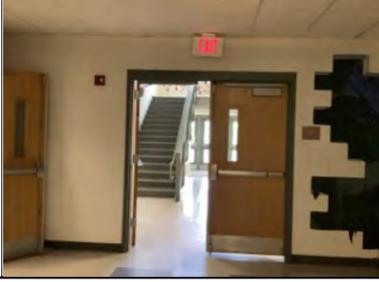
Illuminated ISA symbol not provided (MAAB)	-	Provide an illuminated sign with the International Symbol of Accessibility (ISA).	1

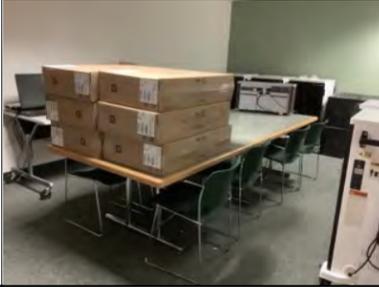
ID	Location	Floor	Room	Element	Type	Photo	Issues	Current Measure	Recommendations	Quantity	Notes
Interior Access Route											
71	Main Office - Conference Room	1	113	Interior Access Route	N/A

Route < 36" wide	-	Ensure that a clear width of 36" min. is maintained at the accessible route.	1	
72	Walkway From Elevator Between Boys' and Girls' Team Room	2		Interior Access Route	N/A

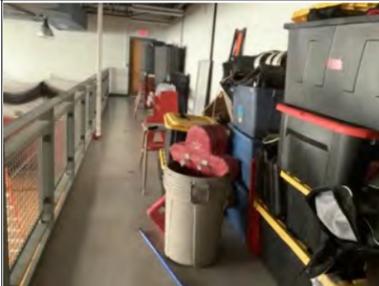
Route < 36" wide	-	Ensure that a clear width of 36" min. is maintained at the accessible route. Relocate the equipment.	1	
73	Media Center	2		Interior Access Route	N/A

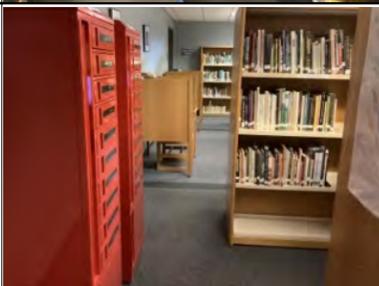
Route < 36" wide	27"	Ensure that a clear width of 36" min. is maintained at the accessible route.	1	
74	Science Classroom	2	222	Interior Access Route	N/A

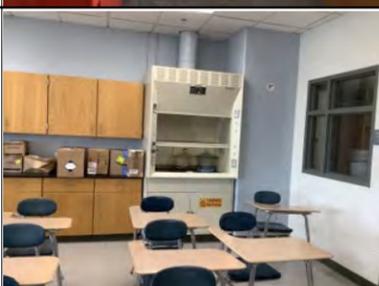
Route < 36" wide	-	Ensure that a clear width of 36" min. is maintained at the accessible route to the fume hood.	1	
75	Special Education	1	174	Interior Access Route	N/A

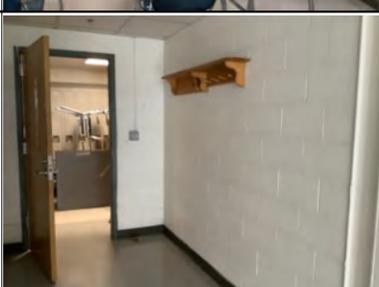
Obstructed by protruding objects	7"	Relocate shelf out of the circulation path.	1

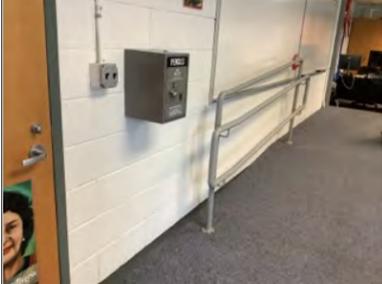
ID	Location	Floor	Room	Element	Type	Photo	Issues	Current Measure	Recommendations	Quantity	Notes
76	Language Lab	1	178	Interior Access Route	N/A

Obstructed by protruding objects	9.3"	Relocate pencil dispenser out of the circulation path.	1	
77	Cafeteria - Kitchen	1		Interior Access Route	N/A

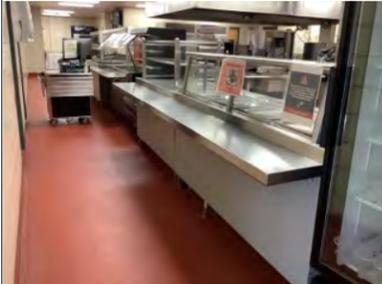
Obstructed by protruding objects	-	Provide a cane-detectable barrier on either ends of the counter.	2	
78	Cafeteria - Kitchen	1		Interior Access Route	N/A

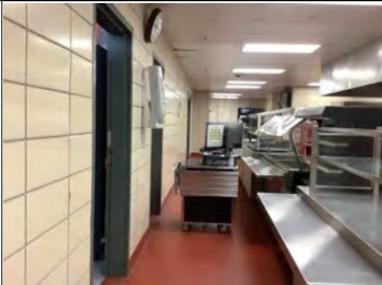
Obstructed by protruding objects	9"	Relocate paper towel dispenser out of the circulation path.	1	
79	Graphic Arts Technology	1	151	Interior Access Route	N/A

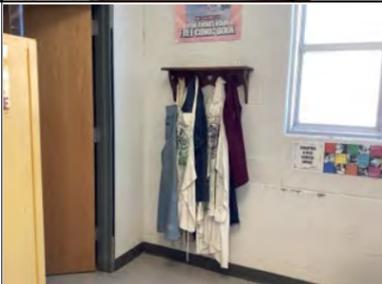
Obstructed by protruding objects	7"	Relocate shelf out of the circulation path.	1	
80	Near Nurse, Near Room 288, Media Center, Near Tech Lab 153, Near Exit 9	1, 2	295, 210	Interior Access Route	N/A

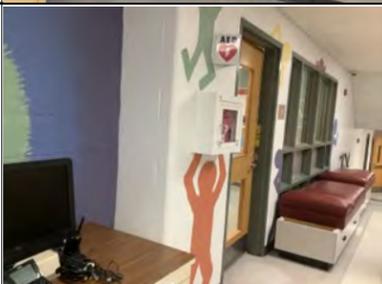
Obstructed by protruding objects	-	Relocate defibrillator out of the circulation path.	5

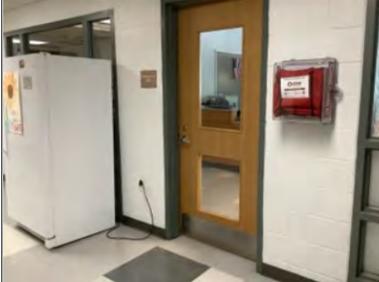
ID	Location	Floor	Room	Element	Type	Photo	Issues	Current Measure	Recommendations	Quantity	Notes
81	Administration	2	297	Interior Access Route	N/A

Obstructed by protruding objects	8"	Relocate bleeding kit out of the circulation path.	1	
82	Near Wrestling	1	145	Interior Access Route	N/A

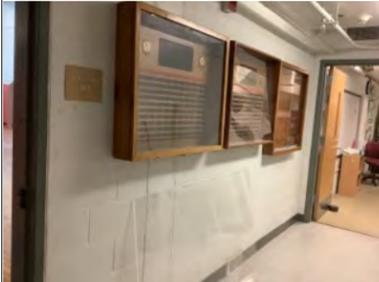
Obstructed by protruding objects Vertical clearance < 80" above finished floor	6" 46"	Provide a cane-detectable barrier underneath the case.	1	
83	Science Classroom	1	128	Interior Access Route	N/A

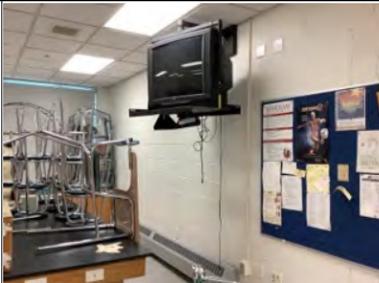
Vertical clearance < 80" above finished floor	70"	Provide a cane-detectable barrier underneath the television.	1	
84	Tech Lab	1	153	Interior Access Route	N/A

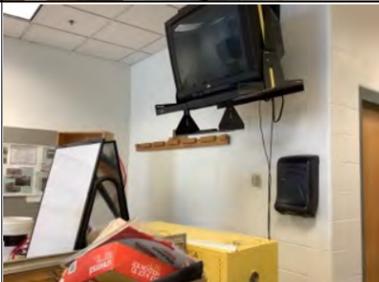
Vertical clearance < 80" above finished floor	70.6"	Provide a cane-detectable barrier underneath the television.	1	
85	Science Classroom	2	222	Interior Access Route	N/A

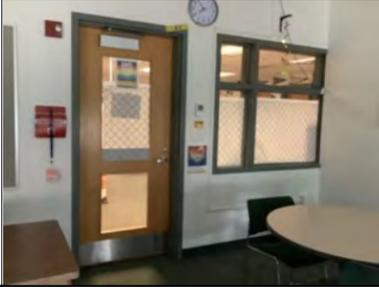
ID	Location	Floor	Room	Element	Type	Photo	Issues	Current Measure	Recommendations	Quantity	Notes
Doors, Doorways, & Gates											
86	Guidance Office - Transition Room	1		Doors, Doorways, & Gates	Office

Maneuvering clearance(s) not provided	-	Relocate table to provide maneuvering clearance that is 12" min. parallel to the door on the latch side and 60" min. perpendicular to the door on the push side of the door.	1	
87	Men's & Women's Single-User Toilet Room	1		Doors, Doorways, & Gates	Toilet Room

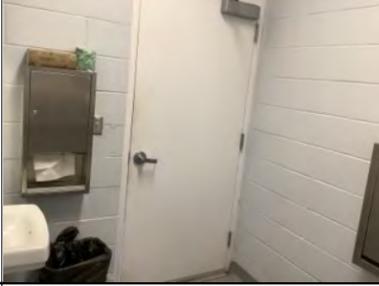
Maneuvering clearance(s) not provided	11"	Relocate paper towel dispenser and trash can to provide maneuvering clearance that is 18" min. on the latch side of the door that is 60" min. deep.	2	
88	Main Office - School Counselor	1	102	Doors, Doorways, & Gates	Office

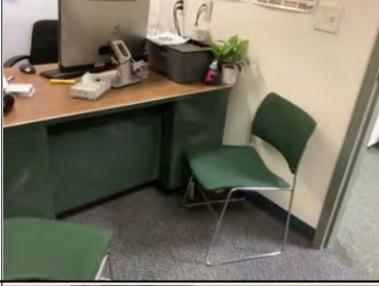
Maneuvering clearance(s) not provided	-	Relocate chair to provide maneuvering clearance that is 18" min. parallel to the door on the latch side and 60" min. perpendicular to the door on the pull side of the door.	1

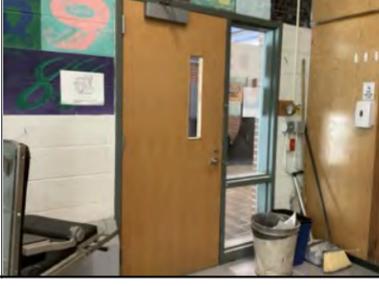
Maneuvering clearance(s) not provided	-	Relocate trash can to provide maneuvering clearance that is 18" min. parallel to the door on the latch side and 60" min. perpendicular to the door on the pull side of the door.	1

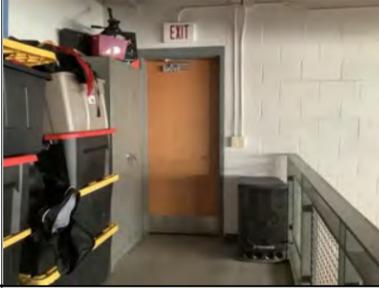
ID	Location	Floor	Room	Element	Type	Photo	Issues	Current Measure	Recommendations	Quantity	Notes
96	Boys' Team Room	2		Doors, Doorways, & Gates	N/A

Maneuvering clearance(s) not provided	-	Relocate furniture to provide maneuvering clearance that is 12" min. parallel to the door on the latch side and 60" min. perpendicular to the door on the push side of the door.	1	
97	Math Classroom	2	225	Doors, Doorways, & Gates	Classroom

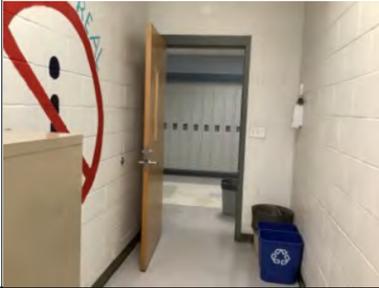
Maneuvering clearance(s) not provided	-	Relocate trash cans to provide maneuvering clearance that is 18" min. parallel to the door on the latch side and 60" min. perpendicular to the door on the pull side of the door.	1	
98	Chinese, Spanish Classrooms	2	277, 275	Doors, Doorways, & Gates	Classroom

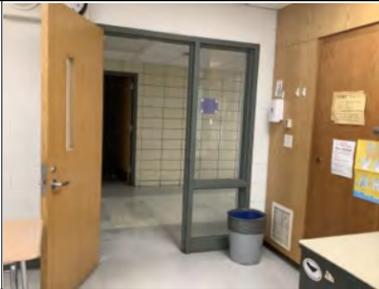
Maneuvering clearance(s) not provided	-	Relocate trash can to provide maneuvering clearance that is 18" min. parallel to the door on the latch side and 60" min. perpendicular to the door on the pull side of the door.	2

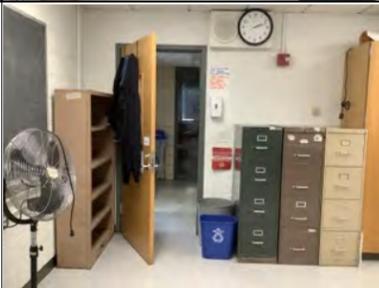
99	Special Education Classroom	2	279	Doors, Doorways, & Gates	Classroom

Maneuvering clearance(s) not provided	-	Relocate trash can and file cabinet to provide maneuvering clearance that is 18" min. parallel to the door on the latch side and 60" min. perpendicular to the door on the pull side of the door.	1	
100	Administration	2	297	Doors, Doorways, & Gates

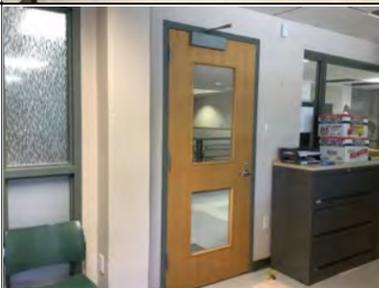
Maneuvering clearance(s) not provided	11"	Relocate cabinet to provide maneuvering clearance that is 18" min. parallel to the door on the latch side and 60" min. perpendicular to the door on the pull side of the door.	1

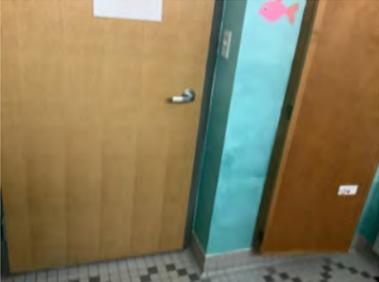
Maneuvering clearance not provided at recess > 6"	8"	Install an automatic door opener or ensure that the door is not recessed greater than 6" deep on both sides.	1	
103	All Gender Toilet Room Near Room 108	1		Doors, Doorways, & Gates	Toilet Room

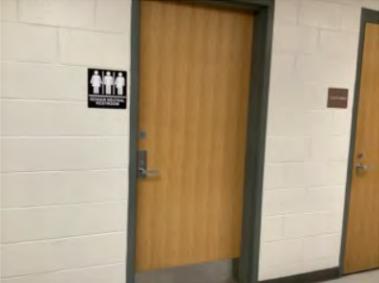
Door requires > 5 lbs. of force to open	10 lbs.	Adjust closers so doors do not require more than 5 pounds of force to open.	1

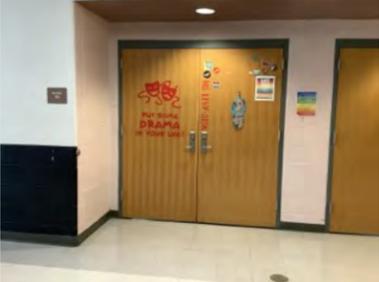
104	Drama	1	191	Doors, Doorways, & Gates	Classroom

Door requires > 5 lbs. of force to open	13 lbs.	Adjust closers so doors do not require more than 5 pounds of force to open.	1	
105	Girls' Locker Room - Lockers	1	149 D	Doors, Doorways, & Gates	Circulation

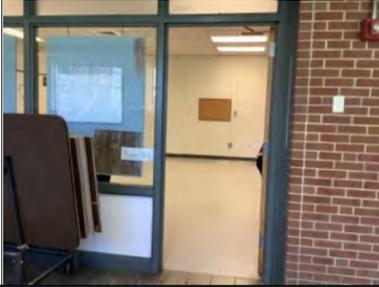
ID	Location	Floor	Room	Element	Type	Photo	Issues	Current Measure	Recommendations	Quantity	Notes
Signage											
106	Special Education Classroom	1	164	Signage	Designation

Raised characters not provided on sign Raised characters < 48" or > 60" above ground Braille not provided on sign	- 39" -	Provide text with raised characters duplicated in braille on sign. Mount signs so that the baseline of the lowest tactile character is 48" min. above finished floor and the baseline of the highest tactile character is 60" max. above the finished floor.	1	
107	Guidance Office - Transition Room, Post-Secondary Planning Office	1		Signage	Designation

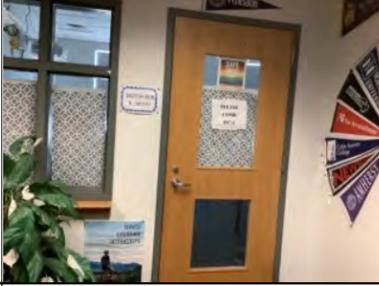
Raised characters not provided on sign Braille not provided on sign	- -	Provide text with raised characters duplicated in braille on sign. Locate the sign on the wall next to the latch side of the door.	2	
108	Main Office - School Counselor	1	102	Signage	Designation

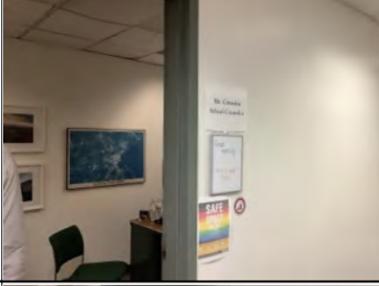
Raised characters not provided on sign Braille not provided on sign	- -	Remove paper placed on the tactile sign. Ensure tactile signs are not covered with paper signs.	1

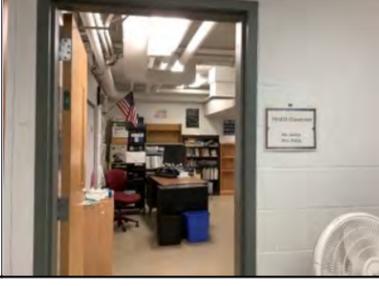
Raised characters not provided on sign Braille not provided on sign	- -	Provide text with raised characters duplicated in braille on sign. Locate the sign on the wall next to the latch side of the door. Best Practice: Recommend updating the tactile sign provided below the paper sign with "Health". Ensure tactile signs are not covered with paper signs.	1

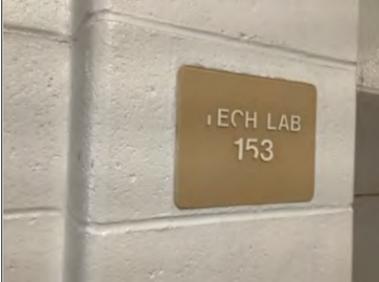
ID	Location	Floor	Room	Element	Type	Photo	Issues	Current Measure	Recommendations	Quantity	Notes
111	Tech Lab	1	153	Signage	Designation

Raised characters not provided on sign Braille not provided on sign	- -	Sign is damaged. Provide text with raised characters duplicated in braille on sign.	1	
112	Autoshop - Classroom	1	159	Signage	Designation

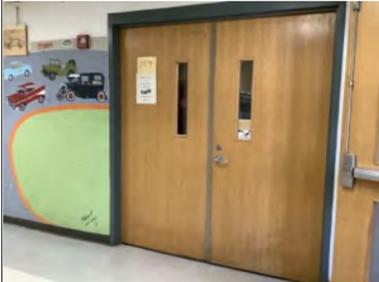
Raised characters not provided on sign Braille not provided on sign	- -	Provide text with raised characters duplicated in braille on sign. Where a tactile sign is provided at double doors with one active leaf, the sign shall be located on the inactive leaf.	1	
113	English Classroom	1	180	Signage	Designation

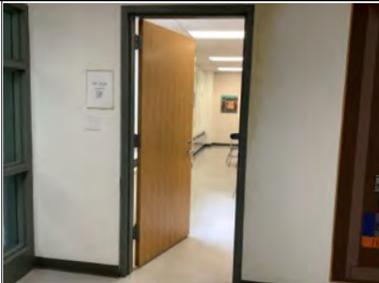
Raised characters not provided on sign Braille not provided on sign Sign not located on the latch side of the door	- - -	Provide text with raised characters duplicated in braille on sign. Locate the sign at permanent rooms alongside the door on the latch side.	1

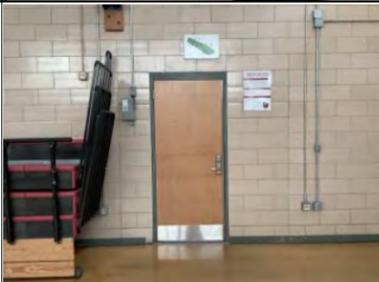
114	Boys' Locker Room - Gymnasium	1		Signage	Designation

Raised characters not provided on sign Braille not provided on sign Sign not located on the latch side of the door	- - -	Provide text with raised characters duplicated in braille on sign. Locate the sign at permanent rooms alongside the door on the latch side.	1	
115	Rise Student Toilet Room	2		Signage	Designation

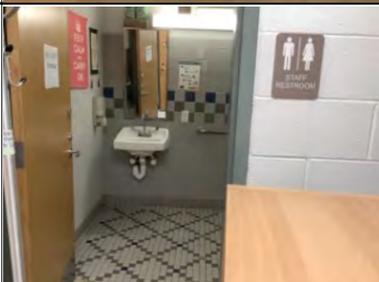
Raised characters not provided on sign Braille not provided on sign Sign not located on the latch side of the door Signage lacks 18" by 18" clear floor space	- - - -	Provide text with raised characters duplicated in braille on sign. Locate the sign at permanent rooms alongside the door on the latch side. Relocate furniture to provide a clear floor space of 18" min. by 18" min. Best Practice: Recommend updating sign with "Rise Student Toilet Room".	1

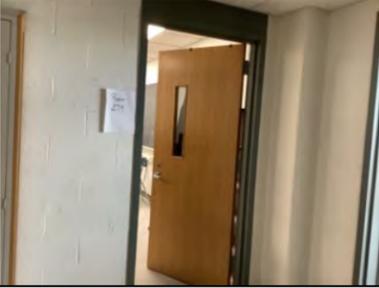
ID	Location	Floor	Room	Element	Type	Photo	Issues	Current Measure	Recommendations	Quantity	Notes
116	Special Education Classroom	2	279	Signage	Designation

Raised characters not provided on sign Braille not provided on sign Sign not located on the latch side of the door	- - -	Provide text with raised characters duplicated in braille on sign. Locate the sign at permanent rooms alongside the door on the latch side.	1	
117	Nurses Office - Toilet Room, Gender Neutral Restroom Sign	2	295	Signage	Designation

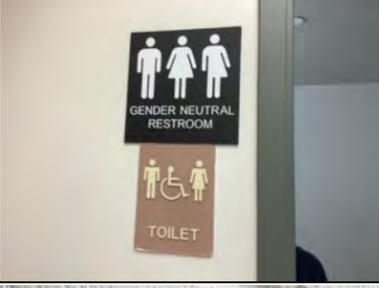
Raised characters < 48" or > 60" above ground	64"	Mount signs so that the baseline of the lowest tactile character is 48" min. above finished floor and the baseline of the highest tactile character is 60" max. above the finished floor.	1	
118	Auditorium	1		Signage	Designation

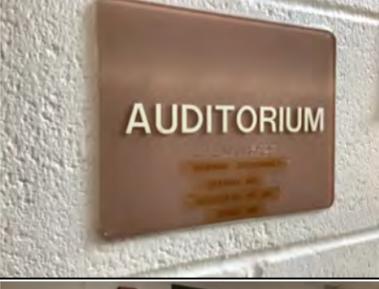
Braille not provided on sign	-	Provide braille on the sign.	1	
119	English, Language Lab, Spanish, Special Education, French, Latin Classrooms	1	180, 178, 177, 174, 175, 172	Signage	Designation

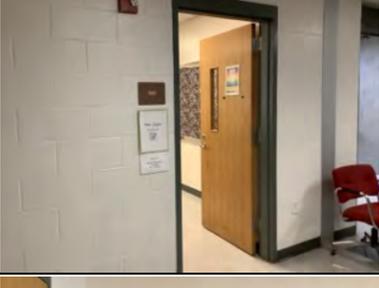
Braille not provided on sign	-	Provide braille on the sign.	6

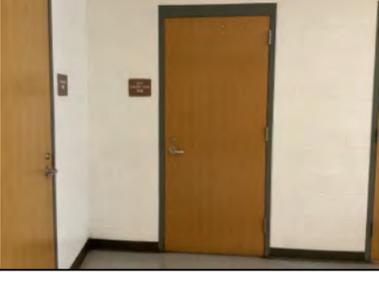
120	Boys' Dressing Room	1	194	Signage	Designation

Braille not provided on sign	-	Provide braille on the sign.	1

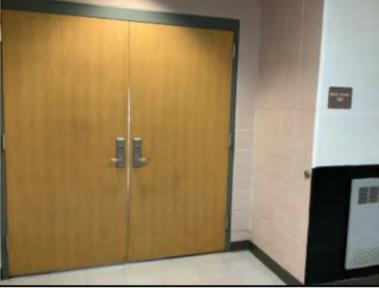
ID	Location	Floor	Room	Element	Type	Photo	Issues	Current Measure	Recommendations	Quantity	Notes
121	Music Room 1, Music Room 2	1	197, 193	Signage	Designation

Braille not provided on sign	-	Provide braille on the sign.	4	
122	Girls' & Boys' Locker Room - Gymnasium	1		Signage	Designation

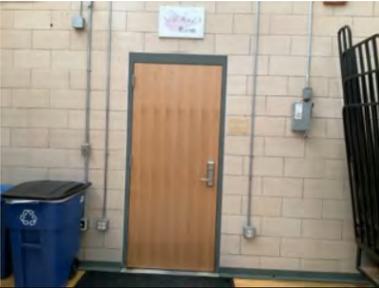
Braille not provided on sign	-	Provide braille on the sign.	2	
123	Men's Toilet Room Near Room 103	1		Signage	Designation

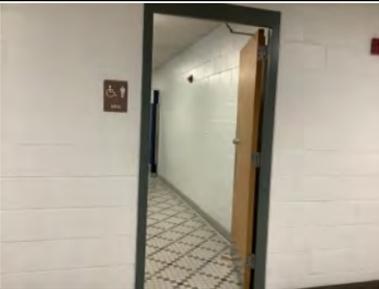
Braille not provided on sign	-	Provide braille on the sign.	1	
124	Wrestling	1	145	Signage	Designation

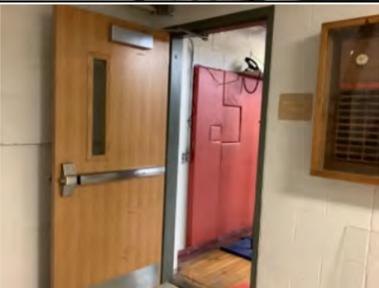
Braille not provided on sign	-	Provide braille on the sign.	1	
125	Boys' Toilet Room Near Room 225	2		Signage	Designation

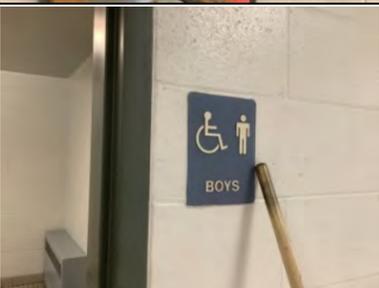
Braille not provided on sign	-	Provide braille on the sign.	1

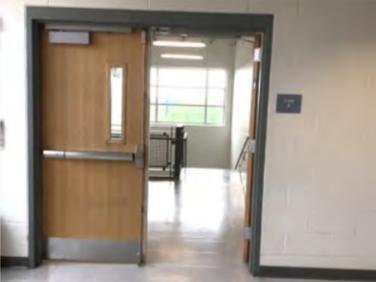
ID	Location	Floor	Room	Element	Type	Photo	Issues	Current Measure	Recommendations	Quantity	Notes
126	Stair 2	2		Signage	Egress

Braille not provided on sign	-	Provide braille on the sign.	1	
127	Media Center - TV Studio, Editing Room, Media Center - Seminar	2	213, 211, 214	Signage	Designation

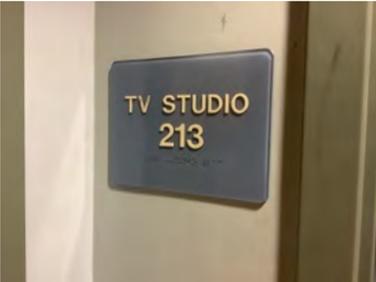
Braille not provided on sign	-	Provide braille on the sign.	3	
128	Science, Math, English, Business, Chinese, Spanish, Latin Classrooms	2	222, 225, 280, 278, 277, 275, 271	Signage	Designation

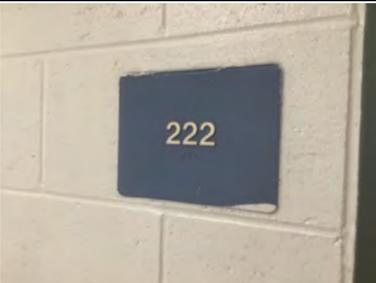
Braille not provided on sign	-	Provide braille on the sign.	7	
129	Special Education 5 Classroom	2	269 A	Signage	Designation

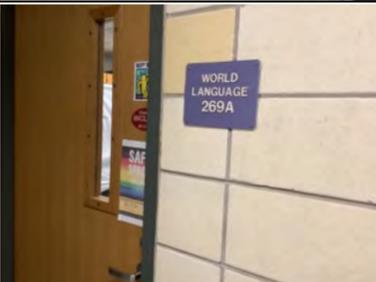
Braille not provided on sign	-	Provide braille on the sign. Best Practice: Recommend updating sign with "Special Education".	1	
130	Drama	1	191	Signage	Designation

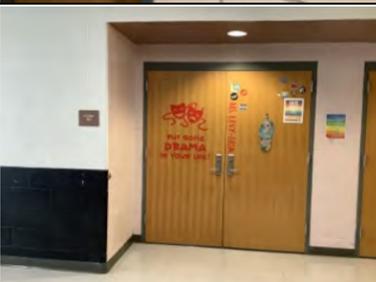
Braille not provided on sign Sign not located on the latch side of the door	- -	Provide braille on the sign. For double-leaf doors with one active leaf, locate sign on the inactive leaf. If each door has an active leaf, locate sign to the right of the right hand door.	1

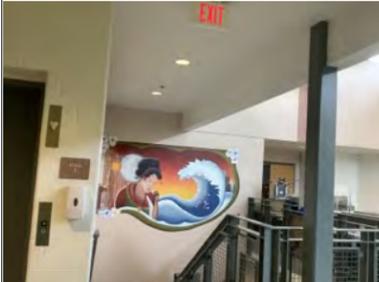
Signage lacks 18" by 18" clear floor space	-	Relocate sanitizer to provide a clear floor space of 18" min. by 18" min. on the tactile designation sign.	1	
133	Administration - Assistant Principal	2	297 A	Signage	Designation

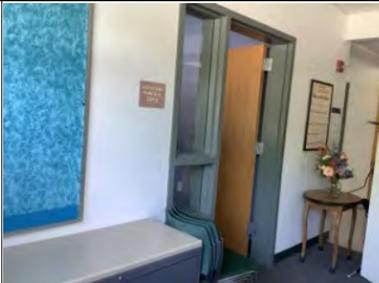
Signage lacks 18" by 18" clear floor space	-	Relocate cabinet to provide a clear floor space of 18" min. by 18" min. on the tactile designation sign.	1	
Service Counter											
134	Guidance Office	1		Service Counter	N/A

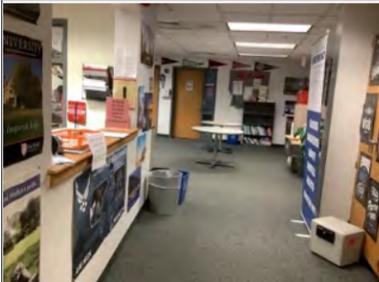
Counter > 36" high	42"	Provide a counter that is 36" max. above the finished floor.	1	
135	Media Center	2	210	Service Counter	N/A

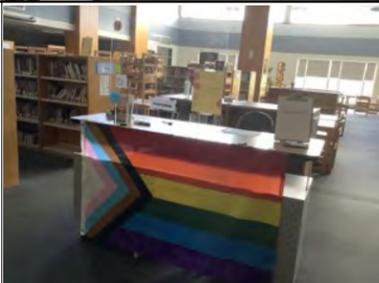
Counter > 36" high	39"	Provide a counter that is 36" max. above the finished floor.	1

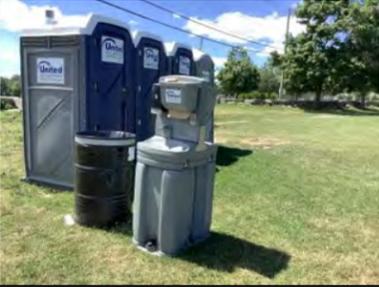
ID	Location	Floor	Room	Element	Type	Photo	Issues	Current Measure	Recommendations	Quantity	Notes
Operable Parts											
136	By Field M	Ext.		Operable Parts	Spigot

Element not on an accessible route	- -	If the rented handwashing sink is used by the public as part of a Town program, ensure that it is located on an accessible route and that the operable parts do not require tight grasping, pinching, or twisting of the wrist and can be operable with one hand.	1	
137	Courtyard Near Gym	Ext.		Operable Parts	Spigot

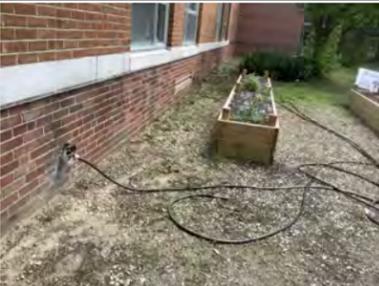
Element not on an accessible route Not operable with a closed fist	- -	Ensure spigot is located on an accessible route. Provide hardware that can be operable with one hand and not require tight grasping, pinching, or twisting of the wrist.	1	
138	Media Center	2		Operable Parts	Other

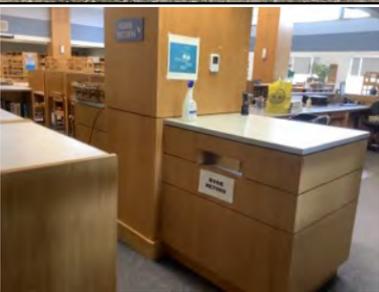
Clear floor space is not provided	-	Provide a 30" min. by 48" min. clear floor space at book drop off. Relocate furniture.	1

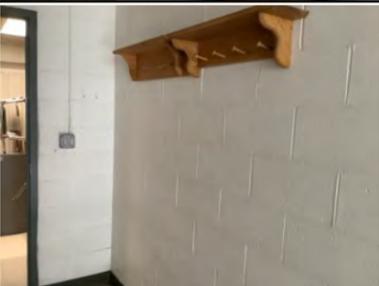
139	Special Education Classroom	1	174	Operable Parts	Clothes Rod/Hooks

Reach < 15" or > 48"(forward/side approach)	69.1"	Provide a coat hook 48" above the finished floor.	1	
140	Special Education Classroom, Math Classroom	1	120, 125	Operable Parts	Clothes Rod/Hooks

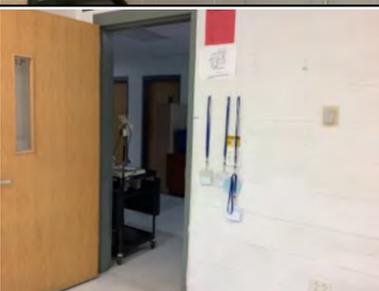
Reach < 15" or > 48"(forward/side approach)	63"	Provide a coat hook 48" above the finished floor.	3

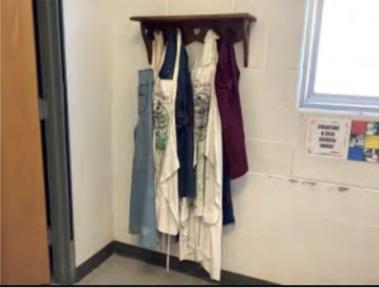
ID	Location	Floor	Room	Element	Type	Photo	Issues	Current Measure	Recommendations	Quantity	Notes
141	Graphic Arts Technology Classroom	1	151	Operable Parts	Clothes Rod/Hooks

Reach < 15" or > 48"(forward/side approach)	62"	Provide a coat hook 48" above the finished floor.	1	
142	Art - Pottery Classroom	1	165	Operable Parts	Clothes Rod/Hooks

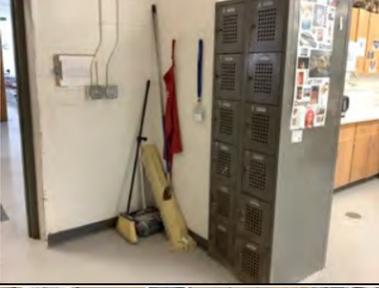
Reach < 15" or > 48"(forward/side approach)	64.5"	Provide a coat hook 48" above the finished floor.	1	
143	Art - Pottery Classroom	1	165	Operable Parts	Other

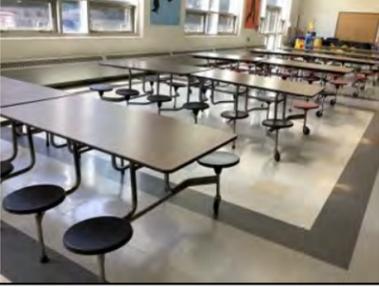
At least one or 5% accessible tables not provided Knee or toe clearance not provided	- -	Ensure that at least 5% of the tables have knee clearance of at least 27-inches high, 30-inches wide, and 19-inches deep.	1

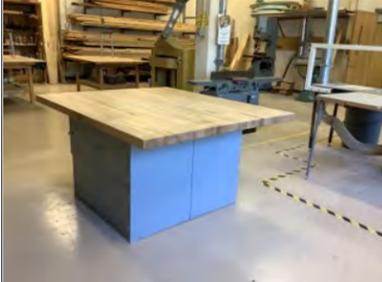
ID	Location	Floor	Room	Element	Type	Photo	Issues	Current Measure	Recommendations	Quantity	Notes
146	Wood Shop, Autoshop - Classroom	1	155, 159	Dining or Work Surfaces	Work Surface

At least one or 5% accessible tables not provided Knee or toe clearance not provided	- 15"	Ensure that at least 5% of the tables have knee clearance of at least 27-inches high, 30-inches wide, and 19-inches deep.	2	
147	School Counselor Near Guidance Office Entrance	1		Dining or Work Surfaces	Work Surface
