East Elementary School

Town of Hingham ADA Transition Plan

October 2023

Institute for Human Centered Design

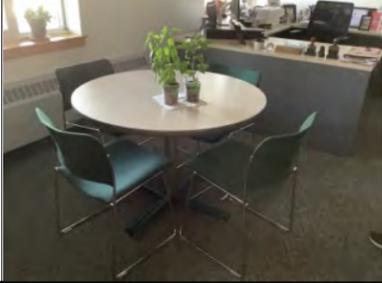
Knee or toe clearance not provided	-	Provide at least one work surface with 27" min. knee and toe clearance. Ensure toe clearance of 30" clear width and 9" clear is provided above the finished floor.	1

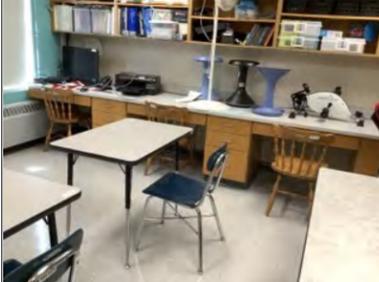
ID	Location	Floor	Room	Element	Type	Photo	Issues	Current Measure	Recommendations	Quantity	Notes
151	Special Education Classroom	2	269 A	Dining or Work Surfaces	Work Surface

Knee or toe clearance not provided	24"	Provide at least one work surface with tops between 28"- 34" above the floor and 27" clear height underneath.	1	
152	Administration	2	297	Dining or Work Surfaces	Work Surface

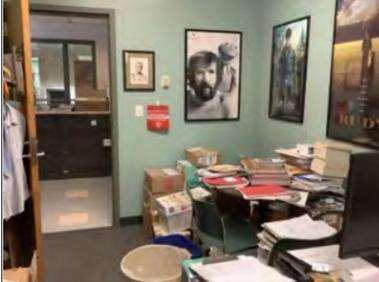
Knee or toe clearance not provided	-	Provide at least one dining or work surface with 27" min. knee and toe clearance. Ensure toe clearance of 30" clear width and 9" clear is provided above the finished floor.	1	
153	Art - Painting	1	163	Dining or Work Surfaces	Work Surface

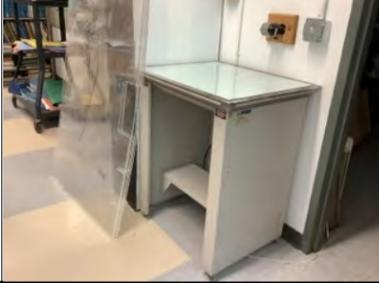
Knee or toe clearance not provided Top of dining/work surface < 28" or > 34"	- 37.8"	Provide at least one work surface with tops between 28"- 34" above the floor and 27" clear height underneath. Ensure toe clearance of 30" clear width and 9" clear is provided above the finished floor. If the work surface shown is used for a unique purpose, a comparable accessible work surface should be provided.	1

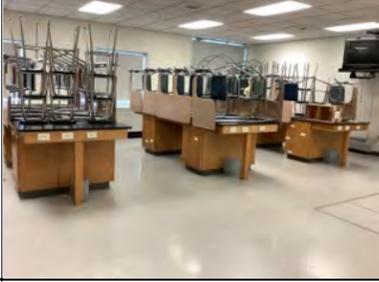
154	Science Classroom	1	128	Dining or Work Surfaces	Work Surface

Top of dining/work surface < 28" or > 34"	37"	Provide at least one work surface with tops between 28"- 34" above the floor and 27" clear height underneath.	1	
155	Courtyard Near Cafeteria - Greenhouse	Ext.		Dining or Work Surfaces	Work Surface

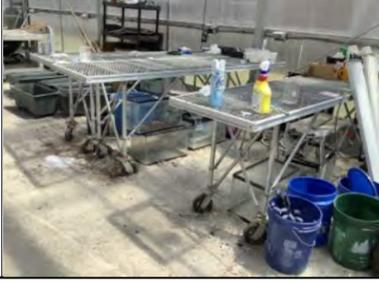
Top of dining/work surface < 28" or > 34"	35"	Provide at least one work surface with tops between 28"- 34" above the floor and 27" clear height underneath.	1

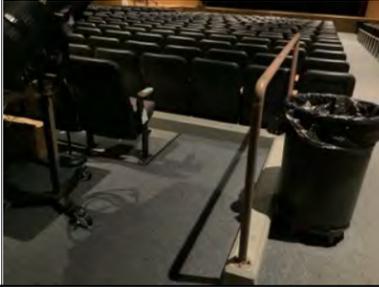
ID	Location	Floor	Room	Element	Type	Photo	Issues	Current Measure	Recommendations	Quantity	Notes
Assembly Area											
156	Auditorium	1		Assembly Area	N/A

Number of seats Number of designated wheelchair spaces Minimum # wheelchair spaces not provided	588 3 -	Provide three (3) additional wheelchair spaces. Remove chairs to provide additional wheelchair spaces.	3	
157	Auditorium	1		Assembly Area	N/A

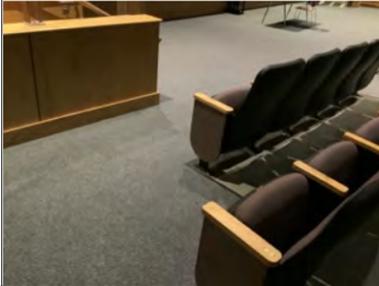
Wheelchair spaces overlap circulation paths	-	Relocate seating area so that wheelchair spaces do not overlap circulation paths.	1	
158	Auditorium	1		Assembly Area	N/A

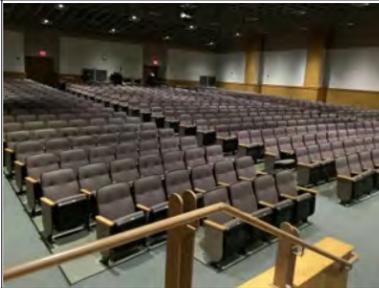
Designated aisle seats < 5% Assistive listening devices not provided	- -	At least 5% of the total number of aisle seats provided must be identified by a sign or marker and have folding or retractable armrests. If audible communication is integral to the use of the space, provide an assistive listening system.	1	
Locker Room

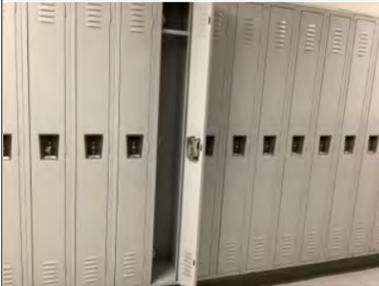
159	Lockers Near Drama	1		Locker Room	N/A

5% of lockers are not accessible Storage > 48" high	- 68.4"	Provide at least one accessible locker (or ensure 5% of all lockers are accessible) . Ensure that at least 5% of lockers are accessible, and no higher than 48 inches above the floor.	1	
160	Girls' & Boys' Locker Room - Team Room	1		Locker Room	N/A

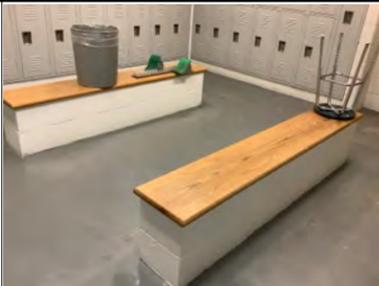
Back support not provided at bench Bench < 24" deep Bench lacks 12" clear underneath	- 13.5" -	Provide at least one bench with back support or that is affixed to a wall with room on the side to transfer. Provide a bench that is 24" deep. Provide a bench that has 12" clear underneath.	2

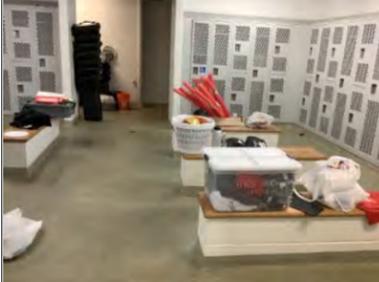
ID	Location	Floor	Room	Element	Type	Photo	Issues	Current Measure	Recommendations	Quantity	Notes
161	Girls' Lacrosse Team Room	2		Locker Room	Girls

Back support not provided at bench Bench < 24" deep Bench lacks 12" clear underneath	- 13" -	Provide at least one bench with back support or that is affixed to a wall with room on the side to transfer. Provide a bench that is 24" deep. Provide a bench that has 12" clear underneath.	1	
162	Boys' Team Room	2		Locker Room	Boys

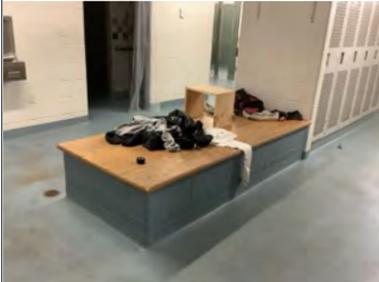
Back support not provided at bench Bench lacks 12" clear underneath	- -	Provide at least one bench with back support or that is affixed to a wall with room on the side to transfer. Provide a bench that has 12" clear underneath.	1	
Laboratory											
163	Science Classroom	2	222	Laboratory	Other

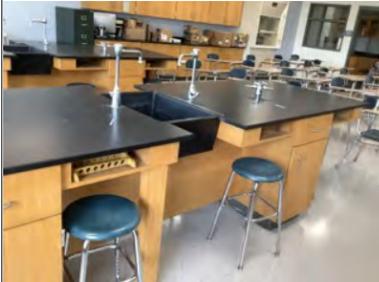
At least one (or 5%) accessible sink not provided At least one (or 5%) acc. work surface not provided	- -	Provide at least one sink with the rim no higher than 34" above the finished floor with knee and toe clearance positioned for a forward approach. Alter so that 5% of work surfaces (at least one) are 28"- 34" above the finished floor with knee and toe clearance positioned for a forward approach.	1

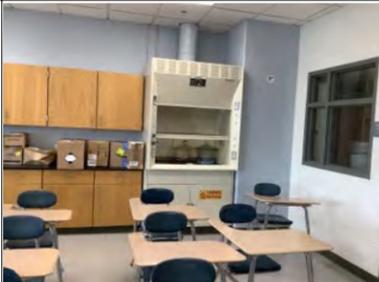
164	Science Classroom	2	222	Laboratory	Other

At least one (or 5%) acc. fume hood not provided	38"	Provide one (1) accessible fume hood with a work surface located no higher than 34" above the finished floor and 27" high knee and toe clearance.	1	
Picnic Tables											
165	South of Main Entrance, Egress Door 1	Ext.		Picnic Tables	N/A

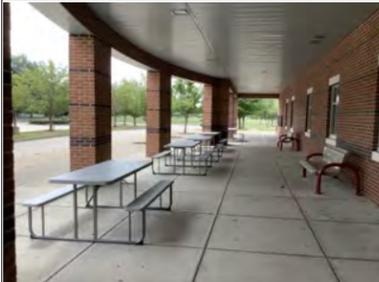
Number of seating spaces at picnic tables At least 5% accessible spaces not provided	6 -	Ensure that at least 5% of the tables have knee clearance of at least 27-inches high, 30-inches wide, and 19-inches deep.	1

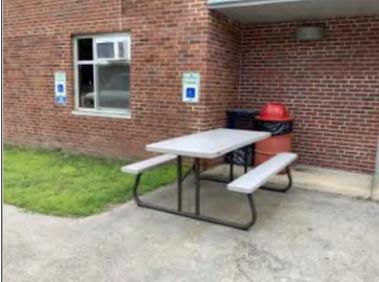
ID	Location	Floor	Room	Element	Type	Photo	Issues	Current Measure	Recommendations	Quantity	Notes
166	By Egress Door 8	Ext.		Picnic Tables	N/A

Number of seating spaces at picnic tables At least 5% accessible spaces not provided	6 -	Ensure that at least 5% of the tables have knee clearance of at least 27-inches high, 30-inches wide, and 19-inches deep.	1	
167	By Toilet Rooms by Football Field	Ext.		Picnic Tables	N/A

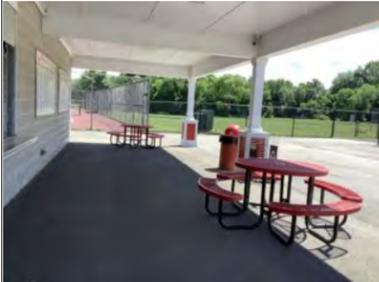
Number of seating spaces at picnic tables At least 5% accessible spaces not provided	2 -	Ensure that at least 5% of the tables have knee clearance of at least 27-inches high, 30-inches wide, and 19-inches deep.	1	
168	By Egress Doors 18 and 19	Ext.		Picnic Tables	N/A

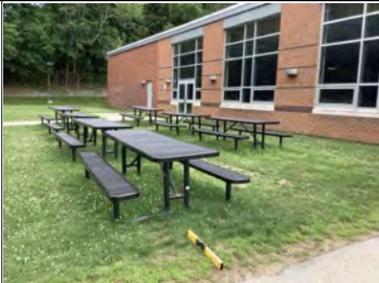
Number of seating spaces at picnic tables At least 5% accessible spaces not provided Picnic table not on an accessible route	8 - -	Ensure that at least 5% of the tables have knee clearance of at least 27-inches high, 30-inches wide, and 19-inches deep. Ensure that the accessible picnic table is located on an accessible route.	1

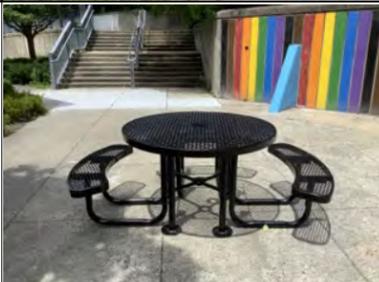
169	By Egress Doors 24 and 25	Ext.		Picnic Tables	N/A

Number of seating spaces at picnic tables 30" clear width not provided	4 13"	Ensure that at least 5% of the tables have knee clearance of at least 27-inches high, 30-inches wide, and 19-inches deep.	1	
170	Courtyard Near Cafeteria	Ext.		Picnic Tables	N/A

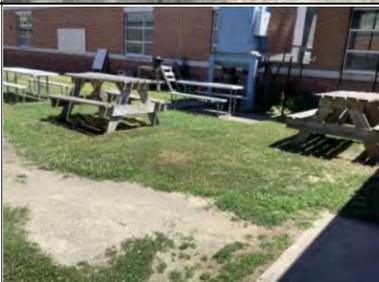
Top of dining/work surfaces < 28" or > 34" Toe or knee clearance at tables not provided Picnic table not on an accessible route	37" - -	Ensure that at least 5% of the tables have knee clearance of at least 27-inches high, 30-inches wide, and 19-inches deep. Ensure that the picnic table is connected to an accessible route.	1

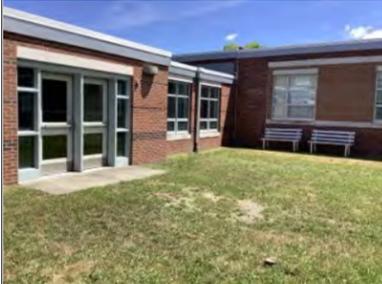
ID	Location	Floor	Room	Element	Type	Photo	Issues	Current Measure	Recommendations	Quantity	Notes
Exterior Benches											
171	Courtyard Near Cafeteria	Ext.		Exterior Benches	N/A

No accessible route to one bench in area	-	Provide an accessible route to one bench in this area.	1	
172	Courtyard Near Gym	Ext.		Exterior Benches	N/A

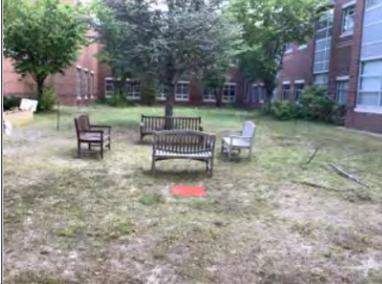
No accessible route to one bench in area	-	Provide an accessible route to one bench in this area.	1	
Kitchens and Kitchenettes											
173	Food Lab	2	299	Kitchens and Kitchenettes	Classrooms

-	Recommend providing a 36" min. by 48" min. stable, firm and slip-resistant surface adjacent to at least one bench by the courtyard in a manner that is substantially similar to what is shown in Figure 1 in the narrative report.	1

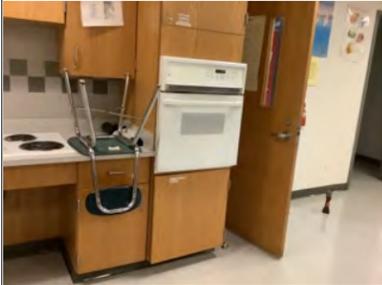
Wall oven controls > 48"	55"	Relocate wall oven so that controls are between 15"-48" above the finished floor. If a wall oven is provided, it must be accessible with controls within reach range.	1	
Toilet & Bathing Rooms											
Lavatory											
174	Men's Single-User Toilet Room, Exterior	1		Lavatory	N/A

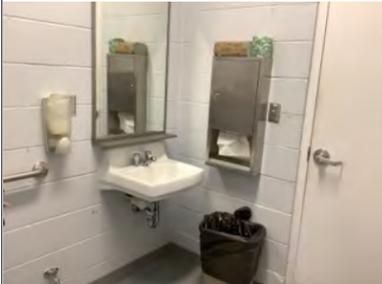
Faucet is not operable with a closed fist Plumbing underneath is exposed	- -	Provide a faucet that can be operable with one hand and not require tight grasping, pinching, or twisting of the wrist for at least one lavatory. Insulate or otherwise configure pipes to prevent contact at the lavatory.	1

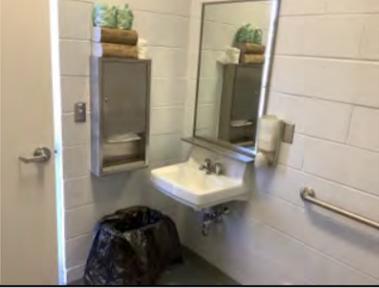
ID	Location	Floor	Room	Element	Type	Photo	Issues	Current Measure	Recommendations	Quantity	Notes
175	Women's Single-User Toilet Room, Exterior	1		Lavatory	N/A

Faucet is not operable with a closed fist Plumbing underneath is exposed	- -	Provide a faucet that can be operable with one hand and not require tight grasping, pinching, or twisting of the wrist for at least one lavatory. Insulate or otherwise configure pipes to prevent contact at the lavatory.	1	
176	Cafeteria - Girls' Toilet Room	1		Lavatory	N/A

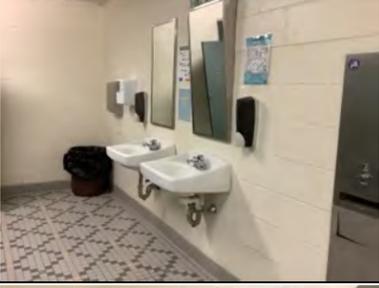
Plumbing underneath is exposed	-	Insulate or otherwise configure pipes to prevent contact for at least one lavatory.	1	
177	Girls' Locker Room - Toilet Room, Women's Toilet Room Near Room 103	1		Lavatory	N/A

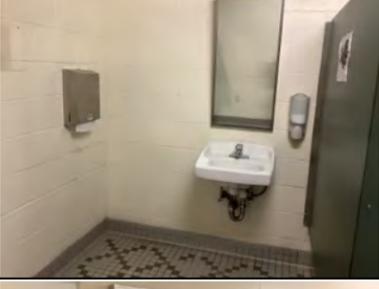
Plumbing underneath is exposed	-	Insulate or otherwise configure pipes to prevent contact at the lavatory.	2	
178	Boys' Toilet Room Near Exit 2	1		Lavatory	N/A

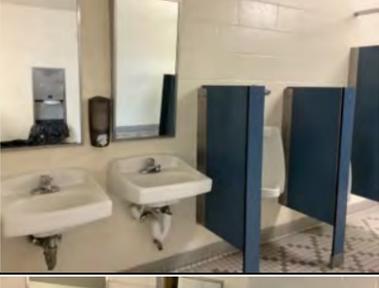
Plumbing underneath is exposed	-	Insulate or otherwise configure pipes to prevent contact for at least one lavatory.	1

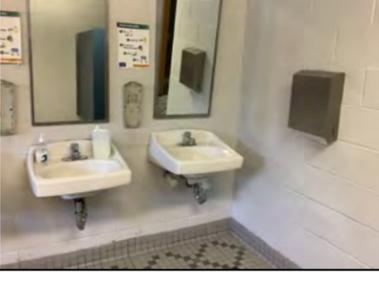
179	Boys' Toilet Room Near Room 286	2		Lavatory	N/A

Plumbing underneath is exposed	-	Insulate or otherwise configure pipes to prevent contact for at least one lavatory.	1

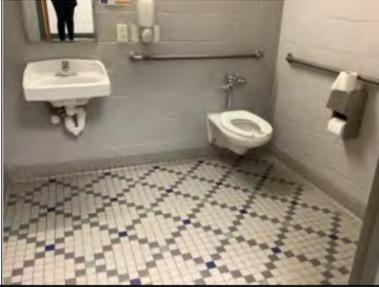
ID	Location	Floor	Room	Element	Type	Photo	Issues	Current Measure	Recommendations	Quantity	Notes
Single-User Toilet											
180	Boys' and Girls' Dressing Room - Toilet Room	1	194, 192	Single-User Toilet	N/A

Dispensers located above grab bar	-	Ensure dispensers are not mounted above the grab bar. Relocate dispensers within 48" above the finished floor.	2	
181	All Gender Toilet Room Near Main Office, Near Room 288	1		Single-User Toilet	N/A

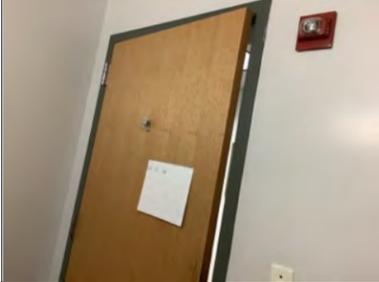
Hook located > 48" high (2010 ADA)	69"	Provide a coat hook 48" above the finished floor.	2	
Toilet Compartment											
182	Cafeteria - Girls' Toilet Room, Girls' Toilet Room Near Room 125, Boys' Toilet Room Near Exit 2	1		Toilet Compartment	Accessible Compartment

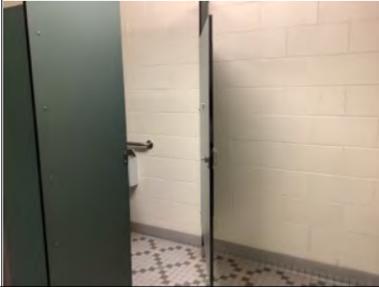
Door has malfunctioning self-closing hinge Door pull not provided	- -	Repair hinge. Provide a door pull on each side of the door between 34" to 48" above the finished floor that does not require tight grasping, pinching or twisting of the wrist.	3

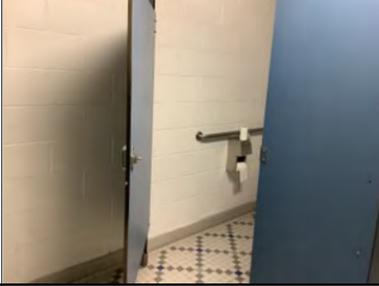
183	Cafeteria - Boys' Toilet Room, Women's & Men's Toilet Room Near Room 103	1		Toilet Compartment	Accessible Compartment

Door has malfunctioning self-closing hinge Door pull not provided	- -	Repair hinge. Provide a door pull on each side of the door between 34" to 48" above the finished floor that does not require tight grasping, pinching or twisting of the wrist.	2	
184	Girls' Locker Room - Toilet Room, Boys' Locker Room - Toilet Room	1		Toilet Compartment	Accessible Compartment

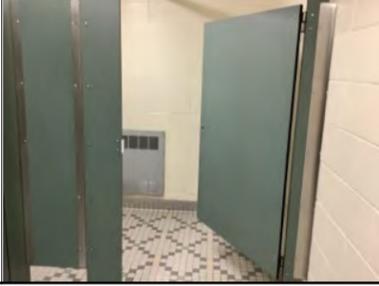
Door has malfunctioning self-closing hinge Door pull not provided	- -	Repair hinge. Provide a door pull on each side of the door between 34" to 48" above the finished floor that does not require tight grasping, pinching or twisting of the wrist.	2

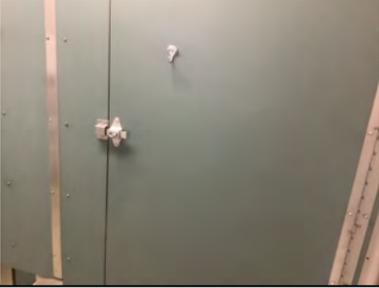
ID	Location	Floor	Room	Element	Type	Photo	Issues	Current Measure	Recommendations	Quantity	Notes
185	Girls' Lacrosse Team Room - Toilet Room, Boys' Team Room - Toilet Room	2		Toilet Compartment	Accessible Compartment

Door has malfunctioning self-closing hinge Door pull not provided	- -	Repair hinge. Provide a door pull on each side of the door between 34" to 48" above the finished floor that does not require tight grasping, pinching or twisting of the wrist.	2	
186	Girls' Toilet Room Near Stair 2, Boys' Toilet Room Near Room 286	2		Toilet Compartment	Accessible Compartment

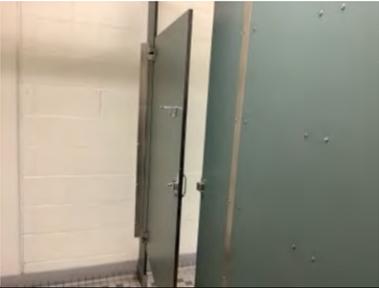
Door has malfunctioning self-closing hinge Door pull not provided	- -	Repair hinge. Provide a door pull on each side of the door between 34" to 48" above the finished floor that does not require tight grasping, pinching or twisting of the wrist.	2	
187	Boys' Toilet Room Near Room 225, Boys' Toilet Room Near Room 286	2		Toilet Compartment	Accessible Compartment

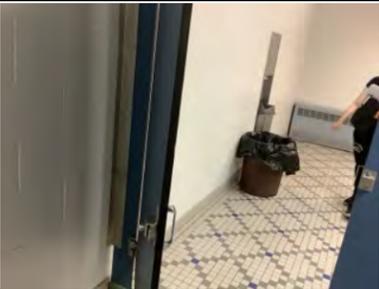
Door has malfunctioning self-closing hinge Door pull not provided	- -	Repair hinge. Provide a door pull on each side of the door between 34" to 48" above the finished floor that does not require tight grasping, pinching or twisting of the wrist.	2

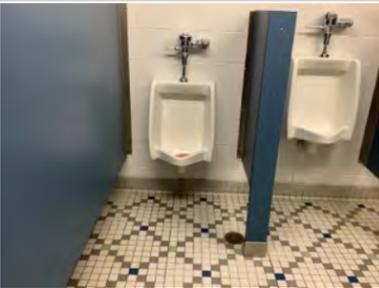
Urinal											
188	Boys' Locker Room - Toilet Room	1		Urinal	N/A

Rim > 17" high Urinal recessed > 24" has > 36" clear width	18.5" 32"	Provide at least one urinal with the rim no higher than 17" max. above the finished floor. If urinal is recessed greater than 24" ensure there is a clear width of 36" min.	1	
189	Boys' Toilet Room Near Room 225, Men's Toilet Room Near Room 103	2		Urinal	N/A

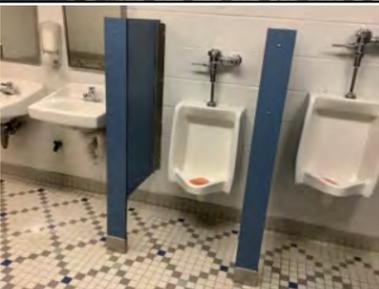
Clear floor space not provided at urinal	27"	Remove partition to provide a 30" min. by 48" min. clear floor space positioned for a forward approach.	2

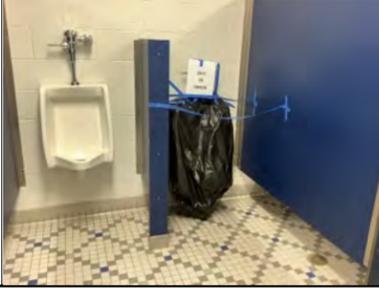
ID	Location	Floor	Room	Element	Type	Photo	Issues	Current Measure	Recommendations	Quantity	Notes
190	Men's Toilet Room Near Room 103	1		Urinal	N/A

Not maintained in operable working condition	-	Ensure that low urinal is maintained in operable working condition.	1	
Dispensers											
191	Cafeteria - Boys' Toilet Room	1		Dispensers	Paper Towel Dispenser

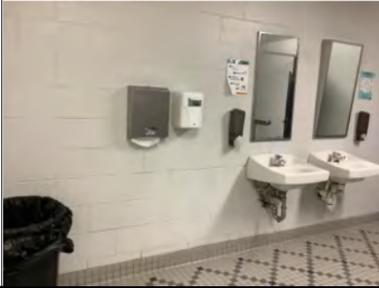
Dispenser acts as a protruding object	7"	Relocate the paper towel dispenser out of the circulation path.	1	
Shower Compartment											
192	Boys' Locker Room - Showers	1		Shower Compartment	Transfer Type

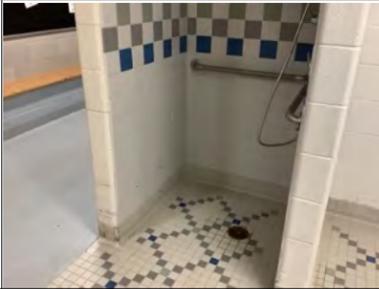
Seat not provided (transfer compartment)	-	Provide a padded folding seat. Ensure that the side grab bar does not overlap the seat.	1	
Portable Toilet											
193	By Field M	Ext.		Portable Toilet	N/A

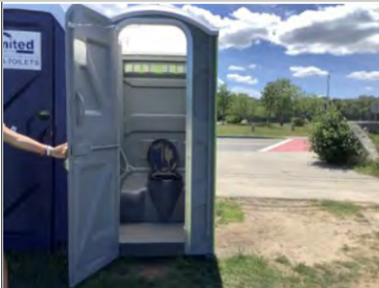
Not located on an accessible route Accessible portable toilets not provided	- -	When portable toilets are provided, ensure that at least 5% of portable toilets is accessible. Locate portable toilet on an accessible route.	1

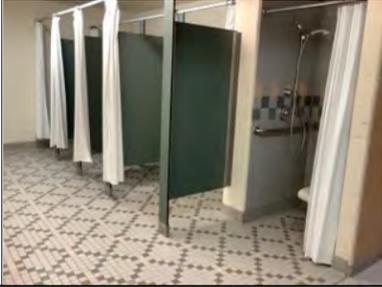
ID	Location	Floor	Room	Element	Type	Photo	Issues	Current Measure	Recommendations	Quantity	Notes
Changing Rooms											
194	Girls' Locker Room - Showers	1		Changing Rooms	Girls

5% of changing rooms are not accessible	-	Recommend providing a curtain for an accessible changing area next to the transfer shower. Changing areas are provided alongside all showers, except for the accessible shower.	1	
Toilet Rooms for Children											
Lavatory (Children)											
195	Child Lab - Toilet Room	2	298	Lavatory (Children)	N/A

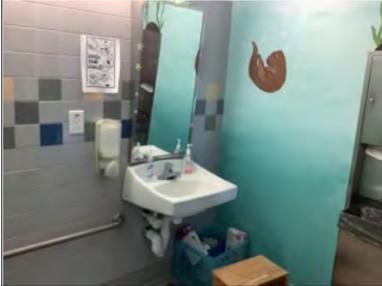
Mirror above lavatory w/reflective surface > 31"	35"	Relocate and lower mirror so that the bottom of the reflecting surface is at 31" above the finished floor max. Optionally, a full length mirror could be added to the room with the bottom of the reflecting surface no higher than 31" above the finished floor max.	1	
Additional Access											
Drinking Fountains

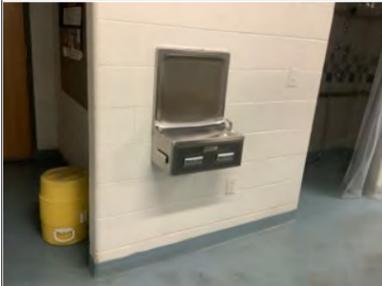
196	Boys' Team Room	2		Drinking Fountains	Low

No drinking fountain provided for standing users	-	Provide an additional drinking fountain for standing users.	1	
197	Drinking Fountain - Near Elevator at Stair 1	2		Drinking Fountains	Low

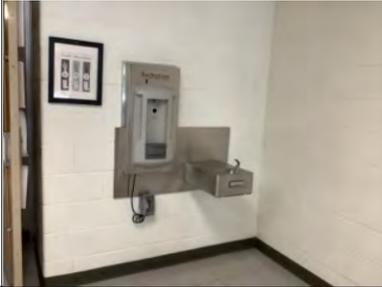
No drinking fountain provided for standing users Standing height fountain does not have cane protection	- -	Install a Hi-Lo drinking fountain. Provide a cane-detectable barrier skirt under the high unit.	1

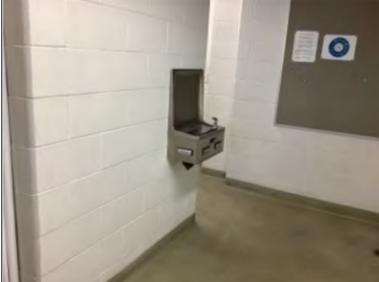
ID	Location	Floor	Room	Element	Type	Photo	Issues	Current Measure	Recommendations	Quantity	Notes
198	Girls' Lacrosse Team Room	2		Drinking Fountains	Low

No drinking fountain provided for standing users Knee or toe clearance not provided	- 25"	Install a Hi-Lo drinking fountain. Provide knee and toe clearance, 27" min. high at drinking fountain for seated users.	1	
199	Near Rooms 180, 184	1		Drinking Fountains	N/A

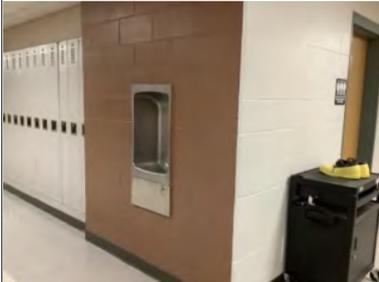
No drinking fountain provided for seated users	-	Provide an additional drinking fountain for seated users.	2	
200	Cafeteria, Near Exit 2	1		Drinking Fountains	High

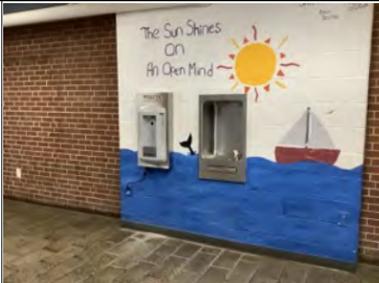
No drinking fountain provided for seated users	-	Provide an additional drinking fountain for seated users by the cafeteria and near Exit 2. Where drinking fountains are provided, 50 percent of the total number must be provided for seated users and 50 percent must be provided for standing users. Where a single drinking Hi-Lo drinking fountain complies for both seating and standing users, it can be substituted for two (2) drinking fountains.	2

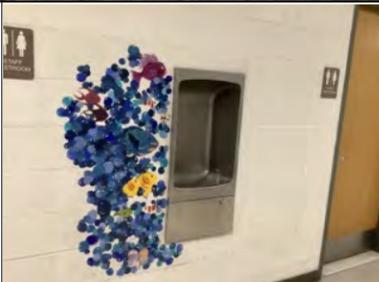
201	Near Room 225	2		Drinking Fountains	High

No drinking fountain provided for seated users	-	Provide an additional drinking fountain for seated users.	1	
202	Drinking Fountain - Near Media Center, Near Girls' Lacrosse	2		Drinking Fountains	Hi-Lo

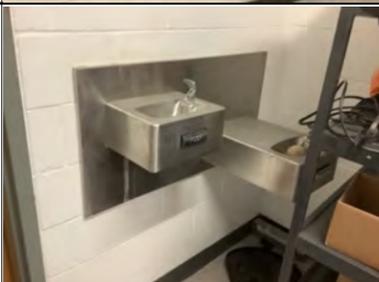
Standing height fountain does not have cane protection		Provide a cane-detectable barrier skirt under the high unit.	2

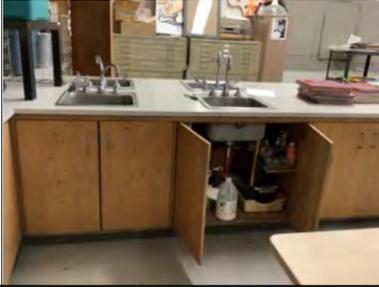
ID	Location	Floor	Room	Element	Type	Photo	Issues	Current Measure	Recommendations	Quantity	Notes
Sink											
203	Art - Painting, Pottery	1	163, 165	Sink	N/A

Clear floor space not provided at sink Toe and knee clearances not provided Rim or counter > 34" Exposed plumbing underneath sink	- - 36.5" -	Provide a 30" by 48" clear floor space positioned for a forward approach. Relocate the table. Ensure there is a 27" min. knee clearance positioned for a forward approach. Relocate sink with the front of the rim or counter no higher than 34" above the finished floor. Insulate or otherwise configure pipes at sink.	2	
204	Science, Physics and Electronics Classrooms	1, 2	129, 128, 127, 222	Sink	Lab

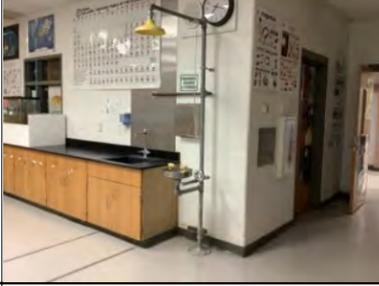
Toe and knee clearances not provided	25"	Ensure there is a 27" min. knee clearance positioned for a forward approach under the emergency eye wash sink.	4	
205	Graphic Arts Technology	1	151	Sink	Other

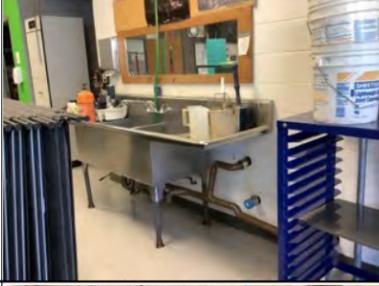
Toe and knee clearances not provided Rim or counter > 34" Exposed plumbing underneath sink	19" 36" -	Ensure there is a 27" min. knee clearance positioned for a forward approach. Relocate sink with the front of the rim or counter no higher than 34" above the finished floor. Insulate or otherwise configure pipes at sink.	1

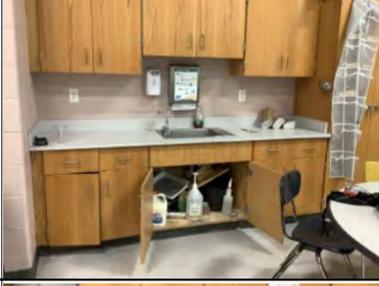
206	Drama, Science Classroom	1	191, 129	Sink	Classroom

Toe and knee clearances not provided Exposed plumbing underneath sink	25.5" -	Ensure there is a 27" min. knee clearance positioned for a forward approach. Insulate or otherwise configure pipes at sink.	2	
207	Special Education Classroom, Science Classroom	1	164, 128	Sink	Classroom

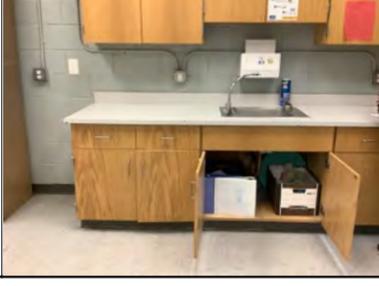
Toe and knee clearances not provided Exposed plumbing underneath sink	26" -	Ensure there is a 27" min. knee clearance positioned for a forward approach. Insulate or otherwise configure pipes at sink.	2

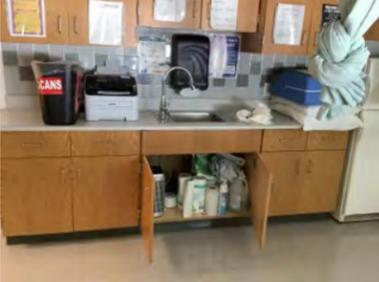
ID	Location	Floor	Room	Element	Type	Photo	Issues	Current Measure	Recommendations	Quantity	Notes
208	Nurses Office	2	295	Sink	N/A

Toe and knee clearances not provided Exposed plumbing underneath sink	- -	Ensure there is a 27" min. knee clearance positioned for a forward approach. Insulate or otherwise configure pipes at sink.	1	
209	Child Lab	2	298	Sink	Classroom

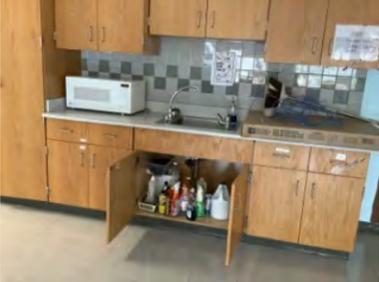
Toe and knee clearances not provided Exposed plumbing underneath sink	- -	Ensure there is a 27" min. knee clearance positioned for a forward approach. Insulate or otherwise configure pipes at sink.	1	
210	Special Education Classroom	2	269 A	Sink	Classroom

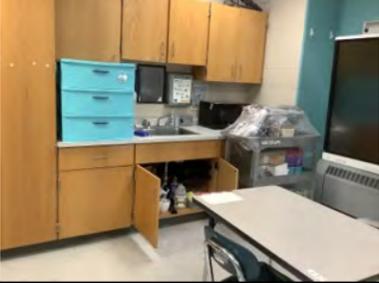
Toe and knee clearances not provided Exposed plumbing underneath sink	- -	Ensure there is a 27" min. knee clearance positioned for a forward approach. Insulate or otherwise configure pipes at sink.	1	
211	Autoshop - Workshop	1	159	Sink	Other

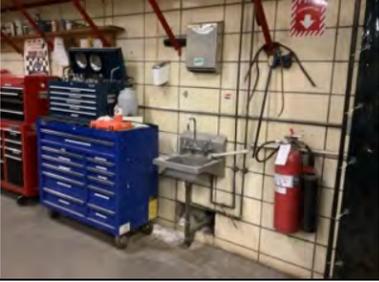
Toe and knee clearances not provided Exposed plumbing underneath sink Dispenser not within reach range	25" - 59"	Ensure there is a 27" min. knee clearance positioned for a forward approach. Insulate or otherwise configure pipes at sink. Relocate paper towel dispenser 48" max. above the finished floor or ground.	1

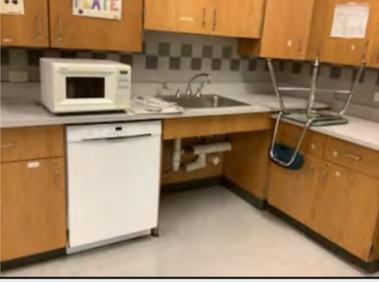
212	Food Lab	2	299	Sink	Classroom

Rim or counter > 34"	37"	Relocate sink with the front of the rim or counter no higher than 34" above the finished floor.	1

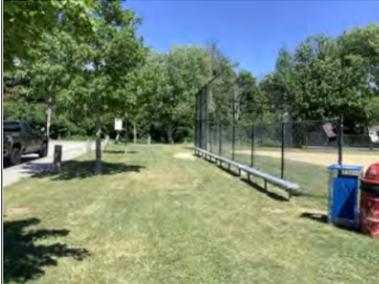
ID	Location	Floor	Room	Element	Type	Photo	Issues	Current Measure	Recommendations	Quantity	Notes
Field											
213	Softball Field A, Team Seating Areas	Ext.		Field	Softball

Accessible spaces not provided at team seating	-	Provide a 36" x 48" clear floor space alongside team seating areas.	2	
214	Baseball Field E, Third Base Bleachers	Ext.		Field	Baseball

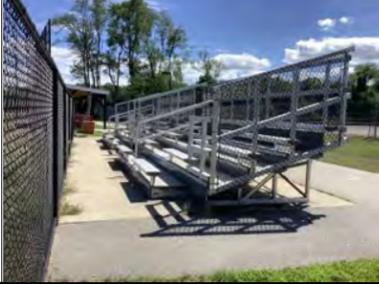
Accessible spaces not provided at sidelines seating	28"x40"	Provide a 36" by 60" clear stable, firm and slip-resistant floor space on each side of the bleacher.	1	
215	Baseball Field L	Ext.		Field	Baseball

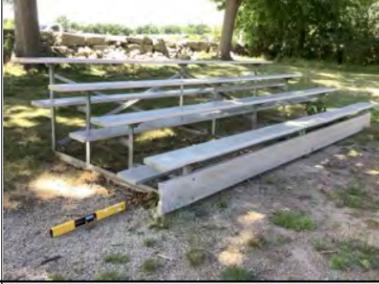
Accessible spaces not provided at sidelines seating Sideline seating not connected to an accessible route	- -	Provide a 36" x 60" clear floor space along each side of the bleacher. Provide an accessible route to the sideline seating.	1	
216	Baseball Field L	Ext.		Field	Baseball

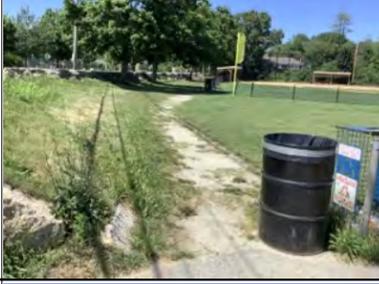
Field not connected to an accessible route No accessible route to all areas of sport activity	- -	Provide an accessible route to the field. Install an accessible route between all areas of sport activity, including the team seating areas.	1

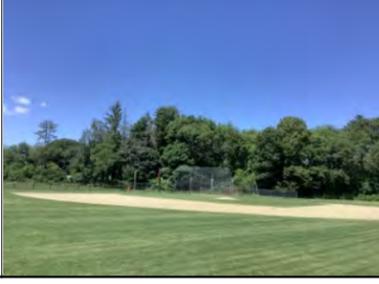
217	Softball Field O	Ext.		Field	Softball

Field not connected to an accessible route No accessible route to all areas of sport activity	- -	Provide an accessible route to the field. Install an accessible route between all areas of sport activity, including team seating areas.	1

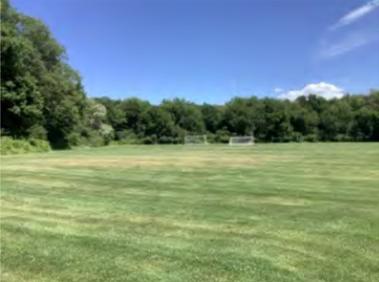
ID	Location	Floor	Room	Element	Type	Photo	Issues	Current Measure	Recommendations	Quantity	Notes
218	Soccer Fields N, M, P and Q	Ext.		Field	Soccer

Field not connected to an accessible route No accessible route to all areas of sport activity	- -	Provide an accessible route to the field. Install an accessible route between all areas of sport activity, including team seating.	3	
219	Lacrosse Fields I, H and G, and Open Fields J and K	Ext.		Field	Lacrosse

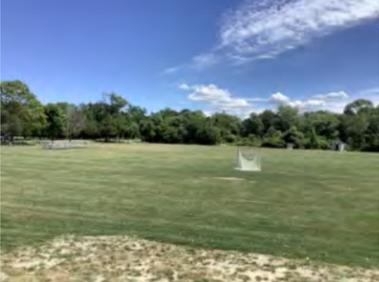
Field not connected to an accessible route No accessible route to all areas of sport activity	- -	Provide an accessible route to each field. Install an accessible route between all areas of sport activity, including team seating.	5	
220	Shot Put	Ext.		Field	Shot Put

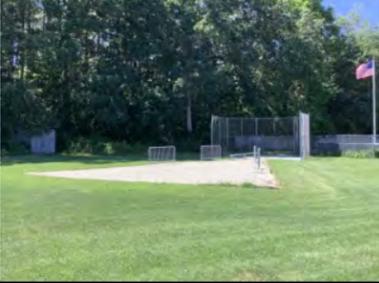
Field not connected to an accessible route No accessible route to all areas of sport activity	- -	Provide an accessible route to the field. Install an accessible route between all areas of sport activity including the shot put.	1

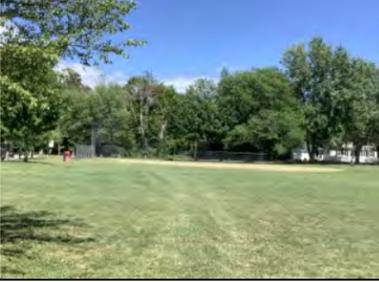
221	Softball Field A	Ext.		Field	Softball

Field not connected to an accessible route No accessible route to all areas of sport activity	- -	Provide an accessible route to the field. Install an accessible route between all areas of sport activity, including team seating areas.	1	
222	Hockey Field F	Ext.		Field	Field Hockey

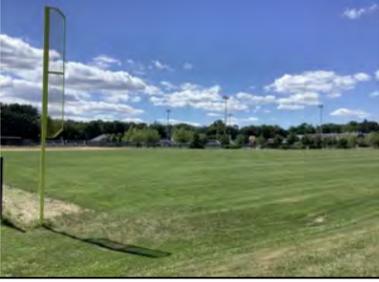
Field not connected to an accessible route No accessible route to all areas of sport activity	- -	Provide an accessible route to the field. Install an accessible route between all areas of sport activity.	1

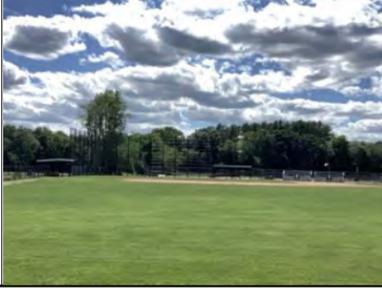
ID	Location	Floor	Room	Element	Type	Photo	Issues	Current Measure	Recommendations	Quantity	Notes
223	Baseball Field E	Ext.		Field	Baseball

Field not connected to an accessible route No accessible route to all areas of sport activity	- -	Provide an accessible route to the field. Install an accessible route between all areas of sport activity, including team seating areas.	1	
Overall Review											
224	Girls' Lacrosse Team Room - Showers	2

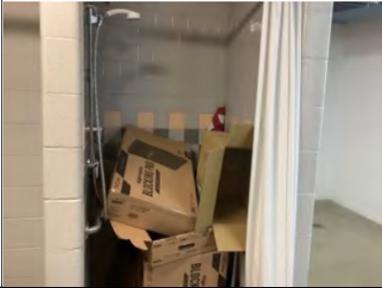
Transfer shower was unable to be surveyed.	1	
Best Practice											
225	Auditorium	1

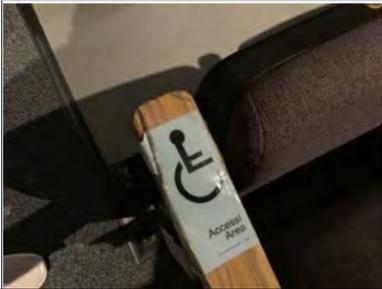
Recommend providing an International Symbol of Accessibility (ISA) sign that is not cut off.	1	
226	Auditorium	1

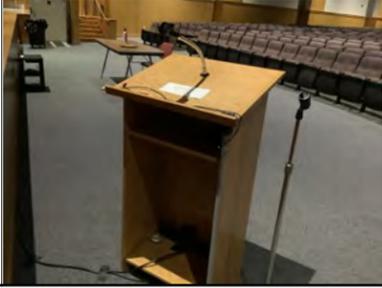
Recommend providing an adjustable podium with knee and toe clearance.	1

- Recommend providing an adjustable podium with knee and toe clearance in the auditorium.
- Recommend providing visually contrasting strips on all staircase treads.

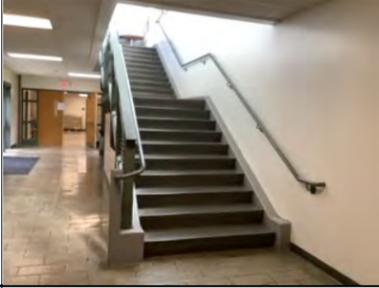
ID	Location	Floor	Room	Element	Type	Photo	Issues	Current Measure	Recommendations	Quantity	Notes
227	Near Exit 24	1

Recommend providing a visual contrasting strip at the edge of each stair tread. Recommendation applies to all stairs.	1	
228	Boys' & Girls' Dressing Room - Toilet Room	1	194, 192

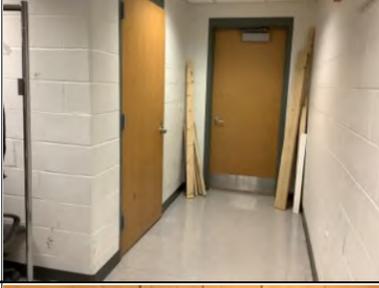
At all permanent rooms and spaces, (such as the boys' and girls' toilet rooms in the dressing rooms), recommend providing signage with raised characters and braille alongside the door on the latch side.	2	
229	Media Center - TV Studio, Editing Room	2	213

- Recommend providing signage with raised characters and braille on the latch side of the door at all permanent rooms that lack designation signage.
- Recommend providing a 36" min. by 48" min. stable, firm and slip-resistant surface adjacent to at least one bench by the tennis courts in a manner that is substantially similar to what is shown in Figure 1.

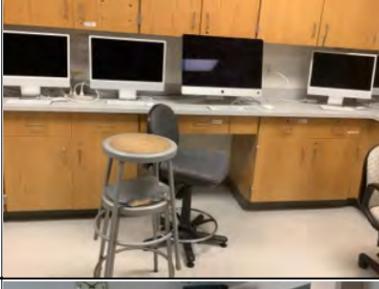
Recommend positioning monitor to the center of accessible seat.	1	
230	Administration Office	2	297

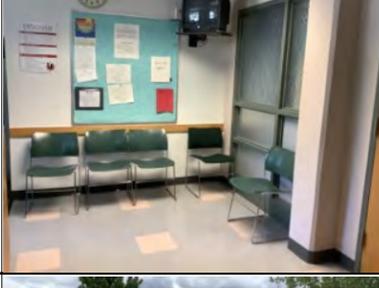
Recommend removing a chair to provide a 36" by 48" clear floor space for a wheelchair space.	1	
231	Towards Softball Field A	Ext.

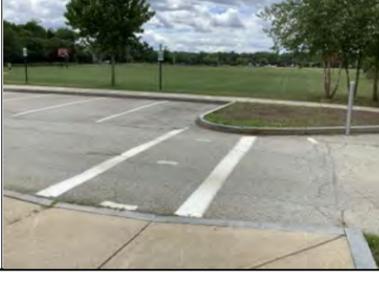
-	Recommend providing a sidewalk and a curb ramp at the street crossing.	1

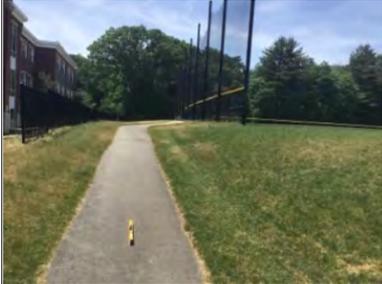
ID	Location	Floor	Room	Element	Type	Photo	Issues	Current Measure	Recommendations	Quantity	Notes
Approach and Entrance											
Exterior Access Route											
1	To Baseball Field			Exterior Access Route	Walkway

Running slope > 1:20 (5.00%)	6.5%	Reducing running slope to 1:20 (5.0%) max. may not be technically feasible.	1	
Curb Ramp											
2	From Parking Lot Towards Roundabout			Curb Ramp	N/A

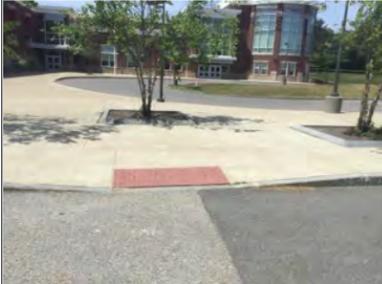
Transition from curb ramp to street not flush	-	Ensure transition from curb ramp to street is flush or free of changes in level.	1	
3	Passenger Loading Zone			Curb Ramp	N/A

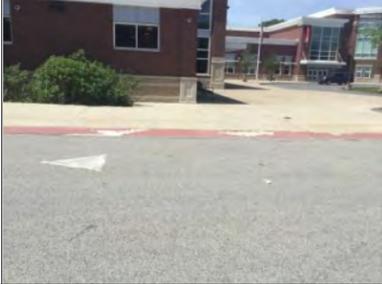
Transition from curb ramp to street not flush	-	Ensure transition from curb ramp to street is flush or free of changes in level.	1	
4	Route to Tennis Courts			Curb Ramp	N/A

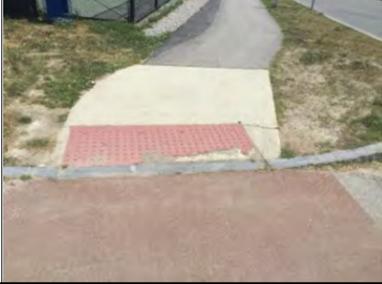
Transition from curb ramp to street not flush	-	Ensure transition from curb ramp to street is flush or free of changes in level.	1	
5	Route to Tennis Courts			Curb Ramp	N/A

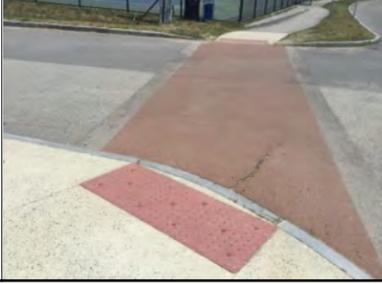
Transition from curb ramp to street not flush	-	Ensure transition from curb ramp to street is flush or free of changes in level.	1

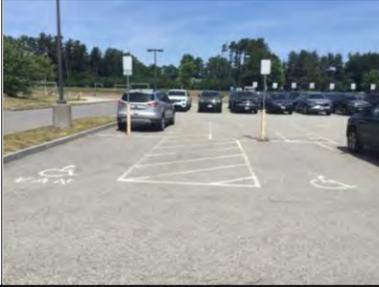
ID	Location	Floor	Room	Element	Type	Photo	Issues	Current Measure	Recommendations	Quantity	Notes
Off-Street Parking Lot or Garage											
6	North Parking by Main Entrance			Off-Street Parking Lot or Garage	N/A

Total # of parking Total # of designated accessible parking spaces Total # of designated van accessible spaces Sign not provided	110 3 1 -	Signs at 3 car and one van accessible parking space are bleached white by the sun. Replace all signs. (Provide four new identification signs with the International Symbol of Accessibility (ISA) and a sign with the designation "Van Accessible" at the van accessible space. Mount all signs 60" min. above the ground measured to the bottom of each sign and 96" max. above the ground measure to the top.	4	
7	Parking by the Soccer Field			Off-Street Parking Lot or Garage	Visitor

Accessibility issues with the parking lot by the main entrance include signs that are not in operable working condition at three (3) car and one (1) van accessible parking space. Accessibility issues with the parking lot by the soccer field include a sign with the International Symbol of Accessibility (ISA) that is not in operable working condition at one (1) car accessible parking space. Additionally, one (1) additional car accessible parking space, along with a marked access aisle, must be provided in the lot by the soccer field.

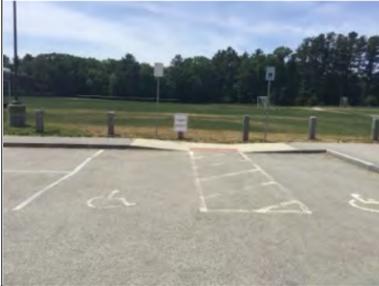
Total # of parking Total # of designated accessible parking spaces Total # of designated van accessible spaces Sign not provided	117 3 1 -	Provide one additional compliant car accessible parking space in this parking lot with a marked access aisle and a sign with the International Symbol of Accessibility (ISA). Replace the sun-faded International Symbol of Accessibility (ISA) sign at the car accessible parking space in this lot that has a faded sign. Ensure all signs are mounted 60" min. and 96" max. above the ground.	1

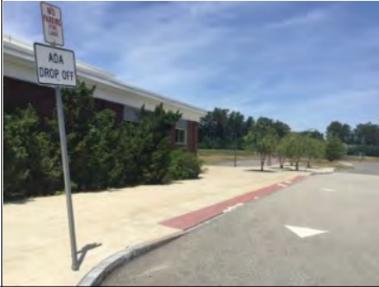
Passenger Loading Zones											
8	Passenger Loading Zone			Passenger Loading Zones	N/A

Marking not provided at access aisle Sign with ISA not provided (MAAB)	- -	Ensure that the 60" wide access aisle is marked so as to discourage parking in them. Provide a sign that includes the International Symbol of Accessibility (ISA) at the head of the space. Locate the sign so that the bottom is 60" min. above the ground and the top is 96" max. above the ground.	1	
Entrance											
9	Main Entrance/ Exit 1 & 2	1		Entrance	Main Entrance

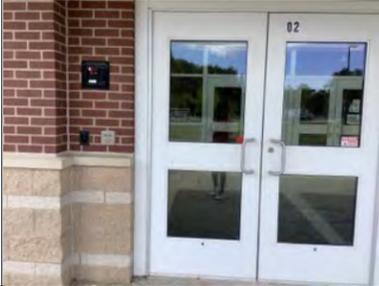
Automatic door opener not operable	-	Repair or replace the door opener. Note: Automatic door opener was not working on the day of the survey.	1

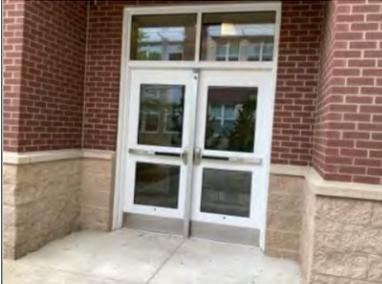
ID	Location	Floor	Room	Element	Type	Photo	Issues	Current Measure	Recommendations	Quantity	Notes
Emergency Exit											
10	Courtyard	1		Emergency Exit	N/A

Door requires > 15 lbs. of force to open	17 lbs.	Adjust closers of exterior doors so doors do not require more than 15 pounds of force. Note: Fire doors shall have a minimum opening force allowable by the appropriate administrative authority.	2	
Access to Goods and Services											
Means of Egress											
11	Stair 2, Egress to Vestibule	1		Means of Egress	N/A

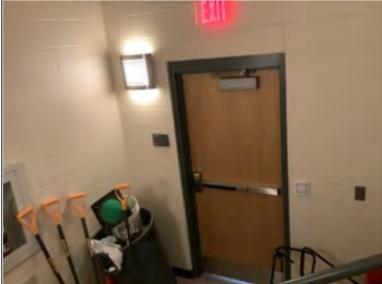
Tactile exit sign not provided	- -	Ensure tactile exit signs with raised characters and braille are provided at exit doors. Mount signs between 48"- 60" above the finished floor located on the latch side of the door.	1	
12	Egress Door 18	1		Means of Egress	N/A

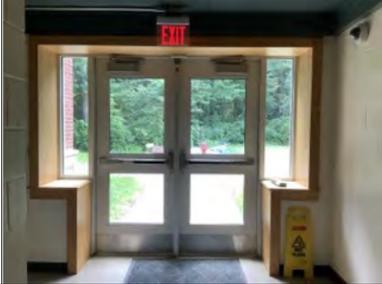
Tactile exit sign not provided	-	Ensure tactile exit signs with raised characters and braille are provided at exit doors. Mount signs between 48"- 60" above the finished floor located on the latch side of the door. Where there is no wall space at the latch side of a single door or at the right side of double doors, signs shall be located on the nearest adjacent wall.	1

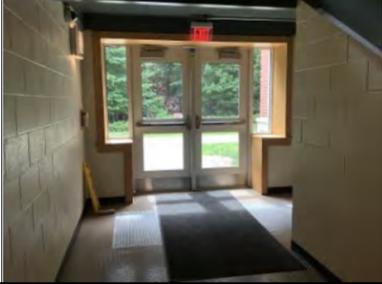
13	Egress Door 19	1		Means of Egress	N/A

Tactile exit sign not provided	-	Ensure tactile exit signs with raised characters and braille are provided at exit doors. Mount signs between 48"- 60" above the finished floor located on the latch side of the door. Where there is no wall space at the latch side of a single door or at the right side of double doors, signs shall be located on the nearest adjacent wall.	1	
14	Egress Door 21	1		Means of Egress	N/A

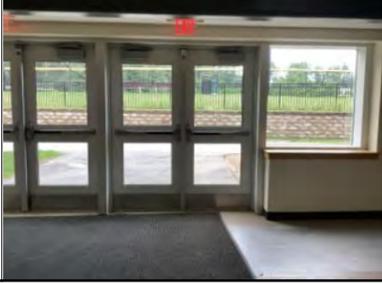
Tactile exit sign not provided		Ensure tactile exit signs with raised characters and braille are provided at exit doors. Mount signs between 48"- 60" above the finished floor located on the latch side of the door. Where a tactile sign is provided at double doors with two active leaves, the sign shall be located to the right of the right hand door.	1

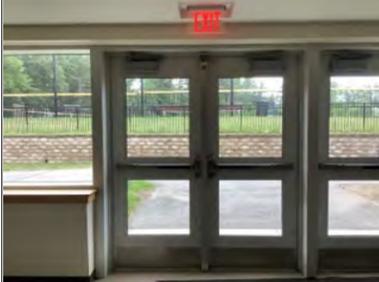
ID	Location	Floor	Room	Element	Type	Photo	Issues	Current Measure	Recommendations	Quantity	Notes
15	Egress Door 20	1		Means of Egress	N/A

Tactile exit sign not provided	-	Ensure tactile exit signs with raised characters and braille are provided at exit doors. Mount signs between 48"- 60" above the finished floor located on the latch side of the door. Where a tactile sign is provided at double doors with two active leafs, the sign shall be located to the right of the right hand door.	1	
16	Exit 03 & 04, Secondary Entrance/ Exit 20 & 21, Main Entrance / Exit 01 & 02	1		Means of Egress	N/A

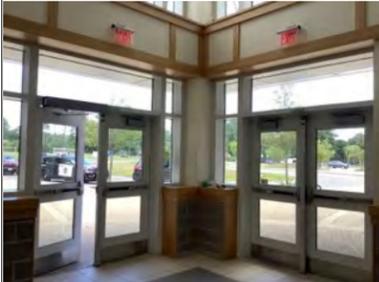
Tactile exit sign not provided	-	Ensure tactile exit signs with raised characters and braille are provided at exit doors. Mount signs between 48"- 60" above the finished floor located on the latch side of the door. Where a tactile sign is provided at double doors with two active leafs, the sign shall be located to the right of the right hand door.	4

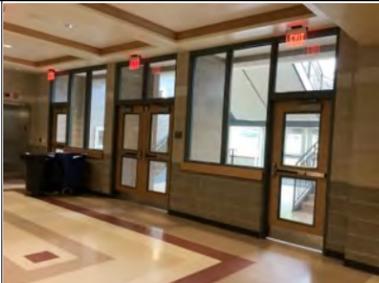
17	Secondary Entrance/ Exit 20 & 21	1		Means of Egress	N/A

Tactile exit sign not provided	-	At each door, ensure tactile exit signs with raised characters and braille are provided at exit doors. Mount signs between 48"- 60" above the finished floor located on the latch side of the door.	2	
18	Exit 07, Exit 06 - Girls' and Boys' Locker Room	1	193, 192	Means of Egress	N/A

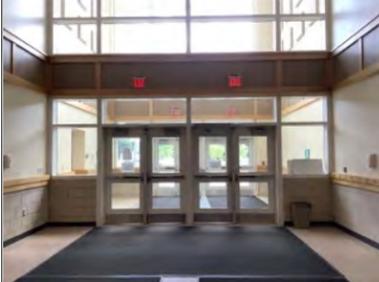
ID	Location	Floor	Room	Element	Type	Photo	Issues	Current Measure	Recommendations	Quantity	Notes
20	Main Entrance / Exit 01 & 02	1		Means of Egress	N/A

Tactile exit sign not provided Illuminated ISA symbol not provided (MAAB)	- -	Ensure tactile exit signs with raised characters and braille are provided at exit doors. Mount signs between 48"- 60" above the finished floor located on the latch side of the door. Where a tactile sign is provided at double doors with two active leafs, the sign shall be located to the right of the right hand door. Provide an illuminated sign with the International Symbol of Accessibility (ISA) over the doors.	2	
21	To Exit 03 & Exit 04	1		Means of Egress	N/A

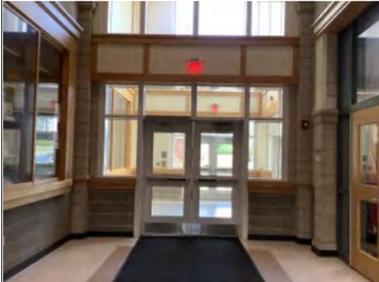
Tactile exit sign not provided Illuminated ISA symbol not provided (MAAB)	- -	Ensure tactile exit signs with raised characters and braille are provided at exit doors. Mount signs between 48"- 60" above the finished floor located on the latch side of the door. Where a tactile sign is provided at double doors with two active leafs, the sign shall be located to the right of the right hand door. Provide an illuminated sign with the International Symbol of Accessibility (ISA) over the door.	2

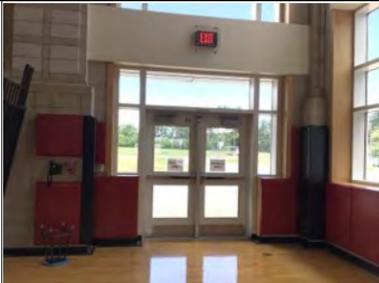
22	Gymnasium- Exit 05	1		Means of Egress	N/A

Tactile exit sign not provided Illuminated ISA symbol not provided (MAAB)	- -	Ensure tactile exit signs with raised characters and braille are provided at exit doors. Mount signs between 48"- 60" above the finished floor located on the latch side of the door. Where a tactile sign is provided at double doors with two active leafs, the sign shall be located to the right of the right hand door. Provide an illuminated sign with the International Symbol of Accessibility (ISA) over the door.	1	
23	Exit 12	1		Means of Egress	N/A

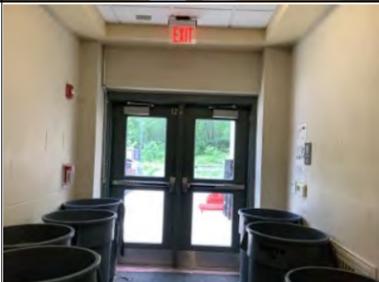
Tactile exit sign not provided Illuminated ISA symbol not provided (MAAB)	- -	Ensure tactile exit signs with raised characters and braille are provided at exit doors. Mount signs between 48"- 60" above the finished floor. Where there is no wall space at the latch side of a single door or at the right side of double doors, signs shall be located on the nearest adjacent wall. Provide an illuminated sign with the International Symbol of Accessibility (ISA) over the door.	1

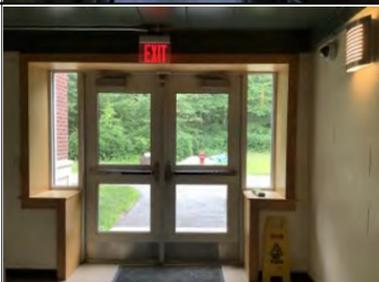
24	Exit 18	1		Means of Egress	N/A

Tactile exit sign not provided Illuminated ISA symbol not provided (MAAB)		Ensure tactile exit signs with raised characters and braille are provided at exit doors. Mount signs between 48"- 60" above the finished floor. Where a tactile sign is provided at double doors with two active leafs, the sign shall be located to the right of the right hand door on the nearest adjacent wall. Provide an illuminated sign with the International Symbol of Accessibility (ISA) over the door.	1

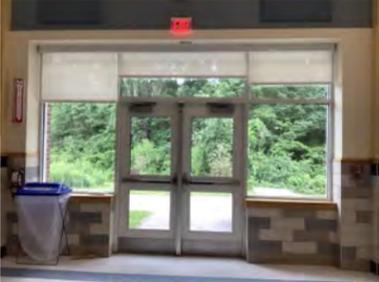
ID	Location	Floor	Room	Element	Type	Photo	Issues	Current Measure	Recommendations	Quantity	Notes
25	Exit 14 & Exit 13 - Cafeteria	1	123	Means of Egress	N/A

Tactile exit sign not provided Illuminated ISA symbol not provided (MAAB)		Ensure tactile exit signs with raised characters and braille are provided at exit doors. Mount signs between 48"- 60" above the finished floor located on the latch side of the door. Where a tactile sign is provided at double doors with two active leafs, the sign shall be located to the right of the right hand door. Provide an illuminated sign with the International Symbol of Accessibility (ISA) over the door.	2	
26	Secondary Entrance / Exit 17	1	120	Means of Egress	N/A

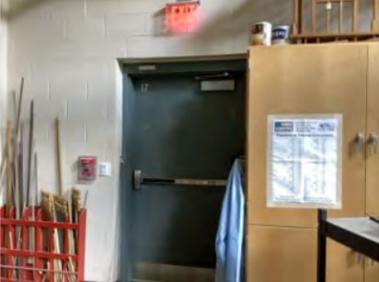
Tactile exit sign not provided Directional sign to accessible emergency exit not provided	- -	Ensure tactile exit signs with raised characters and braille are provided at exit doors. Mount signs between 48"- 60" above the finished floor located on the latch side of the door. Provide a directional sign indicating the location of the nearest accessible emergency exit.	1

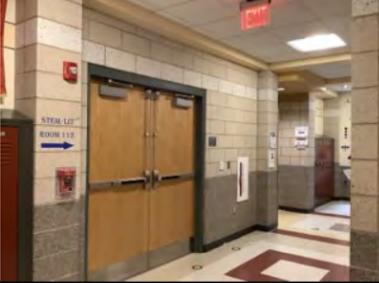
27	Stair 4 and Stair 3	1		Means of Egress	N/A

Illuminated ISA symbol not provided (MAAB)	-	Provide an illuminated sign with the International Symbol of Accessibility (ISA).	2	
28	Stair 1	1		Means of Egress	N/A

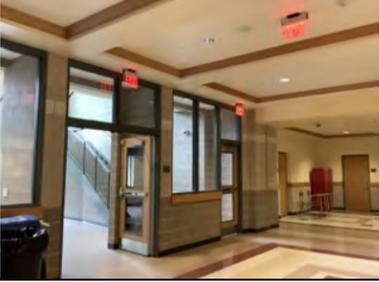
Illuminated ISA symbol not provided (MAAB)	-	Provide an illuminated sign with the International Symbol of Accessibility (ISA).	2	
29	Secondary Entrance/ Exit 20 & 21	1		Means of Egress	N/A

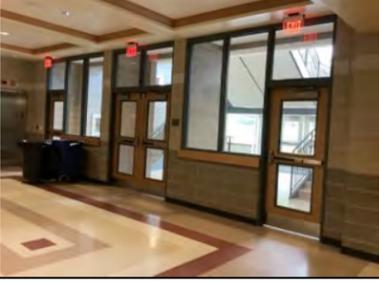
Illuminated ISA symbol not provided (MAAB)	-	Provide an illuminated sign with the International Symbol of Accessibility (ISA) over the door.	3

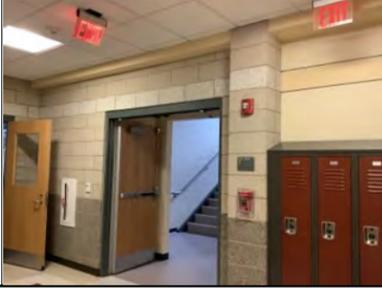
ID	Location	Floor	Room	Element	Type	Photo	Issues	Current Measure	Recommendations	Quantity	Notes
30	To Stair 3 & Exit 18	1		Means of Egress	N/A

Illuminated ISA symbol not provided (MAAB)	-	Provide an illuminated sign with the International Symbol of Accessibility (ISA) over the door.	1	
Interior Access Route											
31	6th Grade Spanish Classroom	1	106	Interior Access Route	N/A

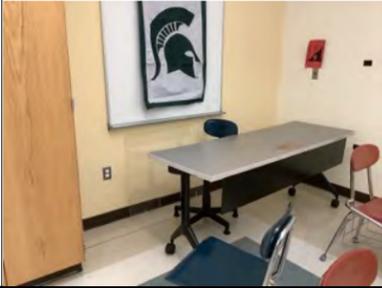
Route < 36" wide	18"	Ensure that a clear width of 36" min. is maintained at the accessible route.	1	
32	Exit 08	1	C108B	Interior Access Route	N/A
