East Elementary School

Town of Hingham ADA Transition Plan

October 2023

Institute for Human Centered Design

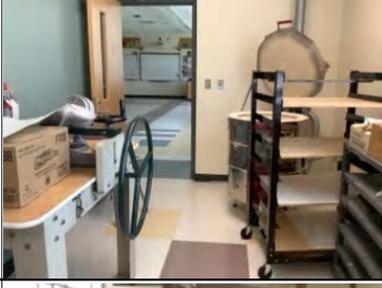
Route < 36" wide	30"	Ensure that a clear width of 36" min. is maintained at the accessible route. Relocate furniture.	1	
34	Library Media Center	2	240	Interior Access Route	N/A

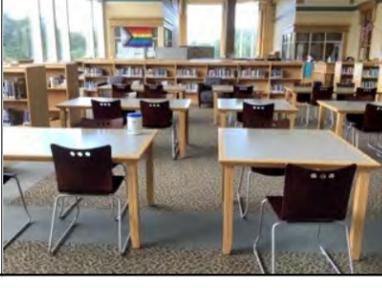
Route < 36" wide	19"	Ensure that a clear width of 36" min. is maintained at the accessible route. Relocate furniture.	1

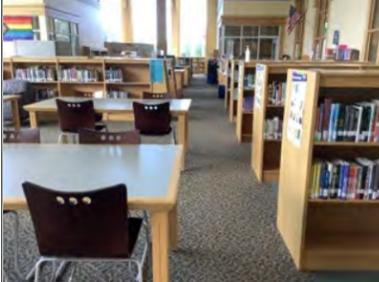
ID	Location	Floor	Room	Element	Type	Photo	Issues	Current Measure	Recommendations	Quantity	Notes
35	Library Media Center	2	240	Interior Access Route	N/A

Route < 36" wide	28"	Ensure that a clear width of 36" min. is maintained at the accessible route. Relocate furniture.	1	
36	Library Media Center	2	240	Interior Access Route	N/A

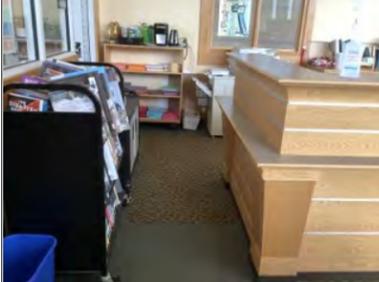
Route < 36" wide	28"	Ensure that a clear width of 36" min. is maintained at the accessible route. Relocate black book case.	1	
37	Media Application Lab	2	241	Interior Access Route	N/A

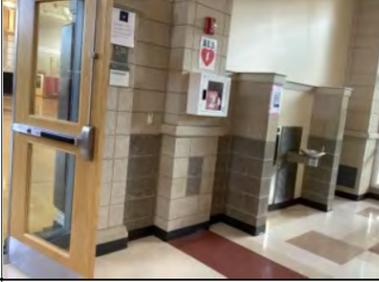
Obstructed by protruding objects	-	Relocate the defibrillator out of the circulation path.	2	
39	Technology Application Lab	1	121	Interior Access Route	N/A

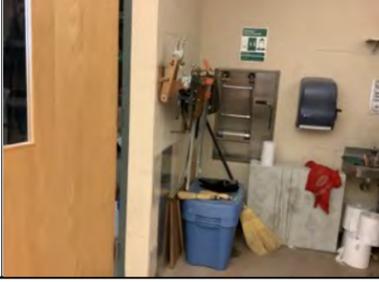
Obstructed by protruding objects	7"	Relocate objects / tools out of the circulation path.	1

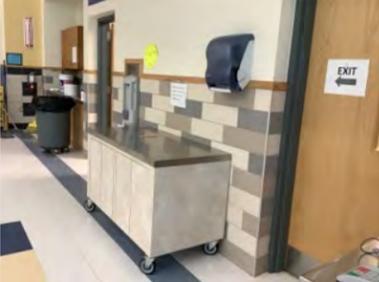
Obstructed by protruding objects	9"	Relocate the paper towel dispenser out of the circulation path.	1	
41	Cafeteria	1	123	Interior Access Route	N/A

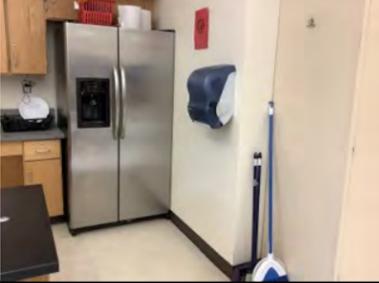
Obstructed by protruding objects	9"	Relocate the paper towel dispenser out of the circulation path.	1	
43	Near Exam Room	1	160	Interior Access Route	N/A

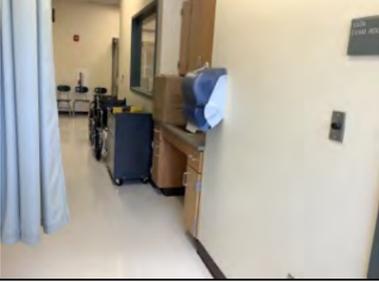
Obstructed by protruding objects	9"	Relocate the paper towel dispenser out of the circulation path.	1	
44	Wellness Center	1	190	Interior Access Route	N/A

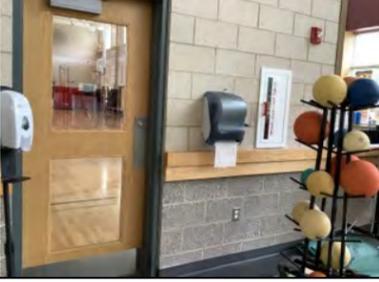
Obstructed by protruding objects	9"	Relocate paper towel dispenser out of the circulation path.	1

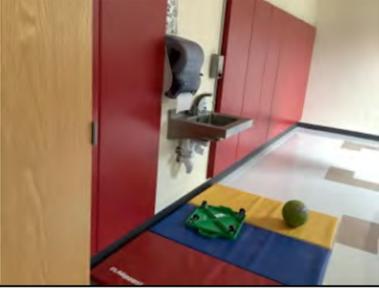
Obstructed by protruding objects	6"	Relocate the paper towel dispenser out of the circulation path.	1	
46	Special Education	1	119	Interior Access Route	N/A

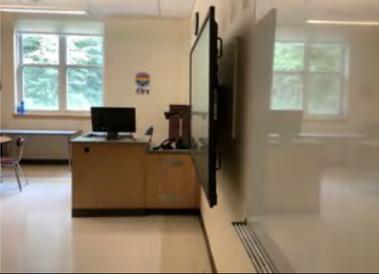
Obstructed by protruding objects Vertical clearance < 80" above finished floor	7.5" 33"	Provide a cane-detectable barrier underneath the television.	1	
47	7th Grade Science Lab	2	205	Interior Access Route	N/A

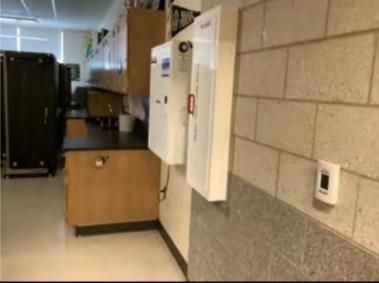
Obstructed by protruding objects Vertical clearance < 80" above finished floor	9" 36"	Provide a cane-detectable barrier under white boxes.	1	
48	7th Grade Math Classroom	2	206	Interior Access Route	N/A

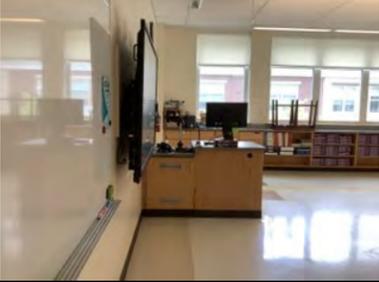
Obstructed by protruding objects Vertical clearance < 80" above finished floor	7" 34"	Provide a cane-detectable barrier under the television	1

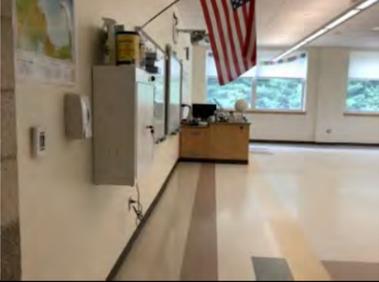
49	STEM Classroom	2	212	Interior Access Route	N/A

Obstructed by protruding objects Vertical clearance < 80" above finished floor	10" 34"	Provide a cane-detectable barrier under the gray cabinet.	1

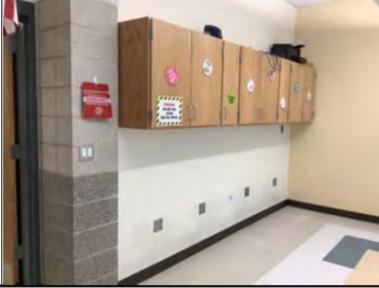
Obstructed by protruding objects Vertical clearance < 80" above finished floor	13" 52"	Provide a cane-detectable barrier under the cabinets.	1	
Doors, Doorways, & Gates											
51	Library Study Room	2	243	Doors, Doorways, & Gates	Other

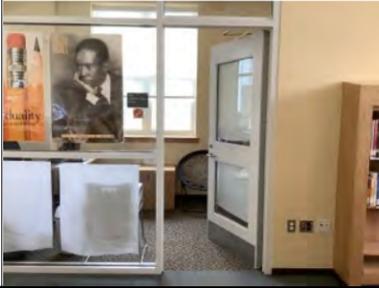
Clear width at door < 32" Door requires > 5 lbs. of force to open	30" 8 lbs	Install offset hinges to ensure that the door has a clear width of 32 inches. Adjust closers so doors do not require more than 5 pounds of force to open.	1	
52	6th Grade Spanish Classroom	1	100	Doors, Doorways, & Gates	Circulation

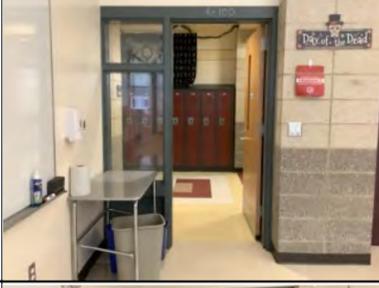
Maneuvering clearance(s) not provided	2"	Relocate the furniture so that there is 12" min. clear on the latch side of the door.	1	
53	Special Education	1	111	Doors, Doorways, & Gates	Circulation

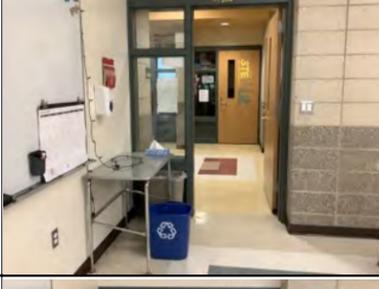
Maneuvering clearance(s) not provided	3"	Remove the desk.	1

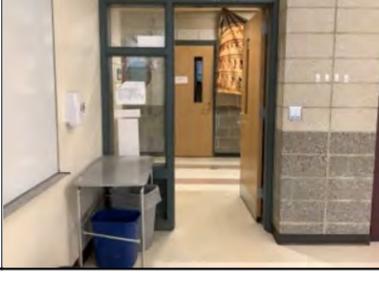
54	6th Grade Math Classroom	1	114	Doors, Doorways, & Gates	Circulation

Maneuvering clearance(s) not provided	3"	Relocate the desk so that there is 12" on the latch side of the door.	1

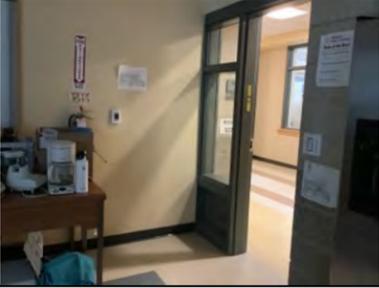
Maneuvering clearance(s) not provided	-	Relocate tables to provide maneuvering clearance that is 12" min. parallel to the door and 60" min. perpendicular to the door on the push side of the door.	1	
56	Guidance Office	1	141	Doors, Doorways, & Gates	Office

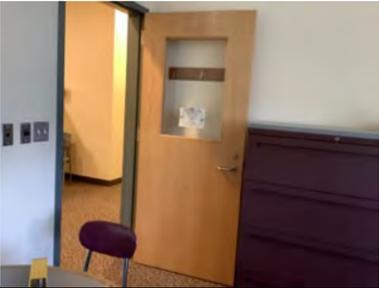
Maneuvering clearance(s) not provided	41"	Relocate cabinet and table to provide maneuvering clearance that is 18" min. parallel to the door and 60" min. perpendicular to the door on the pull side of the door.	1	
57	Inclusion Facilitator	1	146	Doors, Doorways, & Gates	N/A

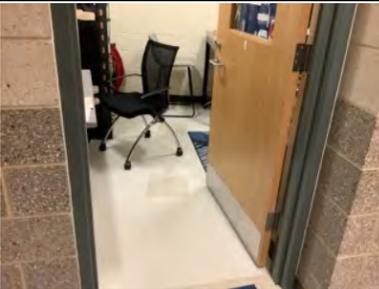
Maneuvering clearance(s) not provided	-	Relocate furniture to provide maneuvering clearance that is 18" min. parallel to the door and 60" min. perpendicular to the door on the pull side of the door.	1

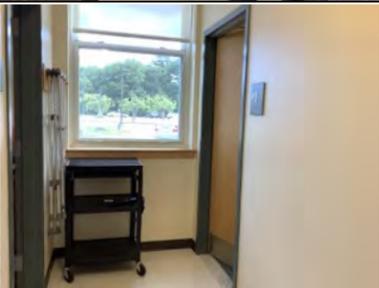
58	Toilet Room - Health Services	1	161	Doors, Doorways, & Gates	Toilet Room

Maneuvering clearance(s) not provided	-	Relocate stand to provide maneuvering clearance that is 12" min. parallel to the door and 60" min. perpendicular to the door on the push side of the door.	1	
59	Educational Support Center - School Psychologist	1	172	Doors, Doorways, & Gates

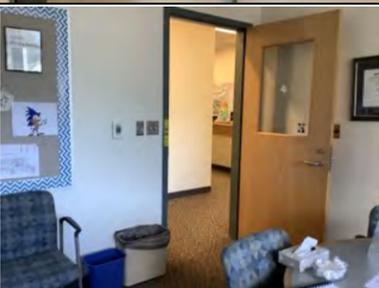
Maneuvering clearance(s) not provided		Relocate the trash cans to provide maneuvering clearance that is 18" min. parallel to the door and 60" min. perpendicular to the door on the pull side of the door.	1

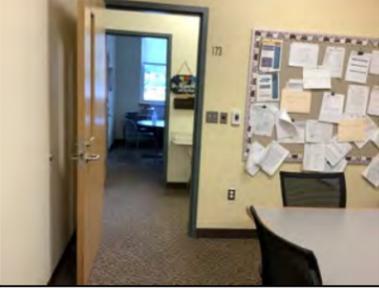
Maneuvering clearance(s) not provided	46"	Relocate table to provide maneuvering clearance that is 18" min. parallel to the door and 60" min. perpendicular to the door on the pull side of the door.	1	
61	Conference Room	2	235	Doors, Doorways, & Gates	Circulation

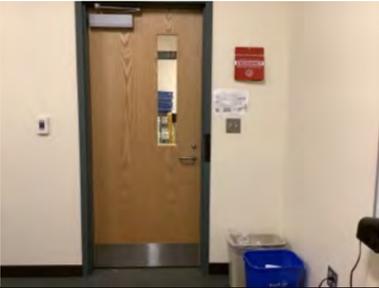
Maneuvering clearance(s) not provided	6"	Relocate the trash bins so that there is 12" clear on the latch side of the door.	1	
62	Mindfulness Room	2	236	Doors, Doorways, & Gates	Circulation

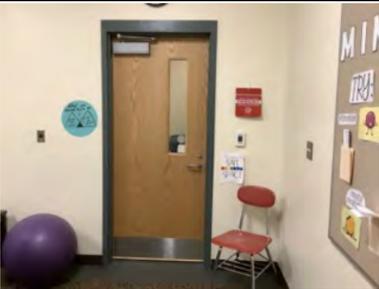
Maneuvering clearance(s) not provided	-	Relocate the chair so that there is 12" clear min. on the latch side of the door.	1	
63	Media Control Room	2	241	Doors, Doorways, & Gates	Circulation

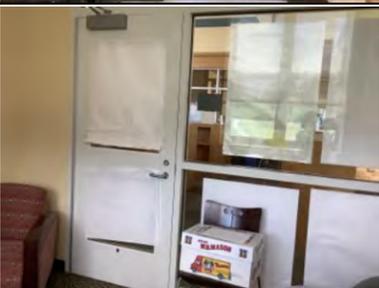
64	Library Study Room	2	243	Doors, Doorways, & Gates	Circulation

Maneuvering clearance(s) not provided	10"	Relocate storage boxes so that there is 12" clear on the latch side of the door.	1

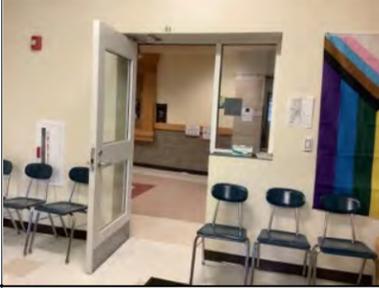
Maneuvering clearance not provided at recess > 6"	9"	Install an automatic door opener. Relocate chairs to ensure that there is 30" by 48" clear at the automatic door opener.	1	
66	Wellness Center From Gymnasium	1	190	Doors, Doorways, & Gates	Other

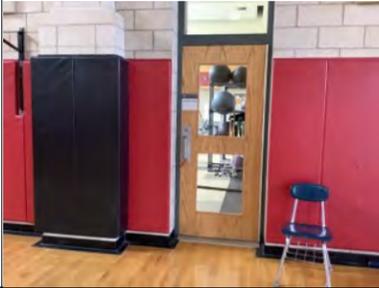
Maneuvering clearance not provided at recess > 6"	13"	Install an automatic door opener.	1	
67	Toilet Room - Gymnasium	1	T191A, T191B	Doors, Doorways, & Gates	Toilet Room

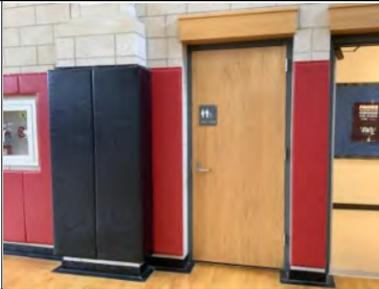
Maneuvering clearance not provided at recess > 6"	13"	Install an automatic door opener.	2	
68	Main Office	1		Doors, Doorways, & Gates	N/A

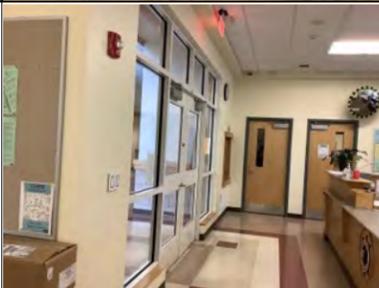
Door requires > 5 lbs. of force to open	15 lbs.	Adjust closers so doors do not require more than 5 pounds of force to open.	1	
69	Chorus Music Room, Instrumental Music, Guidance, Educational Support Center	1	125, 126, 140, 170	Doors, Doorways, & Gates	Classroom

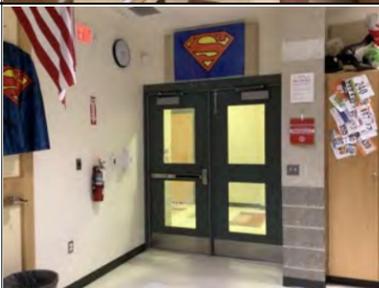
Door requires > 5 lbs. of force to open	22 lbs.	Adjust closers so doors do not require more than 5 pounds of force to open.	4

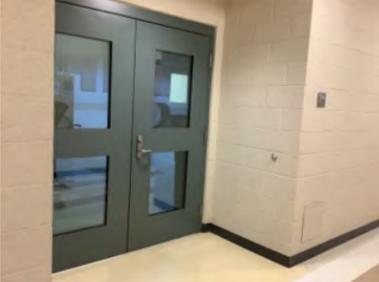
Door requires > 5 lbs. of force to open	32 lbs.	Adjust closers so doors do not require more than 5 pounds of force to open.	2	
71	Stage - Auditorium	1	130A	Doors, Doorways, & Gates	Other

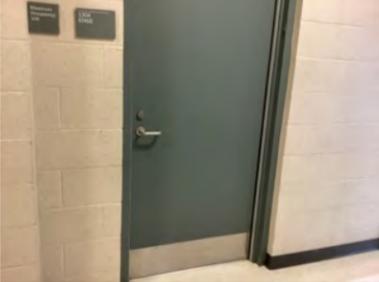
Door requires > 5 lbs. of force to open	27 lbs.	Adjust closers so doors do not require more than 5 pounds of force to open.	2	
72	Toilet Room - Health Services	1	160, 161	Doors, Doorways, & Gates	Toilet Room

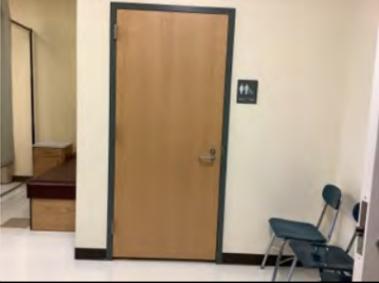
Door requires > 5 lbs. of force to open	11 lbs.	Adjust closers so doors do not require more than 5 pounds of force to open.	2	
73	Toilet Room - Gymnasium	1	T191A, T191B	Doors, Doorways, & Gates	Toilet Room

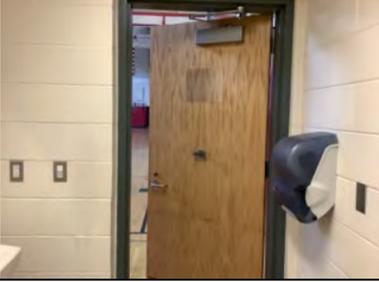
Door requires > 5 lbs. of force to open	14 lbs.	Adjust closers so doors do not require more than 5 pounds of force to open.	2	
74	Ceramics/Kiln Room	2	222B	Doors, Doorways, & Gates	Other

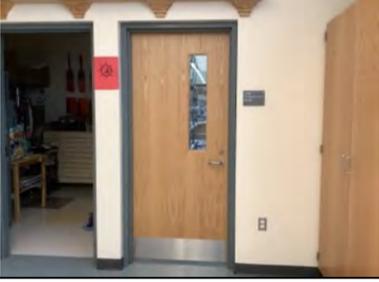
Door requires > 5 lbs. of force to open	16 lbs	Adjust closers so doors do not require more than 5 pounds of force to open.	1

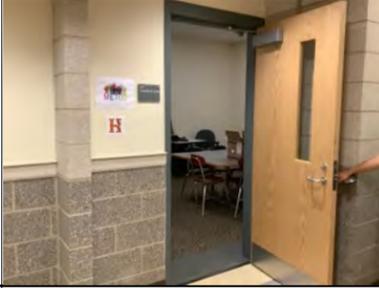
Door requires > 5 lbs. of force to open	9 lbs	Adjust closers so doors do not require more than 5 pounds of force to open.	1	
76	Media Control Room	2	241	Doors, Doorways, & Gates	Classroom

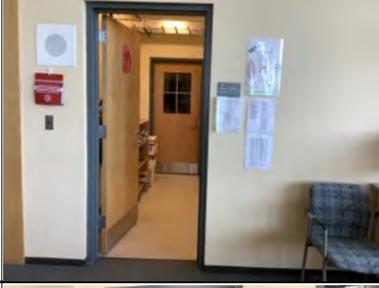
Door requires > 5 lbs. of force to open	8 lbs	Adjust closers so doors do not require more than 5 pounds of force to open.	1	
77	Media Application Lab	2	241	Doors, Doorways, & Gates	Classroom

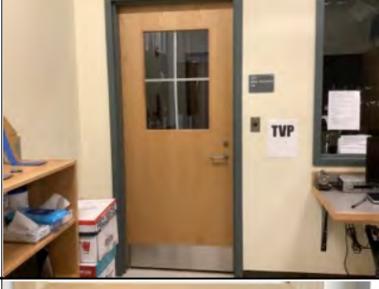
Door requires > 5 lbs. of force to open	8 lbs	Adjust closers so doors do not require more than 5 pounds of force to open.	1	
78	Library Media Center, Librarian Office	2	242	Doors, Doorways, & Gates	Office

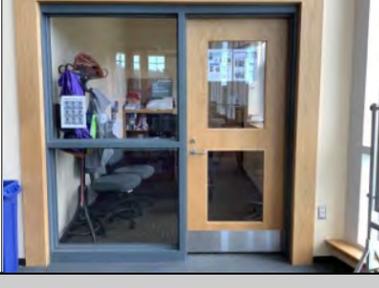
Door requires > 5 lbs. of force to open	8 lbs	Adjust closers so doors do not require more than 5 pounds of force to open.	1	
Signage											
79	Tutoring Room	2	228	Signage	Designation

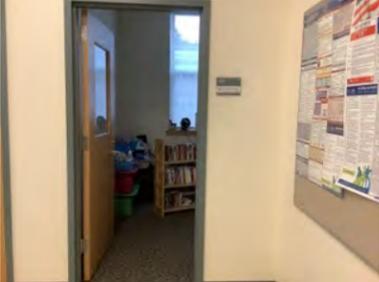
ID	Location	Floor	Room	Element	Type	Photo	Issues	Current Measure	Recommendations	Quantity	Notes
80	Hingham Public Schools District Board Certified Behavioral Analyst	2	235	Signage	Designation

Raised characters not provided on sign Braille not provided on sign	- -	Provide text with raised characters duplicated in braille on sign.	1	
81	6th Grade History Classroom	1	102	Signage	Designation

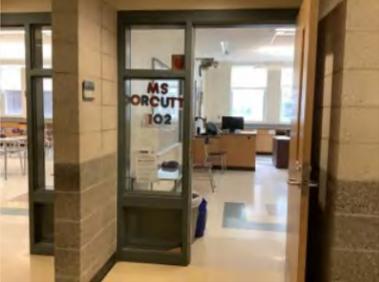
Raised characters not provided on sign Braille not provided on sign Sign not located on the latch side of the door	- - -	Provide text with raised characters duplicated in braille on sign. Locate the sign at permanent rooms alongside the door on the latch side.	1	
82	6th Grade Science Lab	1	105	Signage	Designation

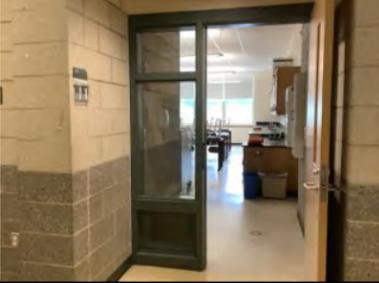
Raised characters not provided on sign Braille not provided on sign Sign not located on the latch side of the door	- - -	Provide text with raised characters duplicated in braille on sign. Locate the sign at permanent rooms alongside the door on the latch side.	1

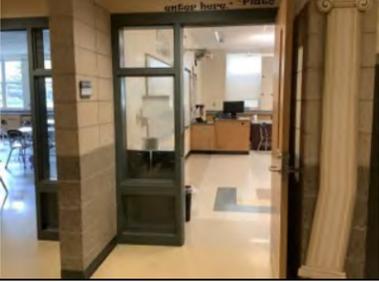
83	6th Grade Spanish Classroom	1	106	Signage	Designation

Raised characters not provided on sign Braille not provided on sign Sign not located on the latch side of the door	- - -	Provide text with raised characters duplicated in braille on sign. Locate the sign at permanent rooms alongside the door on the latch side.	1	
84	6th Grade Stem Lab	1	110	Signage	Designation

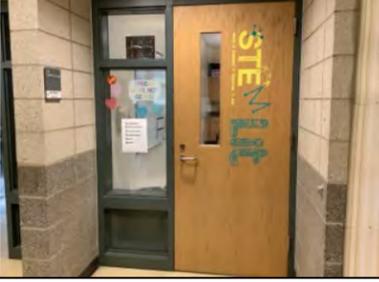
Raised characters not provided on sign Braille not provided on sign Sign not located on the latch side of the door	- - -	Provide text with raised characters duplicated in braille on sign. Locate the sign at permanent rooms alongside the door on the latch side.	1

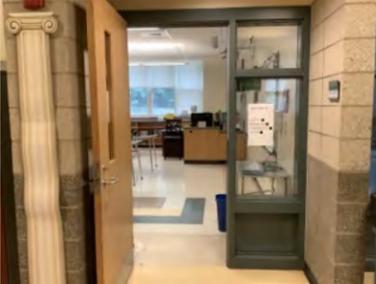
ID	Location	Floor	Room	Element	Type	Photo	Issues	Current Measure	Recommendations	Quantity	Notes
85	Special Education	1	111	Signage	Designation

<ul style="list-style-type: none"> Raised characters not provided on sign Braille not provided on sign Sign not located on the latch side of the door 	<ul style="list-style-type: none"> - - - 	<ul style="list-style-type: none"> Provide text with raised characters duplicated in braille on sign. Locate the sign at permanent rooms alongside the door on the latch side. 	1	
86	Special Education	1	113	Signage	Designation

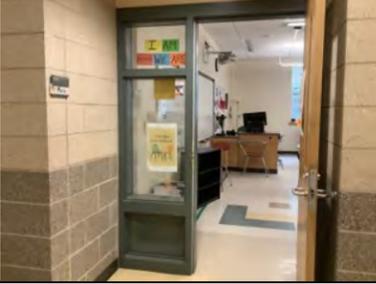
<ul style="list-style-type: none"> Raised characters not provided on sign Braille not provided on sign Sign not located on the latch side of the door 	<ul style="list-style-type: none"> - - - 	<ul style="list-style-type: none"> Provide text with raised characters duplicated in braille on sign. Locate the sign at permanent rooms alongside the door on the latch side. 	1

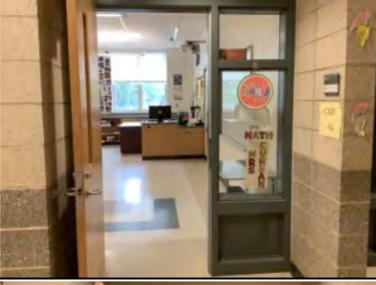
87	6th Grade Math Classroom	1	114	Signage	Designation

<ul style="list-style-type: none"> Raised characters not provided on sign Braille not provided on sign Sign not located on the latch side of the door 	<ul style="list-style-type: none"> - - - 	<ul style="list-style-type: none"> Provide text with raised characters duplicated in braille on sign. Locate the sign at permanent rooms alongside the door on the latch side. 	1	
88	Special Education	1	119	Signage	Designation

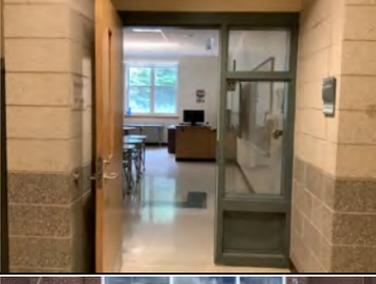
<ul style="list-style-type: none"> Raised characters not provided on sign Braille not provided on sign Sign not located on the latch side of the door 	<ul style="list-style-type: none"> - - - 	<ul style="list-style-type: none"> Provide text with raised characters duplicated in braille on sign. Locate the sign at permanent rooms alongside the door on the latch side. 	1	
89	Main Entrance/ Exit 1 & 2	1		Signage	Designation

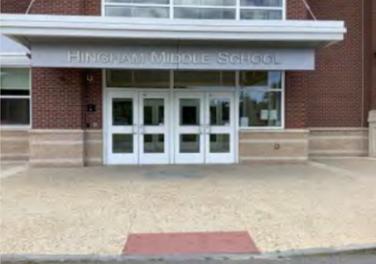
<ul style="list-style-type: none"> Raised characters not provided on sign Braille not provided on sign Sign not located on the latch side of the door 	<ul style="list-style-type: none"> - - - 	<ul style="list-style-type: none"> Provide text with raised characters duplicated in braille on sign. Where a tactile sign is provided at double doors with two active leaves, the sign shall be located to the right of the right hand door. Ensure all entrances that have designation numbers and/or text have tactile signage. 	1

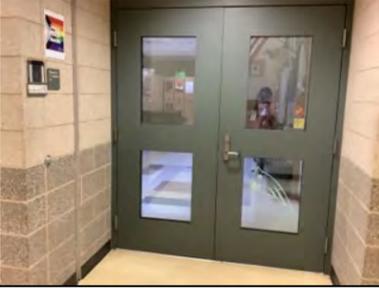
ID	Location	Floor	Room	Element	Type	Photo	Issues	Current Measure	Recommendations	Quantity	Notes
90	Chorus Music Room	1	125	Signage	Designation

<ul style="list-style-type: none"> Raised characters not provided on sign Braille not provided on sign Sign not located on the latch side of the door 	<ul style="list-style-type: none"> - - - 	<ul style="list-style-type: none"> Provide text with raised characters duplicated in braille on sign. For double-leaf doors with one active leaf, locate sign on the inactive leaf. If each door has an active leaf, locate sign to the right of the right hand door. 	1	
91	7th Grade English Classroom	2	203	Signage	Designation

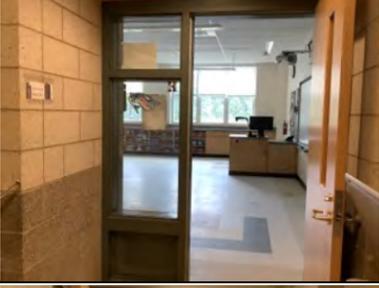
<ul style="list-style-type: none"> Raised characters not provided on sign Braille not provided on sign Sign not located on the latch side of the door 	<ul style="list-style-type: none"> - - - 	<ul style="list-style-type: none"> Provide text with raised characters duplicated in braille on sign. Locate the sign at permanent rooms alongside the door on the latch side on the glass close to the door. 	1

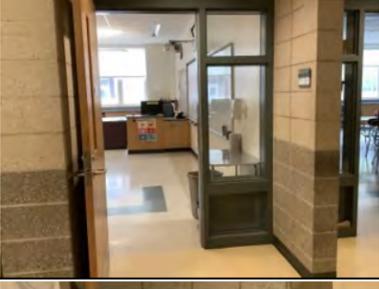
92	6th Grade Spanish Classroom, Family & Consumer Science Lab	1	100, 122	Signage	Designation

<ul style="list-style-type: none"> Sign not located on the latch side of the door 	<ul style="list-style-type: none"> - 	<ul style="list-style-type: none"> Locate the sign at permanent rooms alongside the door on the latch side on the glass close to the door. 	2	
93	Special Education	1	101	Signage	Designation

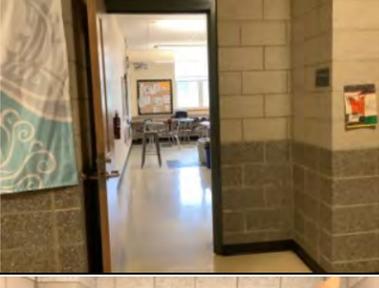
<ul style="list-style-type: none"> Sign not located on the latch side of the door 	<ul style="list-style-type: none"> - 	<ul style="list-style-type: none"> Locate the sign at permanent rooms alongside the door on the latch side on the wall. 	1	
94	Wood Shop	1	120	Signage	Designation

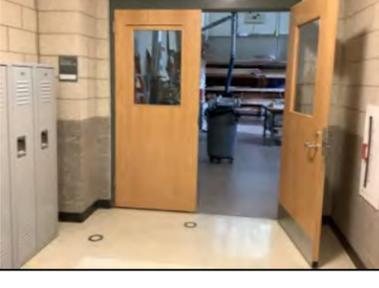
<ul style="list-style-type: none"> Sign not located on the latch side of the door 	<ul style="list-style-type: none"> - 	<ul style="list-style-type: none"> For double-leaf doors with one active leaf, locate sign on the inactive leaf. If each door has an active leaf, locate sign to the right of the right hand door. Ensure at the sign to provide a clear floor space of 18" min. by 18" min. 	1

The current sign designates the space incorrectly. Recommend updating the sign with 'Wood Shop'.	1

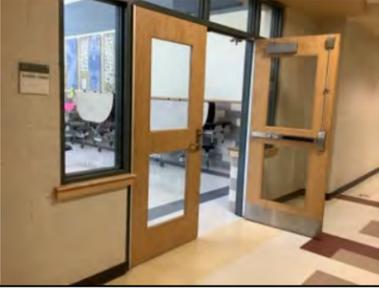
ID	Location	Floor	Room	Element	Type	Photo	Issues	Current Measure	Recommendations	Quantity	Notes
95	Cafeteria	1	123	Signage	Designation

Sign not located on the latch side of the door	-	For double-leaf doors with one active leaf, locate sign on the inactive leaf. If each door has an active leaf, locate sign to the right of the right hand door.	1	
96	Instrumental Music. Special Education	1	126, 127	Signage	Designation

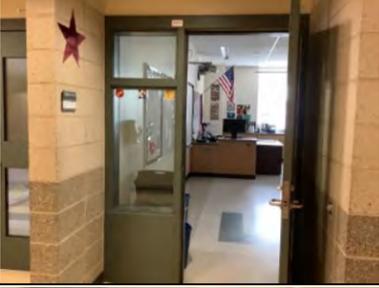
Sign not located on the latch side of the door	-	Locate the sign at permanent rooms alongside the door on the latch side on the glass close to the door.	2	
97	Auditorium	1	130	Signage	Designation

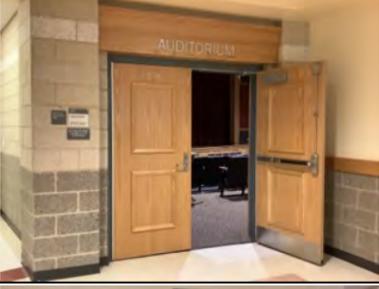
Sign not located on the latch side of the door	-	For double-leaf doors with one active leaf, locate sign on the inactive leaf. If each door has an active leaf, locate sign to the right of the right hand door.	1	
98	Boys' Locker Room - Shower - Gymnasium	1	192 B	Signage	Designation

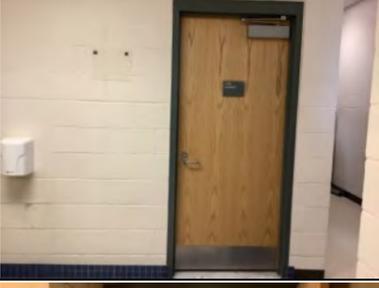
Sign not located on the latch side of the door	-	Locate the sign at permanent rooms alongside the door on the latch side on the wall.	1

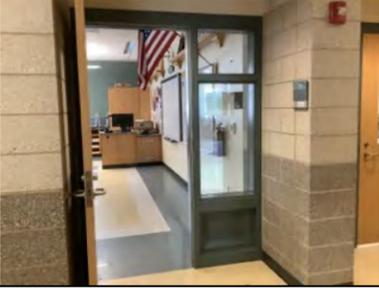
ID	Location	Floor	Room	Element	Type	Photo	Issues	Current Measure	Recommendations	Quantity	Notes
100	Art Classroom (2 Doors), 7th Grade French Classroom, Reading Room	2	224, 226, 220	Signage	Designation

Sign not located on the latch side of the door	-	Locate the sign at permanent rooms alongside the door on the latch side on the glass close to the door.	4	
101	Staff Planning	2	231	Signage	Designation

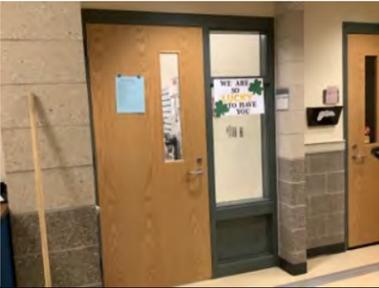
Sign not located on the latch side of the door	-	Locate the sign at permanent rooms alongside the door on the latch side on the frosted glass close to the door.	1	
102	Special Education	3	213, 219, 313, 317	Signage	Designation

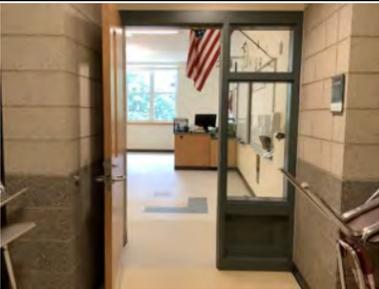
Sign not located on the latch side of the door	-	Locate the sign at permanent rooms alongside the door on the latch side on the glass close to the door.	4	
103	8th Grade English Classrooms and 8th Grade Science Labs	3, 2	309, 311, 315, 316, 217	Signage	Designation

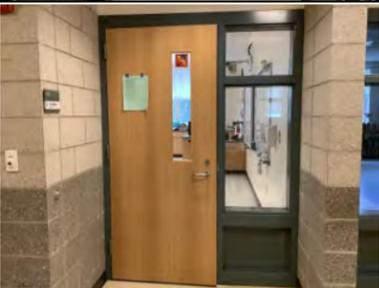
Sign not located on the latch side of the door	-	Locate the sign at permanent rooms alongside the door on the latch side on the glass close to the door.	5

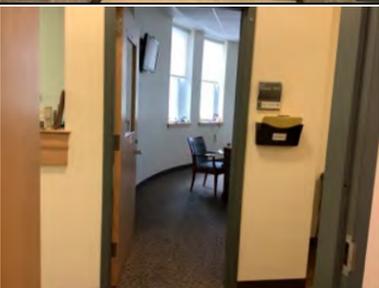
104	Principal Office, Educational Support Center - Office, Guidance Office	1	152, 171, 141	Signage	Designation

Signage lacks 18" by 18" clear floor space	-	Relocate file holder to provide a clear floor space of 18" min. by 18" min.	3

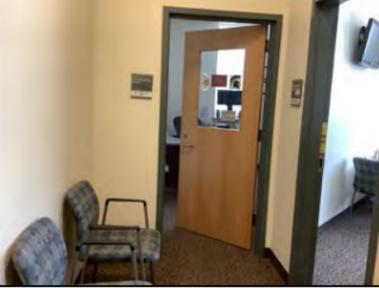
ID	Location	Floor	Room	Element	Type	Photo	Issues	Current Measure	Recommendations	Quantity	Notes
105	Vice Principal	1	153	Signage	Designation

Signage lacks 18" by 18" clear floor space	-	Relocate chair to provide a clear floor space of 18" min. by 18" min.	1	
106	Administrator Office	1	155	Signage	Designation

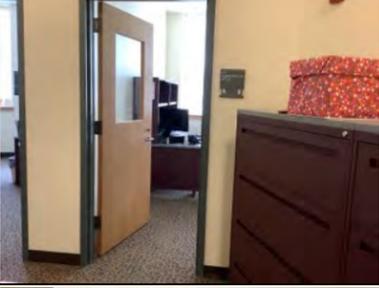
Signage lacks 18" by 18" clear floor space	-	Relocate cabinet to provide a clear floor space of 18" min. by 18" min.	1	
107	Visiting Supervisory Office	1	157	Signage	Designation

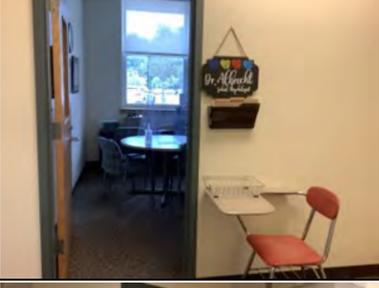
Signage lacks 18" by 18" clear floor space	-	Remove decorative sign, file holder and the chair to provide a clear floor space of 18" min. by 18" min. at the tactile sign.	1	
109	Mindfulness Room	2	236	Signage	Designation

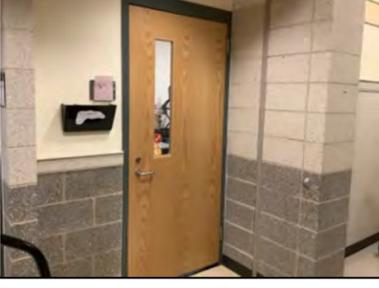
Signage lacks 18" by 18" clear floor space	-	Relocate file folder to provide a clear floor space of 18" min. by 18" min. at the tactile designation sign.	1

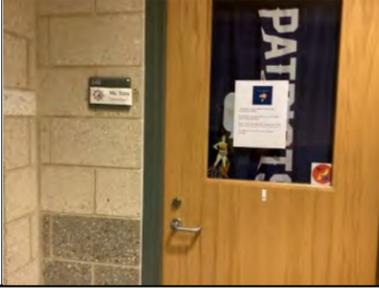
ID	Location	Floor	Room	Element	Type	Photo	Issues	Current Measure	Recommendations	Quantity	Notes
110	Inclusion Facilitator	1	146	Signage	Designation

Sign not maintained	-	Remove paper sign to ensure that the raised characters and braille is not covered.	1	
Operable Parts											
111	Wellness Center	1	190	Operable Parts	Equipment

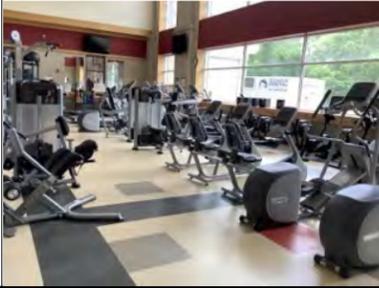
Clear floor space is not provided	-	Provide a 30" min. by 48" min. clear floor space at one of each type of fitness equipment.	1	
112	Corridor Near Gymnasium, Corridor Near Main Office	1		Operable Parts	Equipment

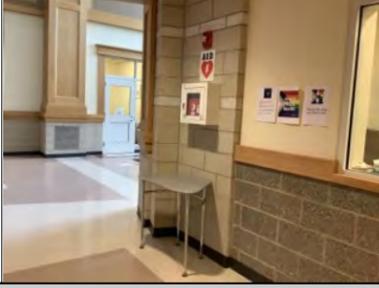
Reach < 15" or > 48"(forward/side approach)	58"	Relocate defibrillator so that controls are between 15"- 48" above the finished floor.	2	
Dining or Work Surfaces											
113	Library Media Center, Classroom	2	244	Dining or Work Surfaces	Work Surface

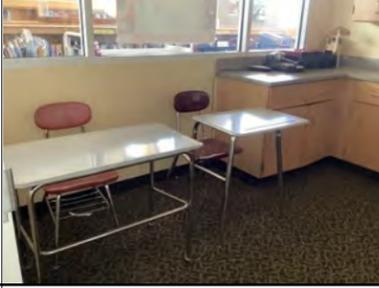
Not on a accessible route Knee or toe clearance not provided	- 26"	Ensure that the accessible work surfaces is located on an accessible route. Provide at least one work surface with 27" min. knee and toe clearance.	1

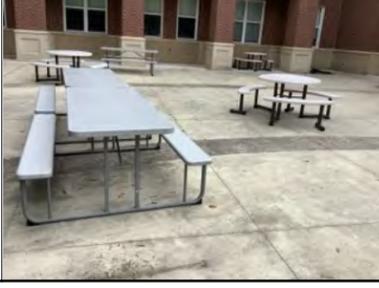
114	Courtyard	1		Dining or Work Surfaces	Dining Surface

At least one or 5% accessible tables not provided Knee or toe clearance not provided	- 12"	Ensure that at least 5% of the tables have knee clearance of at least 27-inches high, 30-inches wide, and 19-inches deep.	1

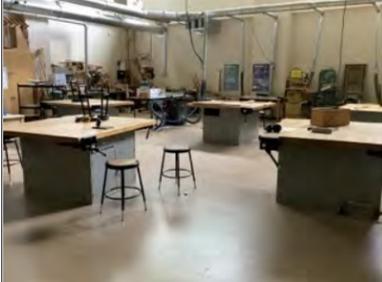
ID	Location	Floor	Room	Element	Type	Photo	Issues	Current Measure	Recommendations	Quantity	Notes
115	Wood Shop , Technology Application Lab	1	120, 121	Dining or Work Surfaces	Work Surface

At least one or 5% accessible tables not provided Knee or toe clearance not provided	- 14"	Ensure that at least 5% of the tables have knee clearance of at least 27-inches high, 30-inches wide, and 19-inches deep.	2	
116	Family & Consumer Science Lab	1	122	Dining or Work Surfaces	Work Surface

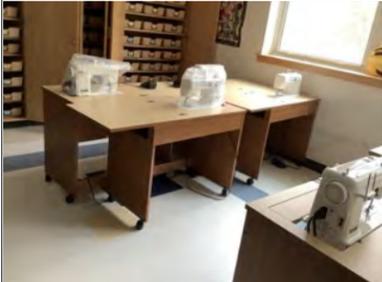
At least one or 5% accessible tables not provided Knee or toe clearance not provided	- 24"	Ensure that at least 5% of the tables have knee clearance of at least 27-inches high, 30-inches wide, and 19-inches deep.	1	
117	Principal Office, Vice Principal's Offices, Guidance Office	1	152, 153, 154, 141, 142, 143, 144	Dining or Work Surfaces	Work Surface

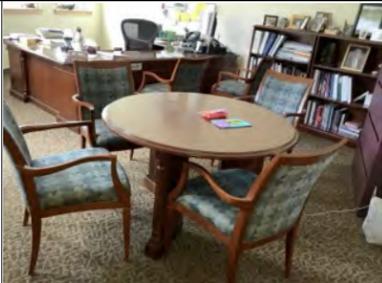
Knee or toe clearance not provided	-	Provide at least one work surface with 27" min. knee and toe clearance. Ensure toe clearance of 30" clear width and 9" clear is provided above the finished floor.	7

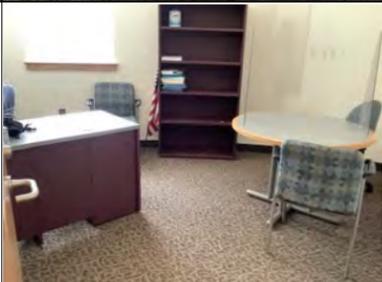
118	Administrator Office, Educational Support Center - Office	1	155, 171	Dining or Work Surfaces	Work Surface

Knee or toe clearance not provided	-	Provide at least one work surface with 27" min. knee and toe clearance. Ensure toe clearance of 30" clear width and 9" clear is provided above the finished floor.	2	
119	Educational Support Center - School Psychologist	1	172	Dining or Work Surfaces	Work Surface

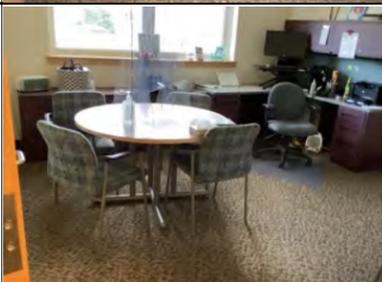
Knee or toe clearance not provided	-	Provide at least one work surface with 27" min. knee and toe clearance. Ensure toe clearance of 30" clear width and 9" clear is provided above the finished floor.	1

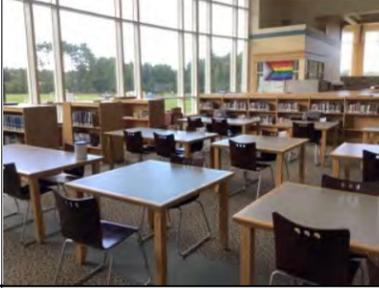
ID	Location	Floor	Room	Element	Type	Photo	Issues	Current Measure	Recommendations	Quantity	Notes
120	Library Media Center	2	240	Dining or Work Surfaces	Work Surface

Knee or toe clearance not provided	26"	Provide at least one (1) work surface with 27" min. knee and toe clearance.	1	
121	6th Grade Stem Lab	1	110	Dining or Work Surfaces	Work Surface

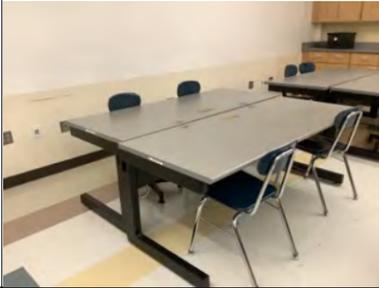
Knee or toe clearance not provided Top of dining/work surface < 28" or > 34"	26" 27"	Provide at least one work surface with tops between 28"- 34" above the floor and 27" clear height underneath.	1	
122	Inclusion Facilitator	1	146	Dining or Work Surfaces	Work Surface

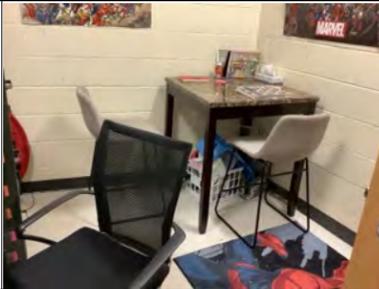
Top of dining/work surface < 28" or > 34"	36"	Provide at least one work surface with tops between 28"- 34" above the floor, 27" clear underneath and 30" wide clear underneath.	1	
Assembly Area											
123	Auditorium, Conference Rooms, Distance Learning Theater	1, 2	230, 145, 156, 173, 229	Assembly Area	N/A

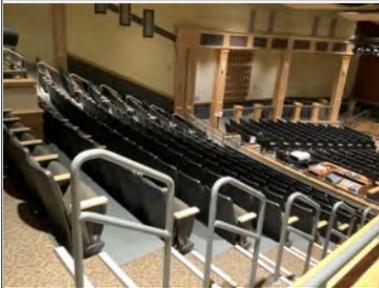
Number of seats Assistive listening devices not provided	688 -	If audible communication is integral to the use of the space, provide an assistive listening system.	1

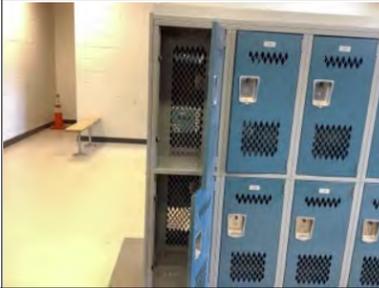
Locker Room											
124	Boys' & Girls' Locker Room - Gymnasium	1		Locker Room	N/A

5% of lockers are not accessible	-	Provide at least one accessible locker (or ensure 5% of all lockers are accessible) . Ensure lower locker shelf is at least 15" min. above the finished floor.	2

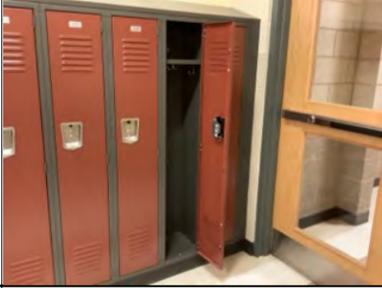
ID	Location	Floor	Room	Element	Type	Photo	Issues	Current Measure	Recommendations	Quantity	Notes
125	Locker 1359 Near Room 125	1		Locker Room	N/A

5% of lockers are not accessible	-	Provide at least one accessible locker (or ensure 5% of all lockers are accessible) .	1	
126	Boys' Locker Room - Gymnasium	1		Locker Room	N/A

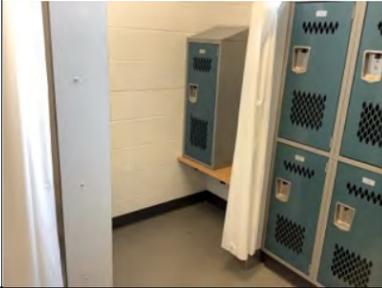
5% of changing rooms are not accessible	-	Ensure that 5% of changing rooms (at least one) are accessible.	1	
127	Girls' Locker Room - Shower - Gymnasium	1	193	Locker Room	N/A

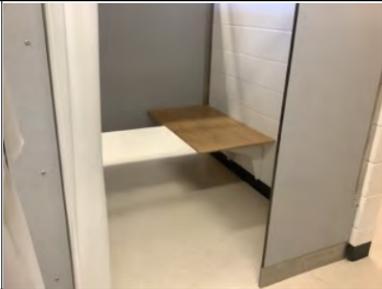
Room is < 78" x 72"	62" x 72"	Provide an accessible changing room that is 78" by 72" min.	1	
128	Boys' Locker Room - Gymnasium	1		Locker Room	N/A

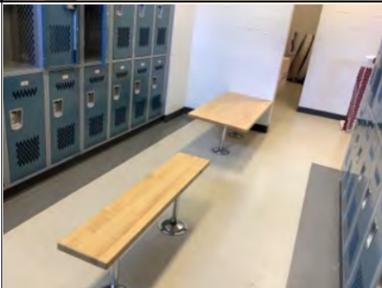
Back support not provided at bench	-	Provide at least one bench with back support or that is affixed to a wall with room on the side to transfer.	1	
Picnic Tables											
129	Picnic Tables By Door 13			Picnic Tables	N/A

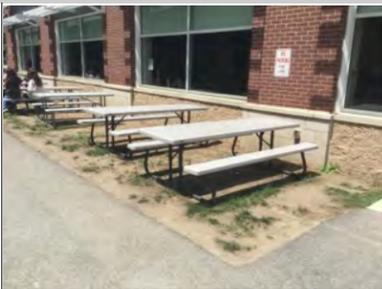
Toe or knee clearance at tables not provided Picnic table not on an accessible route	- -	Provide at least 1 picnic table (or ensure that 5% of picnic tables) have toe and knee clearance. Ensure that the picnic table is connected to an accessible route.	1

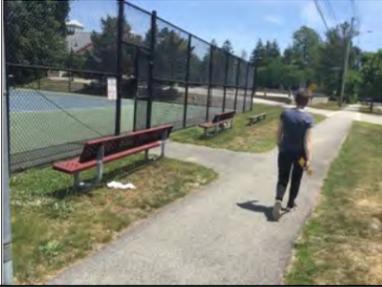
ID	Location	Floor	Room	Element	Type	Photo	Issues	Current Measure	Recommendations	Quantity	Notes
Exterior Benches											
130	By Tennis Courts			Exterior Benches	N/A

No accessible route to one bench in area		Provide an accessible route to one bench in this area.	1	
Toilet & Bathing Rooms											
Lavatory											
131	All Gender Toilet Room Near Stair 1, Girls' & Boys' Toilet Room, Toilet Rooms in the Gymnasium	1	T101, G110, B110, T191A, T191B	Lavatory	N/A

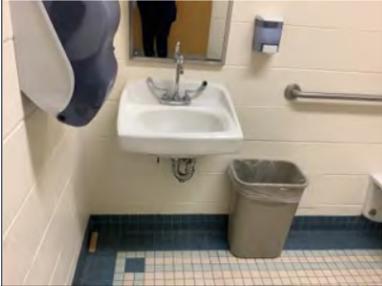
Plumbing underneath is exposed	-	Insulate or otherwise configure pipes to prevent contact at lavatory.	5	
132	Boys' Locker Room - Gymnasium	1		Lavatory	N/A

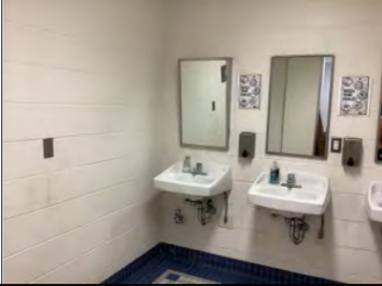
Plumbing underneath is exposed Mirror above lavatory w/reflective surface > 40"	- 43"	Insulate or otherwise configure pipes to prevent contact for at least one lavatory. Lower mirror so that the bottom surface is at 40" max. above the finished floor.	1	
133	Girls' Locker Room - Gymnasium	1	193	Lavatory	N/A

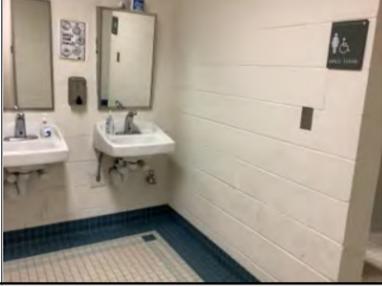
Mirror above lavatory w/reflective surface > 40"	42"	Lower mirror so that the bottom surface is at 40" max. above the finished floor.	1

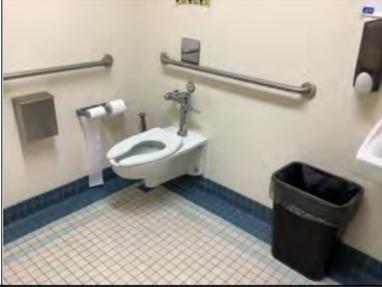
ID	Location	Floor	Room	Element	Type	Photo	Issues	Current Measure	Recommendations	Quantity	Notes
Single-User Toilet											
134	Toilet Room - Health Services, Toilet Room - Gymnasium	1	160, 161, T191A, T191B	Single-User Toilet	N/A

Clearance at toilet < 60" clear width	-	Relocate trash can to ensure that there is 60" wide min. clear floor space at the toilet.	4	
Toilet Compartment											
135	Boys' Locker Room - Gymnasium and Boys' and Girls' Toilet Rooms on the Third Floor	1, 3		Toilet Compartment	Accessible Compartment

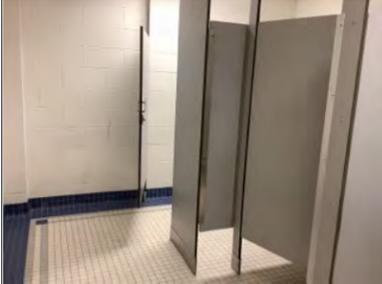
Door has malfunctioning self-closing hinge	-	Repair hinge.	3	
Urinal											
136	Boys' Toilet Room	1	B110	Urinal	N/A

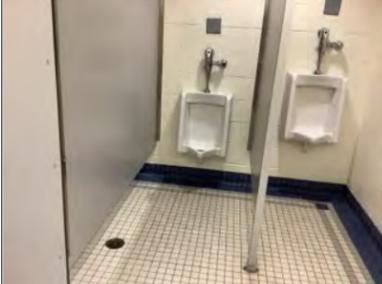
Urinal recessed > 24" has > 36" clear width	34.8"	If urinal is recessed greater than 24" ensure there is a clear width of 36". Relocate the existing partition to provide 36" clear at the accessible urinal or provide a new partition that is less than 24" deep.	1

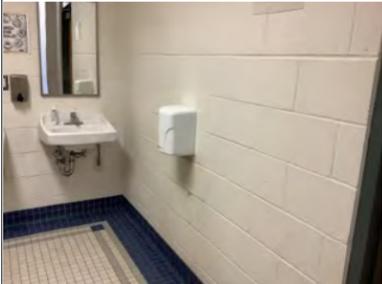
Dispensers											
137	Boys' & Girls' Locker Rooms - Gymnasium	1		Dispensers	Hand Dryer

Dispenser acts as a protruding object	7"	Relocate the hand dryer out of the circulation path.	2

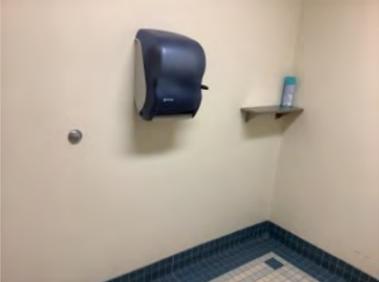
ID	Location	Floor	Room	Element	Type	Photo	Issues	Current Measure	Recommendations	Quantity	Notes
138	Toilet Rooms - Health Services	1	160, 161	Dispensers	Other

Dispenser acts as a protruding object	9"	Relocate paper towel dispenser out of the circulation path.	2	
139	Girls' and Boys' Toilet Rooms	1	G110, B110	Dispensers	Hand Dryer

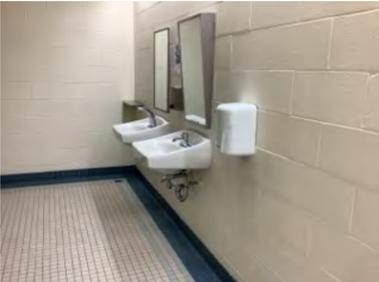
Dispenser acts as a protruding object	6"	Relocate the hand dryer out of the circulation path.	2	
140	All Gender Toilet Room Near Stair 1, Toilet Room - Gymnasium	1	T101, T191A, T191B	Dispensers	Paper Towel Dispenser

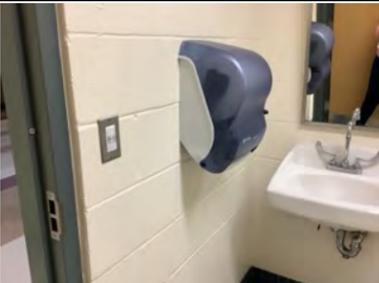
Dispenser acts as a protruding object	9"	Relocate dispenser out of the circulation path.	3	
141	Boys' and Girls' Toilet Rooms	3		Dispensers	Hand Dryer

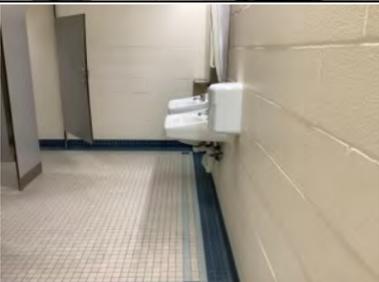
Dispenser acts as a protruding object	6.5"	Relocate the hand dryer out of the circulation path.	2	
142	Single-User Toilet Room	3	T301	Dispensers	Paper Towel Dispenser

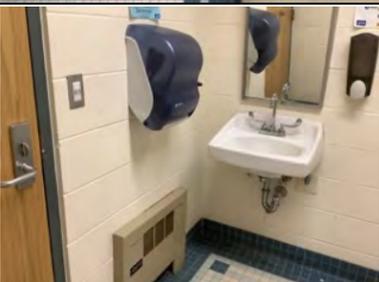
Dispenser acts as a protruding object	8"	Relocate paper towel dispenser out of the circulation path.	1

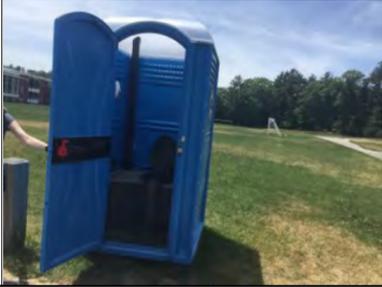
ID	Location	Floor	Room	Element	Type	Photo	Issues	Current Measure	Recommendations	Quantity	Notes
Portable Toilet											
143	By Soccer Field			Portable Toilet	N/A

Not located on an accessible route Accessible portable toilets not provided	- -	Locate portable toilet on an accessible route. Ensure that at least 5% of portable toilets is accessible.	1	
Additional Access											
Drinking Fountains											
144	Corridor Near Gymnasium	1		Drinking Fountains	Low

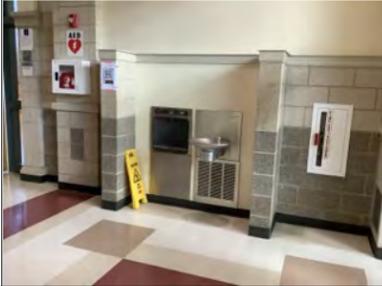
No drinking fountain provided for standing users	-	Install a Hi-Lo drinking fountain.	1	
Sink											
145	Occupational Therapy / Physical Therapy Room	1	194	Sink	Other

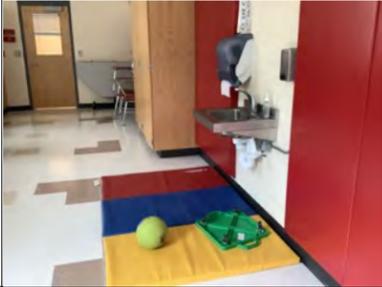
Clear floor space not provided at sink	-	Provide a 30" by 48" clear floor space positioned for a forward approach. Relocate items from underneath the sink.	1	
146	Technology Application Lab	1	121	Sink	Classroom

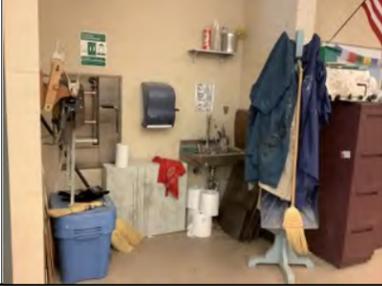
Clear floor space not provided at sink Exposed plumbing underneath sink	- -	Provide a 30" by 48" clear floor space positioned for a forward approach. Relocate items from underneath the sink. Insulate or otherwise configure pipes at sink.	1

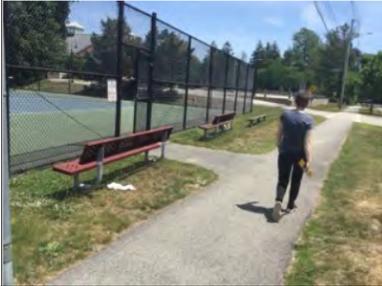
Recommend providing a 36" min. by 48" min. stable, firm and slip-resistant surface adjacent to at least one bench by the tennis courts in a manner that is substantially similar to what is shown in Figure 1 of the narrative report.	1	
150	Special Education	1	101

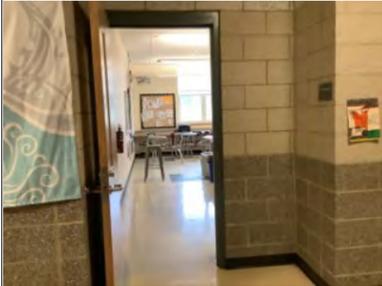
-	Recommend updating sign to match the current room function of "Special Education" (instead of "Staff Workroom").	1	
151	Wood Shop	1	120

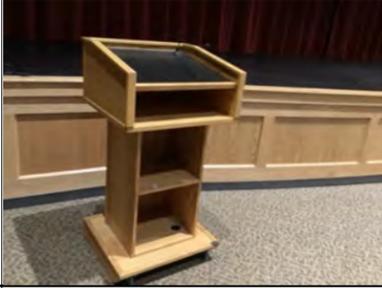
ID	Location	Floor	Room	Element	Type	Photo	Issues	Current Measure	Recommendations	Quantity	Notes
152	Auditorium	1	130

Recommend providing an adjustable podium with knee and toe clearance.	1	
153	Main Office and Health Services Center	1	160

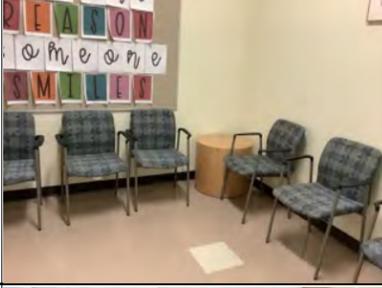
-	Recommend removing a chair to provide a 36" min. x 48" min. clear floor space for wheelchair users in the waiting area.	1	
154	Library Media Center, Classroom	2	244

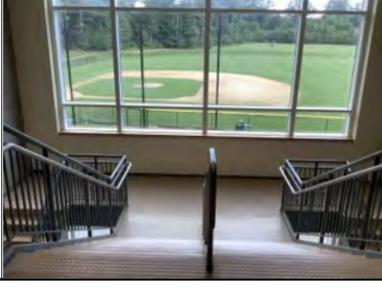
Recommend providing visually contrasting strips on all staircase treads.	1

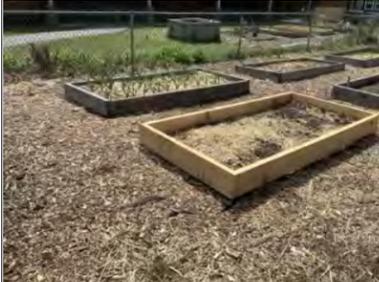
ID	Location	Floor	Room	Element	Type	Photo	Issues	Current Measure	Recommendations	Quantity	Notes
Approach and Entrance											
Exterior Access Route											
1	Garden	Ext.		Exterior Access Route	Walkway

Exterior route < 36" wide Accessible route not provided	- -	Ensure an accessible route is provided to and around all of the garden beds. Ensure that a clear width of 36" min. is maintained at the accessible route.	1	
2	Route to Doors 13,13A,14A and 12	Ext.		Exterior Access Route	Walkway

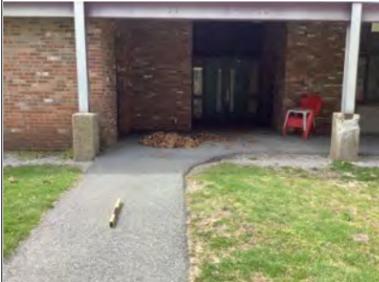
Running slope > 1:20 (5.00%)	8.4%	Reduce running slope to be no steeper than 1:20 (5.00%).	4	
3	Castle by Southwest Parking Area	Ext.		Exterior Access Route	Walkway

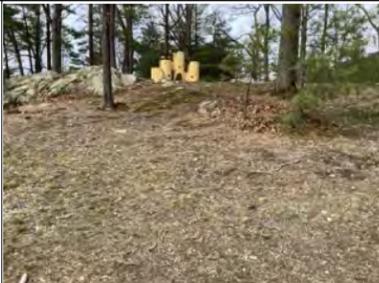
Running slope > 1:20 (5.00%)	20%	Reduce running slope to be no steeper than 1:20 (5.00%) or relocate play element to an accessible location.	1	
4	Covered Basketball Entry	Ext.		Exterior Access Route	Exterior

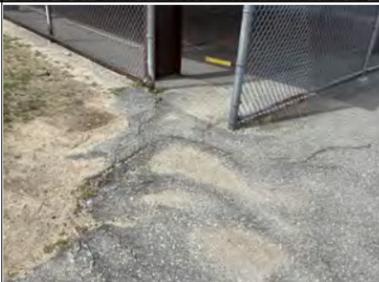
Running slope > 1:20 (5.00%) Level changes > 1/4" Route not maintained in operable working condition	8.2% 3" -	Reduce running slope to be no steeper than 1:20 (5.00%). Alter change in level to be 1/4" high max. Ensure the accessible route is maintained in operable working condition.	1

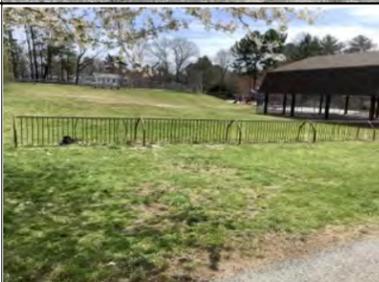
5	Bike Racks Near Tennis and Covered Basketball	Ext.		Exterior Access Route	Walkway

Surface is not stable, firm, and slip-resistant Accessible route not provided	- -	Repair surface. Ensure an accessible route is provided to the bike racks.	1

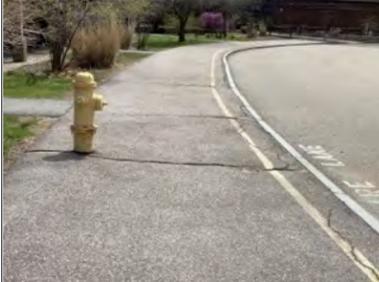
Route not maintained in operable working condition	-	Ensure the accessible route is maintained in operable working condition (repair asphalt).	1	
7	Outdoor Gathering Area	Ext.		Exterior Access Route	Walkway

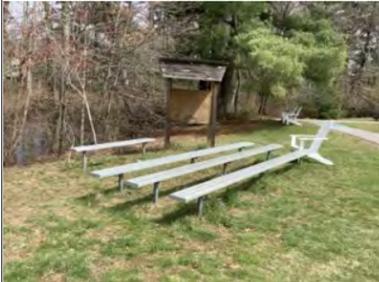
Accessible route not provided Surface is not stable, firm, and slip-resistant	- -	Ensure a stable and firm accessible route is provided to the seating area.	1	
8	Exit Door 21	Ext.		Exterior Access Route	Exterior

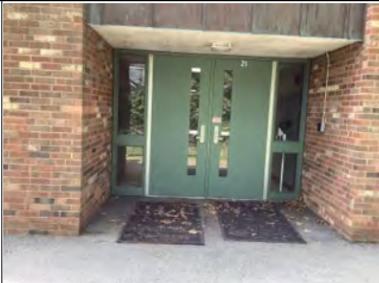
Vertical clearance < 80" above ground	76"	The overhang at this door is just 76" above the ground and is therefore a protruding object. It is required to be located no lower than 80" above the ground. Consider adding signage that says, "Low Headroom" or "Low Ceiling".	1	
Off-Street Parking Lot or Garage											
9	Southwest Lot Near Main Entrance	Ext.		Off-Street Parking Lot or Garage	N/A

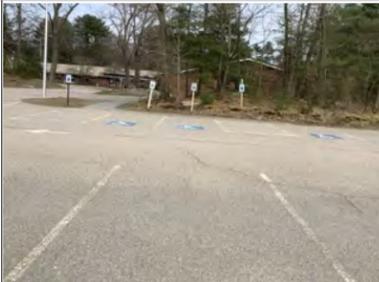
Total # of parking Total # of designated accessible parking spaces Total # of designated van accessible spaces Sign does not have the designation "Van Accessible"	85 4 1 -	Relocate sign with the International Symbol of Accessibility (ISA) from in front of the access aisle to in front of the right-most accessible parking space. Add the designation "Van Accessible" to the sign located at the van accessible space.	1

Accessibility issues at the lower lot on the southwest side include an International Symbol of Accessibility (ISA) identification sign that is located improperly and lack of signage with the designation "Van Accessible" at the van accessible parking space. Accessibility issues at the lot on the north side include lack of one additional standard accessible parking space. Additionally, in the north lot, the van accessible parking space is missing signage with the designation "Van Accessible".

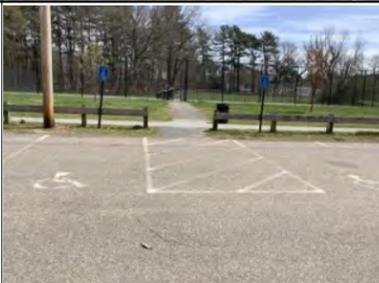
10	North Lot Near Tennis Courts	Ext.		Off-Street Parking Lot or Garage	N/A

Total # of parking Total # of designated accessible parking spaces Total # of designated van accessible spaces Sign does not have the designation "Van Accessible"	80 1 1 -	Provide one additional standard accessible parking space 96" wide min. with a marked access aisle 60" wide min. and a sign with the International Symbol of Accessibility (ISA). Add the designation 'Van Accessible' to the sign at the van accessible parking space. Ensure all parking signs are mounted 60" min. and 96" max. above the ground.	1
