East Elementary School

Town of Hingham ADA Transition Plan

October 2023

Institute for Human Centered Design

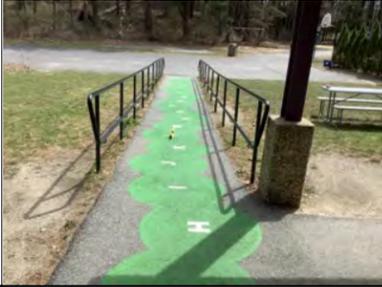
Edge protection < 4" high	-	Provide edge protection that prevents the passage of a 4" diameter sphere, where any portion of the sphere is within 4" of the finished floor or ground surface.	1	
12	Ramp From Basketball to Main Entrance	Ext.		Exterior Ramp	N/A

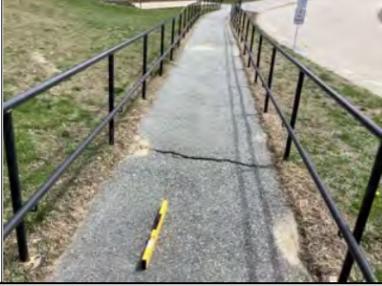
Edge protection < 4" high Not maintained in operable working condition	- -	Provide edge protection that prevents the passage of a 4" diameter sphere, where any portion of the sphere is within 4" of the finished floor or ground surface. Ensure the ramp is maintained in operable working condition by repairing cracks in the asphalt. The resulting surface should be stable, firm and slip resistant with a maximum cross slope of 2.00 % (1:50) and a maximum running slope of 8.33% (1:12).	1

Accessibility issues at the two (2) exterior ramps include the lack of edge protection. Additionally, the ramp between the basketball court and the main entrance is not maintained in operable working condition.

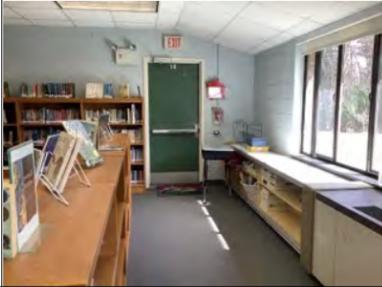
Emergency Exit											
13	Library Exit and First Grade Classroom Exit	1	14, 29	Emergency Exit	N/A

Tactile sign not provided at exit Directional sign to accessible emergency exit not provided	- -	Provide tactile exit signs with raised characters and braille at exit doors. Mount signs between 48"- 60" above the finished floor located on the latch side of the door. Provide a directional sign indicating the location of the nearest accessible emergency exit. Locate the directional sign at a height that complies with ADA Table 703.5.5.	2	
14	Exit Across From 23 in Corridor	1	23	Emergency Exit	N/A

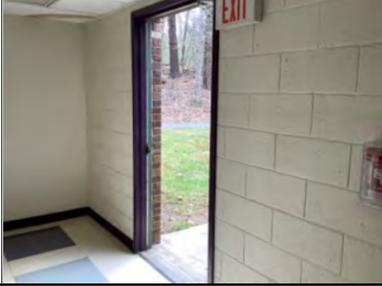
Tactile sign not provided at exit Directional sign to accessible emergency exit not provided	- -	Provide tactile exit signs with raised characters and braille at exit doors. Mount signs between 48"- 60" above the finished floor located on the latch side of the door. Provide a directional sign indicating the location of the nearest accessible emergency exit.	1

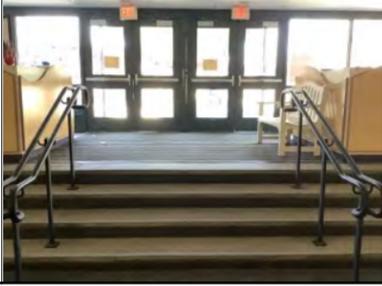
15	Main Entrance	1		Emergency Exit	N/A

Tactile sign not provided at exit Illuminated Int. Symbol of Acc. not provided (MAAB 2006)	- -	Provide tactile exit signs with raised characters and braille at exit doors. Mount signs between 48"- 60" above the finished floor located on the latch side of the door. Provide an illuminated sign with the International Symbol of Accessibility (ISA).	2

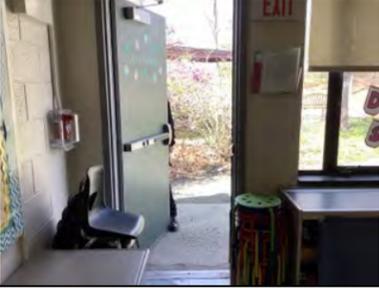
Tactile sign not provided at exit Illuminated Int. Symbol of Acc. not provided (MAAB 2006)	- -	Provide tactile exit signs with raised characters and braille at exit doors. Mount signs between 48"- 60" above the finished floor located on the latch side of the door. Provide an illuminated sign with the International Symbol of Accessibility (ISA).	4	
17	Fourth Grade Classroom Exit, Fifth Grade Classroom Exit 11, and Fifth Grade Classroom Exit 5	1	9, 3, 2	Emergency Exit	N/A

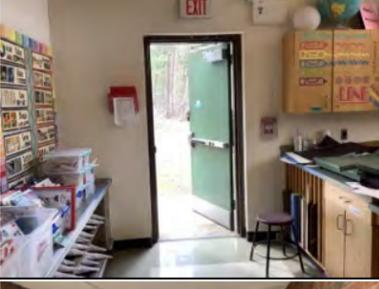
18	Art Room and Computer Lab, Second Grade Classroom, Kindergarten Classroom and Exit 6 by Gym and Room 2	1	24, 26, 32, 11, 6	Emergency Exit	N/A

Tactile sign not provided at exit Illuminated Int. Symbol of Acc. not provided (MAAB 2006)	- -	Provide tactile exit signs with raised characters and braille at exit doors. Mount signs between 48"- 60" above the finished floor located on the latch side of the door. Provide an illuminated sign with the International Symbol of Accessibility (ISA).	5	
19	Exit by Room 32 (Exit Door 25), Corridor Exit by 38 and Special Education by First Grade Classroom (Exit 26)	1	32, 38, 30	Emergency Exit	N/A

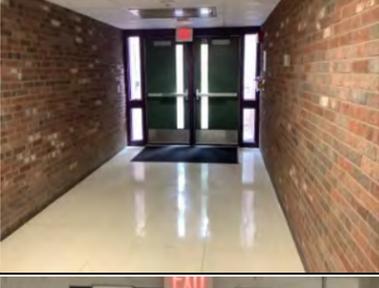
Tactile sign not provided at exit Illuminated Int. Symbol of Acc. not provided (MAAB 2006)	- -	Provide tactile exit signs with raised characters and braille at exit doors. Mount signs between 48"- 60" above the finished floor located on the latch side of the door. Where a tactile sign is provided at double doors with two active leaves, the sign shall be located to the right of the right hand door. Provide an illuminated sign with the International Symbol of Accessibility (ISA).	3

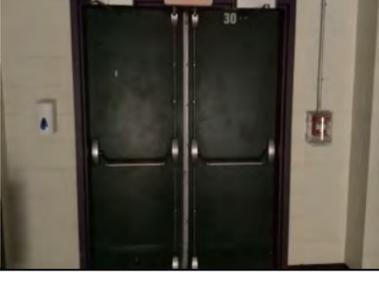
20	Ramp to Exit and Cafeteria by 15A (Exit 30)	1		Emergency Exit	N/A

Tactile sign not provided at exit Illuminated Int. Symbol of Acc. not provided (MAAB 2006)	- -	Provide tactile exit signs with raised characters and braille at exit doors. Mount signs between 48"- 60" above the finished floor located on the latch side of the door. Where a tactile sign is provided at double doors with two active leaves, the sign shall be located to the right of the right hand door. Provide an illuminated sign with the International Symbol of Accessibility (ISA).	1

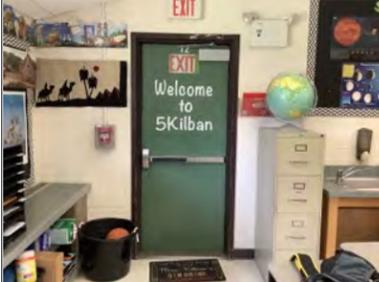
Tactile sign not provided at exit Illuminated Int. Symbol of Acc. not provided (MAAB 2006)	- -	Provide tactile exit signs with raised characters and braille at exit doors. Mount signs between 48"- 60" above the finished floor located on the latch side of the door. Provide an illuminated sign with the International Symbol of Accessibility (ISA).	3	
22	Second Grade Classrooms Math Classroom, Third Grade Classroom and First Grade Classroom	1	31, 34, 4, 35, 27	Emergency Exit	N/A

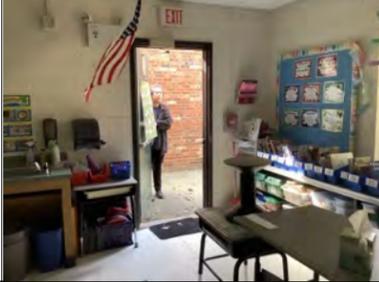
Tactile sign not provided at exit Illuminated Int. Symbol of Acc. not provided (MAAB 2006)	- -	Provide tactile exit signs with raised characters and braille at exit doors. Mount signs between 48"- 60" above the finished floor located on the latch side of the door. Provide an illuminated sign with the International Symbol of Accessibility (ISA).	5

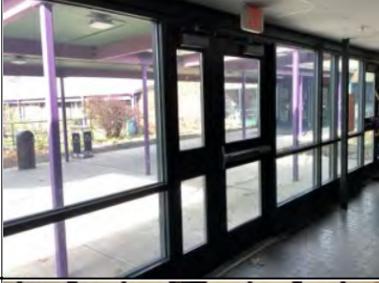
23	Cafeteria Exits	1		Emergency Exit	N/A

Tactile sign not provided at exit Illuminated Int. Symbol of Acc. not provided (MAAB 2006)	- -	Provide tactile exit signs with raised characters and braille at exit doors. Mount signs between 48"- 60" above the finished floor located on the latch side of the door. Provide an illuminated sign with the International Symbol of Accessibility (ISA).	2	
24	Auditorium Exit Doors 31 and 32, Small Group Room - Psychologist Room 23, and Two (2) Gym Exits	1	16 23	Emergency Exit	N/A

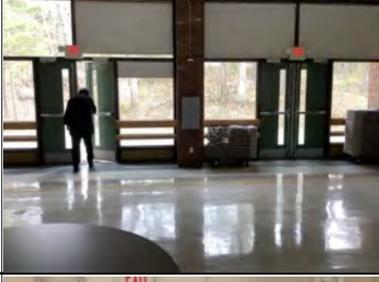
Tactile sign not provided at exit Illuminated Int. Symbol of Acc. not provided (MAAB 2006)	- -	Provide tactile exit signs with raised characters and braille at exit doors. Mount signs between 48"- 60" above the finished floor located on the latch side of the door. Provide an illuminated sign with the International Symbol of Accessibility (ISA).	5	
25	Literacy Reading Team Exit 22	1	38	Emergency Exit	N/A

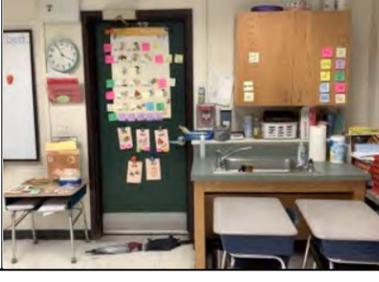
Maneuvering clearance(s) not provided	-	Reverse the swing of the door to provide maneuvering clearance and relocate the small desk. 12" of maneuvering clearance is required on the latch push side of the door.	1

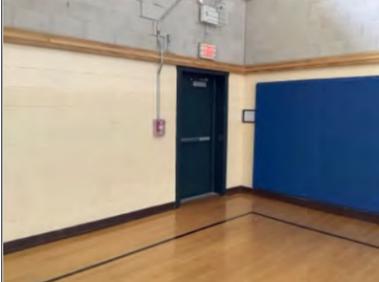
Maneuvering clearance not provided at recess > 6"	12"	Install an automatic door opener. The door is recessed greater than 6" deep.	1	
27	Second Grade Classroom	1	32	Emergency Exit	N/A

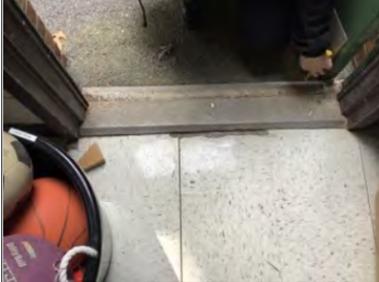
Surface not stable, firm, and slip-resistant Threshold > 1/2" high	- 1.5"	Repair the surface. Alter the threshold to be 1/2" high max.	1	
28	First Grade Classroom and Third Grade Classroom	1	27, 35	Emergency Exit	N/A

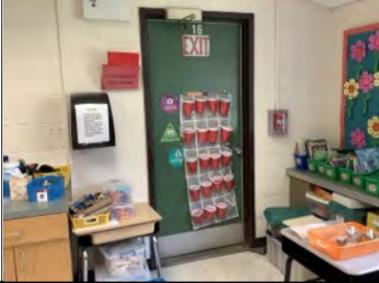
Hardware not operable with a closed fist Threshold > 1/2" high	- 1"	Provide door hardware that can be operable with one hand and not require tight grasping, pinching, or twisting of the wrist. Alter the threshold to be 1/2" high max.	2	
29	First Grade Classroom Room 29	1	29	Emergency Exit	N/A

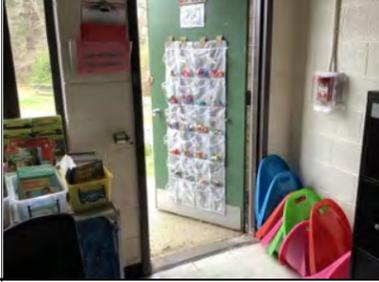
Hardware not operable with a closed fist Threshold > 1/2" high	- .75"	Provide hardware that can be operable with one hand and not require tight grasping, pinching, or twisting of the wrist. Alter the threshold to be 1/2" high max.	1

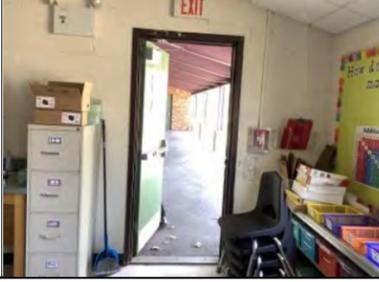
30	Math Classroom, Second Grade Classrooms and Kindergarten Classroom	1	4, 31, 34, 11	Emergency Exit	N/A

Threshold > 1/2" high	1"	Alter the threshold to be 1/2" high max.	4

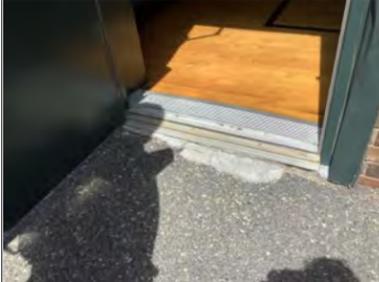
Threshold > 1/2" high	2"	Alter the threshold to be 1/2" high max.	1	
32	Gym Exit	1		Emergency Exit	N/A

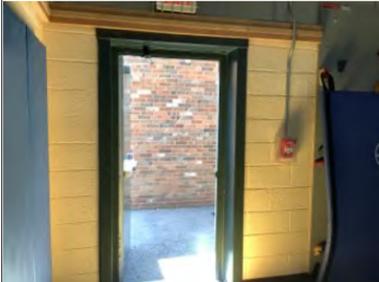
Threshold > 1/2" high	1"	Alter the threshold to be 1/2" high max.	1	
33	Small Group Room - Psychologist	1	23	Emergency Exit	N/A

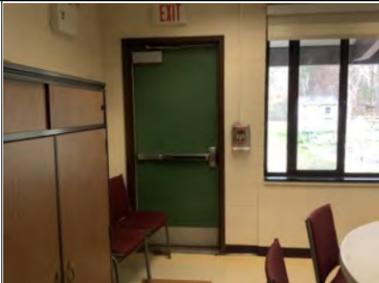
Threshold > 1/2" high	1.25"	Alter the threshold to be 1/2" high max.	1	
34	Exit by Room 32 (Exit Door 25), Corridor Exit by 38, and Fifth Grade Classroom	1	32, 38, 5	Emergency Exit	N/A

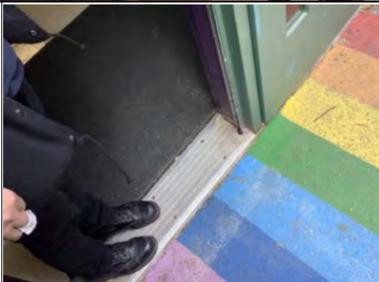
Threshold > 1/2" high	.75"	Alter the threshold to be 1/2" high max.	3	
35	Auditorium Exit Doors 31 and 32	1	16	Emergency Exit	N/A

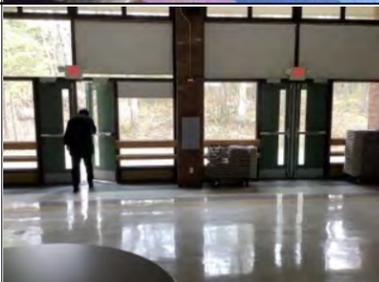
Threshold > 1/2" high	.75"	Alter the threshold to be 1/2" high max.	2

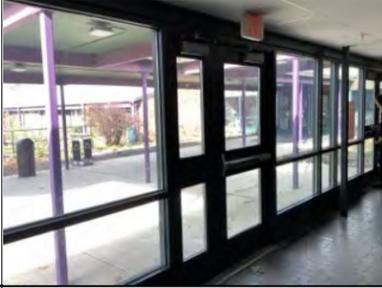
Threshold > 1/2" high	1"	Alter the threshold to be 1/2" high max.	2	
37	Third Grade Classroom Exit 20	1	37	Emergency Exit	N/A

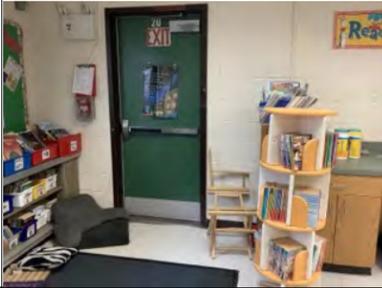
Threshold > 1/2" high	1.5"	Alter the threshold to be 1/2" high max.	1	
38	Kindergarten Classroom Exit and Double Door Exit by Room 11	1	10 11	Emergency Exit	N/A

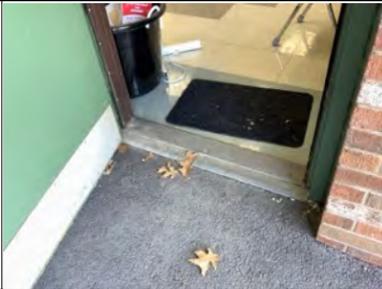
Threshold > 1/2" high Threshold not beveled	1"	Alter the threshold to be 1/2" high max. Bevel the threshold.	2	
39	Special Education by First Grade Classroom (Exit 26)	1	30	Emergency Exit	N/A

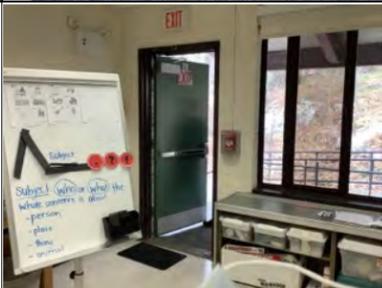
Threshold > 1/2" high Threshold not beveled	.75 -	Alter the threshold to be 1/2" high max. Bevel the threshold.	1	
Access to Goods and Services											
Interior Access Route											
40	Main Entrance by Lift	1		Interior Access Route	N/A

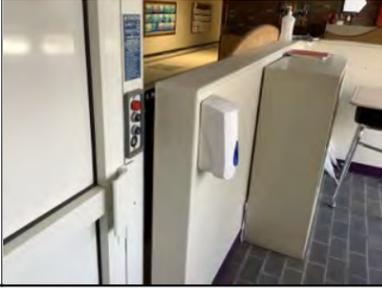
Obstructed by protruding objects	4.5"	Relocate the soap dispenser out of the circulation path. Alternatively, a cane-detectable barrier could be provided underneath the dispenser.	1

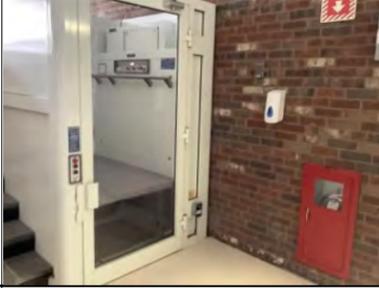
Obstructed by protruding objects	4.5"	Relocate the soap dispenser out of the circulation path. Alternatively, a cane-detectable barrier could be provided underneath the dispenser.	1	
42	Library Classroom	1	14A	Interior Access Route	N/A

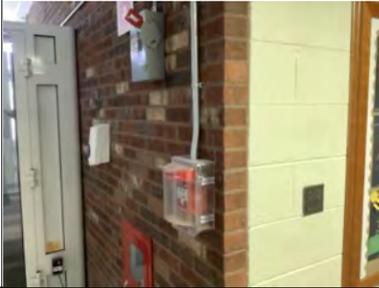
Obstructed by protruding objects	5.5", 6.75" 4.5"	Relocate fire pull, electrical panel and soap dispenser out of the circulation path. Alternatively, a cane-detectable barrier could be provided underneath the objects.	3	
43	Wall Outside Gym	1		Interior Access Route	N/A

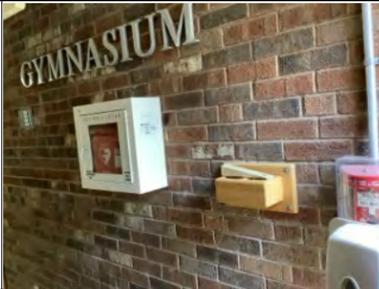
Obstructed by protruding objects	5"-6"	Relocate wood box, fire alarm and defibrillator out of the circulation path. Alternatively, a cane-detectable barrier could be provided underneath the objects.	3	
44	Nurse's Office Toilet Room	1	22	Interior Access Route	N/A

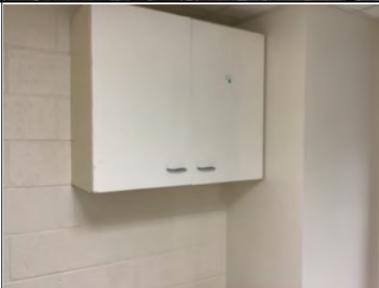
Obstructed by protruding objects	12.75"	Remove shelf or provide a cane-detectable barrier underneath.	1

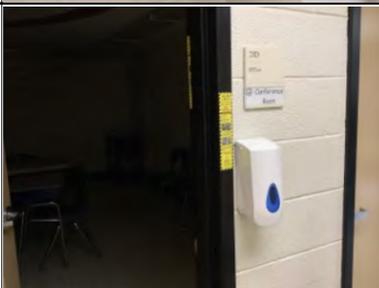
45	Conference Room	1	21D	Interior Access Route	N/A

Obstructed by protruding objects	4.5"	Relocate soap dispenser out of the circulation path.	1

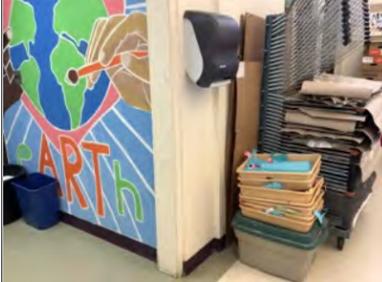
ID	Location	Floor	Room	Element	Type	Photo	Issues	Current Measure	Recommendations	Quantity	Notes
46	Art Room	1	24	Interior Access Route	N/A

Obstructed by protruding objects	9"	Relocate paper towel dispenser out of the circulation path.	1	
47	Corridor by Room 24	1	24	Interior Access Route	N/A

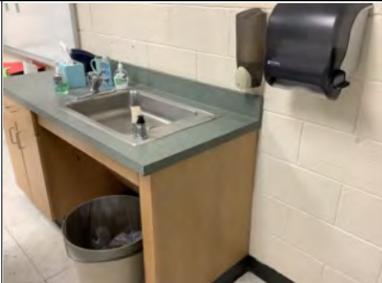
Obstructed by protruding objects	9"	Relocate the paper towel dispenser out of the circulation path.	1	
49	Exit by Room 32	1	32	Interior Access Route	N/A

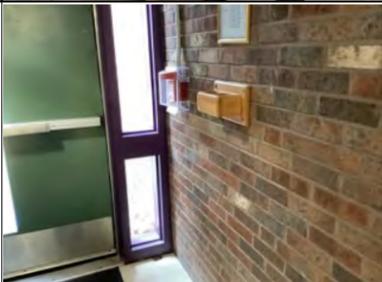
Obstructed by protruding objects	5.5", 5"	Relocate fire pull and wood box out of the circulation path. Alternatively, a cane-detectable barrier could be provided underneath the objects.	2	
50	Corridor by 37A	1	37A	Interior Access Route	N/A

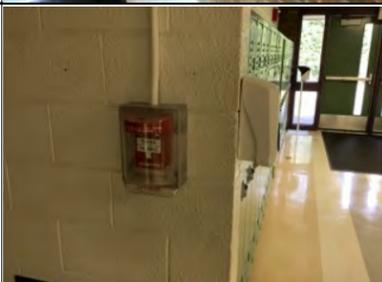
Obstructed by protruding objects	4.5", 5.5"	Relocate soap dispenser and fire pull out of the circulation path. Alternatively, a cane-detectable barrier could be provided underneath the objects.	2

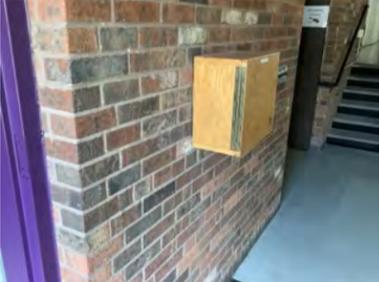
ID	Location	Floor	Room	Element	Type	Photo	Issues	Current Measure	Recommendations	Quantity	Notes
51	Cafeteria	1	16	Interior Access Route	N/A

Obstructed by protruding objects	8"	Remove wood box from the circulation path. Alternatively, a cane-detectable barrier could be provided underneath the box.	1	
52	Nurse's Office	1	22	Interior Access Route	N/A

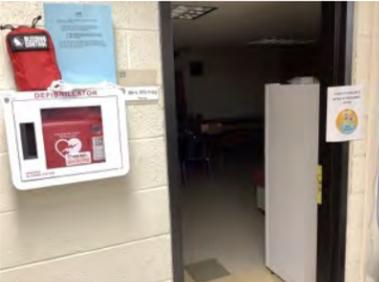
Obstructed by protruding objects	- -	Relocate white box out of the circulation route. Alternatively, a cane-detectable barrier could be provided underneath the box.	1	
Doors, Doorways, & Gates											
53	Library Classroom	1	14A	Doors, Doorways, & Gates	Classroom

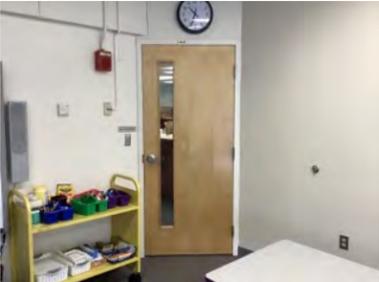
Maneuvering clearance(s) not provided	2"	Provide an automatic door opener.	1	
54	Women's Toilet Room by Media Center	1	T10	Doors, Doorways, & Gates	Toilet Room

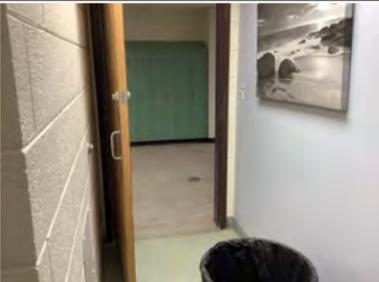
Maneuvering clearance(s) not provided	5"	Provide an automatic door opener.	1	
55	Men's Toilet Room by Room 11	1	T9	Doors, Doorways, & Gates	Toilet Room

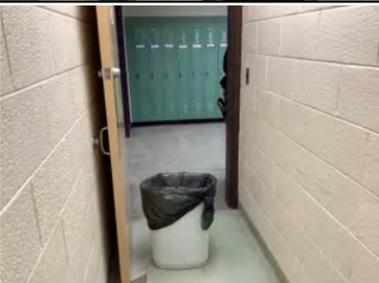
Maneuvering clearance(s) not provided	2"	Provide an automatic door opener.	1

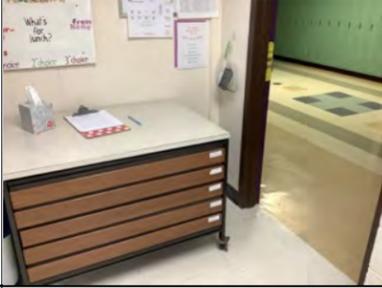
Maneuvering clearance(s) not provided	-	Relocate desk to provide door maneuvering clearance.	1	
57	Nurse's Office	1	22	Doors, Doorways, & Gates	Office

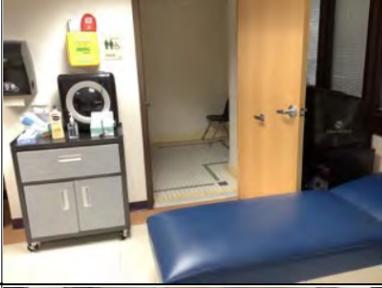
Maneuvering clearance(s) not provided	-	Relocate bed to provide maneuvering clearance at door.	1	
58	Nurse's Office	1	21	Doors, Doorways, & Gates	Office

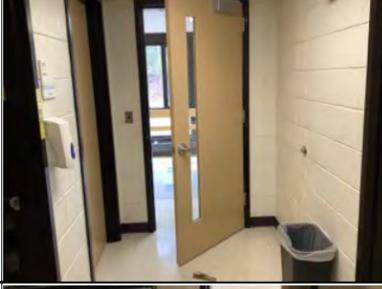
Maneuvering clearance(s) not provided	10.5"	Provide an automatic door opener.	1	
59	Nurse's Office	1	22	Doors, Doorways, & Gates	Office

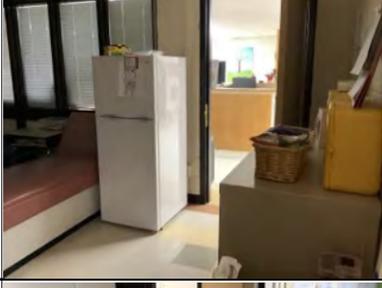
Maneuvering clearance(s) not provided	-	Relocate the refrigerator to provide maneuvering clearance at the door.	1	
60	Nurse's Office	1	22	Doors, Doorways, & Gates	Office

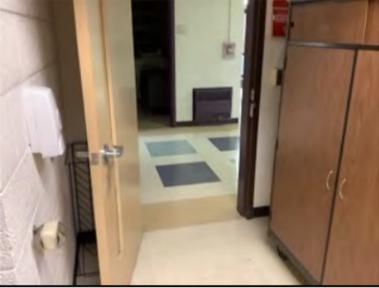
ID	Location	Floor	Room	Element	Type	Photo	Issues	Current Measure	Recommendations	Quantity	Notes
61	Small Group Room	1	35B	Doors, Doorways, & Gates	Office

Maneuvering clearance(s) not provided	-	Relocate cabinet so that there is 18" min. clear on the latch side of the door.	1	
62	Cafeteria	1		Doors, Doorways, & Gates	Circulation

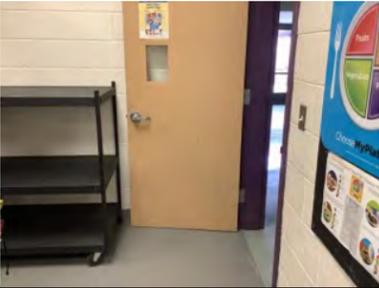
Maneuvering clearance(s) not provided	-	Relocate cart to provide maneuvering clearance at the door.	1	
63	Toilet Room by Media Center	1	T11	Doors, Doorways, & Gates	Toilet Room

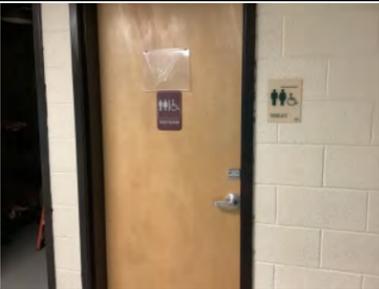
Door requires > 5 lbs. of force to open	12 lbs	Adjust closers so doors do not require more than 5 pounds of force to open.	1	
Ramps											
64	Ramp to Exit and Cafeteria by 15A (Exit 30)	1		Ramps	Interior

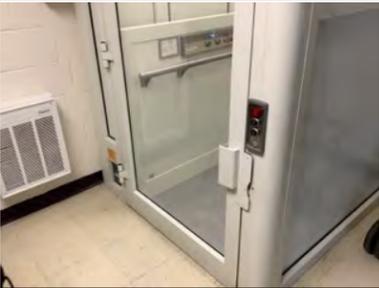
Not independently operable	-	Lift did not function on the day of survey. Ensure that the controls are functional and can be independently operable.	1

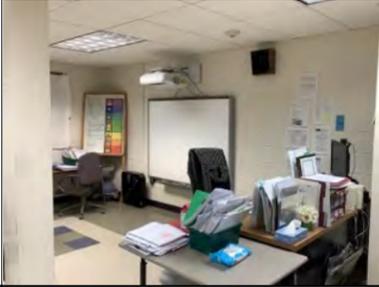
ID	Location	Floor	Room	Element	Type	Photo	Issues	Current Measure	Recommendations	Quantity	Notes
Signage											
66	Special Education Classroom	1	13	Signage	Informational

Signage is not provided		Provide a sign informing patrons of the availability of the assistive listening system. The sign should include the International Symbol of Access for Hearing Loss.	1	
67	Auditorium Stage	1	16	Signage	Informational

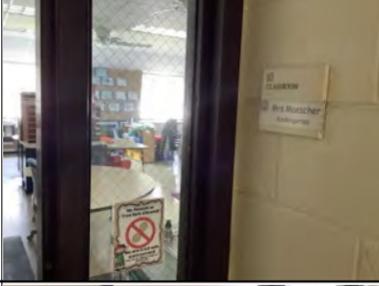
Sign not located on the latch side of the door	-	Ensure that all classroom signs are located alongside the door on the latch side (on the glazed wall in this photo).	1	
69	Main Office	1	21	Signage	Designation

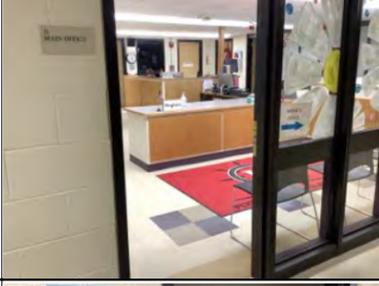
Sign not located on the latch side of the door	-	Locate the sign at permanent rooms alongside the door on the latch side.	1

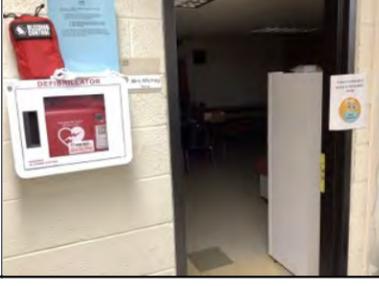
70	Nurse's Office	1	22	Signage	Designation

Sign not located on the latch side of the door	-	Locate the sign at permanent rooms alongside the door on the latch side.	1

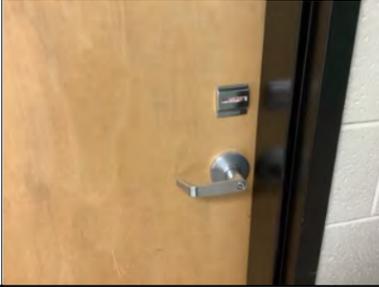
ID	Location	Floor	Room	Element	Type	Photo	Issues	Current Measure	Recommendations	Quantity	Notes
Operable Parts											
71	Toilet Room by Media Center	1	T11	Operable Parts	Other

Element is not in operable working condition	-	Repair the door lock.	1	
72	Main Entrance	1		Operable Parts	Other

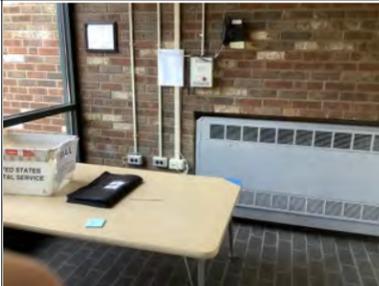
Reach < 15" or > 48"(forward/side approach) Forward reach if obstruction > 20"- 25" deep is > 44" high	60" 45.5"	Move the table and ensure that the controls of the phone are located no higher than 48" above the finished floor.	1	
73	First Grade Classroom	1	27	Operable Parts	Other

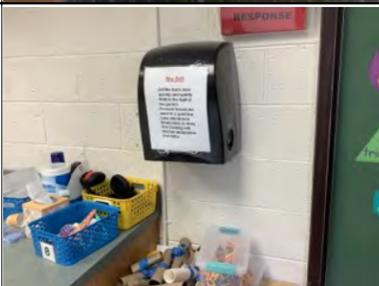
Not operable with a closed fist	-	On the paper towel dispenser, provide hardware that can be operable with one hand and not require tight grasping, pinching, or twisting of the wrist.	1	
Dining or Work Surfaces											
74	Cafeteria	1		Dining or Work Surfaces	Dining Surface

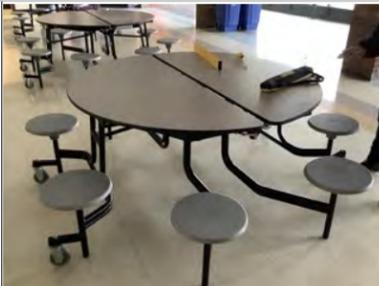
At least one or 5% accessible tables not provided	-	Ensure that at least one dining surface is accessible.	1

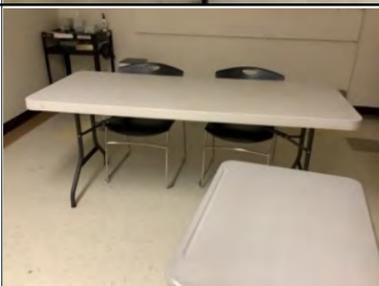
75	Conference Room	1	21D	Dining or Work Surfaces	Work Surface

Knee or toe clearance not provided	26.6"	Provide at least one work surface with 27" min. knee and toe clearance.	1

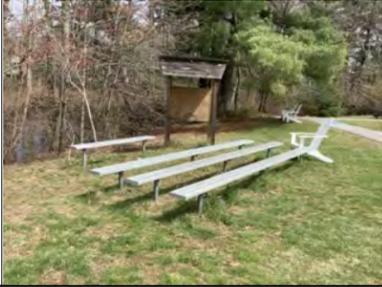
ID	Location	Floor	Room	Element	Type	Photo	Issues	Current Measure	Recommendations	Quantity	Notes
Assembly Area											
76	Outdoor Gathering Area	Ext.		Assembly Area	N/A

Minimum # wheelchair spaces not provided	-	Provide a stable, firm and slip-resistant wheelchair space alongside a companion seat that is 36" by 60" min.	1	
Locker Room											
77	Corridor Lockers by Media Center	1	14	Locker Room	N/A

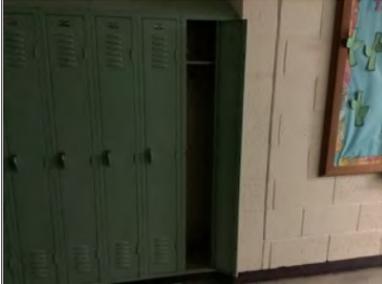
5% of lockers are not accessible Storage > 48" high	- 55.25"	Ensure that at least 5% of lockers are accessible, with storage and clothes hooks no higher than 48 inches above the floor.	1	
Picnic Tables											
78	By Garden	Ext.		Picnic Tables	N/A

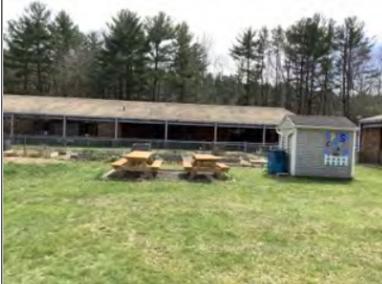
Not on a accessible route At least one or 5% accessible tables not provided Knee or toe clearance not provided	- - -	Ensure dining surfaces are located on an accessible route. Ensure that at least one dining surface is accessible. Provide at least one dining surface with 27" min. knee and toe clearance.	1

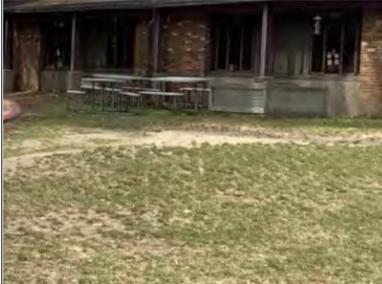
79	By Door 24	Ext.		Picnic Tables	N/A

Not on a accessible route At least one or 5% accessible tables not provided Knee or toe clearance not provided	- - -	Ensure dining surfaces are located on an accessible route. Ensure that at least one dining surface is accessible. Provide at least one dining surface with 27" min. knee and toe clearance.	1	
80	By Back Playground Near Southwest Parking	Ext.		Picnic Tables	N/A

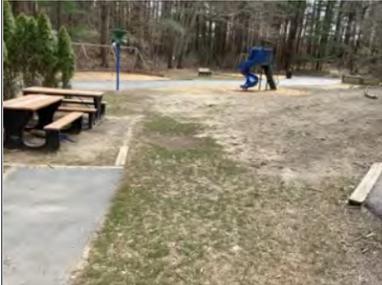
At least 5% accessible spaces not provided Picnic table not on an accessible route	- -	Ensure that at least 5% (minimum of one) of picnic tables are accessible. Ensure that the picnic table is connected to an accessible route.	1

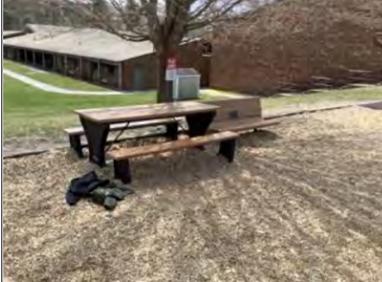
ID	Location	Floor	Room	Element	Type	Photo	Issues	Current Measure	Recommendations	Quantity	Notes
81	Playground by Soccer Field	Ext.		Picnic Tables	N/A

Toe or knee clearance at tables not provided Picnic table not on an accessible route	- -	Provide at least 1 picnic table (or ensure that 5% of picnic tables) have toe and knee clearance. Ensure that the picnic table is connected to an accessible route.	1	
82	Picnic Table by Back Playground	Ext.		Picnic Tables	N/A

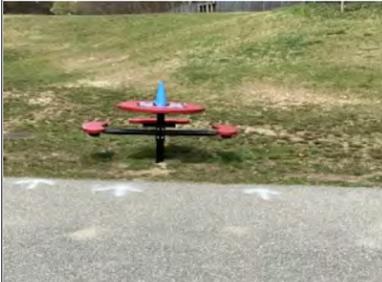
Picnic table not on an accessible route	-	Ensure that the picnic table is connected to an accessible route.	1	
Exterior Benches											
83	By Main Entrance	Ext.		Exterior Benches	N/A

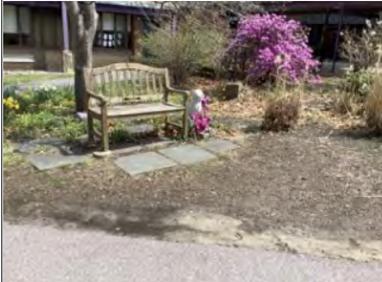
No accessible route to one bench in area	-	Provide an accessible route to one bench in this area.	1	
Toilet & Bathing Rooms											
Overall Access											
84	Men's Toilet Room by Room 11	1	T9	Overall Access	N/A

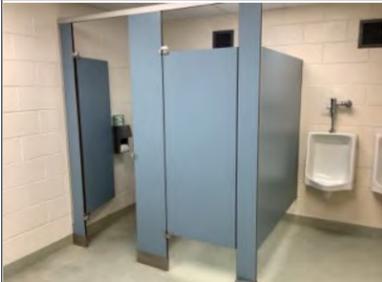
Accessible plumbing fixtures or stalls not provided	-	Provide one accessible wheelchair compartment.	1

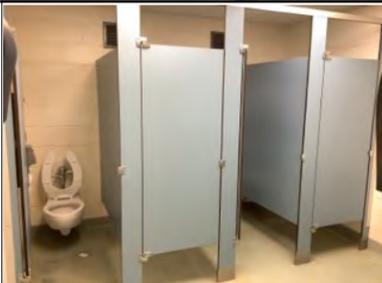
85	Women's Toilet Room by Media Center	1	T10	Overall Access	Toilet Room

Accessible plumbing fixtures or stalls not provided Audible and visible alarms not provided	- -	Provide one accessible wheelchair compartment. When fire system is updated, ensure that a visible and audible fire alarm is installed.	1

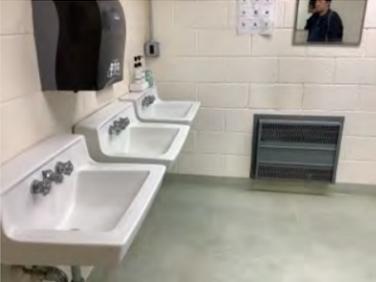
ID	Location	Floor	Room	Element	Type	Photo	Issues	Current Measure	Recommendations	Quantity	Notes
Lavatory											
86	Men's Toilet Room by Room 11	1	T9	Lavatory	N/A

Toe or knee clearances not provided Faucet is not operable with a closed fist Plumbing underneath is exposed Mirror above lavatory w/reflective surface > 40"	24" - - 48"	Provide at least one lavatory with knee and toe clearance positioned for a forward approach. Provide a faucet that can be operable with one hand and not require tight grasping, pinching, or twisting of the wrist for at least one lavatory. Insulate or otherwise configure pipes to prevent contact for at least one lavatory. Lower mirror so that the bottom surface is at 40" max. above the finished floor.	1	
87	Toilet Room by Media Center	1	T11	Lavatory	N/A

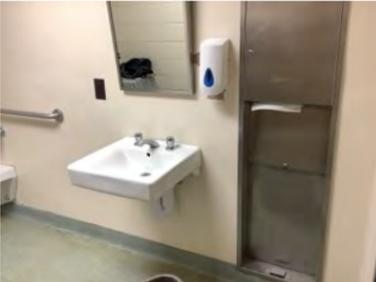
Toe or knee clearances not provided Mirror above lavatory w/reflective surface > 40"	26.5" 42"	Provide at least one lavatory with knee and toe clearance positioned for a forward approach. Lower mirror so that the bottom surface is at 40" max. above the finished floor.	1

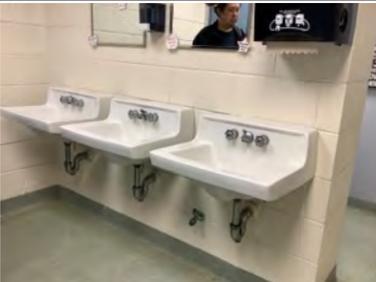
88	Women's Toilet Room by Media Center	1	T10	Lavatory	N/A

Faucet is not operable with a closed fist Plumbing underneath is exposed Mirror above lavatory w/reflective surface > 40"	- - 48"	Provide a faucet that can be operable with one hand and not require tight grasping, pinching, or twisting of the wrist for at least one lavatory. Insulate or otherwise configure pipes to prevent contact for at least one lavatory. Lower mirror so that the bottom surface is at 40" max. above the finished floor.	1	
Single-User Toilet											
89	Toilet Room by Media Center	1	T11	Single-User Toilet	N/A

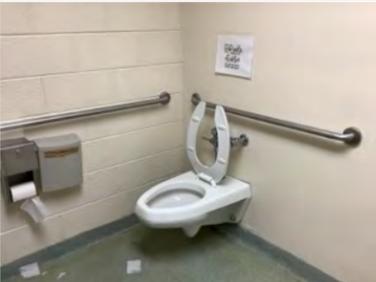
Flush control not on open side	-	Relocate the flush control to the open side.	1	
90	Toilet Room by Media Center	1	T11	Single-User Toilet	N/A

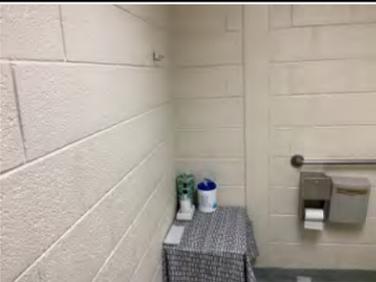
Clearance at toilet < 72" clear depth Hook located > 54" high	61" 61"	Remove the table so that there is 72" of depth provided at the toilet. Locate the coat hook no higher than 48" above the finished floor.	1

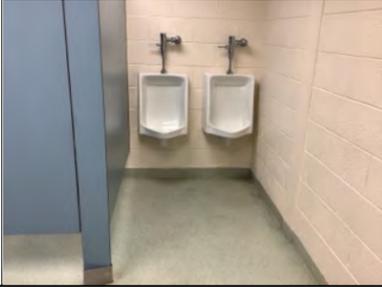
Rim > 17" high Flush control too high or not properly located	21.5" 50"	Provide at least one urinal with the rim no higher than 17" above the finished floor. Mount flush control at 44" max. above the finished floor.	1	
Dispensers											
92	Women's Toilet Room by Media Center	1	T10	Dispensers	Paper Towel Dispenser

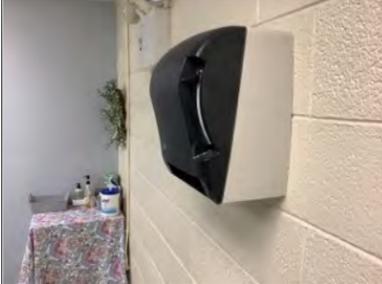
Controls > 48" high Dispenser acts as a protruding object	62.2" 9"	Relocate the paper towel dispenser so the operable part is 48" max. above the finished floor. Relocate the paper towel dispenser out of the circulation path.	1	
Toilet Rooms for Children											
Single-User Toilet (Children)											
93	Nurse's Office Toilet Room	1	22	Single-User Toilet (Children)	N/A

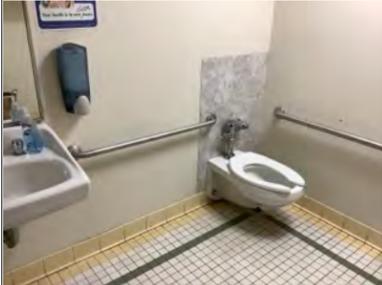
Side or rear grab bar < 42" long Soap dispenser is located above the grab bar	36" -	Provide a rear wall grab bar that is 42" long located 6" max. from the interior corner. Ensure dispensers and other devices are not mounted above grab bars.	1

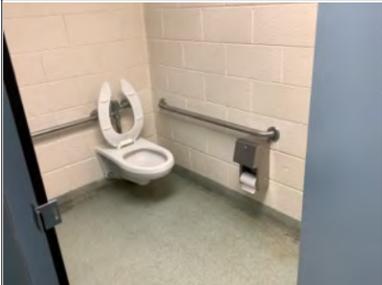
Toilet Compartment (Children)											
94	Girls' Toilet Room by Room 5	1	T4	Toilet Compartment (Children)	Accessible Compartment

Door with malfunctioning self-closing hinge Door pull not provided Side or rear grab bar < 42" long	- 2 36"	Repair self-closing hinge. Provide a door pull on each side of the door between 34" to 48" above the finished floor that does not require tight grasping, pinching or twisting of the wrist. Provide a rear wall grab bar that is 42" long located 6" max. from the interior corner.	1

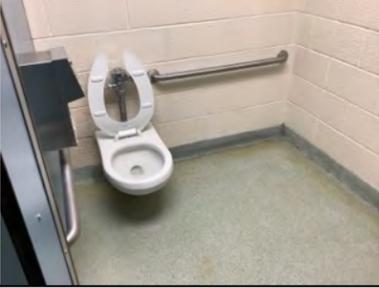
ID	Location	Floor	Room	Element	Type	Photo	Issues	Current Measure	Recommendations	Quantity	Notes
95	Boys' Toilet Room by Room 29	1	29A	Toilet Compartment (Children)	Accessible Compartment

Door with malfunctioning self-closing hinge Door pull not provided Side or rear grab bar < 42" long Flush control not on open side	- 1 36" - -	Repair self-closing hinge. Provide a door pull on each side of the door between 34" to 48" above the finished floor that does not require tight grasping, pinching or twisting of the wrist. Provide a rear wall grab bar that is 42" long located 6" max. from the interior corner. Provide the flush control on the open side of the toilet (transfer side), no higher than 44" above the finished floor.	1	
96	Girls' Toilet Room by Room 27	1	27A	Toilet Compartment (Children)	Accessible Compartment

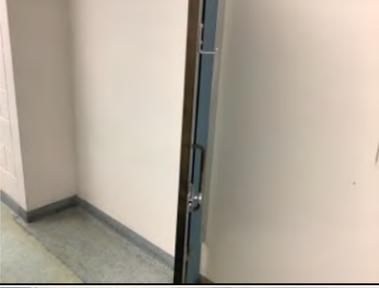
Door pull not provided	1	Provide a door pull on each side of the door between 34" to 48" above the finished floor that does not require tight grasping, pinching or twisting of the wrist.	1

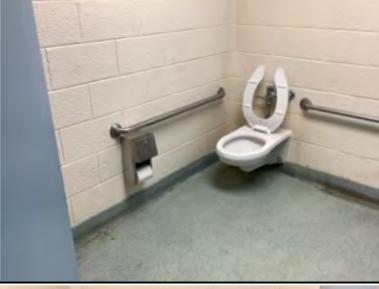
97	Boys' Toilet Room by 3	1	T3	Toilet Compartment (Children)	Accessible Compartment

Door pull not provided Side or rear grab bar < 42" long	- 36"	Provide a door pull on each side of the door between 34" to 48" above the finished floor that does not require tight grasping, pinching or twisting of the wrist. Provide a side/rear wall grab bar that is 42" long located 6" max. from the interior corner.	1	
98	Girls' Toilet Room by Room 27	1	27A	Toilet Compartment (Children)	Accessible Compartment

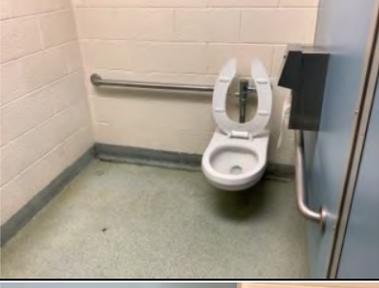
Side or rear grab bar < 42" long Non-compliant toilet paper dispenser	36" -	Provide a rear wall grab bar that is 42" long located 6" max. from the interior corner. Ensure dispensers and other devices are not mounted above grab bars. Relocate toilet paper dispenser so that it is between 14"- 19" above the finished floor and between 7"- 9" in front of the toilet.	1	
99	Boys' Toilet Room by Room 29	1	29A	Toilet Compartment (Children)	Accessible Compartment

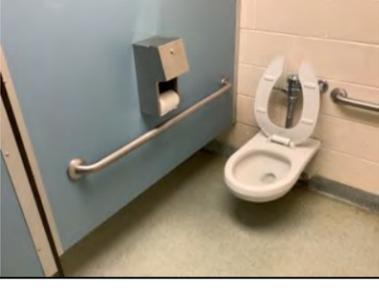
Non-compliant toilet paper dispenser	-	Ensure dispensers and other devices are not mounted above grab bars. Relocate toilet paper dispenser so that it is between 14"- 19" above the finished floor and between 7"- 9" in front of the toilet.	1

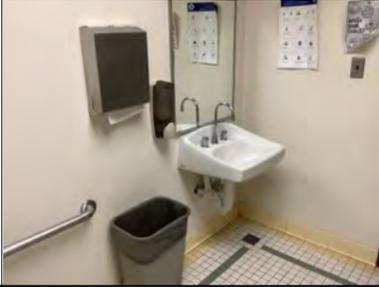
ID	Location	Floor	Room	Element	Type	Photo	Issues	Current Measure	Recommendations	Quantity	Notes
Lavatory (Children)											
100	Special Education Classroom Toilet Room and Girls' Toilet Room by Room 5	1	13, T4	Lavatory (Children)	N/A

Toe or knee clearances not provided	23"	Provide at least one lavatory with 25" min. knee clearance positioned for a forward approach. Ensure toe clearance is also provided.	2	
101	Nurse's Office Toilet Room	1	22	Lavatory (Children)	N/A

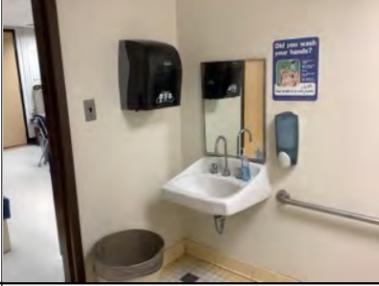
Toe or knee clearances not provided Exposed plumbing underneath Mirror above lavatory w/reflective surface > 31"	23" - 33"	Provide at least one lavatory with 25" min. knee clearance positioned for a forward approach. Ensure toe clearance is also provided. Insulate or otherwise configure pipes to prevent contact, for at least one lavatory. Lower mirror so that the bottom surface is at 31" above the finished floor.	1

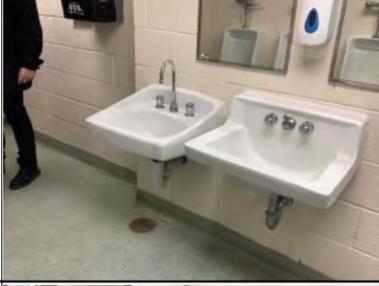
102	Boys' Toilet Room by 3 and Girls' Toilet Room by Room 27	1	T3, 27A	Lavatory (Children)	N/A

Toe or knee clearances not provided Mirror above lavatory w/reflective surface > 31"	23" 40"	Provide at least one lavatory with 25" min. knee clearance positioned for a forward approach. Ensure toe clearance is also provided. Lower mirror so that the bottom surface is at 31" above the finished floor.	2	
103	Boys' Toilet Room by Room 29	1	29A	Lavatory (Children)	N/A

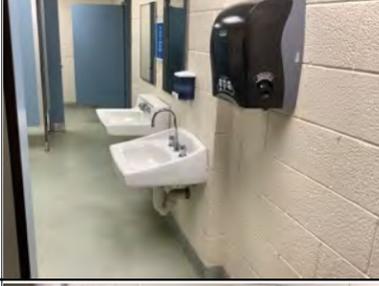
Toe or knee clearances not provided Mirror above lavatory w/reflective surface > 31"	22" 40"	Provide at least one lavatory with 25" min. knee clearance positioned for a forward approach. Ensure toe clearance is also provided. Lower mirror so that the bottom surface is at 31" above the finished floor.	1	
104	Girls' Toilet Room by Room 5	1	T4	Lavatory (Children)	N/A

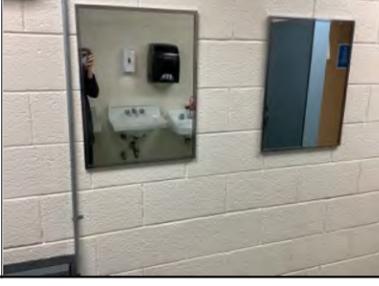
Mirror above lavatory w/reflective surface > 31"		Lower one mirror so that the bottom surface is at 31" above the finished floor.	1

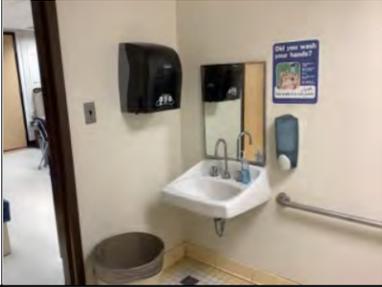
ID	Location	Floor	Room	Element	Type	Photo	Issues	Current Measure	Recommendations	Quantity	Notes
Dispensers (Children)											
105	Nurse's Office Toilet Room	1	22	Dispensers (Children)	Paper Towel Dispenser

Dispenser not operable with a closed fist	-	Provide a paper towel dispenser that can be operable with one hand and not require tight grasping, pinching, or twisting of the wrist.	1	
106	Boys' Toilet Room by 3	1	T3	Dispensers (Children)	Paper Towel Dispenser

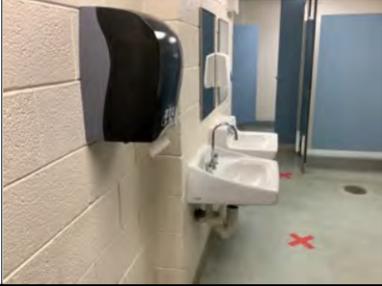
Dispenser is a protruding object	10"	Relocate the paper towel dispenser out of the circulation path.	1	
107	Boys' Toilet Room by Room 29	1	29A	Dispensers (Children)	Paper Towel Dispenser

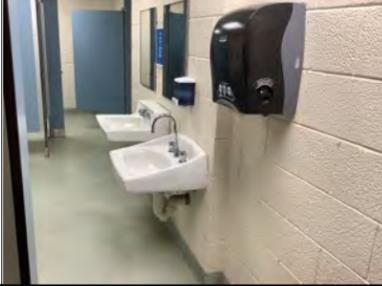
Dispenser is a protruding object	10"	Relocate the paper towel dispenser out of the circulation path. Alternatively, a cane-detectable barrier could be provided underneath the dispenser or a low profile dispenser that is 4" deep or less could be provided.	1

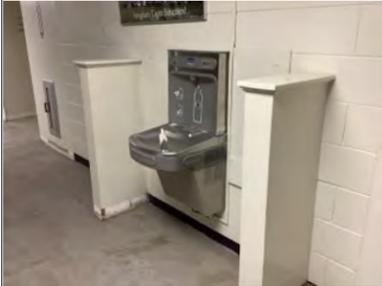
Additional Access											
Drinking Fountains											
108	Corridor by 10	1	10	Drinking Fountains	Low

No drinking fountain provided for standing users		Provide an additional drinking fountain for standing users. No fewer than two (2) drinking fountains must be provided. One drinking fountain must comply as a drinking fountain for seated users (ADA 602.1 through 602.6) and one drinking fountain must comply as a drinking fountain for standing users (ADA 602.7).	1

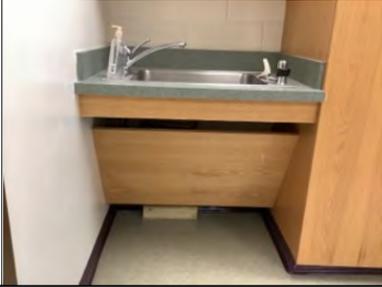
Toe and knee clearances not provided	-	Remove piece of wood that is located in the toe clearance.	1	
Play and Sport Areas											
Play Areas											
110	Playground by Soccer Field Near Southwest Parking	Ext.		Play Areas	N/A

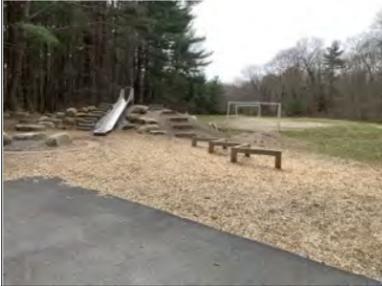
Accessible route not provided to playground Accessible route not provided around playground Accessible route not provided to play components	- - -	Install an accessible route to and around the playground. Provide an accessible route around the play area. Provide a compliant impact-attenuating surface to and around the play components.	1	
111	Play Element Near Southwest Parking Area	Ext.		Play Areas	N/A

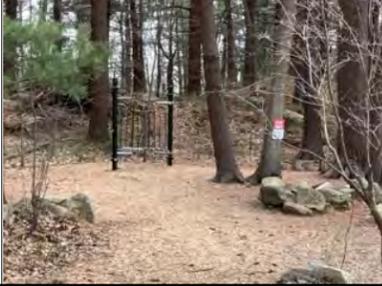
Accessible route not provided to playground Accessible route not provided around playground Accessible route not provided to play components Surface not stable, firm, and slip-resistant	- - - -	Install an accessible route to and around the playground. Provide an accessible route around the play area. Provide a compliant impact-attenuating surface to and around the play components. Repair surface and ensure that surface is firm, stable and slip-resistant (to areas around play components).	1

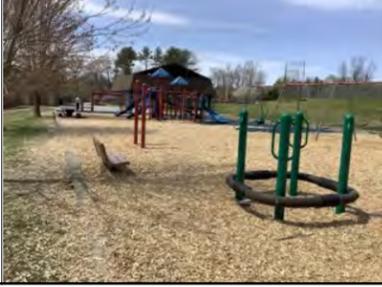
112	Playground by Soccer Field	Ext.		Play Areas	N/A

Accessible route not provided around playground Accessible route not provided to play components	- -	Provide an accessible route around the play area. Provide a compliant impact-attenuating surface to and around the play components.	1

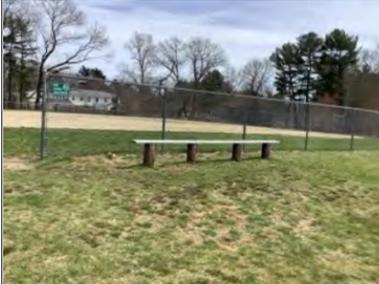
ID	Location	Floor	Room	Element	Type	Photo	Issues	Current Measure	Recommendations	Quantity	Notes
Field											
113	Softball Field	Ext.		Field	Softball

Accessible spaces not provided at team seating No accessible route to all areas of sport activity	- -	Provide a 36" x 48" clear floor space at team seating. Install an accessible route between all areas of sport activity including to the softball field and team seating areas.	1	
114	Soccer Field	Ext.		Field	Soccer

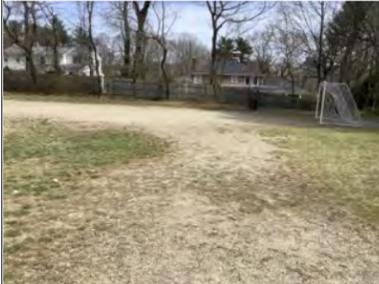
Field not connected to an accessible route No accessible route to all areas of sport activity	- -	Provide an accessible route to the field. Install an accessible route between all areas of sport activity.	1	
Court											
115	Gaga Ball Court	Ext.		Court	Gaga Ball

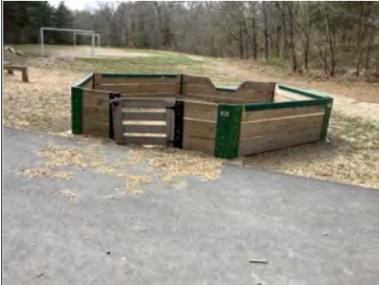
No accessible route between all areas of sport activity	-	Install an accessible route to the gaga ball court. (Remove excess engineered wood fiber at gaga ball pit entry.)	1

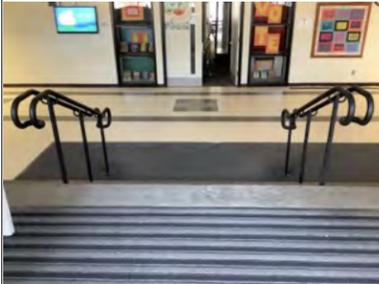
Best Practice											
116	Main Entrance	1

Recommend providing visual contrast strips on the stair treads.	1

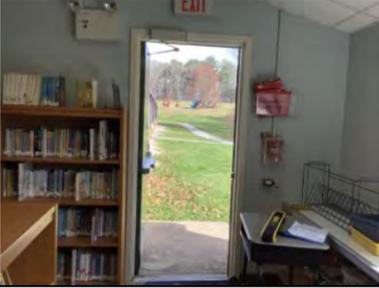
ID	Location	Floor	Room	Element	Type	Photo	Issues	Current Measure	Recommendations	Quantity	Notes
117	Library	1	14

Recommend providing an accessible route from the exit to the nearest right of way.	1	
118	Main Entrance	1

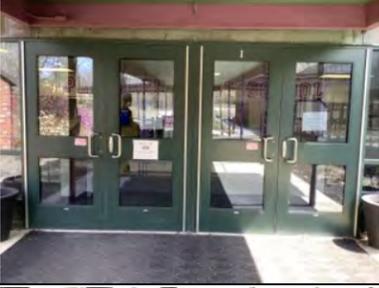
Recommend providing an automatic door opener at the entrance.	1	
119	Main Entrance	1

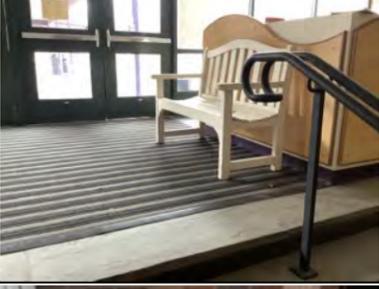
This is a good example of a wood bench with back and arms.	1	
120	Main Entrance	1

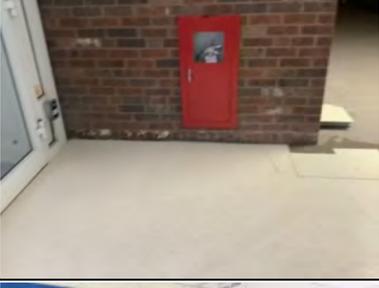
This is a good example of a recessed fire extinguisher.	1	
121	Route to Nurse's Office From Corridor	1	22

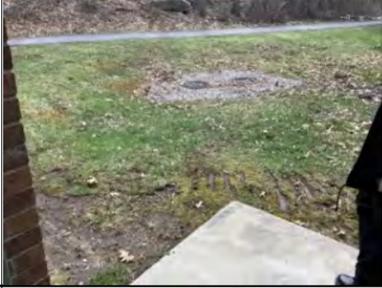
ID	Location	Floor	Room	Element	Type	Photo	Issues	Current Measure	Recommendations	Quantity	Notes
122	Corridor Exit Across From Room 23	1	23

Recommend building an accessible route from the exit to the path around the school.	1	
123	First Grade Classroom	1	29

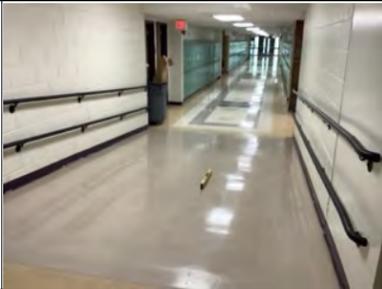
Flooring in some areas, has glare and may pose challenges to people with low vision. This may be a simple fix of changing the maintenance from polishing to maintenance of a matte finish.	1	
125	Ramp to Auditorium by Main Entrance	1	16

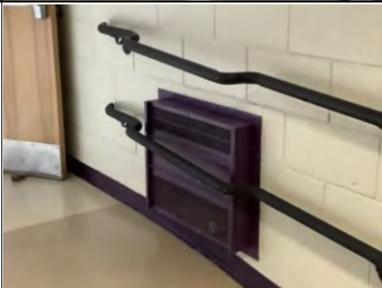
Heater may pose a burn hazard and heat up the metal handrails. IHCD recommends monitoring this and relocating the heater in that case.	1	
126	School Sign	1

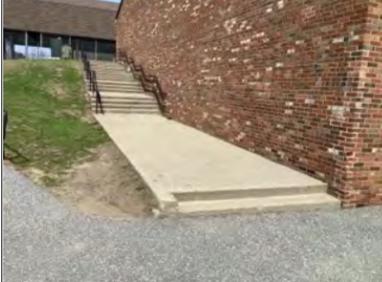
ID	Location	Floor	Room	Element	Type	Photo	Issues	Current Measure	Recommendations	Quantity	Notes
127	Stairs By Door 7	Ext.

Recommend providing handrails on all stairs.	1	
128	Playground by Soccer Field	Ext.

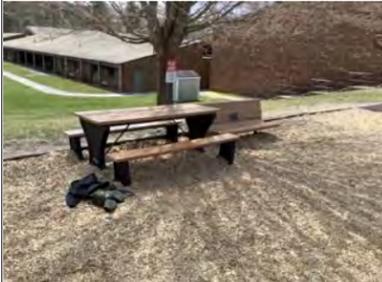
-	Recommend providing a 48" wide min. stable, firm and slip-resistant surface around the boundary of an accessible picnic table located on an accessible route. See Figure 1 in the narrative report for an example of the clear route around the picnic table.	1	
129	By Main Entrance	Ext.

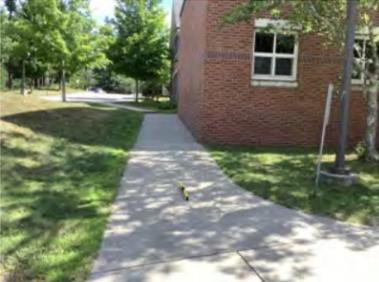
ID	Location	Floor	Room	Element	Type	Photo	Issues	Current Measure	Recommendations	Quantity	Notes
Approach and Entrance											
Exterior Access Route											
1	Egress Door 8 to Egress Door 10	Ext.		Exterior Access Route	Walkway

Running slope > 1:20 (5.00%)	8.3%	Provide compliant handrails for a ramp or reduce the slope to 5%.	1	
2	Soccer Field by the Playground to Egress Door 6	Ext.		Exterior Access Route	Walkway

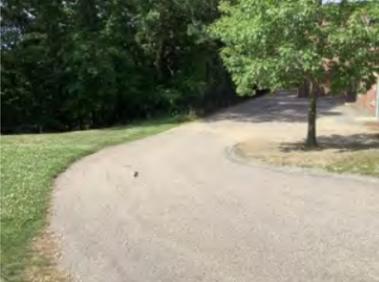
Running slope > 1:20 (5.00%)	11.7%	It may be technically infeasible to reduce this running slope to 1:20 (5.00%).	1	
3	Entrance/ Egress Door 3 (First Grade Entrance)	Ext.		Exterior Access Route	Walkway

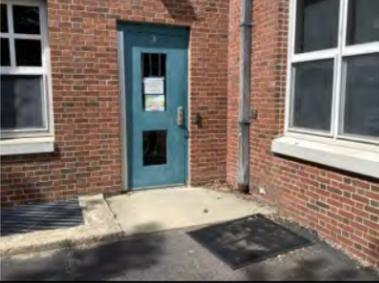
Level changes > 1/4"	2"	Alter change in level to be 1/4" high max.	1	
4	Route to Exit Door 10	Ext.		Exterior Access Route	Walkway

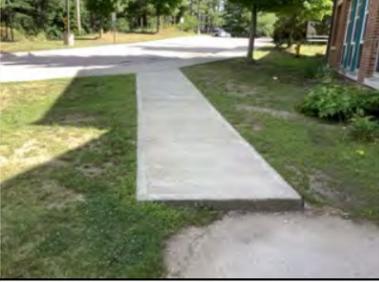
Level changes > 1/4" Accessible route not provided	- -	Ensure an accessible route is provided. Alter change in level to be 1/4" high max.	1

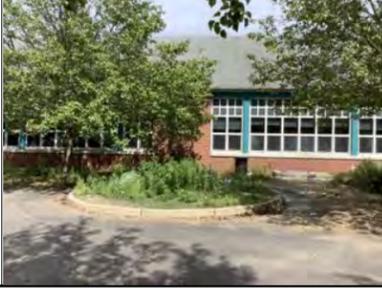
ID	Location	Floor	Room	Element	Type	Photo	Issues	Current Measure	Recommendations	Quantity	Notes
6	Garden Beds by Egress Door 2	Ext.		Exterior Access Route	Walkway

Accessible route not provided	8.5"	Ensure an accessible route is provided to the garden bed. Currently there is an 8.5" change in level and this must be reduced to a level change no greater than 1/4" max.	1	
Curb Ramp											
7	Accessible Parking by Main Entrance 1	Ext.		Curb Ramp	N/A

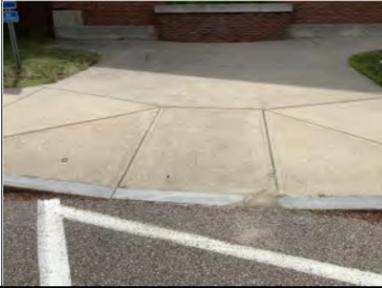
Surface not stable, firm and slip-resistant	-	Repair damage at base of curb ramp.	1	
Off-Street Parking Lot or Garage											
8	Accessible Parking by Egress Door 1	Ext.		Off-Street Parking Lot or Garage	Visitor

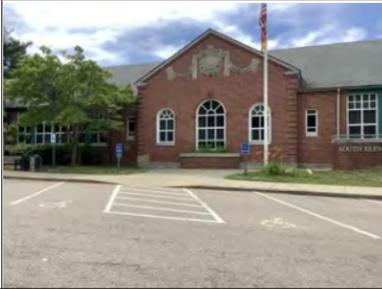
Total # of parking Total # of designated accessible parking spaces Total # of designated van accessible spaces Sign bottom < 60" above finished grade	29 1 1 29.6", 39.3"	The parking lot has the required number of accessible and van accessible parking spaces. Locate the signs with the bottom of the sign 60" above the ground.	1

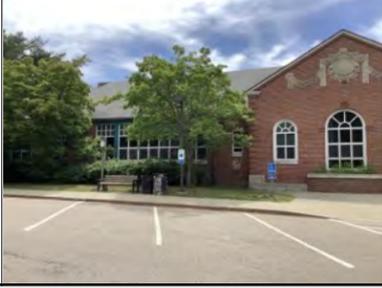
9	Parking Lot	Ext.		Off-Street Parking Lot or Garage	Visitor

Access aisle not provided Sign not provided Sign bottom < 60" above finished grade	- - 54.4"	Additional signage designating accessible parking spaces is provided in this parking lot, however these go beyond the number of spaces that are required. If the Town wants to make these parking spaces compliant, an access aisle must be provided and the signs must be raised so that the bottom of the sign is no lower than 60" above the ground.	1	
Access to Goods and Services
