East Elementary School

Town of Hingham ADA Transition Plan

October 2023

Institute for Human Centered Design

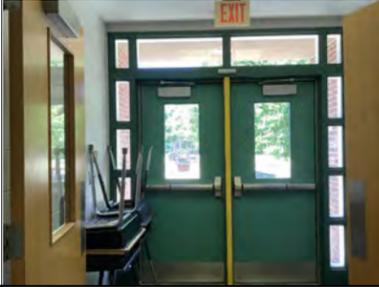
ID	Location	Floor	Room	Element	Type	Photo	Issues	Current Measure	Recommendations	Quantity	Notes
Means of Egress											
15	Egress Door 5, Used by Kindergarten	1		Means of Egress	N/A

Tactile exit sign not provided	-	Ensure tactile exit signs with raised characters and braille are provided at exit doors. Mount signs between 48"- 60" above the finished floor. Where a tactile sign is provided at double doors with two active leaves, the sign shall be located to the right of the right hand door.	1	
16	Main Entrance/ Exit 1	1		Means of Egress	N/A

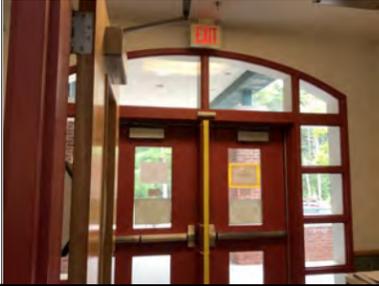
Tactile exit sign not provided	-	Ensure tactile exit signs with raised characters and braille are provided at exit doors. Mount signs between 48"- 60" above the finished floor located on the latch side of the door. Where a tactile sign is provided at double doors with two active leaves, the sign shall be located to the right of the right hand door.	1

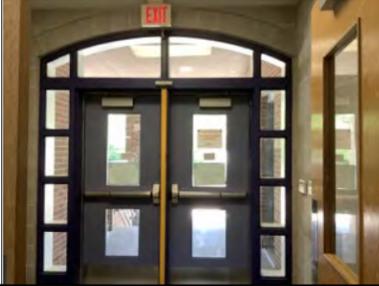
17	Egress Door 8 by the Cafeteria	LL		Means of Egress	N/A

Tactile exit sign not provided	- -	Ensure tactile exit signs with raised characters and braille are provided at exit doors. Mount signs between 48"- 60" above the finished floor located on the latch side of the door. Where a tactile sign is provided at double doors with two active leaves, the sign shall be located to the right of the right hand door.	1	
18	Egress Door 2 to Playground	1		Means of Egress	N/A

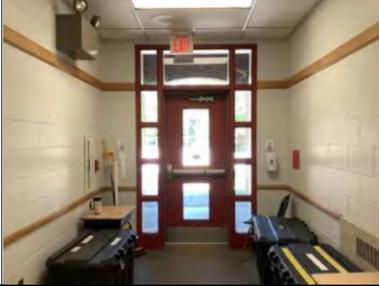
Tactile exit sign not provided Illuminated ISA symbol not provided (MAAB)	- -	Ensure tactile exit signs with raised characters and braille are provided at exit doors. Mount signs between 48"- 60" above the finished floor located on the latch side of the door. Provide an illuminated sign with the International Symbol of Accessibility (ISA).	1	
19	Entrance/ Egress Door 3 (First Grade Entrance)	1		Means of Egress	N/A

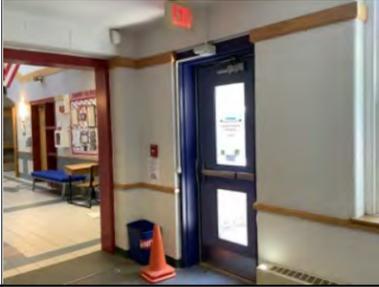
Tactile exit sign not provided Illuminated ISA symbol not provided (MAAB)	- -	Ensure tactile exit signs with raised characters and braille are provided at exit doors. Mount signs between 48"- 60" above the finished floor located on the latch side of the door. After the 2" change in level is repaired in the walkway, provide an illuminated sign with the International Symbol of Accessibility (ISA).	1

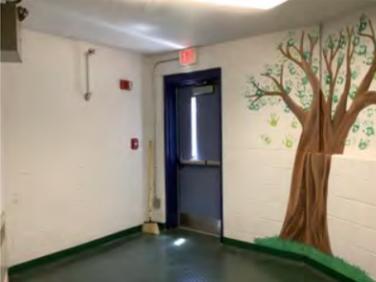
ID	Location	Floor	Room	Element	Type	Photo	Issues	Current Measure	Recommendations	Quantity	Notes
20	Stair 1, Egress Door 11	LL		Means of Egress	N/A

Tactile exit sign not provided Illuminated ISA symbol not provided (MAAB)	- -	Ensure tactile exit signs with raised characters and braille are provided at exit doors. Mount signs between 48"- 60" above the finished floor located on the latch side of the door. Provide an illuminated sign with the International Symbol of Accessibility (ISA).	1	
21	Egress Door 6	LL		Means of Egress	N/A

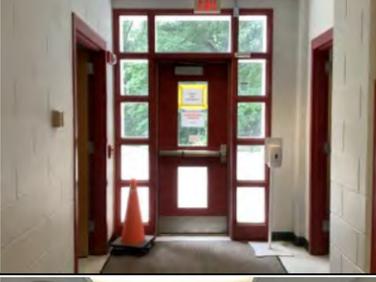
Tactile exit sign not provided Illuminated ISA symbol not provided (MAAB)	- -	Ensure tactile exit signs with raised characters and braille are provided at exit doors. Mount signs between 48"- 60" above the finished floor located on the latch side of the door. Provide an illuminated sign with the International Symbol of Accessibility (ISA).	1	
22	Egress Door 14	LL		Means of Egress	N/A

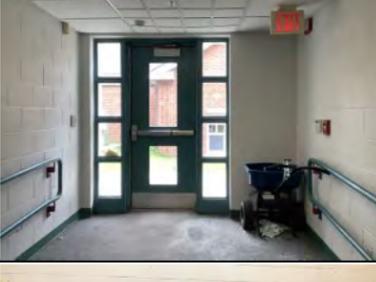
Tactile exit sign not provided Illuminated ISA symbol not provided (MAAB)	- -	Ensure tactile exit signs with raised characters and braille are provided at exit doors. Mount signs between 48"- 60" above the finished floor located on the latch side of the door. Provide an illuminated sign with the International Symbol of Accessibility (ISA).	1

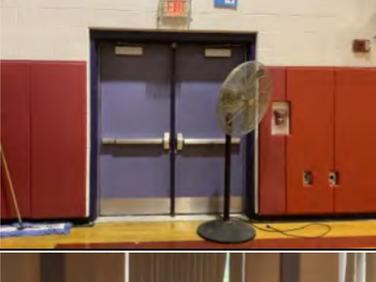
23	Gymnasium, Egress Door 7	LL	011	Means of Egress	N/A

Tactile exit sign not provided Illuminated ISA symbol not provided (MAAB)	- -	Ensure tactile exit signs with raised characters and braille are provided at exit doors. Mount signs between 48"- 60" above the finished floor located on the latch side of the door. Where a tactile sign is provided at double doors with two active leafs, the sign shall be located to the right of the right hand door. Provide an illuminated sign with the International Symbol of Accessibility (ISA).	1	
24	Cafetorium, Egress Door 10	LL	013	Means of Egress	N/A

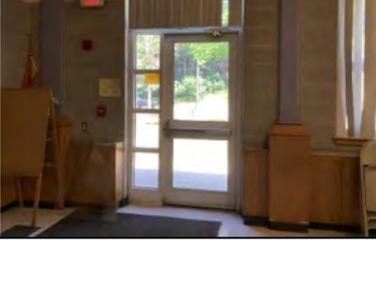
Tactile exit sign not provided Illuminated ISA symbol not provided (MAAB)	- -	Ensure tactile exit signs with raised characters and braille are provided at exit doors. Mount signs between 48"- 60" above the finished floor located on the latch side of the door. After the exterior walkway is renovated, provide an illuminated sign with the International Symbol of Accessibility (ISA).	1

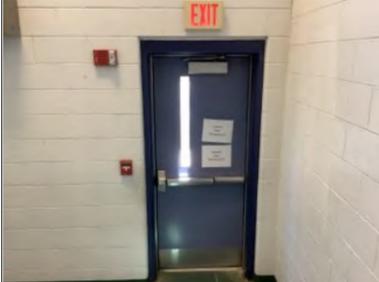
ID	Location	Floor	Room	Element	Type	Photo	Issues	Current Measure	Recommendations	Quantity	Notes
25	Egress Door 4, Stair 2	1		Means of Egress	N/A

Tactile exit sign not provided Directional sign to accessible emergency exit not provided	- -	Ensure tactile exit signs with raised characters and braille are provided at exit doors. Mount signs between 48"- 60" above the finished floor located on the latch side of the door. Provide a directional sign indicating the location of the nearest accessible emergency exit by the exit door.	1	
26	To Egress Door 5, Used by Kindergarten	1		Means of Egress	N/A

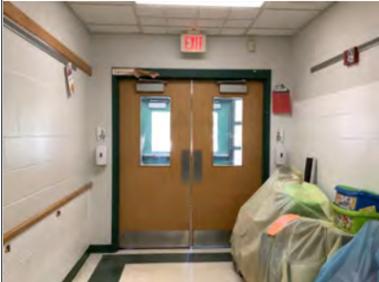
Illuminated ISA symbol not provided (MAAB)	-	Provide an illuminated sign with the International Symbol of Accessibility (ISA).	1	
27	Main Entrance/ Exit 1	1		Means of Egress	N/A

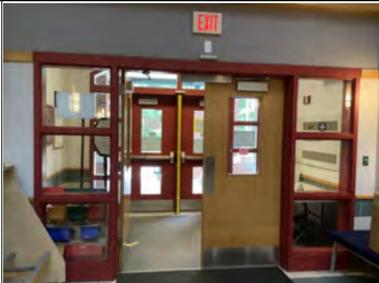
Illuminated ISA symbol not provided (MAAB)	-	Provide an illuminated sign with the International Symbol of Accessibility (ISA).	1

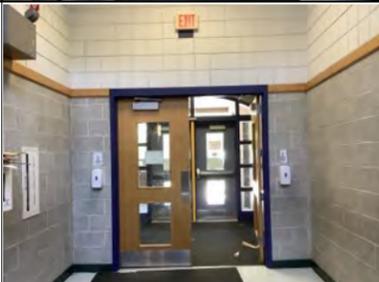
28	To Egress Door 8 Vestibule by the Cafeteria	LL		Means of Egress	N/A

Illuminated ISA symbol not provided (MAAB)	- -	Provide an illuminated sign with the International Symbol of Accessibility (ISA).	1	
29	Stair 2	1		Means of Egress	N/A

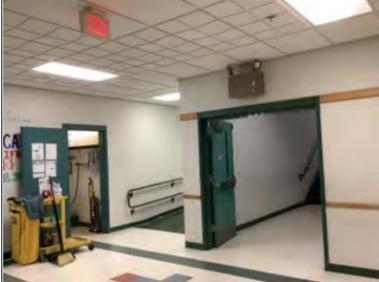
ID	Location	Floor	Room	Element	Type	Photo	Issues	Current Measure	Recommendations	Quantity	Notes
30	Stair 2	B		Means of Egress	N/A

Directional sign to accessible emergency exit not provided	-	Provide a directional sign indicating the location of the nearest accessible emergency exit by the exit door. Recommend providing it above the tactile designation sign.	1	
31	Stair 1	LL		Means of Egress	N/A

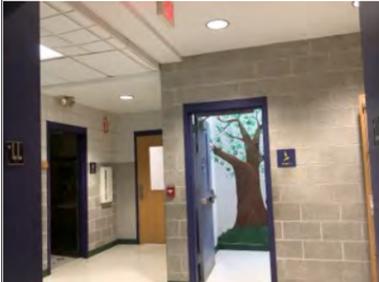
Directional sign to accessible emergency exit not provided	-	Provide a directional sign indicating the location of the nearest accessible emergency exit by the exit door. Recommend providing it above the tactile designation sign.	1	
Interior Access Route											
32	Library	1	115	Interior Access Route	N/A

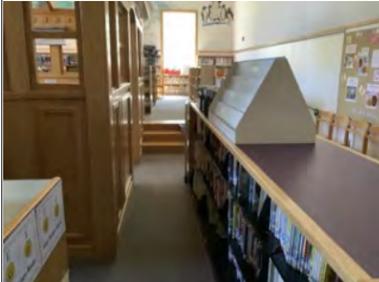
Route < 36" wide	29"	Ensure that a clear width of 36" min. is maintained at the accessible route.	1	
33	Reading Room	LL	005	Interior Access Route	N/A

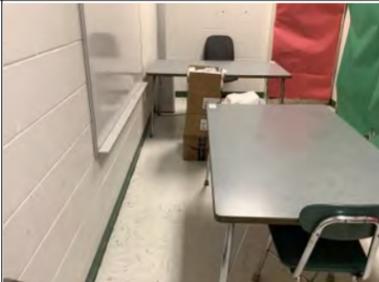
Route < 36" wide	24"	Ensure that a clear width of 36" min. is maintained at the accessible route.	1

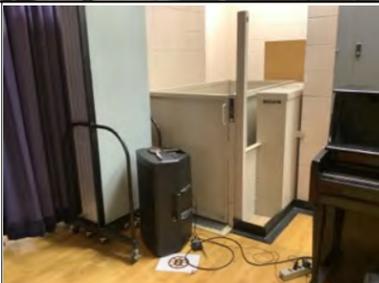
37	Cafetorium Stage Lift	LL	013	Interior Access Route	N/A

Route < 36" wide Surface not stable, firm, and slip-resistant	- -	Relocate the cables and speaker to ensure clear floor space at the door to the lift.	1

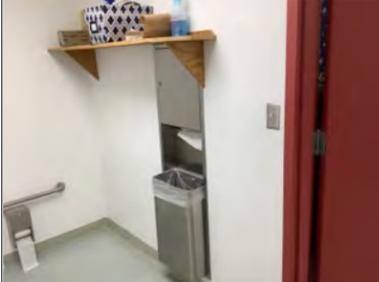
ID	Location	Floor	Room	Element	Type	Photo	Issues	Current Measure	Recommendations	Quantity	Notes
34	Motor Room/ Occupational Therapy/ Physical Therapy Single-User Toilet	1	110	Interior Access Route	N/A

Obstructed by protruding objects	12.8"	Remove the shelf.	1	
35	RISE/Special Education Classroom	1	111	Interior Access Route	N/A

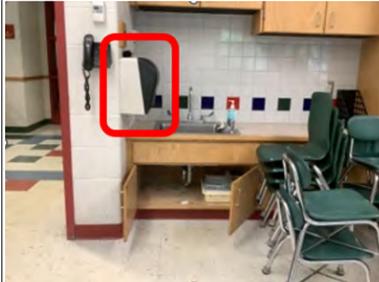
Obstructed by protruding objects	9.4"	Relocate the paper towel dispenser out of the circulation path.	1	
36	By Egress Door 8	LL		Interior Access Route	N/A

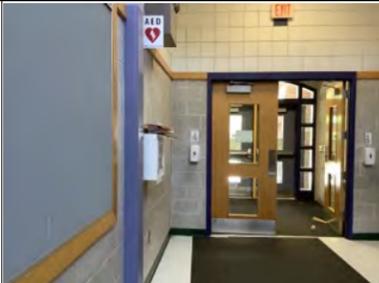
Obstructed by protruding objects	6"	Relocate the defibrillator out of the circulation path.	1	
Doors, Doorways, & Gates											
38	Girls' Toilet Room	1		Doors, Doorways, & Gates	Toilet Room

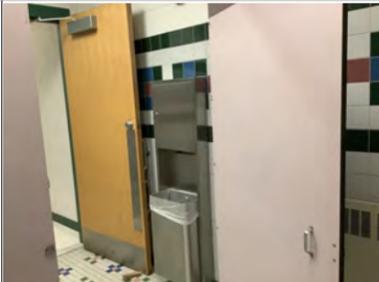
Maneuvering clearance(s) not provided	8.9"	Relocate the paper towel dispenser and trash bin out of the 60" deep required maneuvering clearance at the door.	1	
39	Guidance Office	1	106	Doors, Doorways, & Gates	Office

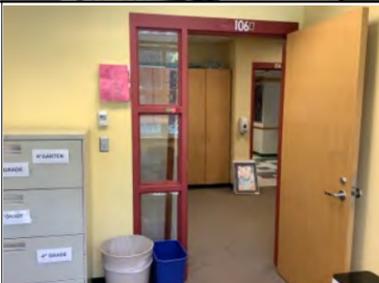
Maneuvering clearance(s) not provided		Remove the trash and recycling bins to ensure that there is 18" min. clear on the latch side of the door.	1

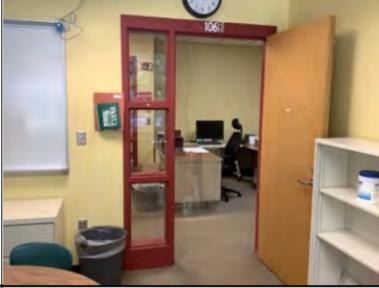
ID	Location	Floor	Room	Element	Type	Photo	Issues	Current Measure	Recommendations	Quantity	Notes
40	Guidance Office	1	106B	Doors, Doorways, & Gates	Office

Maneuvering clearance(s) not provided	-	Relocate white cabinet on the right side so that there is 60" clear deep min. in front of the door.	1	
41	Math Specialist	1	109	Doors, Doorways, & Gates	Classroom

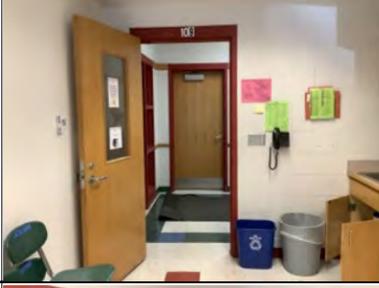
Maneuvering clearance(s) not provided	-	Relocate trash containers and recycling bins so that there is 18" clear on the latch side of the door.	1	
42	Motor Room/ Occupational Therapy/ Physical Therapy Single-User Toilet	1	110	Doors, Doorways, & Gates	Toilet Room

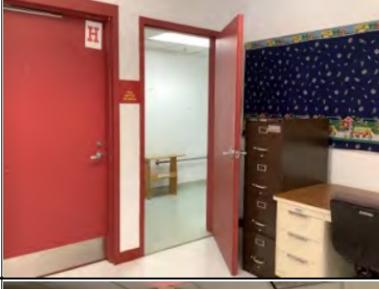
Maneuvering clearance(s) not provided	33.5"	Relocate the file cabinet so that there is 60" clear in front of the door.	1	
43	Computer to Lobby	1	119	Doors, Doorways, & Gates	Circulation

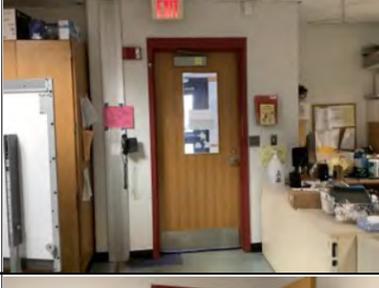
Maneuvering clearance(s) not provided	6.9"	Relocate the desk so that there is 12" on the latch push side of the door.	1

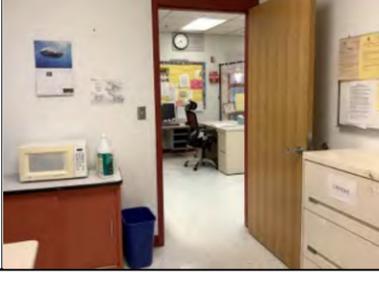
44	Health Room/Nurse, Exam Room	1	119	Doors, Doorways, & Gates	Office

Maneuvering clearance(s) not provided	-	Relocate furniture so that there is 18" clear on the latch pull side of the door and there is 60" deep clear.	1

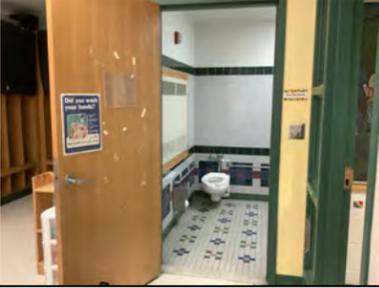
ID	Location	Floor	Room	Element	Type	Photo	Issues	Current Measure	Recommendations	Quantity	Notes
45	Kindergarten Classroom, Single-User Toilet Room	1	123	Doors, Doorways, & Gates	Toilet Room

Maneuvering clearance(s) not provided	10"	As long as a closer is not provided on the door, reverse the swing of the door. If a closer is provided, then an automatic door opener is required.	1	
46	Art Room, West Door	1	135	Doors, Doorways, & Gates	Classroom

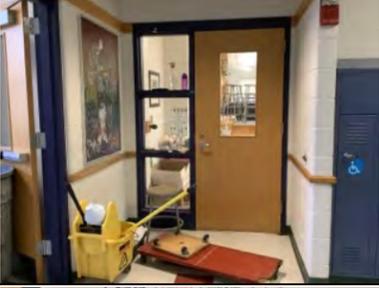
Maneuvering clearance(s) not provided	-	Relocate equipment so that there is 18" clear on the latch pull side of the door.	1	
47	Third Grade Classroom	LL	006	Doors, Doorways, & Gates	Classroom

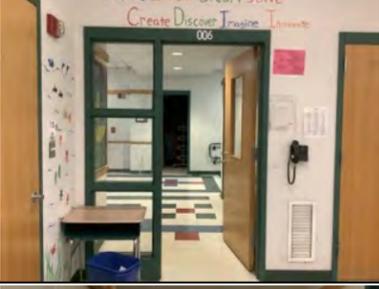
Maneuvering clearance(s) not provided	-	Relocate table so that there is 12" clear on the latch pull side of the door.	1	
48	First Grade Classroom	LL	010	Doors, Doorways, & Gates	Classroom

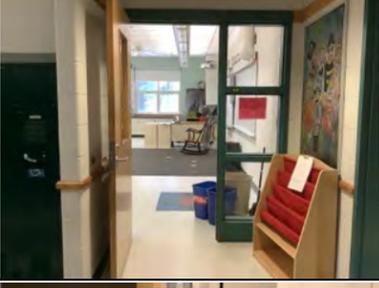
Maneuvering clearance(s) not provided	-	Relocate furniture so that there is 18" clear on the latch side of the door.	1

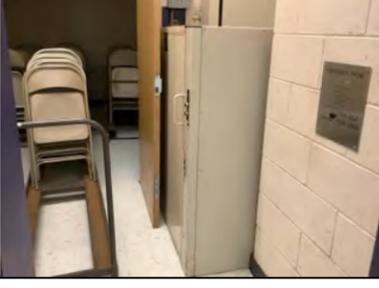
49	Cafetorium Stage Lift - Top and Bottom	LL	013	Doors, Doorways, & Gates	Other

Maneuvering clearance(s) not provided	-	Relocate furniture so that there is 54" clear depth in front of the door to the lift.	2

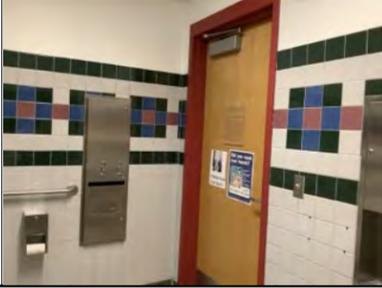
Door requires > 5 lbs. of force to open	8 lbs.	Adjust closers so doors do not require more than 5 pounds of force to open.	1	
Ramps											
51	Library	1	115	Ramps	Interior

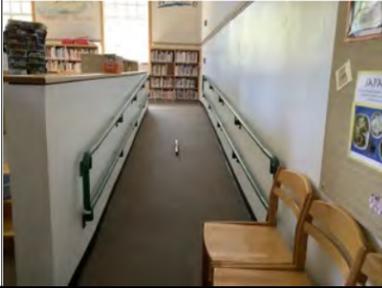
Handrails do not extend 12" past top & bottom	-	Alter handrails to extend horizontally above the landing for 12" min. beyond the top and bottom of ramp runs.	1	
Stairways											
52	Library	1	115	Stairways	Other

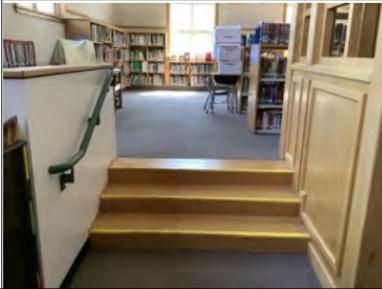
Handrail height < 34" or > 38" Handrail not provided on both sides Handrails do not extend 12" from stairs	31.7" - -	Alter so the handrails are 34"- 38" high above the floor. Provide handrails on each side. Top: Ensure handrails extend horizontally above the landing for 12" min. beginning above the first riser nosing. Bottom: Ensure handrails extend to one tread depth beyond the last riser.	1

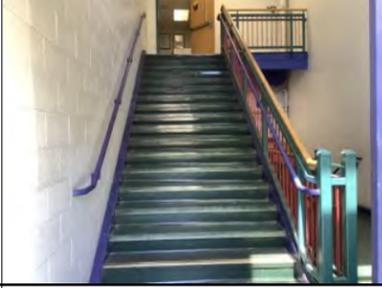
53	Stair 2	1		Stairways	Egress

Handrails do not extend 12" from stairs	-	Top: Ensure handrails extend horizontally above the landing for 12" min. beginning above the first riser nosing. Bottom: Ensure handrails extend to one tread depth beyond the last riser.	1	
54	Stair 1, to Egress Door 11	LL		Stairways	Egress

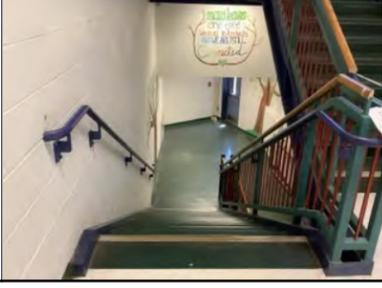
Handrails do not extend 12" from stairs	-	Top: Ensure handrails extend horizontally above the landing for 12" min. beginning above the first riser nosing. Bottom: Ensure handrails extend to one tread depth beyond the last riser.	1

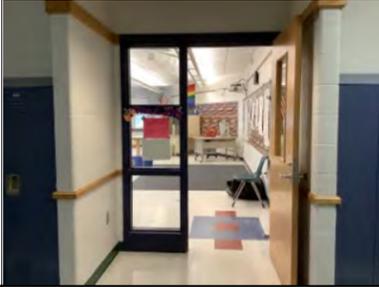
ID	Location	Floor	Room	Element	Type	Photo	Issues	Current Measure	Recommendations	Quantity	Notes
Signage											
55	Art Room, East Door	1	135	Signage	Designation

Raised characters not provided on sign Braille not provided on sign	- -	Provide text with raised characters duplicated in braille on sign.	1	
58	First Grade Classroom	LL	010	Signage	N/A

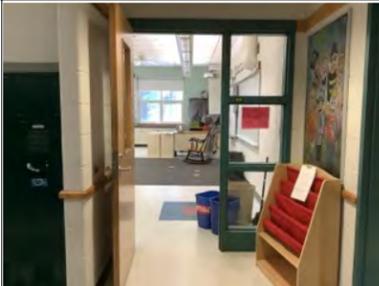
Raised characters not provided on sign Braille not provided on sign	- -	Provide text with raised characters duplicated in braille on sign.	1	
56	Staff Only Toilet Room	LL		Signage	Designation

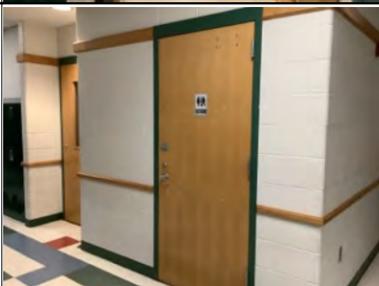
Raised characters not provided on sign Braille not provided on sign Sign not located on the latch side of the door	- - -	Provide text with raised characters duplicated in braille on sign. Locate the sign at permanent rooms alongside the door on the latch side.		
57	Reading Room	LL	005	Signage	Designation

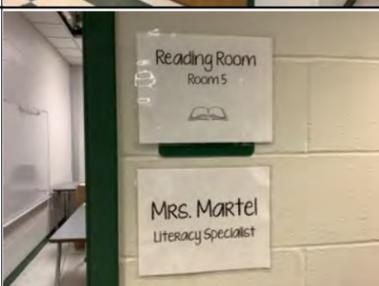
Raised characters not provided on sign Braille not provided on sign Non-glare finish and contrast not provided on sign	- - -	Provide text with raised characters duplicated in braille on sign. Install a sign with a non-glare finish.	1

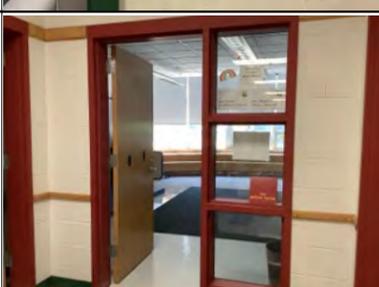
59	Motor Room/ Occupational Therapy/ Physical Therapy	1	110	Signage	Designation

Raised characters < 48" or > 60" above ground	35.4"	Mount designation signs so that the baseline of the lowest tactile character is 48" min. above finished floor and the baseline of the highest tactile character is 60" max. above the finished floor.	1

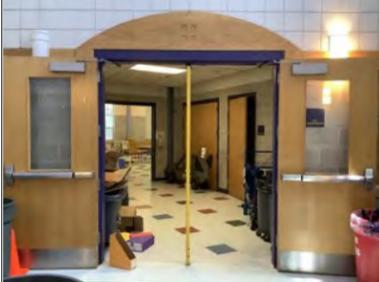
ID	Location	Floor	Room	Element	Type	Photo	Issues	Current Measure	Recommendations	Quantity	Notes
60	Cafetorium	LL	013	Signage	Designation

Raised characters < 48" or > 60" above ground	63"	Mount signs so that the baseline of the lowest tactile character is 48" min. above finished floor and the baseline of the highest tactile character is 60" max. above the finished floor.	1	
61	Stair 1	ML		Signage	Designation

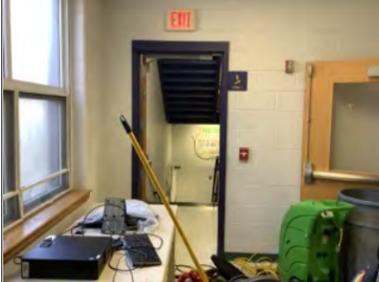
Raised characters < 48" or > 60" above ground Directional sign to accessible emergency exit not provided	83"	Relocate the tactile sign so that the baseline of the lowest tactile character is 48" min. above finished floor and the baseline of the highest tactile character is 60" max. above the finished floor. Provide a directional sign indicating the location of the nearest accessible emergency exit.	1	
62	Girls' Toilet Room	2		Signage	Designation

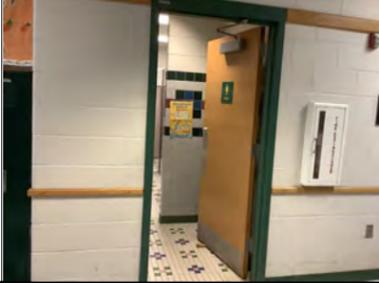
Braille not provided on sign Sign not located on the latch side of the door	-	Provide braille on the sign. Locate the sign at permanent rooms alongside the door on the latch side.	1

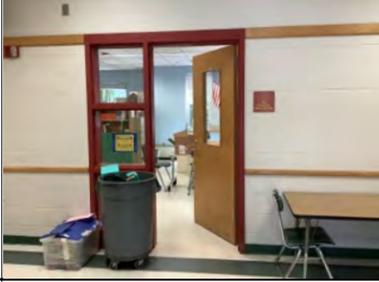
63	Reading Room	1	109	Signage	Designation

Sign not located on the latch side of the door	-	Locate the sign at permanent rooms alongside the door on the latch side.	1	
64	Kindergarten Classroom, Single-User Toilet Room	1	123	Signage	Designation

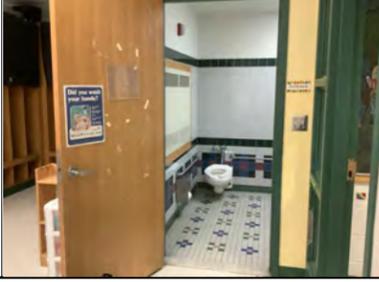
Sign not located on the latch side of the door	-	Locate the sign at permanent rooms alongside the door on the latch side.	1

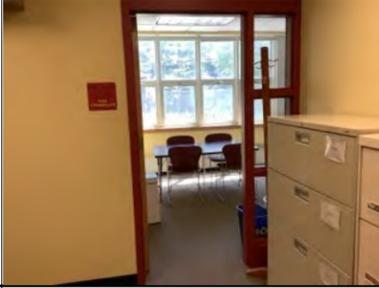
ID	Location	Floor	Room	Element	Type	Photo	Issues	Current Measure	Recommendations	Quantity	Notes
65	Guidance Office	1	106	Signage	Designation

Sign not located on the latch side of the door Signage lacks 18" by 18" clear floor space	-	Locate the sign at permanent rooms alongside the door on the latch side. After the sign is moved, relocate file cabinet to ensure that there is an 18" by 18" min. clear floor space at the sign.	1	
66	Across From Stair 2	1		Signage	Directional

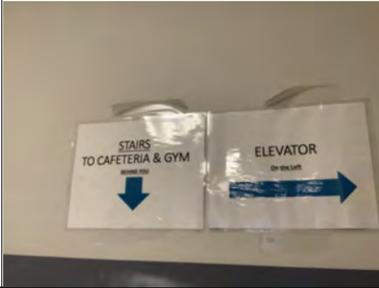
Non-glare finish and contrast not provided on sign	-	Install directional signs with a non-glare finish.	2	
67	Grade 2 Classroom	2	201	Signage	Designation

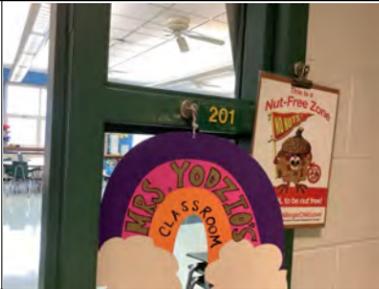
Signage lacks 18" by 18" clear floor space		Relocate signs that are blocking the designation sign with raised characters and braille.	1	
Dining or Work Surfaces											
68	Reading Room	1	109	Dining or Work Surfaces	Work Surface

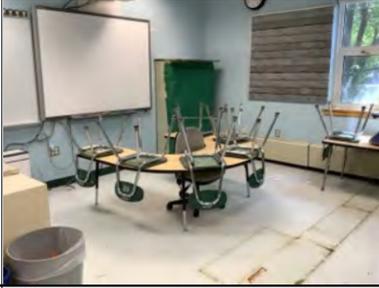
Knee or toe clearance not provided	22"	Provide at least one work surface with 24" min. knee and toe clearance.	1

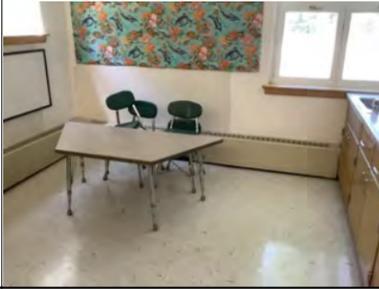
69	Motor Room/ Occupational Therapy/ Physical Therapy	1	110	Dining or Work Surfaces	Work Surface

Knee or toe clearance not provided	21.2"	Provide at least one work surface with 24" min. knee and toe clearance.	1

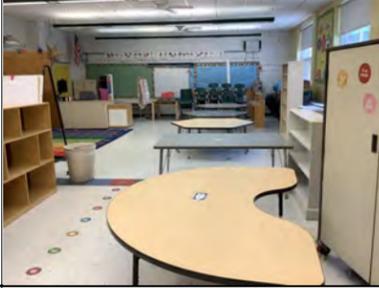
ID	Location	Floor	Room	Element	Type	Photo	Issues	Current Measure	Recommendations	Quantity	Notes
70	Kindergarten Classroom	1	123	Dining or Work Surfaces	Work Surface

Knee or toe clearance not provided	20.7"	Provide at least one work surface with 24" min. knee and toe clearance.	1	
71	Cafetorium	LL	013	Dining or Work Surfaces	Dining Surface

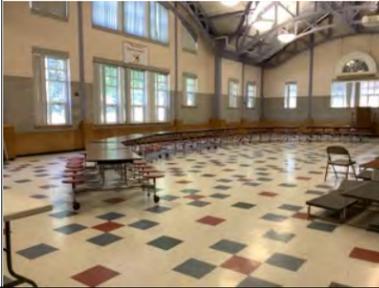
Knee or toe clearance not provided	16.7"	Provide at least one dining surface with knee clearance that is 19" deep min.	1	
Assembly Area											
72	Cafetorium Stage	LL	013	Assembly Area	N/A

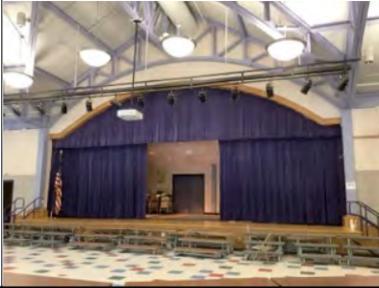
Assistive listening devices not provided		If audible communication is integral to the use of the space, provide an assistive listening system.	1	
Locker Room											
73	Accessible Locker by Third Grade Corridor and Throughout the School	LL		Locker Room	N/A

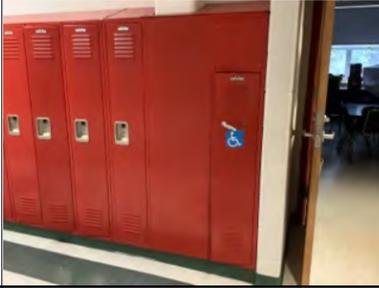
Total # of locker 5% of lockers are not accessible Total # of accessible locker	306 5 -	Ensure 5% of all lockers are accessible. Based on a count of 306, 16 lockers should be accessible.	1

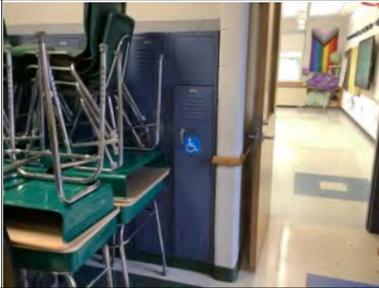
74	Accessible Locker by Art Room, West Door	1		Locker Room	N/A

Non-compliant hardware	-	At the two accessible lockers in this area, provide hardware that can be operable with one hand and not require tight grasping, pinching, or twisting of the wrist.	2

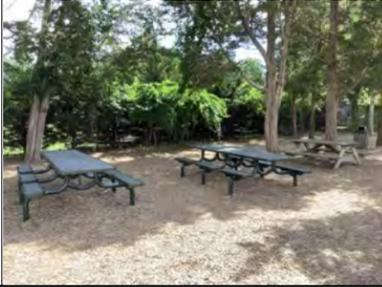
ID	Location	Floor	Room	Element	Type	Photo	Issues	Current Measure	Recommendations	Quantity	Notes
Picnic Tables											
75	Playground	Ext.		Picnic Tables	N/A

Surface not stable, firm and slip-resistant Picnic table not on an accessible route	- -	Ensure that the surface at one picnic table is stable, firm and slip-resistant. Ensure that the picnic table is connected to an accessible route.	1	
Exterior Benches											
76	Garden Beds by Egress Door 2	Ext.		Exterior Benches	N/A

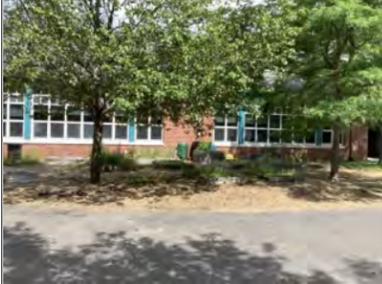
No accessible route to one bench in area	6.5"	Relocate one bench in this area to an accessible route.	1	
77	Bench Near Egress Door 5	Ext.		Exterior Benches	N/A

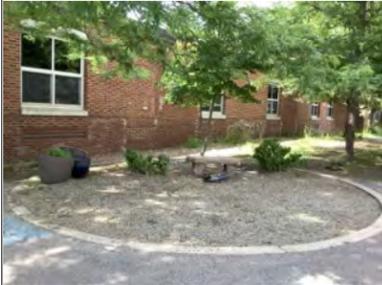
No accessible route to one bench in area	-	Provide an accessible route to one bench in this area.	1	
78	Playground	Ext.		Exterior Benches	N/A

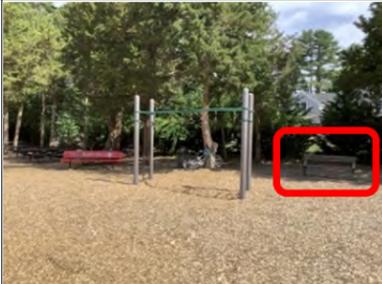
No accessible route to one bench in area	-	Provide an accessible route to one bench in this area.	1

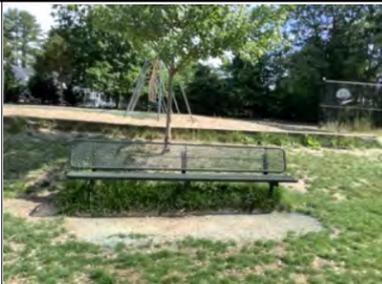
79	Soccer Field by the Playground	Ext.		Exterior Benches	N/A

No accessible route to one bench in area	-	Provide an accessible route to one bench in this area.	1	
Toilet & Bathing Rooms

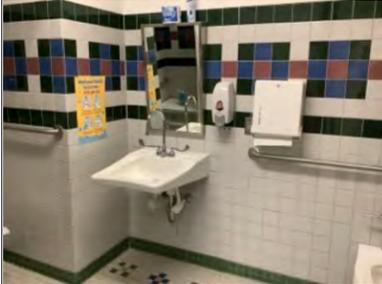
ID	Location	Floor	Room	Element	Type	Photo	Issues	Current Measure	Recommendations	Quantity	Notes
Lavatory											
80	Health Room/Nurse - Single-User Toilet Room	1	119	Lavatory	N/A

Plumbing underneath is exposed	-	Insulate or otherwise configure pipes to prevent contact at lavatory.	1	
81	Boys' Toilet Room	2		Lavatory	N/A

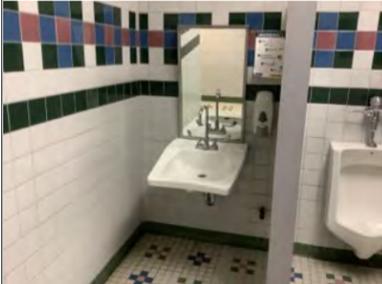
Plumbing underneath is exposed	-	Insulate or otherwise configure pipes to prevent contact at lavatory.	1	
Single-User Toilet											
82	Health Room/Nurse - Single-User Toilet Room	1	119	Single-User Toilet	N/A

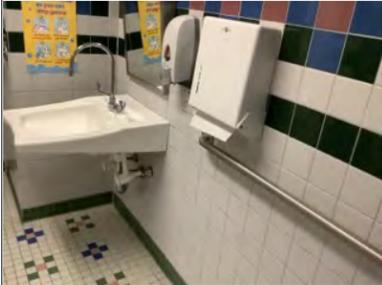
Dispenser mounted over grab bar	6"	Relocate the paper towel dispenser so that it is not mounted above the grab bar. Per 521 CMR MAAB, nothing can be mounted over the grab bar.	1	
Toilet Compartment											
83	Girls' Toilet Room by the Gym	LL		Toilet Compartment	Accessible Compartment

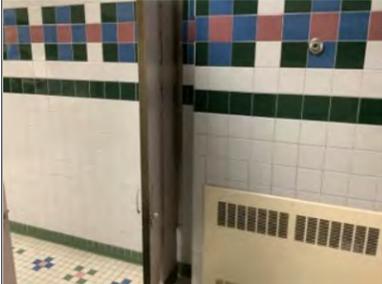
Door has malfunctioning self-closing hinge Door pull not provided	- -	Repair hinge. Provide a door pull on each side of the door between 34" to 48" above the finished floor that does not require tight grasping, pinching or twisting of the wrist.	1

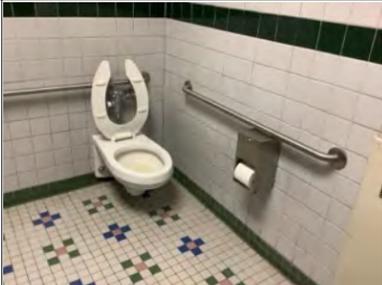
84	Boys' Toilet Room	2		Toilet Compartment	Accessible Compartment

Non-compliant toilet paper dispenser	-	Relocate toilet paper so that it is 24" min high, located under the grab bar, and between 7" and 9" from the front of the toilet. Ensure that there is 1.5" min. clear between the bottom of the grab bar and the top of the toilet paper dispenser.	1

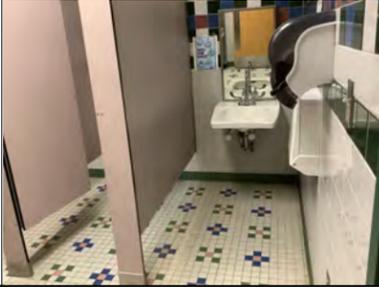
ID	Location	Floor	Room	Element	Type	Photo	Issues	Current Measure	Recommendations	Quantity	Notes
Dispensers											
85	Girls' Toilet Room	1		Dispensers	Paper Towel Dispenser

Dispenser acts as a protruding object	8"	Relocate paper towel dispenser out of the circulation path. In addition to being a protruding object, the paper towel dispenser narrows the route to less than 27.4" wide.	1	
86	Boys' Toilet Room	1		Dispensers	Paper Towel Dispenser

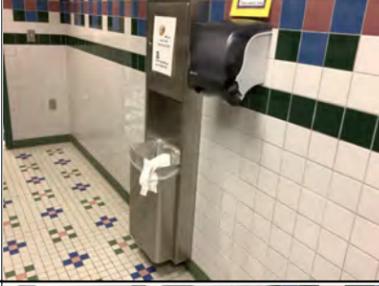
Dispenser acts as a protruding object	9"	Relocate paper towel dispenser out of the circulation path.	1	
88	Boys' Toilet Room	2		Dispensers	Paper Towel Dispenser

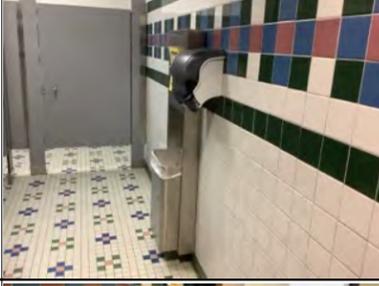
Dispenser acts as a protruding object	9"	Relocate paper towel dispenser out of the circulation path.	1

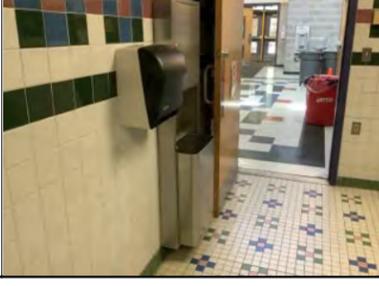
89	Boys' Toilet Room by the Gym	LL		Dispensers	Paper Towel Dispenser

Dispenser acts as a protruding object	8.7"	Relocate paper towel dispenser out of the circulation path.	1

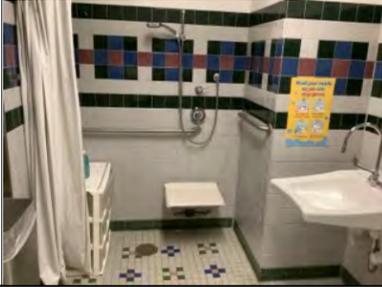
ID	Location	Floor	Room	Element	Type	Photo	Issues	Current Measure	Recommendations	Quantity	Notes
Shower Compartment											
90	Health Room/Nurse - Single-User Toilet Room	1	119	Shower Compartment	Roll-In Type

Grab bars mounted in wrong location		Remove the grab bar from behind the shower seat. Ensure that the shower is kept clear of furniture.	1	
Toilet Rooms for Children											
Single-User Toilet (Children)											
91	RISE/Special Education, Single-User Toilet Room	1	111	Single-User Toilet (Children)	N/A

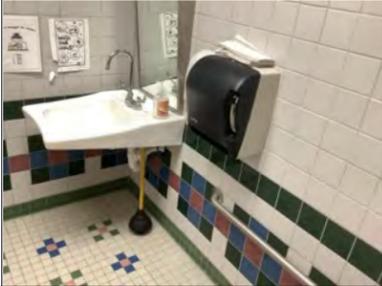
Dispenser mounted over grab bar	-	Relocate the paper towel dispenser so that it is not mounted above the grab bar. Per 521 CMR MAAB, nothing can be mounted over the grab bar.	1	
92	Kindergarten Classroom, Single-User Toilet Room	1	123	Single-User Toilet (Children)	N/A

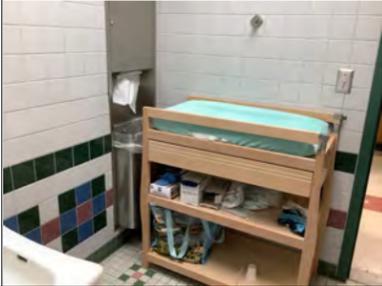
Coat hook not within reach range	54.4"	Lower hook so that it is no higher than 40" above the floor.	1

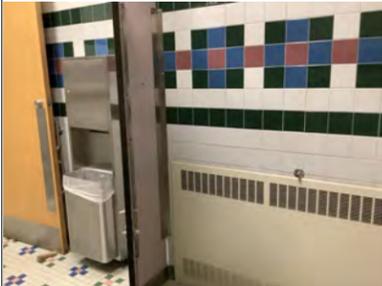
Toilet Compartment (Children)											
93	Girls' Toilet Room	1		Toilet Compartment (Children)	Accessible Compartment

Door with malfunctioning self-closing hinge	-	Repair self-closing hinge.	1

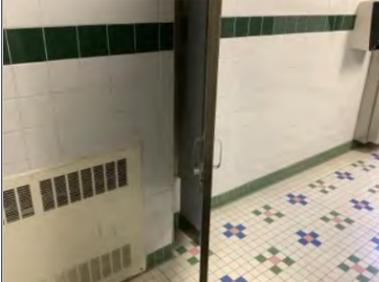
ID	Location	Floor	Room	Element	Type	Photo	Issues	Current Measure	Recommendations	Quantity	Notes
94	Boys' Toilet Room by the Gym	LL		Toilet Compartment (Children)	Accessible Compartment

Door with malfunctioning self-closing hinge	-	Repair self-closing hinge.	1	
95	Boys' Toilet Room	1		Toilet Compartment (Children)	Accessible Compartment

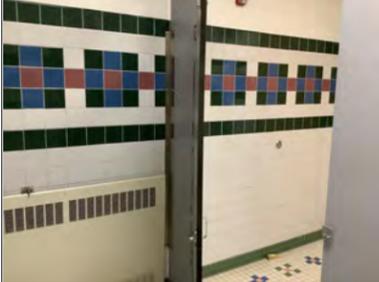
Door with malfunctioning self-closing hinge Door pull not provided	- -	Repair self-closing hinge. Provide a door pull on each side of the door between 34" to 48" above the finished floor that does not require tight grasping, pinching or twisting of the wrist.	1	
96	Boys' Toilet Room by the Gym	LL		Toilet Compartment (Children)	Accessible Compartment

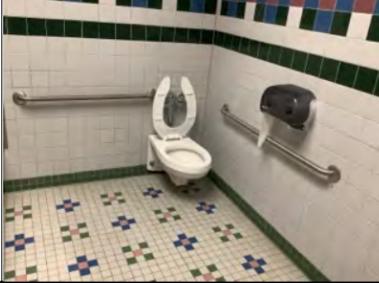
Non-compliant toilet paper dispenser	-	Relocate toilet paper dispenser so that it is between 14"- 19" above the finished floor and between 7"- 9" in front of the toilet. Ensure that no dispensers are mounted over grab bars.	1

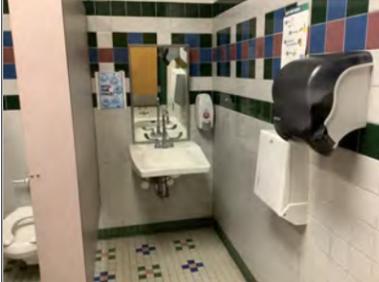
Lavatory (Children)											
97	Girls' Toilet Room	1		Lavatory (Children)	N/A

Exposed plumbing underneath	-	Insulate or otherwise configure pipes to prevent contact at the lavatory.	1	
98	Motor Room/ Occupational Therapy/ Physical Therapy Single-User Toilet	1	110	Lavatory (Children)	N/A

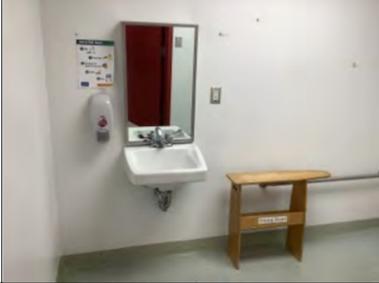
Exposed plumbing underneath Mirror above lavatory w/reflective surface > 31"	- 33.9"	Insulate or otherwise configure pipes to prevent contact at lavatory. Lower mirror so that the bottom surface is at 31" above the finished floor or provide a full length mirror in the room.	1

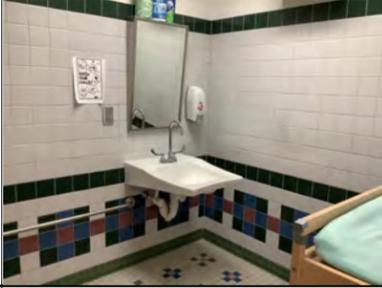
ID	Location	Floor	Room	Element	Type	Photo	Issues	Current Measure	Recommendations	Quantity	Notes
99	Kindergarten Classroom, Single-User Toilet Room	1	123	Lavatory (Children)	N/A

Mirror above lavatory w/reflective surface > 31"	40"	Lower mirror so that the bottom surface is at 31" above the finished floor.	1	
100	Boys' Toilet Room by the Gym	LL		Lavatory (Children)	N/A

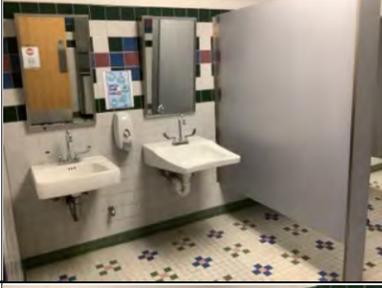
Mirror above lavatory w/reflective surface > 31"	40"	Lower mirror so that the bottom surface is at 31" above the finished floor.	1	
101	Girls' Toilet Room by the Gym	LL		Lavatory (Children)	N/A

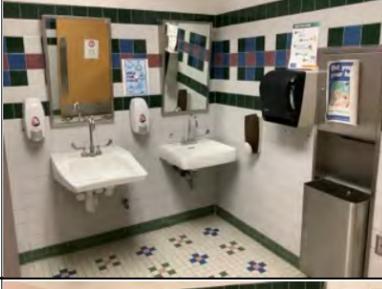
Mirror above lavatory w/reflective surface > 31"	39.5"	Lower mirror so that the bottom surface is at 31" above the finished floor.	1	
102	Girls' Toilet Room by Classroom 009	LL		Lavatory (Children)	N/A

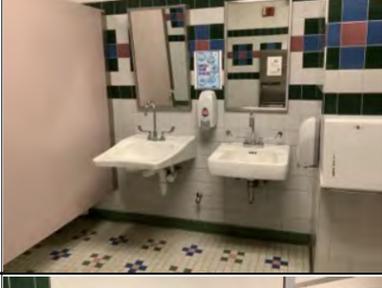
Mirror above lavatory w/reflective surface > 31"	41"	Lower mirror so that the bottom surface is at 31" above the finished floor.	1

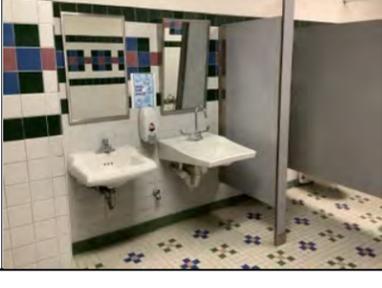
103	Boys' Toilet Room by Classroom 009	LL		Lavatory (Children)	N/A

Mirror above lavatory w/reflective surface > 31"	40.7"	Lower mirror so that the bottom surface is at 31" above the finished floor.	1

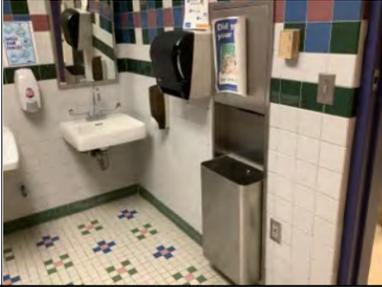
ID	Location	Floor	Room	Element	Type	Photo	Issues	Current Measure	Recommendations	Quantity	Notes
Dispensers (Children)											
104	Girls' Toilet Room by the Gym	LL		Dispensers (Children)	Paper Towel Dispenser

Dispenser is a protruding object	8.4"	Relocate paper towel dispenser out of the circulation path.	1	
105	Girls' Toilet Room by Classroom 009	LL		Dispensers (Children)	Paper Towel Dispenser

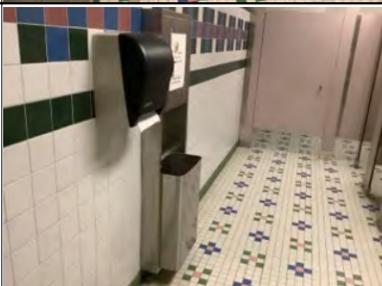
Dispenser is a protruding object	8.5"	Relocate paper towel dispenser out of the circulation path.	1	
107	Boys' Toilet Room by Classroom 009	LL		Dispensers (Children)	Paper Towel Dispenser

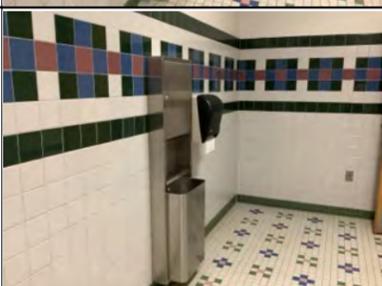
Dispenser is a protruding object	9"	Relocate the paper towel dispenser out of the circulation path.	1	
Additional Access

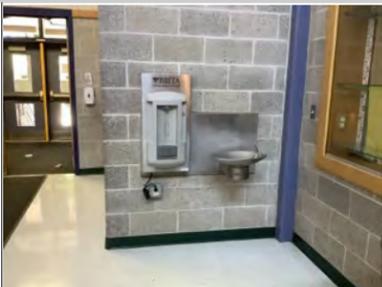
Drinking Fountains											
108	By Egress Door 8	LL		Drinking Fountains	Low

No drinking fountain provided for standing users	-	Provide an additional drinking fountain for standing users.	1

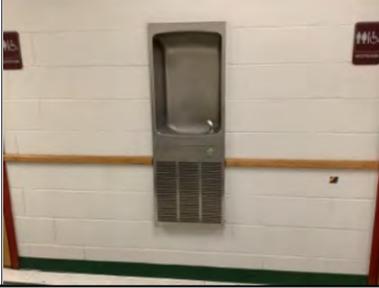
ID	Location	Floor	Room	Element	Type	Photo	Issues	Current Measure	Recommendations	Quantity	Notes
109	Corridor by Guidance Office	1		Drinking Fountains	High

No drinking fountain provided for seated users	-	Provide an additional drinking fountain for seated users.	1	
Sink											
110	Motor Room/ Occupational Therapy/ Physical Therapy	1	110	Sink	Other

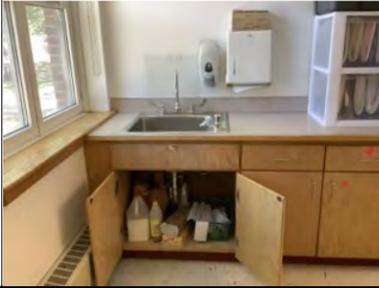
Toe and knee clearances not provided Exposed plumbing underneath sink	- -	Ensure there is a 27" min. knee clearance positioned for a forward approach. Insulate or otherwise configure pipes at sink.	1	
111	Health Room/Nurse	1	119	Sink	Other

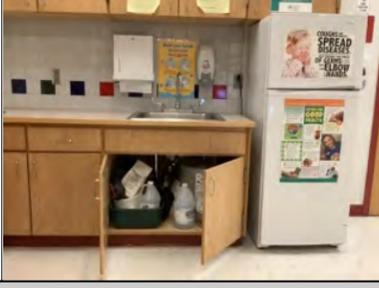
Toe and knee clearances not provided Exposed plumbing underneath sink	- -	Ensure there is a 27" min. knee clearance positioned for a forward approach. Insulate or otherwise configure pipes at sink.	1	
Sinks for Children's Use											
112	Spanish Language Classroom	1	130	Sinks for Children's Use	Classroom

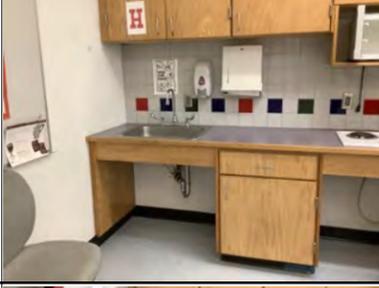
Exposed plumbing underneath	-	Insulate or otherwise configure pipes to prevent contact at the sink.	1

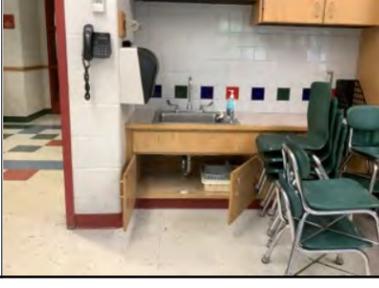
113	RISE/Special Education Classroom	1	111	Sinks for Children's Use	Classroom

Exposed plumbing underneath Knee/toe clearance <24" at sink 31" high	- -	Insulate or otherwise configure pipes to prevent contact. Provide at least one sink with 27" high knee and toe clearance positioned for a forward approach (per 521 CMR 12.2.2.c).	1

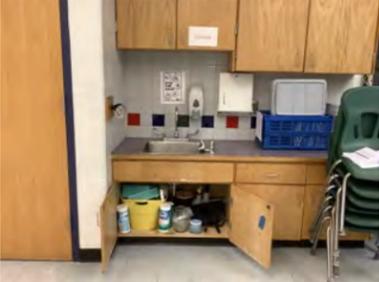
ID	Location	Floor	Room	Element	Type	Photo	Issues	Current Measure	Recommendations	Quantity	Notes
114	Fourth Grade Classroom	1	131	Sinks for Children's Use	Classroom

Exposed plumbing underneath Knee/toe clearance <24" at sink 31" high	- -	Insulate or otherwise configure pipes to prevent contact. Provide at least one sink with 27" high knee and toe clearance positioned for a forward approach (per 521 CMR 12.2.2.c).	1	
115	Grade 2 Classroom	2	201	Sinks for Children's Use	Classroom

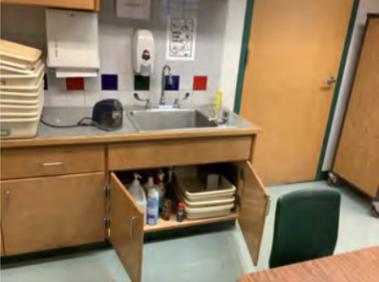
Exposed plumbing underneath Knee/toe clearance <24" at sink 31" high	- 23"	Insulate or otherwise configure pipes to prevent contact. Provide at least one sink with 27" high knee and toe clearance positioned for a forward approach (per 521 CMR 12.2.2.c).	1	
116	Grade 4 Classroom	2	206	Sinks for Children's Use	Classroom

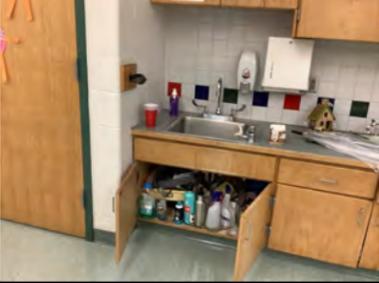
Exposed plumbing underneath Knee/toe clearance <24" at sink 31" high	- 23"	Insulate or otherwise configure pipes to prevent contact. Provide at least one sink with 27" high knee and toe clearance positioned for a forward approach (per 521 CMR 12.2.2.c).	1

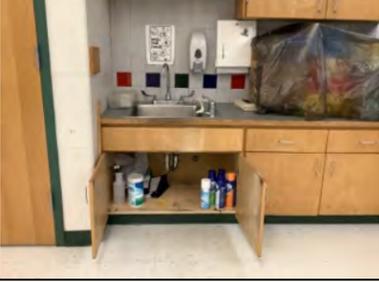
117	First Grade Classroom	LL	010	Sinks for Children's Use	Classroom

Exposed plumbing underneath Knee/toe clearance <24" at sink 31" high	- -	Insulate or otherwise configure pipes to prevent contact. Provide at least one sink with 27" high knee and toe clearance positioned for a forward approach (per 521 CMR 12.2.2.c).	1	
118	Music Room	LL	016	Sinks for Children's Use	Classroom

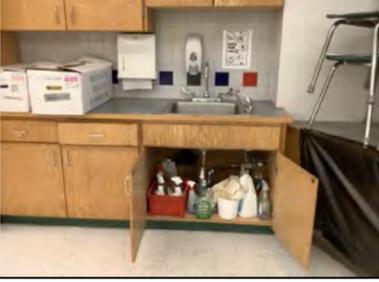
Exposed plumbing underneath Knee/toe clearance <24" at sink 31" high	- -	Insulate or otherwise configure pipes to prevent contact. Provide at least one sink with 27" high knee and toe clearance positioned for a forward approach (per 521 CMR 12.2.2.c).	1

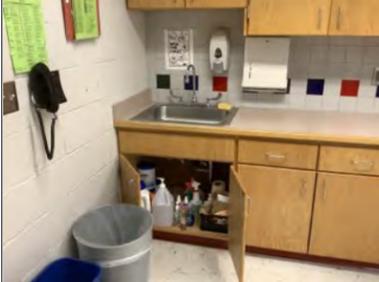
ID	Location	Floor	Room	Element	Type	Photo	Issues	Current Measure	Recommendations	Quantity	Notes
119	Math Specialist	1	109	Sinks for Children's Use	Classroom

Exposed plumbing underneath Knee/toe clearance <27" at sink > 31" high	- -	Insulate or otherwise configure pipes to prevent contact. Provide at least one sink with 27" high knee and toe clearance positioned for a forward approach (per 521 CMR 12.2.2.c).	1	
120	Reading Room	1	109	Sinks for Children's Use	Other

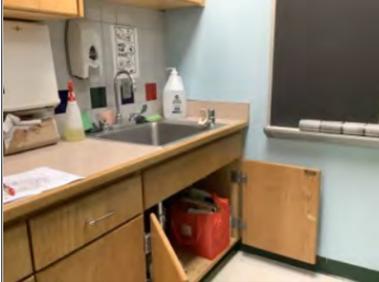
Exposed plumbing underneath Knee/toe clearance <27" at sink > 31" high	- -	Insulate or otherwise configure pipes to prevent contact. Provide at least one sink with 27" high knee and toe clearance positioned for a forward approach (per 521 CMR 12.2.2.c).	1	
121	Art Room	1	135	Sinks for Children's Use	Classroom

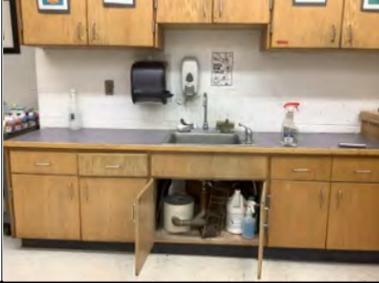
Exposed plumbing underneath Knee/toe clearance <27" at sink > 31" high	- -	Insulate or otherwise configure pipes to prevent contact. Provide at least one sink with 27" high knee and toe clearance positioned for a forward approach (per 521 CMR 12.2.2.c).	1

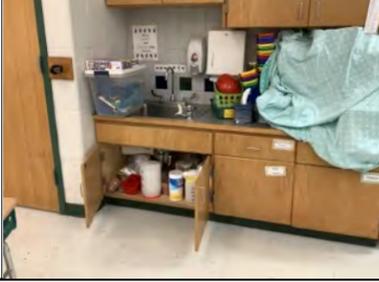
122	Third Grade Classroom	LL	006	Sinks for Children's Use	Classroom

Exposed plumbing underneath Knee/toe clearance <27" at sink > 31" high	- -	Insulate or otherwise configure pipes to prevent contact. Provide at least one sink with 27" high knee and toe clearance positioned for a forward approach (per 521 CMR 12.2.2.c).	1	
Play and Sport Areas											
Play Areas											
123	Playground to Basketball Court	Ext.		Play Areas	N/A

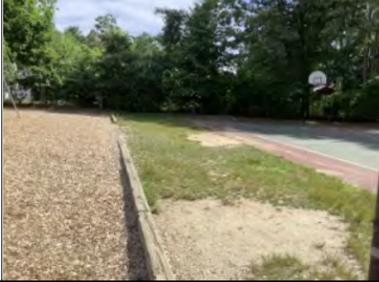
Accessible route not provided around playground	-	Provide an accessible route around the play area.	1

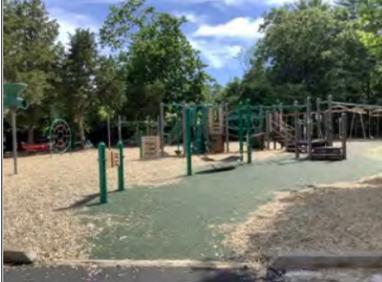
ID	Location	Floor	Room	Element	Type	Photo	Issues	Current Measure	Recommendations	Quantity	Notes
124	Playground	Ext.		Play Areas	N/A

Accessible route not provided to play components Surface not stable, firm, and slip-resistant	- -	Provide a compliant impact-attenuating surface to and around one of each type of play component. Repair surface and ensure that surface is firm, stable and slip-resistant. Ensure that engineered wood fiber (EWF) is kept off of accessible routes.	1	
125	Playground	Ext.		Play Areas	N/A

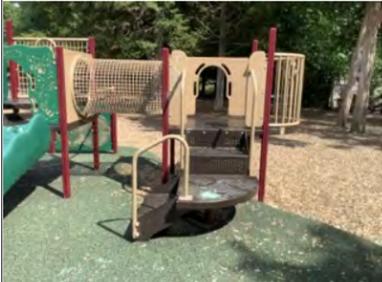
No compliant transfer system	-	Alteration might be technically infeasible.	1	
126	Playground	Ext.		Play Areas	N/A

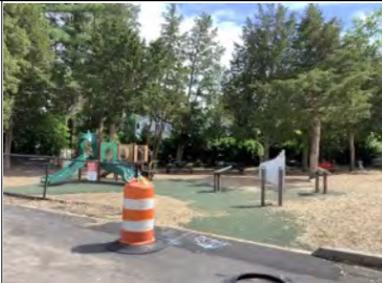
Surface not stable, firm, and slip-resistant	-	Repair surface and ensure that surface is firm, stable and slip-resistant. Ensure that engineered wood fiber (EWF) is kept off of accessible routes.	1	
Field											
127	Soccer Field by the Playground	Ext.		Field	Soccer

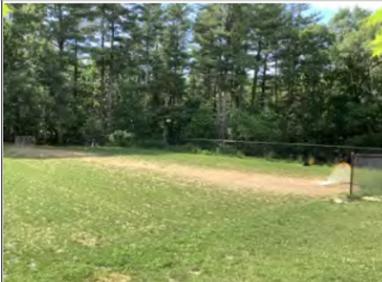
Field not connected to an accessible route		Provide an accessible route to the soccer field.	1

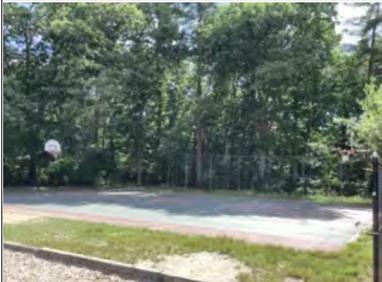
Court											
128	Basketball Court	Ext.		Court	Basketball

Court is not connected to an accessible route	-	Provide an accessible route to the basketball court.	1	
Overall Review

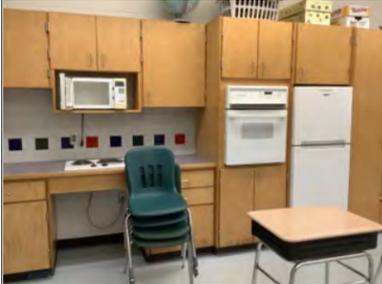
ID	Location	Floor	Room	Element	Type	Photo	Issues	Current Measure	Recommendations	Quantity	Notes
129	Spanish Language Classroom	1	130

Note: The kitchen in Spanish language classroom is no longer in use.	1	
Best Practice											
130	Stair 2	1
