Central Fire Station

Town of Hingham ADA Transition Plan

October 2023

Institute for Human Centered Design

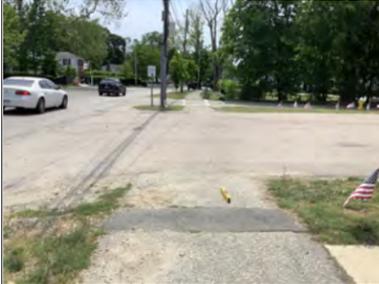
ID	Location	Floor	Room	Element	Type	Photo	Issues	Current Measure	Recommendations	Quantity	Notes
Approach and Entrance											
Exterior Access Route											
1	Main Street Sidewalk - Route to Parking	Ext.		Exterior Access Route	Walkway

Cross slope > 1:50 (2.00%)	3.5%	Reduce cross slope to be no steeper than 1:50 (2.00%).	1	
2	Main Street Sidewalk - Route to Parking	Ext.		Exterior Access Route	Walkway

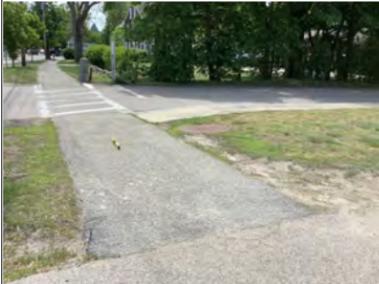
Cross slope > 1:50 (2.00%)	3%	Reduce cross slope to be no steeper than 1:50 (2.00%).	1	
3	Sidewalk - Route to Parking	Ext.		Exterior Access Route	Walkway

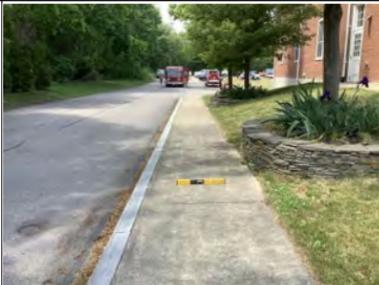
Cross slope > 1:50 (2.00%)	2.5%	Reduce cross slope to be no steeper than 1:50 (2.00%).	1	
4	Sidewalk - Route to Parking	Ext.		Exterior Access Route	Walkway

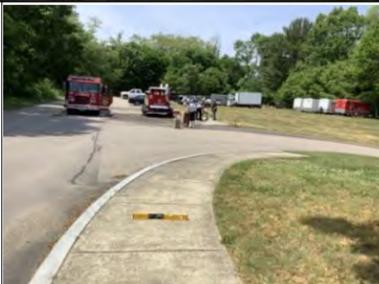
Cross slope > 1:50 (2.00%)	2.7%	Reduce cross slope to be no steeper than 1:50 (2.00%).	1	
5	Sidewalk - Route to Main Entrance	Ext.		Exterior Access Route	Walkway

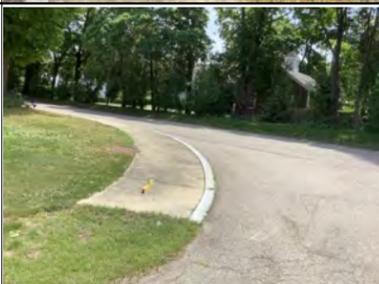
Cross slope > 1:50 (2.00%)	3%	Reduce cross slope to be no steeper than 1:50 (2.00%).	1

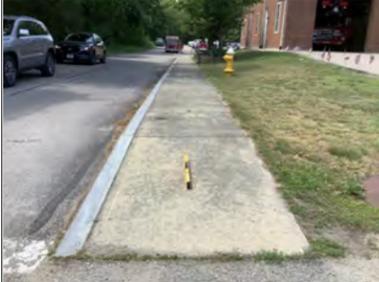
ID	Location	Floor	Room	Element	Type	Photo	Issues	Current Measure	Recommendations	Quantity	Notes
6	Sidewalk - Route to Parking	Ext.		Exterior Access Route	Walkway

Cross slope > 1:50 (2.00%) Running slope > 1:20 (5.00%)	3,4% 5.7%	Reduce cross slope to be no steeper than 1:50 (2.00%). Reduce running slope to be no steeper than 1:20 (5.00%).	1	
7	Sidewalk - Main Street Route to Parking	Ext.		Exterior Access Route	Walkway

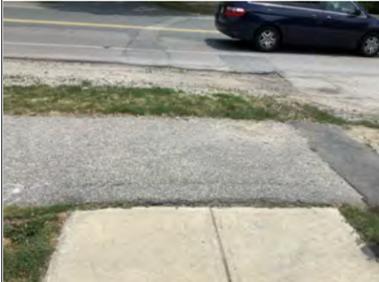
Route not maintained in operable working condition	-	Ensure the accessible route is maintained in operable working condition. Repair route at transition between materials.	1	
Curb Ramp											
8	Sidewalk - Route to Main Entrance	Ext.		Curb Ramp	N/A

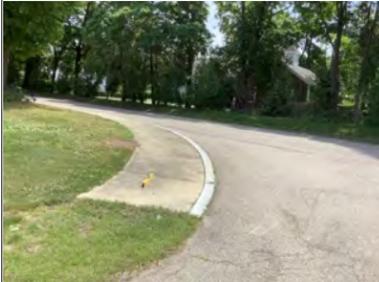
Accessibility issues include lack of a curb ramp at the route to the parking area on the rear side of the building.

Curb ramp not provided	-	Provide a curb ramp.	1	
Off-Street Parking Lot or Garage											
9	Parking Lot	Ext.		Off-Street Parking Lot or Garage	Visitor

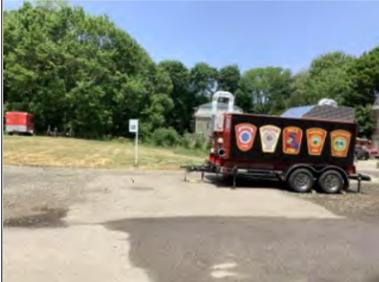
The van accessible parking space in the rear parking area lacks a sign with the designation "Van Accessible".

Total # of parking Total # of designated accessible parking spaces Sign does not have the designation "Van Accessible"	12 1 -	Add the designation "Van Accessible" to the sign located at the van accessible space. Ensure that nothing is stored in the parking space.	1

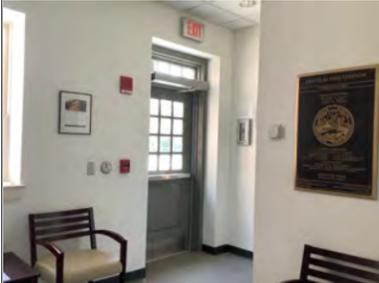
Emergency Exit											
10	Main Entrance	1		Emergency Exit	N/A

Tactile sign not provided at exit Illuminated Int. Symbol of Acc. not provided (MAAB 2006)	- -	Provide tactile exit signs with raised characters and braille at exit doors. Mount signs between 48"- 60" above the finished floor located on the latch side of the door. Provide an illuminated sign with the International Symbol of Accessibility (ISA).	1

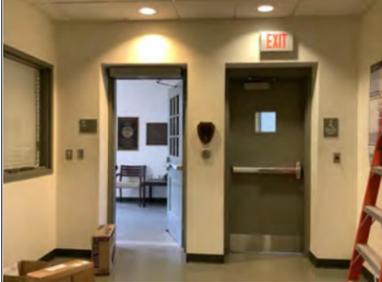
ID	Location	Floor	Room	Element	Type	Photo	Issues	Current Measure	Recommendations	Quantity	Notes
Access to Goods and Services											
Means of Egress											
11	Route to South Corridor	1		Means of Egress	N/A

Tactile exit sign not provided Directional sign to accessible emergency exit not provided	- -	Ensure tactile exit signs with raised characters and braille are provided at exit doors. Mount signs between 48" - 60" above the finished floor located on the latch side of the door. Provide a directional sign indicating the location of the nearest accessible emergency exit.	1	
Interior Access Route											
12	Administration	1	117	Interior Access Route	N/A

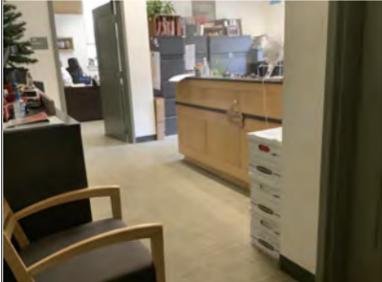
Route < 36" wide	34.1"	Ensure that a clear width of 36" min. is maintained at the accessible route. Remove or relocate the chair.	1	
13	Administration	1	117	Interior Access Route	N/A

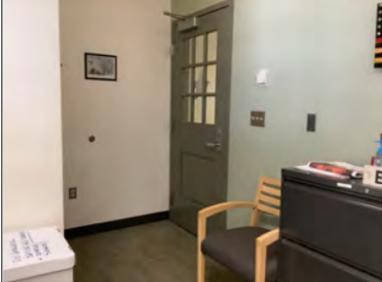
Route < 36" wide	32"	Ensure that a clear width of 36" min. is maintained at the accessible route. Remove or relocate the chair.	1

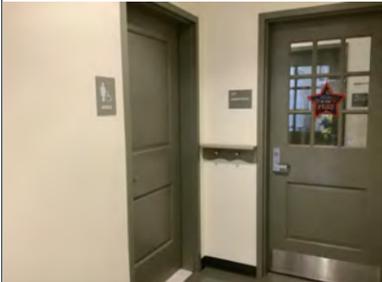
Doors, Doorways, & Gates											
14	Women's Toilet Room	1		Doors, Doorways, & Gates	Toilet Room

Door requires > 5 lbs. of force to open	8 lbs	Adjust closers so doors do not require more than 5 pounds of force to open.	1

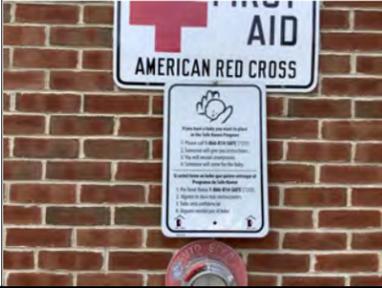
Text size non-compliant on sign	-	Ensure that character size on the sign complies with the Character Height Table 703.5.5 in the 2010 ADA Standards.	1	
Operable Parts											
17	To Administration	1		Operable Parts	Other

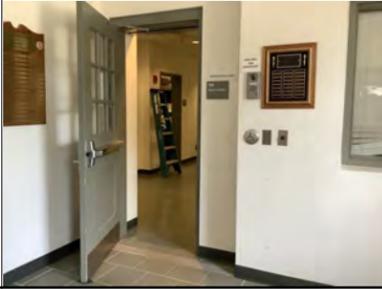
Reach < 15" or > 48"(forward/side approach)	58"	Relocate the bell so that controls are between 15"- 48" above the finished floor.	1	
Toilet & Bathing Rooms											
Lavatory											
18	Women's Toilet Room	1		Lavatory	N/A

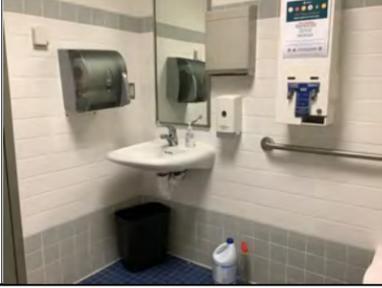
Clear floor space not provided at lavatory Toe or knee clearances not provided	- -	Provide at least one lavatory with a 30" min. by 48" min. clear floor space positioned for a forward approach. Provide at least one lavatory with knee and toe clearance positioned for a forward approach. Relocate trash and other items from underneath the lavatory.	1

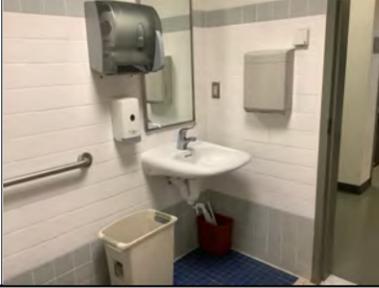
ID	Location	Floor	Room	Element	Type	Photo	Issues	Current Measure	Recommendations	Quantity	Notes
19	Men's Toilet Room	1		Lavatory	N/A

Clear floor space not provided at lavatory Toe or knee clearances not provided Dispensers not within reach range	- - 54.8"	Provide at least one lavatory with a 30" min. by 48" min. clear floor space positioned for a forward approach. Relocate trash bins and other items stored under the lavatory. Lower the paper towel dispensers controls to 48" max. above the finished floor.	1	
Single-User Toilet											
20	Women's Toilet Room	1		Single-User Toilet	N/A

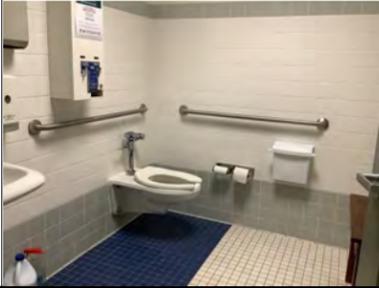
Dispenser located over grab bar	47"	Relocate the sanitary napkin dispenser under the grab bar or outside of the toilet clear space.	1	
21	Women's Toilet Room	1		Single-User Toilet	N/A

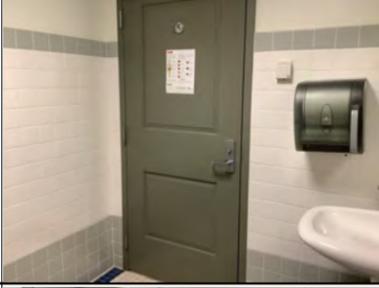
Hook located > 54" high	71.1"	Locate the coat hook no higher than 48" above the finished floor.	1	
22	Men's Toilet Room	1		Single-User Toilet	N/A

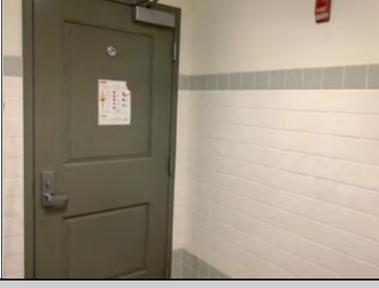
Hook located > 54" high	72.7"	Locate the coat hook no higher than 48" above the finished floor.	1

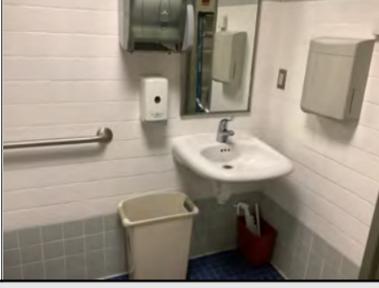
Dispensers											
23	Men's Toilet Room	1		Dispensers	Paper Towel Dispenser

Controls > 48" high	54.8" -	Relocate the paper towel dispenser so the operable part is 48" max. above the finished floor.	1	
Best Practice

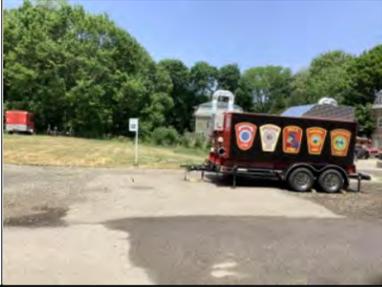
ID	Location	Floor	Room	Element	Type	Photo	Issues	Current Measure	Recommendations	Quantity	Notes
24	Parking	Ext.

-	Recommend providing an accessible parking space closer to the entrance door.	1	
25	Main Entrance	Ext.

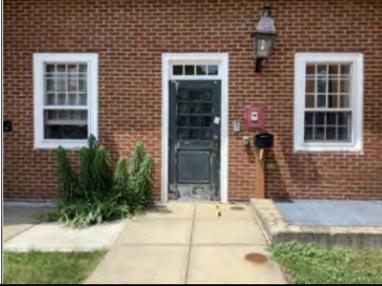
Recommend providing an automatic door opener at the entrance on Main Street as the public often has difficulty opening this door and needs to be assisted by Central Fire Department staff. The automatic door opener should have clear floor space and be located outside of the swing of the door. Recommend locating it on a post or other structure.	1

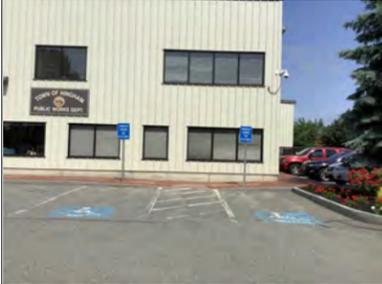
ID	Location	Floor	Room	Element	Type	Photo	Issues	Current Measure	Recommendations	Quantity	Notes
Approach and Entrance											
Off-Street Parking Lot or Garage											
1	Parking by Main Entrance, Egress Door	Ext.		Off-Street Parking Lot or Garage	Visitor

Total # of parking Total # of designated accessible parking spaces Total # of designated van accessible spaces Van space < 132" or <96" wide Access aisle < 96" wide at van space Sign does not have the designation "Van Accessible"	8 2 0 106" or 108" 75" -	Provide one (1) compliant van accessible parking space. Provide a van accessible space that is at least 96" wide. Provide a marked access aisle that is at least 96" wide. Add the designation "Van Accessible" to the sign located at the van accessible space.	1	
Access to Goods and Services											
Means of Egress											
2	Main Entrance, Egress Door	1		Means of Egress	N/A

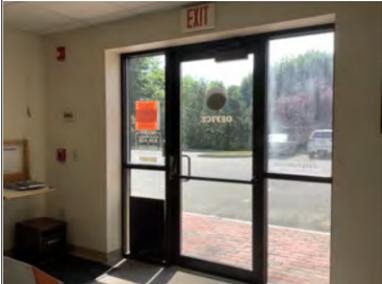
Tactile exit sign not provided Illuminated ISA symbol not provided (MAAB)	- -	Ensure tactile exit signs with raised characters and braille are provided at exit doors. Mount signs between 48"- 60" above the finished floor located on the latch side of the door on the glass. Provide an illuminated sign with the International Symbol of Accessibility (ISA) over the door.	1

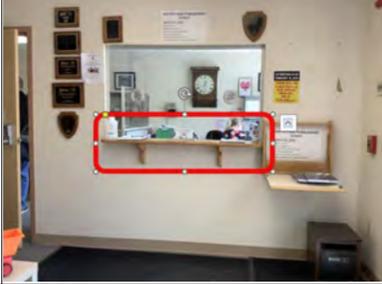
Service Counter											
3	Lobby, Service Counter	1		Service Counter	N/A

Counter > 36" high	41.1"	Provide a counter that is 36" max. above the finished floor. The existing wood counter could be lowered.	1	
Operable Parts											
4	By Elevator	1		Operable Parts	Other

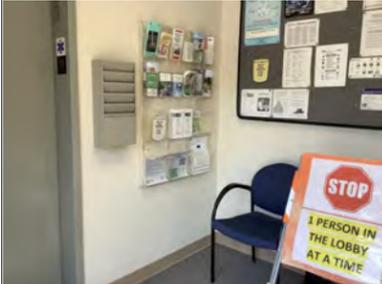
Reach < 15" or > 48"(forward/side approach) Side reach over an obstruction > 34" high	68.9" 36.3"	Relocate flyers so that one of each is located between 15"- 48" above the finished floor. Ensure that flyers are not located over an obstruction that is greater than 34" above the finished floor.	1

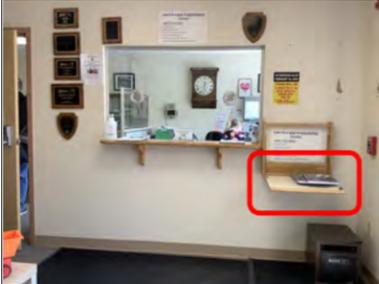
ID	Location	Floor	Room	Element	Type	Photo	Issues	Current Measure	Recommendations	Quantity	Notes
Dining or Work Surfaces											
5	Lobby, Work Surface	1		Dining or Work Surfaces	Work Surface

Knee or toe clearance not provided Work surface acts as a protruding object	- 29.7"	Provide at least one work surface with 27" min. knee and toe clearance. Because the existing work surface can also act as a protruding object, we recommend removing the existing work surface and providing a table.	1

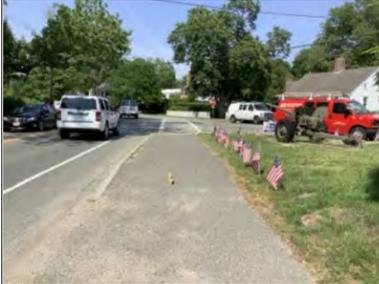
ID	Location	Floor	Room	Element	Type	Photo	Issues	Current Measure	Recommendations	Quantity	Notes
Approach and Entrance											
Exterior Access Route											
1	Main Street at Pond Street	Ext.		Exterior Access Route	Sidewalk

Cross slope > 1:50 (2.00%)	3%	Reduce cross slope to be no steeper than 1:50 (2.00%).	1	
2	Pond Street at Northeast Egress	Ext.		Exterior Access Route	Sidewalk

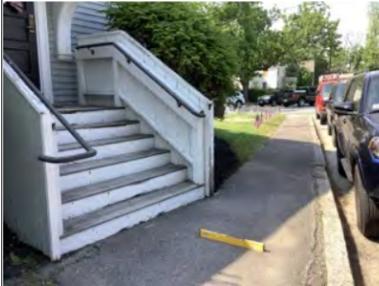
Cross slope > 1:50 (2.00%)	4.3%	Reduce cross slope to be no steeper than 1:50 (2.00%).	1	
3	Main Entrance	Ext.		Exterior Access Route	Walkway

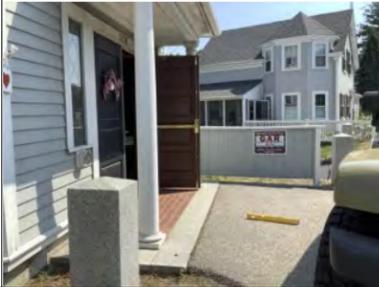
Running slope > 1:20 (5.00%)	7%	Reduce running slope to be no steeper than 1:20 (5.00%).	1	
4	Pond Street Towards Northeast Egress	Ext.		Exterior Access Route	Sidewalk

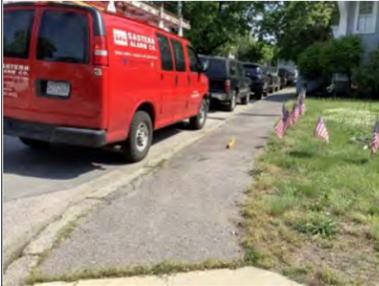
Route not maintained in operable working condition	-	Ensure the accessible route is maintained in operable working condition. Repair deteriorated pavement.	1	
Off-Street Parking Lot or Garage

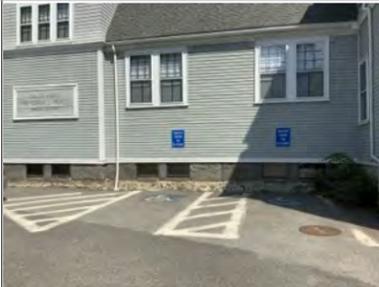
5	Parking Lot	Ext.		Off-Street Parking Lot or Garage	Visitor

Total # of parking Total # of designated accessible parking spaces Total # of designated van accessible spaces Access aisle < 96" wide at van space Sign bottom < 60" above finished grade Sign with ISA not provided	3 1 1 50" 57.7" -	A minimum of one van accessible parking space is required in this lot. Provide a marked access aisle that is at least 96" wide for a 96" wide van accessible parking space. Provide signs that includes the International Symbol of Accessibility (ISA) at the head of the parking space. Locate signs with the bottom of the sign 60" above the ground.	1

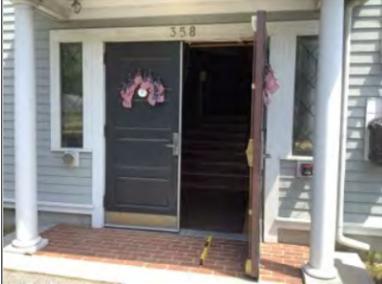
Automatic door opener not operable Clear floor space at opener not provided	- -	Repair or replace the door opener. Relocate automatic door opener to provide 30" x 48" min. clear floor space. Currently, the automatic door opener is located behind a column.	1	
Access to Goods and Services											
Means of Egress											
8	Northeast Egress/From Legion Hall	3		Means of Egress	N/A

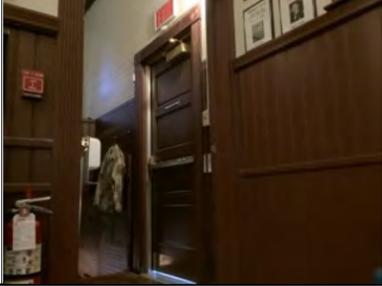
9	Northeast Egress/From Legion Hall	3		Means of Egress	N/A

Tactile exit sign not provided	-	Ensure tactile exit signs with raised characters and braille are provided at exit doors. Mount signs between 48"- 60" above the finished floor located on the latch side of the door.	1

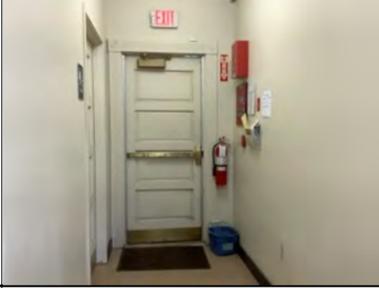
ID	Location	Floor	Room	Element	Type	Photo	Issues	Current Measure	Recommendations	Quantity	Notes
10	South Egress	B		Means of Egress	N/A

Tactile exit sign not provided	-	Ensure tactile exit signs with raised characters and braille are provided at exit doors. Mount signs between 48"- 60" above the finished floor located on the latch side of the door.	1	
11	Main Entrance	2		Means of Egress	N/A

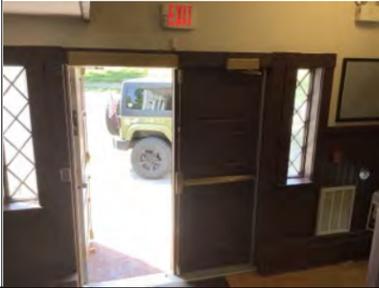
Tactile exit sign not provided Illuminated ISA symbol not provided (MAAB)	- -	Ensure tactile exit signs with raised characters and braille are provided at exit doors. Mount signs between 48"- 60" above the finished floor located on the latch side of the door. Where a tactile sign is provided at double doors with two active leafs, the sign shall be located to the right of the right hand door. Provide an illuminated sign with the International Symbol of Accessibility (ISA).	1	
Interior Access Route

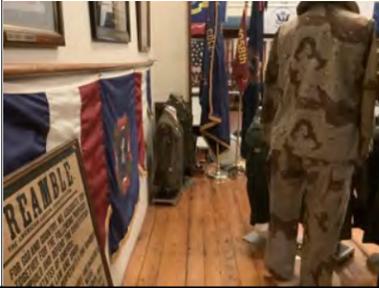
12	Legion Hall Stage	3		Interior Access Route	N/A

Route < 36" wide	31"	Ensure that a clear width of 36" min. is maintained at the accessible route.	1	
13	Legion Hall Stage	3		Interior Access Route	N/A

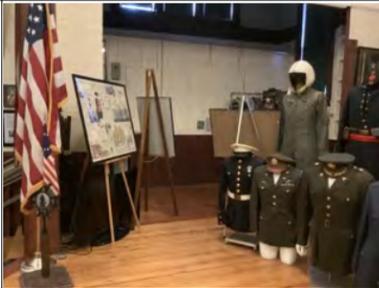
Route < 36" wide	18.6"	Ensure that a clear width of 36" min. is maintained at the accessible route.	1	
14	Route From Toilet Rooms to Elevator	B		Interior Access Route	N/A

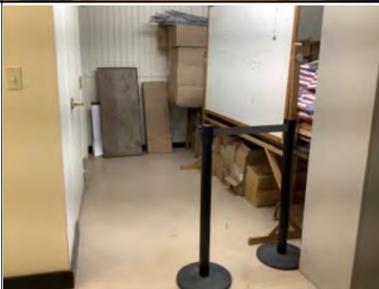
Route < 36" wide	24.5"	Ensure that a clear width of 36" min. is maintained at the accessible route. Relocate stanchions.	1

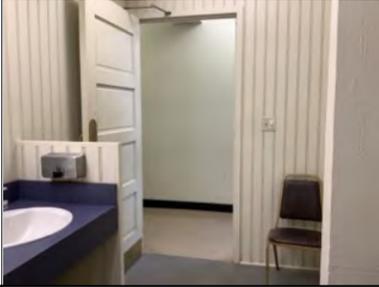
ID	Location	Floor	Room	Element	Type	Photo	Issues	Current Measure	Recommendations	Quantity	Notes
Doors, Doorways, & Gates											
15	Men's Toilet Room	B		Doors, Doorways, & Gates	Toilet Room

Maneuvering clearance(s) not provided	14.6"	Relocate the chair so that there is 18" min. on the latch pull side of the door.	1	
16	Workout to Toilet Rooms	B		Doors, Doorways, & Gates	Toilet Room

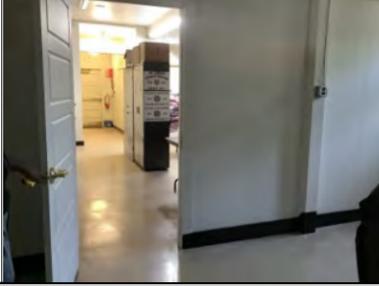
Hardware not operable with a closed fist	-	Provide hardware that can be operable with one hand and not require tight grasping, pinching, or twisting of the wrist.	1	
Stairways											
17	Northeast Egress/From Legion Hall to Basement Workout Area	3		Stairways	Egress

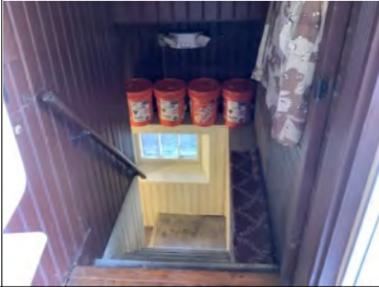
Handrail not provided on both sides Handrails do not extend 12" from stairs	- -	Provide a handrail on each side. Top: Ensure handrails extend horizontally above the landing for 12" min. beginning above the first riser nosing. Bottom: Ensure handrails extend to one tread depth beyond the last riser.	1

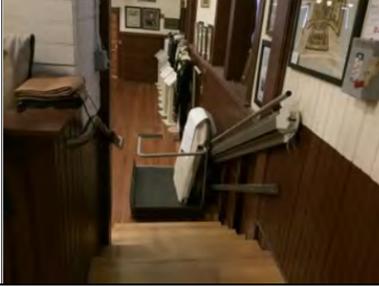
18	Legion Hall Stage Lift	3		Stairways	Other

Handrails do not extend 12" from stairs	-	Top: Ensure handrail (on the right side of the photo extends horizontally above the landing for 12" min. beginning above the first riser nosing.	1	
Platform Lift or LULA Elevator											
19	Legion Hall Stage Lift	3		Platform Lift or LULA Elevator	Interior

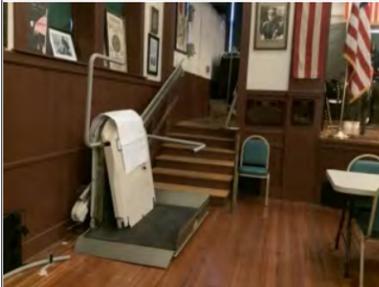
Not in operable working condition	-	Ensure lift is maintained in operable working condition.	1

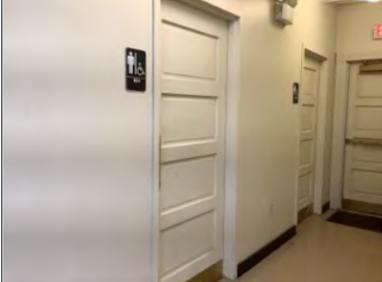
Raised characters < 48" or > 60" above ground	60.9"	Mount signs so that the baseline of the lowest tactile character is 48" min. above finished floor and the baseline of the highest tactile character is 60" max. above the finished floor.	1	
22	Women's Toilet Room	B		Signage	Designation

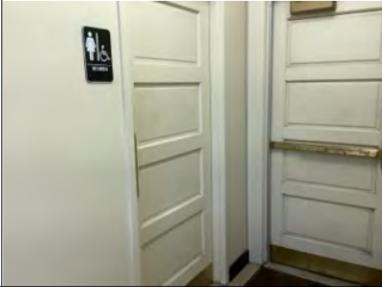
Raised characters < 48" or > 60" above ground	60.9"	Mount signs so that the baseline of the lowest tactile character is 48" min. above finished floor and the baseline of the highest tactile character is 60" max. above the finished floor.	1	
Toilet & Bathing Rooms

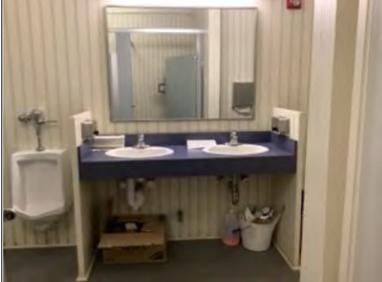
Lavatory											
23	Men's Toilet Room	B		Lavatory	N/A

Toe or knee clearances not provided Mirror above lavatory w/reflective surface > 40"	- 43"	Provide at least one lavatory with knee and toe clearance positioned for a forward approach - remove stored items to provide knee clearance at the lavatory that is shown on the left. Lower mirror so that the bottom surface is at 40" max. above the finished floor.	1

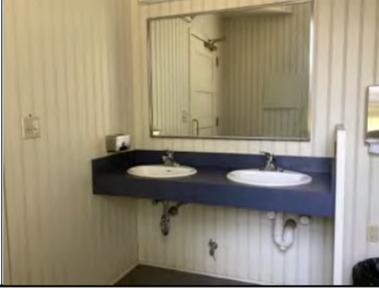
ID	Location	Floor	Room	Element	Type	Photo	Issues	Current Measure	Recommendations	Quantity	Notes
24	Women's Toilet Room	B		Lavatory	N/A

Mirror above lavatory w/reflective surface > 40"	42.8"	Lower mirror so that the bottom surface is at 40" max. above the finished floor.	1	
Toilet Compartment											
25	Men's Toilet Room	B		Toilet Compartment	Accessible Compartment

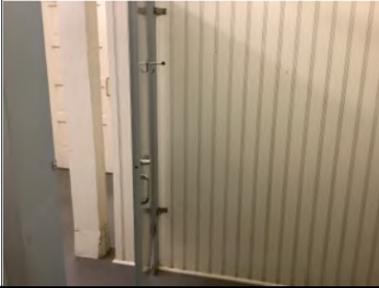
Door has malfunctioning self-closing hinge Door pull not provided	-	Repair the hinge. Provide a door pull on each side of the door between 34" to 48" above the finished floor that does not require tight grasping, pinching or twisting of the wrist.	1	
26	Women's Toilet Room	B		Toilet Compartment	Accessible Compartment

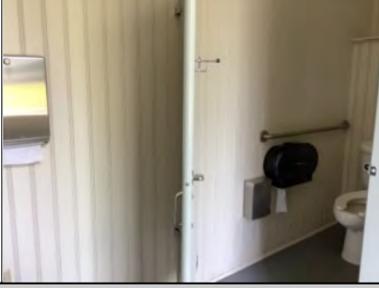
Door pull not provided	-	Provide a door pull on each side of the door between 34" to 48" above the finished floor that does not require tight grasping, pinching or twisting of the wrist.	1	
Dispensers

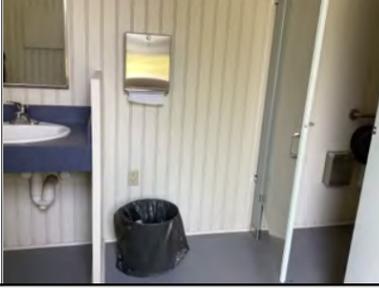
27	Women's Toilet Room	B		Dispensers	Paper Towel Dispenser

Clear floor space not provided at accessory	-	Relocate the trash bin so that there is clear floor space provided at the paper towel dispenser.	1	
Best Practice

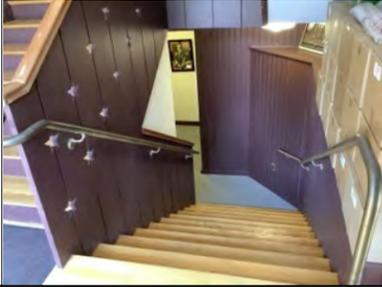
ID	Location	Floor	Room	Element	Type	Photo	Issues	Current Measure	Recommendations	Quantity	Notes
28	Stairs Throughout the Building	2

-	Recommend providing visually contrasting strips on each stair tread.	1	
29	Legion Hall	3

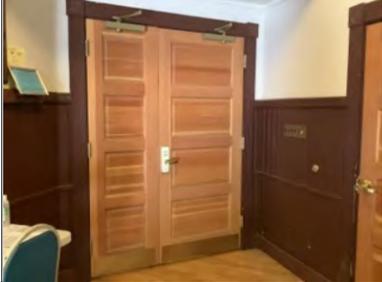
-	Recommend providing designation signs with raised characters and braille at all permanent rooms and spaces where signage is not provided.	1	
30	By Elevator to Toilet Room	B

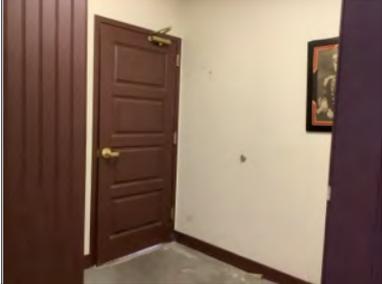
-	Recommend providing directional signage at this point so that people know that toilet rooms are located through this door.	1

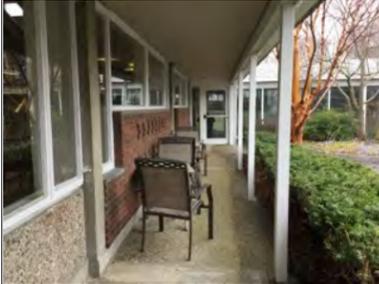
ID	Location	Floor	Room	Element	Type	Photo	Issues	Current Measure	Recommendations	Quantity	Notes
Approach and Entrance											
Exterior Access Route											
1	Courtyard	2		Exterior Access Route	Exterior

Exterior route < 36" wide	29.5"	Ensure that a clear width of 36" min. is maintained at the accessible route. Remove the furniture from the walkway.	1	
2	Leavitt Street	Ext.		Exterior Access Route	Walkway

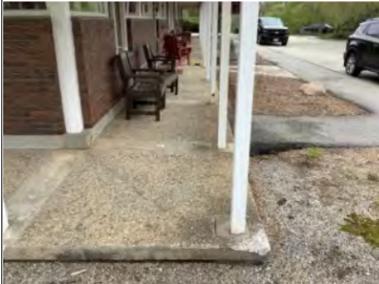
Exterior route < 36" wide	24"	Ensure that a clear width of 36" min. is maintained at the accessible route. (Recommend relocating the first chair and table in this photograph to create an accessible seating space near the walkway access point.)	1	
3	Leavitt Street	Ext.		Exterior Access Route	Walkway

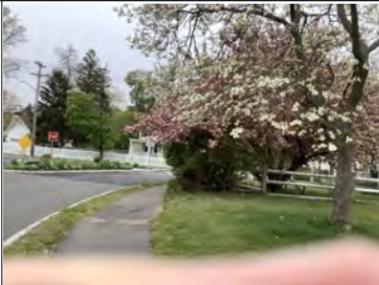
Obstructed by protruding objects	75"	Trim low hanging branches in trees.	1	
4	Courtyard Walkway	2		Exterior Access Route	Exterior

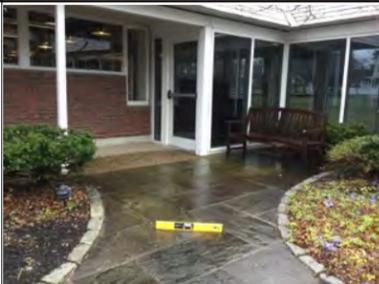
Cross slope > 1:50 (2.00%)	3%	Reduce cross slope to be no steeper than 1:50 (2.00%).	1

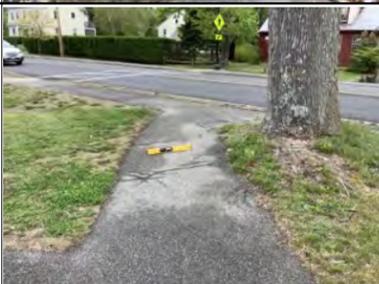
5	West Side of Library at Main Road Near Children's Entrance	Ext.		Exterior Access Route	Walkway

Cross slope > 1:50 (2.00%) Surface is not stable, firm, and slip-resistant	9.7% -	Reduce cross slope to be no steeper than 1:50 (2.00%). Repair surface where it is deteriorated at the tree root.	1

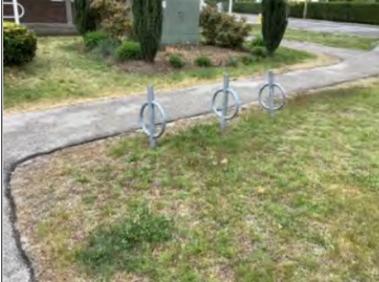
ID	Location	Floor	Room	Element	Type	Photo	Issues	Current Measure	Recommendations	Quantity	Notes
6	Bike Rack by Children's Entrance	Ext.		Exterior Access Route	Walkway

Accessible route not provided	-	Ensure an accessible route is provided to the bike rack.	1	
7	East Side of Library Around the Corner From the Accessible Parking by the Main Entrance	Ext.		Exterior Access Route	Exterior

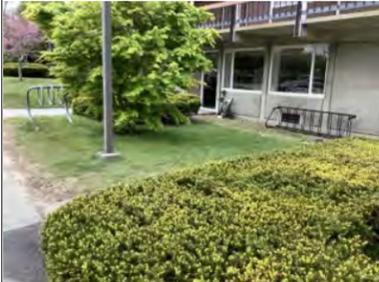
Accessible route not provided	- -	Ensure an accessible route is provided to at least one bike rack in this area, or relocate at least one bike rack to an accessible route.	2	
Curb Ramp											
8	Leavitt Street	Ext.		Curb Ramp	N/A

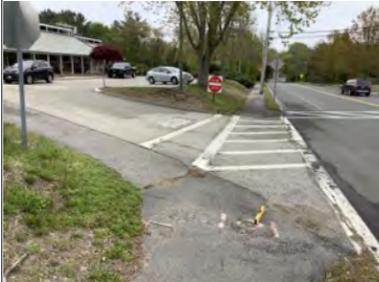
Running slope > 1:12 (8.33%) Transition from curb ramp to street not flush	11.5% -	Reduce running slope to be no steeper than 1:12 (8.33%). Ensure transition from curb ramp to street is flush or free of changes in level.	2	
Off-Street Parking Lot or Garage											
9	Parking by Main Entrance	Ext.		Off-Street Parking Lot or Garage	N/A

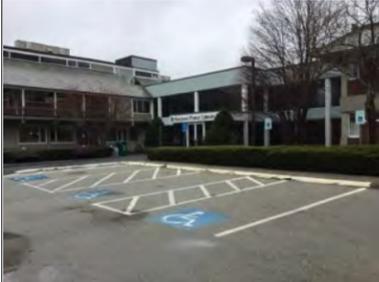
Total # of parking Total # of designated accessible parking spaces Total # of designated van accessible spaces	91 2 1	Provide an additional car accessible parking space.	1

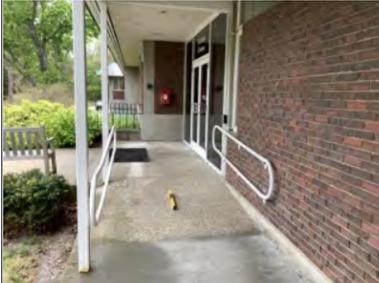
Exterior Ramp											
10	Ramp to Children's Entry Door	Ext.		Exterior Ramp	N/A

Edge protection < 4" high		Provide edge protection that prevents the passage of a 4" diameter sphere, where any portion of the sphere is within 4" of the finished floor or ground surface.	1

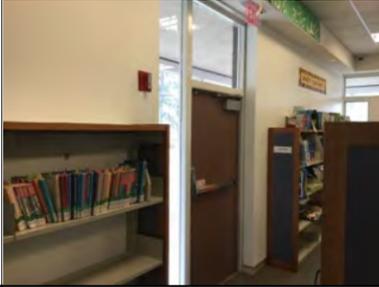
ID	Location	Floor	Room	Element	Type	Photo	Issues	Current Measure	Recommendations	Quantity	Notes
Emergency Exit											
11	Exit Door From the Northwest	2		Emergency Exit	N/A

Tactile sign not provided at exit Directional sign to accessible emergency exit not provided	- -	Provide tactile exit signs with raised characters and braille at exit doors. Mount signs between 48"- 60" above the finished floor located on the latch side of the door. Provide a directional sign indicating the location of the nearest accessible emergency exit.	1	
12	Exit Door on East	2		Emergency Exit	N/A

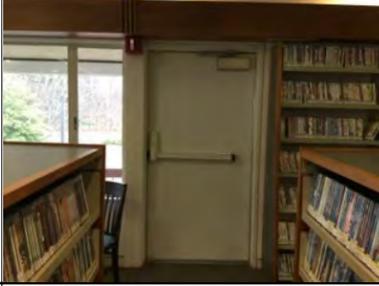
Tactile sign not provided at exit Directional sign to accessible emergency exit not provided	- -	Provide tactile exit signs with raised characters and braille at exit doors. Mount signs between 48"- 60" above the finished floor located on the latch side of the door. Provide a directional sign indicating the location of the nearest accessible emergency exit.	1

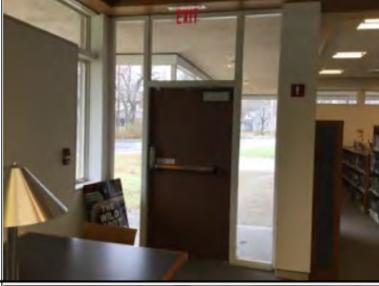
13	Exit Door on the Northwest	2		Emergency Exit	N/A

Tactile sign not provided at exit Directional sign to accessible emergency exit not provided	- -	Provide tactile exit signs with raised characters and braille at exit doors. Mount signs between 48"- 60" above the finished floor located on the latch side of the door. Provide a directional sign indicating the location of the nearest accessible emergency exit.	1	
14	Exit Door on West	2		Emergency Exit	N/A

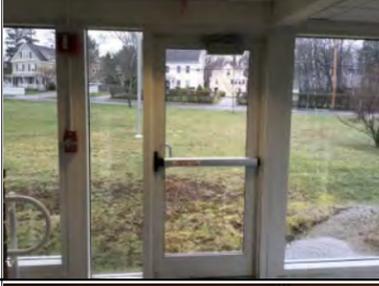
Tactile sign not provided at exit Directional sign to accessible emergency exit not provided	- -	Provide tactile exit signs with raised characters and braille at exit doors. Mount signs between 48"- 60" above the finished floor located on the latch side of the door. Provide a directional sign indicating the location of the nearest accessible emergency exit.	1	
15	Exit Door to Step	2		Emergency Exit	N/A

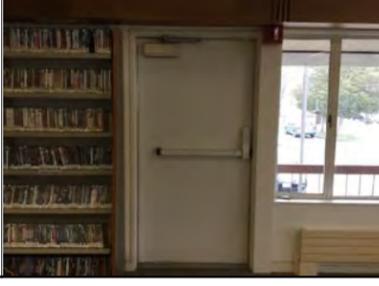
Tactile sign not provided at exit Directional sign to accessible emergency exit not provided	- -	Provide tactile exit signs with raised characters and braille at exit doors. Mount signs between 48"- 60" above the finished floor located on the latch side of the door. Provide a directional sign indicating the location of the nearest accessible emergency exit.	1

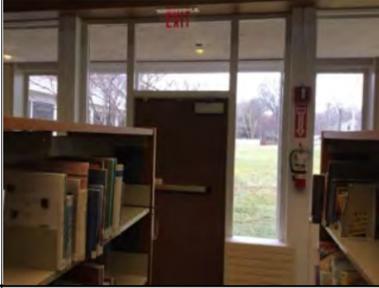
ID	Location	Floor	Room	Element	Type	Photo	Issues	Current Measure	Recommendations	Quantity	Notes
16	Exit Door to Step	2		Emergency Exit	N/A

Tactile sign not provided at exit Directional sign to accessible emergency exit not provided	- -	Provide tactile exit signs with raised characters and braille at exit doors. Mount signs between 48"- 60" above the finished floor located on the latch side of the door. Provide a directional sign indicating the location of the nearest accessible emergency exit.	1	
17	Egress Door on Southeast Near Large Print	1		Emergency Exit	N/A

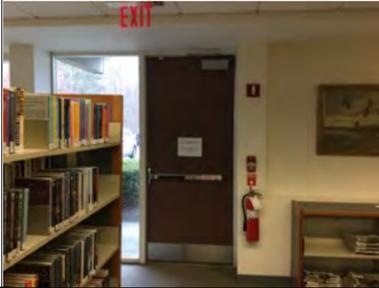
Tactile sign not provided at exit Illuminated Int. Symbol of Acc. not provided (MAAB 2006)	- -	Provide tactile exit signs with raised characters and braille at exit doors. Mount signs between 48"- 60" above the finished floor located on the latch side of the door. Provide an illuminated sign with the International Symbol of Accessibility (ISA).	1

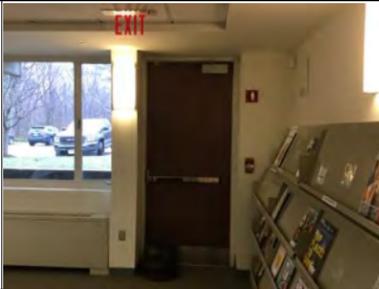
18	Egress Door on Southeast Near Periodicals	1		Emergency Exit	N/A

Tactile sign not provided at exit Illuminated Int. Symbol of Acc. not provided (MAAB 2006)	- -	Provide tactile exit signs with raised characters and braille at exit doors. Mount signs between 48"- 60" above the finished floor located on the latch side of the door. Provide an illuminated sign with the International Symbol of Accessibility (ISA).	1	
19	Entrance	1		Emergency Exit	N/A

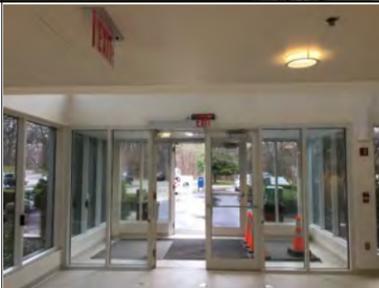
Tactile sign not provided at exit Illuminated Int. Symbol of Acc. not provided (MAAB 2006)	- -	Provide tactile exit signs with raised characters and braille at exit doors. Mount signs between 48"- 60" above the finished floor located on the latch side of the door. Provide an illuminated sign with the International Symbol of Accessibility (ISA).	1	
20	Exit Door at the Lobby	2		Emergency Exit	N/A

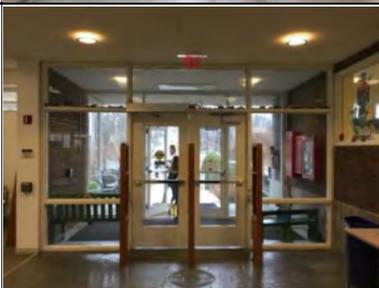
Tactile sign not provided at exit Illuminated Int. Symbol of Acc. not provided (MAAB 2006)	- -	Provide tactile exit signs with raised characters and braille at exit doors. Mount signs between 48"- 60" above the finished floor located on the latch side of the door. Provide an illuminated sign with the International Symbol of Accessibility (ISA).	1

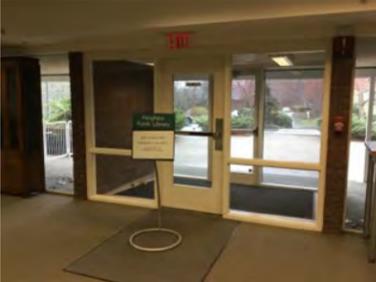
ID	Location	Floor	Room	Element	Type	Photo	Issues	Current Measure	Recommendations	Quantity	Notes
21	Staff Entrance Lobby/Public Egress on South Side	2	127	Emergency Exit	N/A

Tactile sign not provided at exit Illuminated Int. Symbol of Acc. not provided (MAAB 2006)	- -	Provide tactile exit signs with raised characters and braille at exit doors. Mount signs between 48"- 60" above the finished floor located on the latch side of the door. Provide an illuminated sign with the International Symbol of Accessibility (ISA).	1	
22	Exit Door on West	2		Emergency Exit	N/A

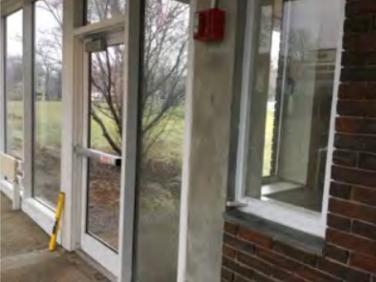
Tactile sign not provided at exit Illuminated Int. Symbol of Acc. not provided (MAAB 2006)	- -	Provide tactile exit signs with raised characters and braille at exit doors. Mount signs between 48"- 60" above the finished floor located on the latch side of the door. Provide an illuminated sign with the International Symbol of Accessibility (ISA).	1

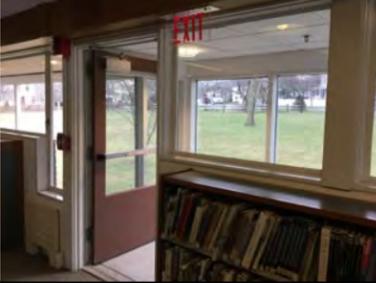
23	Hallway Between North and South Buildings	2		Emergency Exit	N/A

Tactile sign not provided at exit Illuminated Int. Symbol of Acc. not provided (MAAB 2006)	- -	Provide tactile exit signs with raised characters and braille at exit doors. Mount signs between 48"- 60" above the finished floor located on the latch side of the door. Provide an illuminated sign with the International Symbol of Accessibility (ISA).	1	
24	Egress Door South of Main Entrance by Periodicals	1	036	Emergency Exit	N/A

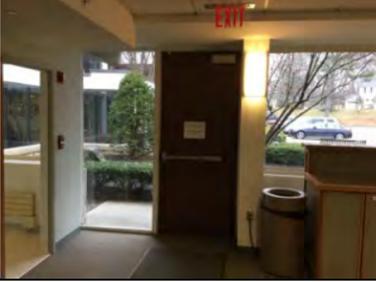
Illuminated Int. Symbol of Acc. not provided (MAAB 2006) Tactile sign not provided at exit	- -	Provide tactile exit signs with raised characters and braille at exit doors. Mount signs between 48"- 60" above the finished floor located on the latch side of the door on the glass. Provide an illuminated sign with the International Symbol of Accessibility (ISA).	1	
25	Exit Door on West	2		Emergency Exit	N/A

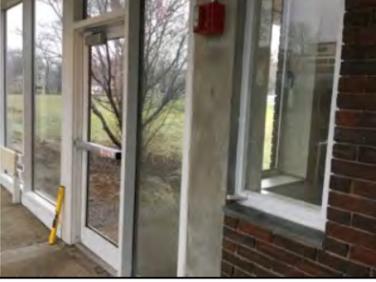
Clear width at door < 32"	31"	Install offset hinges to ensure that the door has a clear width of 32 inches.	1

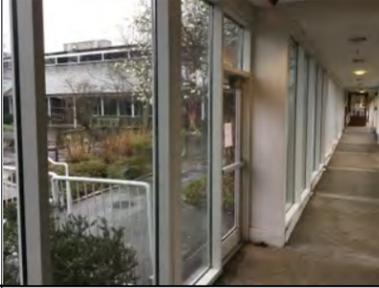
ID	Location	Floor	Room	Element	Type	Photo	Issues	Current Measure	Recommendations	Quantity	Notes
26	Exit Door to Courtyard	2		Emergency Exit	N/A

Clear width at door < 32"	31"	Install offset hinges to ensure that the door has a clear width of 32 inches.	1	
27	Egress Door on Southeast Near Periodicals	1		Emergency Exit	N/A

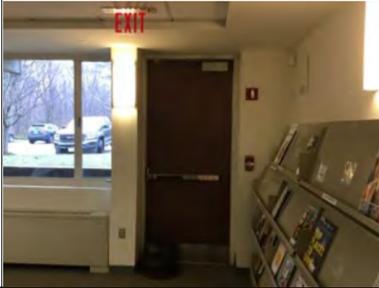
Maneuvering clearance not provided at recess > 6"	14"	The door is recessed greater than 6" from the edge of the interior wall. Install an automatic door opener. Additionally, the door could be rebuilt so that it is not recessed greater than 6" deep.	1	
28	Exit Door on Northeast	1		Emergency Exit	N/A

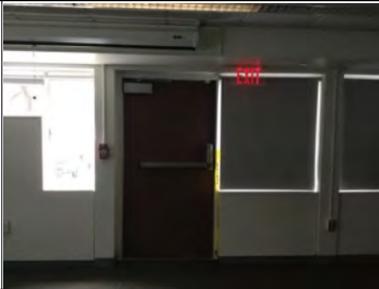
Threshold > 1/2" high	1.25"	Alter the threshold to be 1/2" high max.	1	
29	Exit Door on Northeast	1		Emergency Exit	N/A

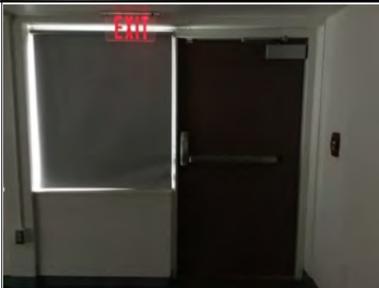
Threshold > 1/2" high	1"	Alter the threshold to be 1/2" high max.	1	
30	Hallway Between North and South Buildings	2		Emergency Exit	N/A

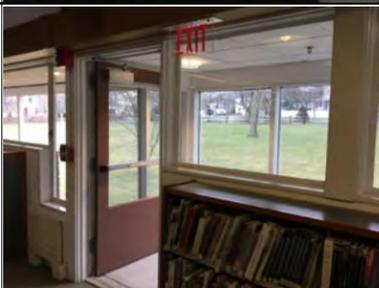
Threshold > 1/2" high	0.75"	Alter the threshold to be 1/2" high max.	1

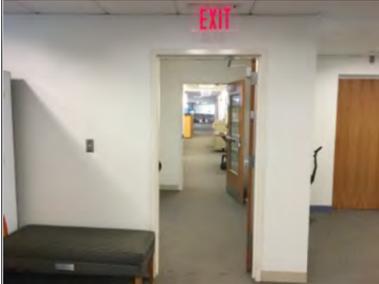
ID	Location	Floor	Room	Element	Type	Photo	Issues	Current Measure	Recommendations	Quantity	Notes
Means of Egress											
31	Staircase by Children's Multi-Media	2		Means of Egress	N/A

Tactile exit sign not provided	-	Ensure tactile exit signs with raised characters and braille are provided at exit doors. Mount signs between 48"- 60" above the finished floor located on the latch side of the door.	1	
32	Exit on Northeast	2		Means of Egress	N/A

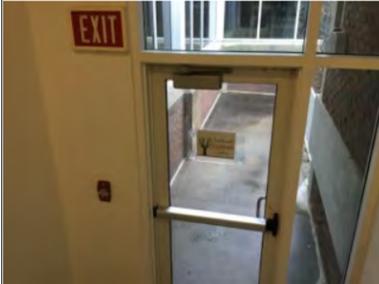
Tactile exit sign not provided Directional sign to accessible emergency exit not provided	-- -	Ensure tactile exit signs with raised characters and braille are provided at exit doors. Mount signs between 48"- 60" above the finished floor located on the latch side of the door. Provide a directional sign indicating the location of the nearest accessible emergency exit.	1	
Interior Access Route											
33	Near Reception Area	1		Interior Access Route	N/A

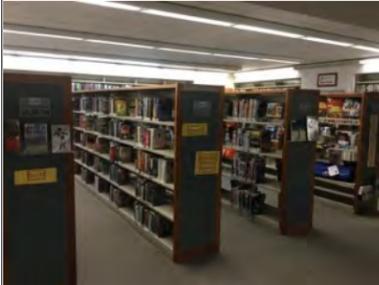
Route < 36" wide	34.9"	Ensure that a clear width of 36" min. is maintained at the accessible route.	1

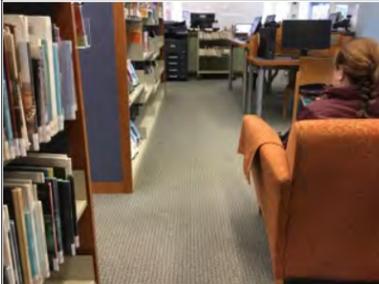
34	Children's Collection	2		Interior Access Route	N/A

Route < 36" wide	30"	Ensure that a clear width of 36" min. is maintained at the accessible route. Relocate furniture.	1	
35	Children's Collection	2		Interior Access Route	N/A

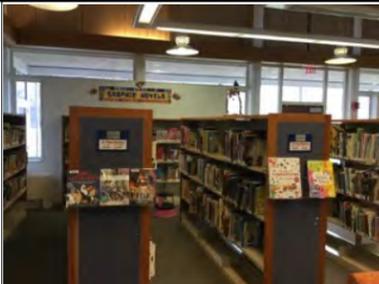
Route < 36" wide	34"	Ensure that a clear width of 36" min. is maintained at the accessible route.	1

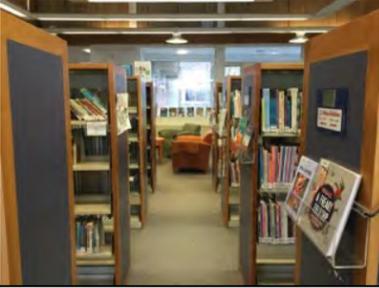
ID	Location	Floor	Room	Element	Type	Photo	Issues	Current Measure	Recommendations	Quantity	Notes
36	Children's Collection	2		Interior Access Route	N/A

Route < 36" wide	33.5"	Ensure that a clear width of 36" min. is maintained at the accessible route.	1	
37	Near Exit Door on East	2		Interior Access Route	N/A

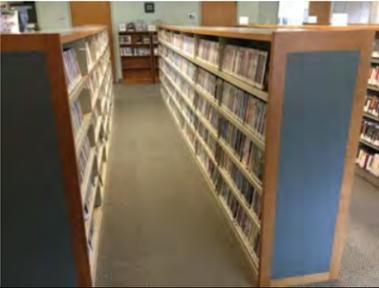
Route < 36" wide	35"	Ensure that a clear width of 36" min. is maintained at the accessible route.	1	
38	Young Adults Section	2		Interior Access Route	N/A

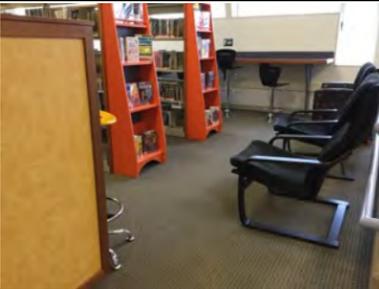
Route < 36" wide	27"	Ensure that a clear width of 36" min. is maintained at the accessible route. Relocate furniture.	1	
39	Near Reception Area	1		Interior Access Route	N/A

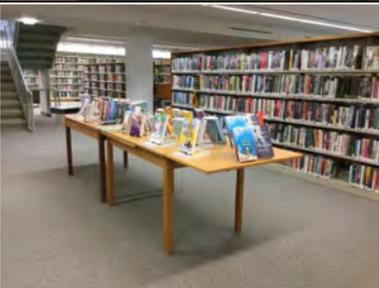
Obstructed by protruding objects	28"	Provide a cane-detectable barrier under the table that is no higher than 27" above the finished floor.	1	
40	Trustees Conference Room	1	9	Interior Access Route	N/A

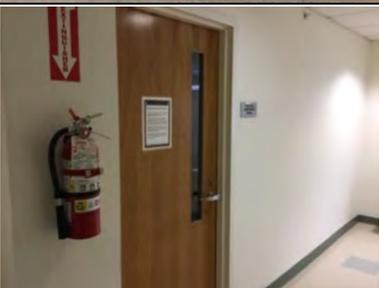
Obstructed by protruding objects	-	Relocate the fire extinguisher out of the circulation path. Additionally a cane-detectable barrier could be provided underneath the extinguisher.	1

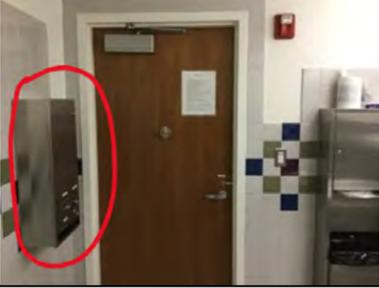
ID	Location	Floor	Room	Element	Type	Photo	Issues	Current Measure	Recommendations	Quantity	Notes
41	All Gender Children's Toilet Room	2		Interior Access Route	N/A

Obstructed by protruding objects	6.8"	Relocate the metal box out of the circulation route. Additionally a cane-detectable barrier could be provided underneath the box or a low profile dispenser or recessed dispenser could be provided.	1	
42	By Student Project Room	2		Interior Access Route	N/A

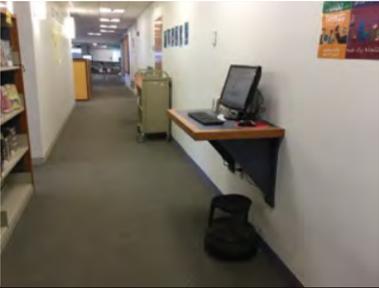
Obstructed by protruding objects	22"	Provide a cane-detectable barrier on each side of the desk.	2	
43	Near Reception Area	1		Interior Access Route	N/A

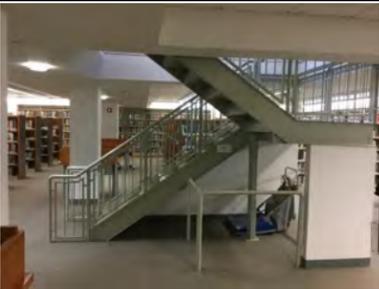
Vertical clearance < 80" above finished floor	31.9"	Provide a cane-detectable barrier under the table that is no higher than 27" above the finished floor. The current rail is located too high to be cane-detectable.	1	
Doors, Doorways, & Gates											
44	Courtyard	2		Doors, Doorways, & Gates	Other

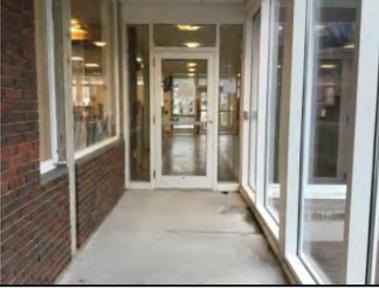
Clear width at door < 32"	31"	Install offset hinges to ensure that the door has a clear width of 32 inches.	1

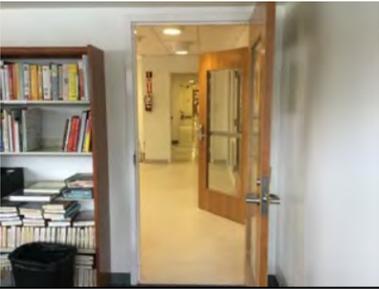
45	Book Store	1		Doors, Doorways, & Gates	Other

Maneuvering clearance(s) not provided	6"	Relocate furniture to ensure that there is 18" clear on the latch side of the door.	1

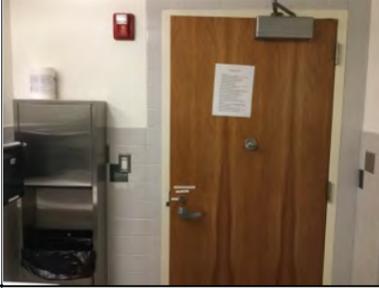
ID	Location	Floor	Room	Element	Type	Photo	Issues	Current Measure	Recommendations	Quantity	Notes
46	Toilet Room by Training Room	1		Doors, Doorways, & Gates	Toilet Room

Maneuvering clearance(s) not provided	13"	Relocate paper towel dispenser to ensure that there is 18" on the latch pull side of the door.	1	
47	Men's Toilet Room Near Music Section	2		Doors, Doorways, & Gates	Toilet Room

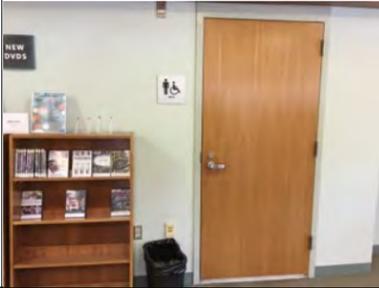
Maneuvering clearance(s) not provided	-	Relocate the trash can out to ensure that there is 18" clear on the latch side of the door.	1	
48	Story Telling/Activity Room	2	116A	Doors, Doorways, & Gates	Other

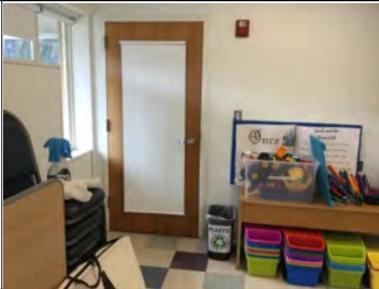
Maneuvering clearance(s) not provided	13"	Relocate the trash container (and furniture if necessary) so that there is 18" clear on the latch pull side of the door.	1	
49	Staff Entrance Lobby/Public Egress on South Side	2	127	Doors, Doorways, & Gates	Emergency Egress

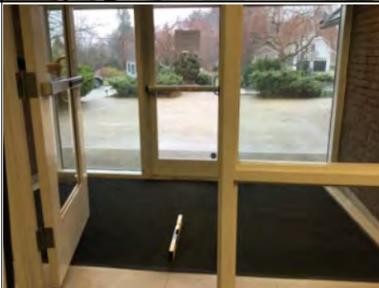
Maneuvering clearance at door > 1:50 (2.00%)	6%	Provide an automatic door opener at the exterior door.	1

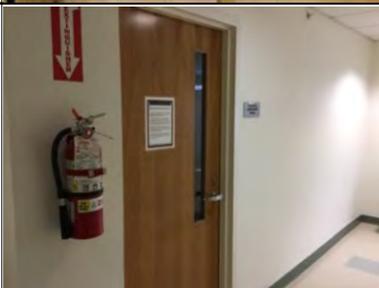
50	Trustees Conference Room	1	9	Doors, Doorways, & Gates	Other

Door requires > 5 lbs. of force to open	7 lbs	Adjust closers so doors do not require more than 5 pounds of force to open.	1

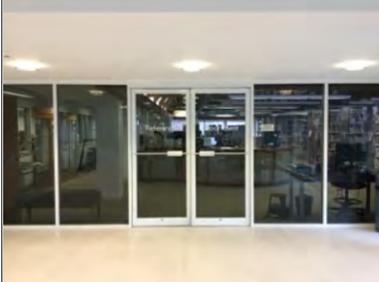
ID	Location	Floor	Room	Element	Type	Photo	Issues	Current Measure	Recommendations	Quantity	Notes
51	Middleton Reading and Reference Room	2		Doors, Doorways, & Gates	Other

Door requires > 5 lbs. of force to open	10 lbs	Adjust closers so doors do not require more than 5 pounds of force to open.	1	
52	Women's Toilet Room by Audio Visual Department	2		Doors, Doorways, & Gates	Toilet Room

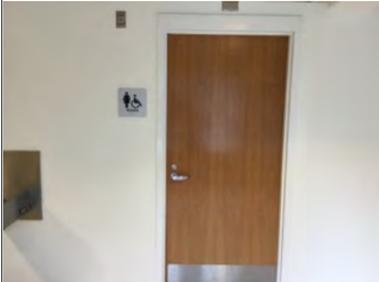
Door requires > 5 lbs. of force to open	10 lbs	Adjust closers so doors do not require more than 5 pounds of force to open.	1	
Ramps											
53	Ramp Leading to Young Adults Section	2		Ramps	Interior

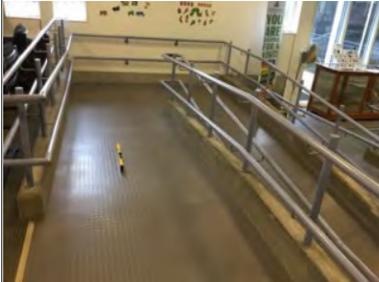
Running slope >1:12 (8.33%)	9.2%	Repair to this ramp might be technically infeasible.	1	
Signage											
54	Student Project Room 1	2		Signage	Designation

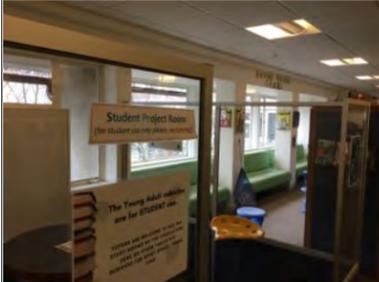
Raised characters not provided on sign Braille not provided on sign	- -	Provide text with raised characters duplicated in braille on sign. The baseline of raised characters should be located between 48" and 60" above finished floor and the sign should be located on the wall or glass alongside the latch side of the door.	2

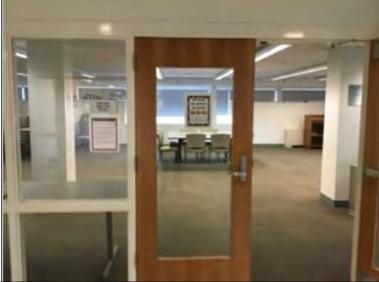
55	Whiton Meeting Room	1		Signage	Designation

Sign not located on the latch side of the door	-	Where a tactile sign is provided at double doors with one active leaf, the sign shall be located on the inactive leaf. Where a tactile sign is provided at double doors with two active leaves, the sign must be located to the right of the right hand door.	1

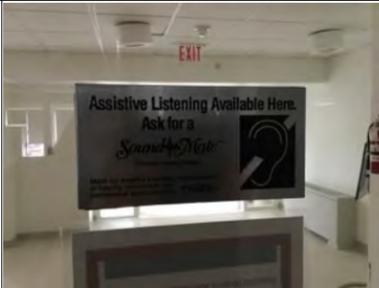
ID	Location	Floor	Room	Element	Type	Photo	Issues	Current Measure	Recommendations	Quantity	Notes
56	Whiton Meeting Room	1		Signage	Informational

Non-glare finish and contrast not provided on sign	-	Install a sign with a non-glare finish with characters that have a high contrast to the background.	1	
57	Preschool	2		Signage	Informational

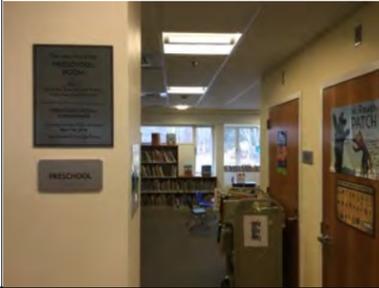
Non-glare finish and contrast not provided on sign	-	Install a sign with characters that have a high contrast to the background.	1	
58	Story Telling/ Activity Room	2	116	Signage	Designation

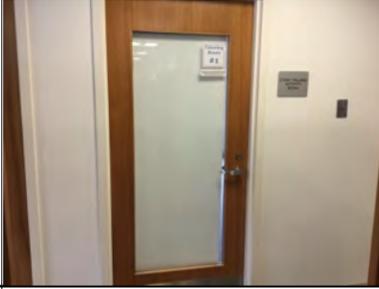
Non-glare finish and contrast not provided on sign	-	Install a sign with characters that have a high contrast to the background.	1	
59	Story Telling/ Activity Room	2	116A	Signage	Designation

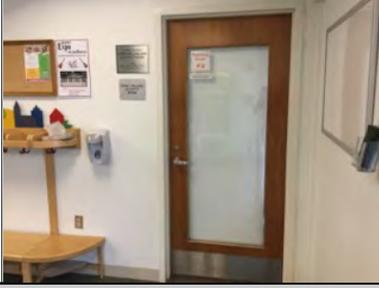
Non-glare finish and contrast not provided on sign	-	Install a sign with a non-glare finish with characters that have a high contrast to the background.	2	
Operable Parts

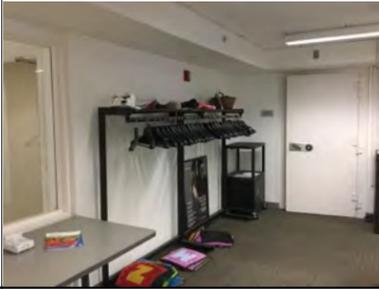
60	Whiton Meeting Room	1		Operable Parts	Clothes Rod/Hooks

Reach < 15" or > 48"(forward/side approach)	58.7"	Provide a clothes rod that is no higher than 48" above the finished floor.	1

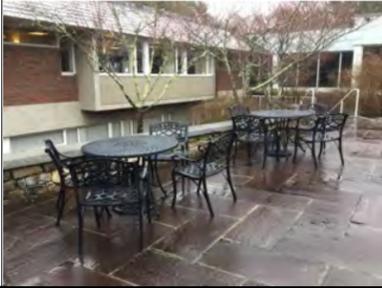
Side reach > 54"	61"	Relocate baby changing table so that controls are between 15" - 48" above the finished floor.	1	
Dining or Work Surfaces											
62	Courtyard	2		Dining or Work Surfaces	Dining Surface

At least one or 5% accessible tables not provided Knee or toe clearance not provided	- -	Ensure that at least one dining surface is accessible. Provide at least one dining surface with 27" min. knee and toe clearance.	1	
63	Student Project Rooms 1 and 2	2		Dining or Work Surfaces	Work Surface
