Central Fire Station

Town of Hingham ADA Transition Plan

October 2023

Institute for Human Centered Design

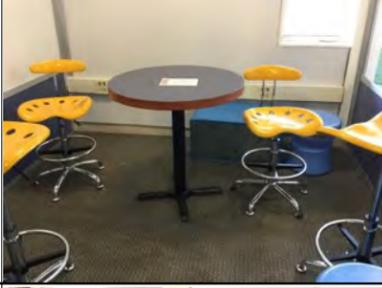
At least one or 5% accessible tables not provided Knee or toe clearance not provided	- -	Ensure that at least one dining surface is accessible. Provide at least one dining surface with 27" min. knee and toe clearance.	1	
63	Student Project Rooms 1 and 2	2		Dining or Work Surfaces	Work Surface

Knee or toe clearance not provided	-	Provide at least one dining or work surface with toe clearance.	2	
64	By Student Project Room	2		Dining or Work Surfaces	Work Surface

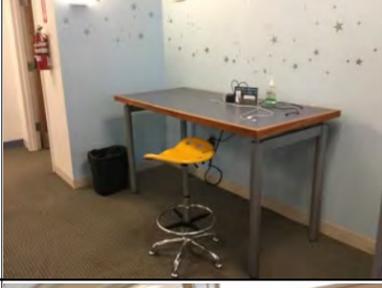
Top of dining/work surface < 28" or > 34"	36"	Provide at least one work surface with top between 28"- 34" above the floor and 27" clear height underneath.	1

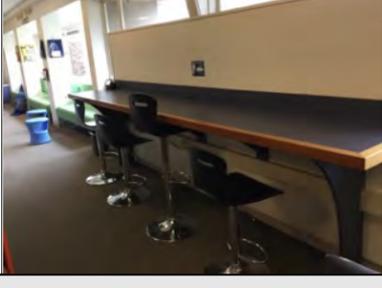
65	Young Adults Section	2		Dining or Work Surfaces	Work Surface

Top of dining/work surface < 28" or > 34"	36.3"	Provide at least one work surface with top between 28"- 34" above the floor and 27" clear height underneath.	1	
Toilet & Bathing Rooms

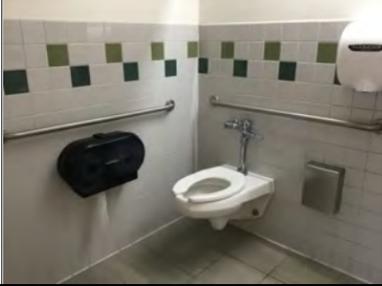
Plumbing underneath is exposed	-	Insulate or otherwise configure pipes to prevent contact at the lavatory.	1	
Single-User Toilet											
67	Women's Toilet Room by Audio Visual Department	2		Single-User Toilet	N/A

Toilet seat < 17" or > 19" high	21"	Install a toilet with a seat between 17"- 19" high above the finished floor.	1	
68	Women's and Men's Toilet Rooms by the Elevator	1		Single-User Toilet	N/A

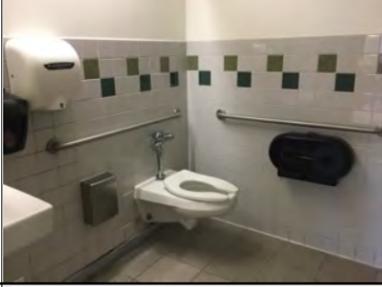
Paper towel dispenser is mounted over the grab bar	-	Ensure that no dispensers are mounted over the grab bar.	2	
69	Men's Toilet Room Near Music Section	2		Single-User Toilet	N/A

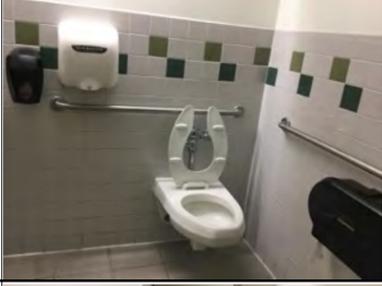
Paper towel dispenser is mounted over the grab bar	-	Ensure that no dispensers are mounted over the grab bar.	1	
70	Women's Toilet Room by Audio Visual Department	2		Single-User Toilet	N/A

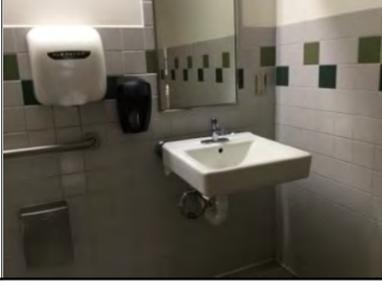
Paper towel dispenser is mounted over the grab bar	-	Ensure that no dispensers are mounted over the grab bar.	1

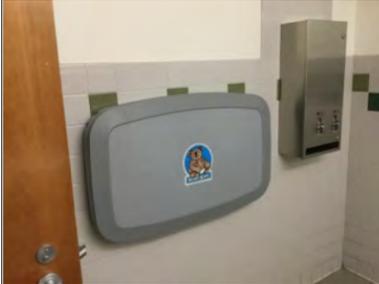
ID	Location	Floor	Room	Element	Type	Photo	Issues	Current Measure	Recommendations	Quantity	Notes
Dispensers											
71	Toilet Room by Training Room	1		Dispensers	Other

Not operable with a closed fist	-	Provide baby changing table that can be operable with one hand and not require tight grasping, pinching, or twisting of the wrist.	1	
Additional Access											
Drinking Fountains											
72	By Book Store	1		Drinking Fountains	Hi-Lo

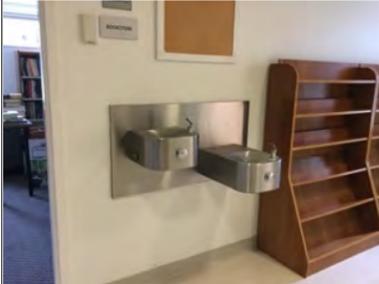
Standing height fountain does not have cane protection	-	Provide a cane-detectable barrier skirt under the high unit.	1	
73	Corridor by Toilet Rooms	1		Drinking Fountains	Hi-Lo

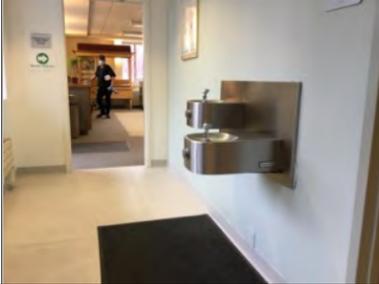
Standing height fountain does not have cane protection	32.5"	Provide a cane-detectable barrier skirt under the high unit.	1	
74	By Audio Visual Department	2		Drinking Fountains	Hi-Lo

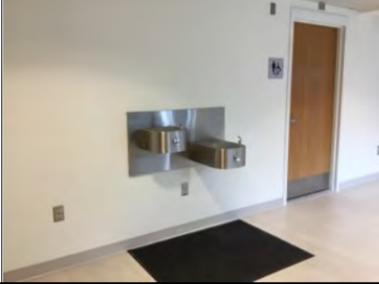
Standing height fountain does not have cane protection	-	Provide a cane-detectable barrier skirt under the high unit.	1

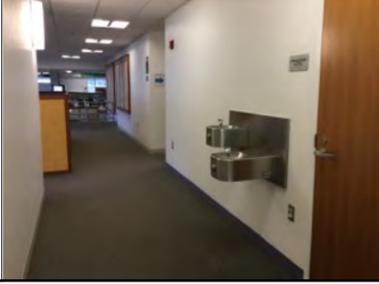
75	Corridor Leading to Ramp	2		Drinking Fountains	Hi-Lo

Standing height fountain does not have cane protection	-	Provide a cane-detectable barrier skirt under the high unit.	1

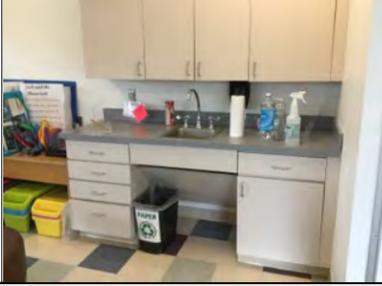
Clear floor space not provided at sink Toe and knee clearances not provided	- 26"	Provide a 30" by 48" clear floor space positioned for a forward approach. Relocate furniture. Ensure there is a 27" min. knee clearance positioned for a forward approach.	1	
77	Story Telling/ Activity Room	2	116A	Sink	Classroom

Toe and knee clearances not provided	26"	Ensure there is a 27" min. knee clearance positioned for a forward approach.	1	
Best Practice											
78	Lobby	1

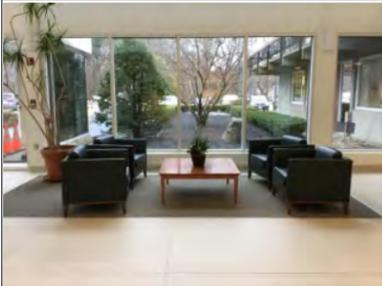
Recommend providing furniture that has a high contrast to the floor (that will be easier to detect by people with low vision).	1	
79	Staircase C	1

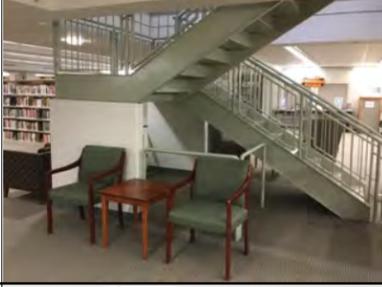
Good example of seating with back rests and armrests by the stairs.	1	
80	Study Room	1

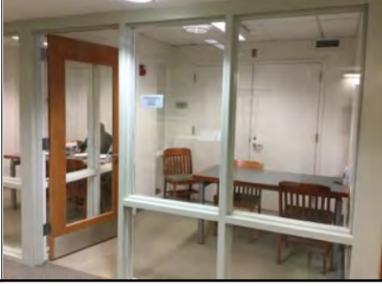
Recommend providing visual manifestations on the glass to help people who are low vision detect the glass wall.	1

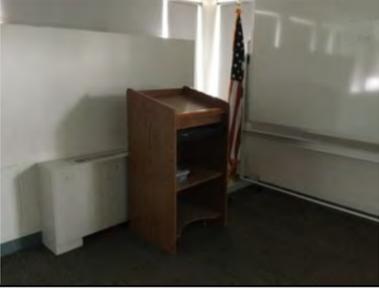
ID	Location	Floor	Room	Element	Type	Photo	Issues	Current Measure	Recommendations	Quantity	Notes
81	Whiton Meeting Room	1

Recommend providing an adjustable height podium with knee and toe clearance.	1	
82	Courtyard	2

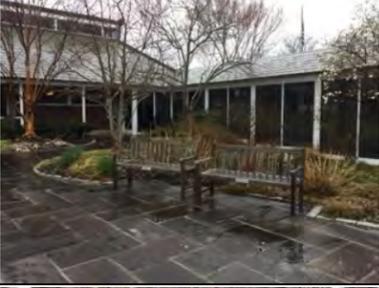
Recommend providing 36" wide by 48" deep clear floor space next to at least one bench in the courtyard so that a wheelchair user is able to sit shoulder-to-shoulder with a person seated on the bench.	1	
83	Courtyard Stair	2

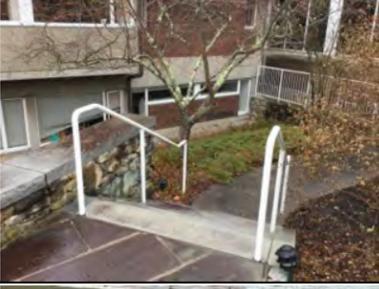
Recommend providing color contrasting strips on the stair treads.	1	
84	Children's Entrance Stairs	Ext.

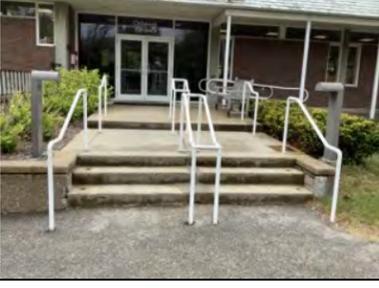
Recommend contrasting color strips on stairs. Railings are excellent.	1

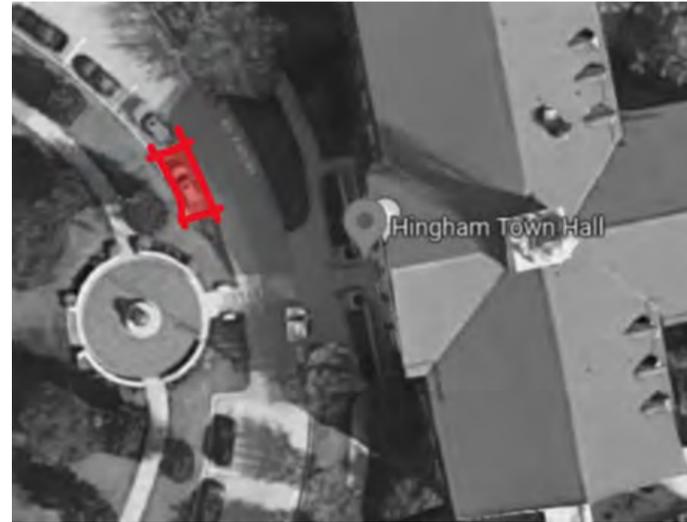
- Recommend providing one (1) accessible parallel parking space by the main entrance to Town Hall. Provide signage with the International Symbol of Accessibility (ISA) at the head of the parking space to reserve it for people using HP plates or placards. See **Figure 1**:

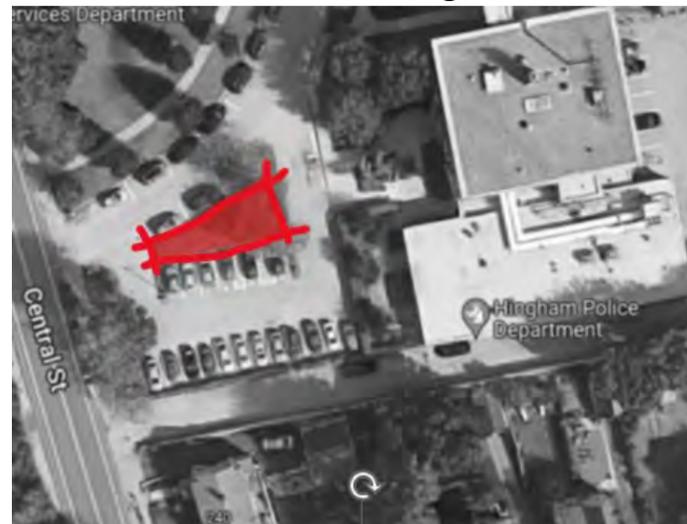
- The senior center parking lot is often full and people must park a great distance away from the building entrance. IHCD recommends providing additional perpendicular or angled accessible parking spaces in the red highlighted area by the senior center shown below in **Figure 2**:

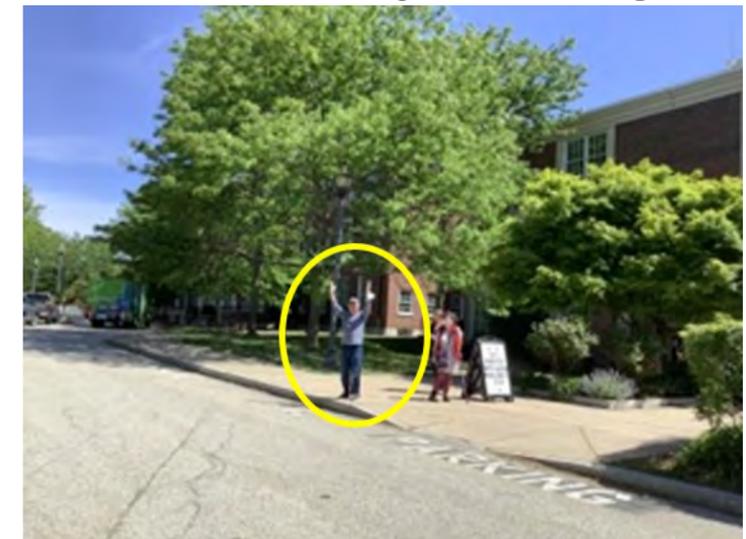
- Recommend providing a bench by the drop off area for the senior center so that people are able to see when their ride arrives. Recommend providing an enclosure for inclement weather.
- Recommend creating a compliant passenger loading zone in front of the senior center. (Provide a marked access aisle that is at least 60" wide and that extends the full length of the vehicle. Provide a sign that includes the International Symbol of Accessibility (ISA) at the head of the space. Locate the sign so that the bottom is 60" min. above the ground and the top is 96" max. above the ground.)
- The entrance to the senior center is obscured by plantings. Recommend placing a sign denoting the main entrance to the senior center at the following location. See **Figure 3**:

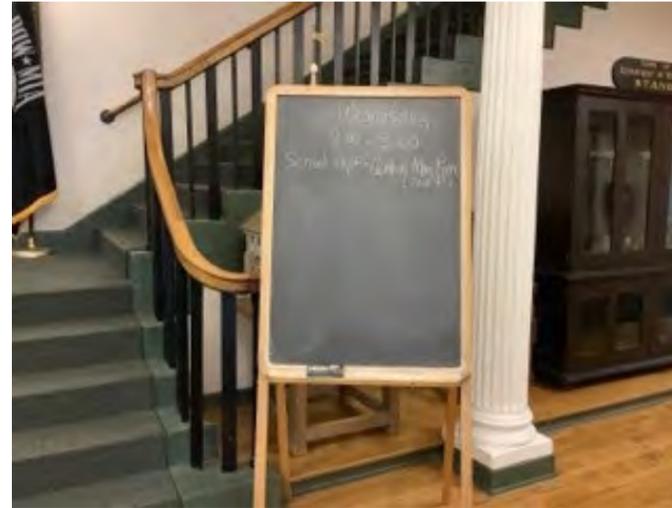
- The chalkboard announcing the location of meetings is handwritten and difficult to read. IHCD recommends providing a computer screen that has visual characters that comply with 2010 ADA Standards 703.5; including providing contrast between characters and their background, providing a non-glare finish, and providing characters in a conventional form (not italic, oblique, script, highly decorative, or of other unusual forms). Consider also updating this information (showing meeting location) on the Town web site. **Figure 5** illustrates the existing chalkboard:

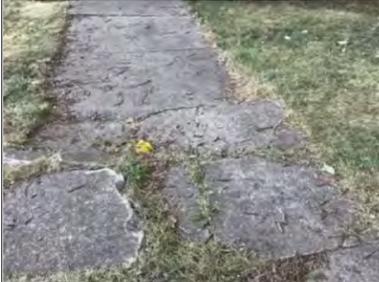
ID	Location	Floor	Room	Element	Type	Photo	Issues	Current Measure	Recommendations	Quantity	Notes
Approach and Entrance											
Exterior Access Route											
1	Building C, Route From Central Auditorium Stair South	Ext.		Exterior Access Route	Walkway

Surface openings > 1/2" Level changes > 1/4" Surface is not stable, firm, and slip-resistant		Repair pavement so that openings are 1/2" max. Alter change in level to be 1/4" high max.	1	
2	South Accessible Parking by Building A, Senior Center to Building A, Senior Center Drop-Off	Ext.		Exterior Access Route	Exterior

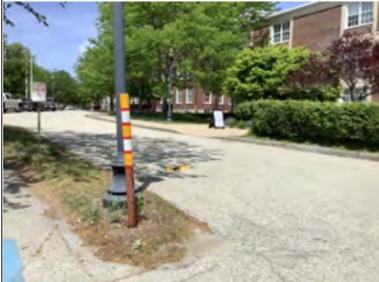
Cross slope > 1:50 (2.00%)	3.2%	Reduce cross slope to be no steeper than 1:50 (2.00%).	1	
3	Building B, School Department to Building B, Police Station	Ext.		Exterior Access Route	Walkway

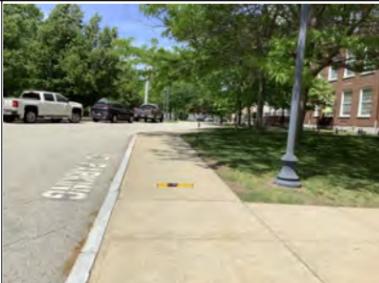
Cross slope > 1:50 (2.00%)	3.6%	Reduce cross slope to be no steeper than 1:50 (2.00%).	1	
4	Building B, Police Station to Building C, Town Hall	Ext.		Exterior Access Route	Walkway

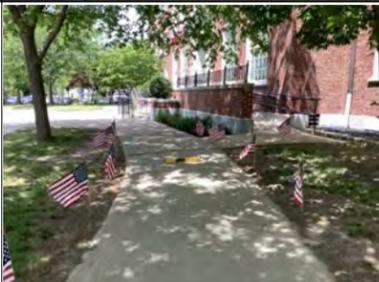
Cross slope > 1:50 (2.00%)	4.1%	Reduce cross slope to be no steeper than 1:50 (2.00%).	1

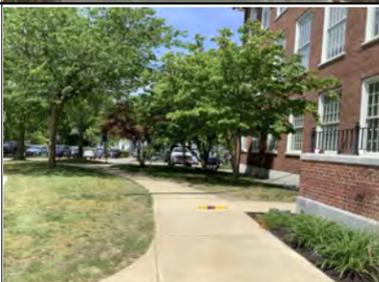
5	Building C Town Hall to Building D, Recreation Department	Ext.		Exterior Access Route	Walkway

Cross slope > 1:50 (2.00%)	5.2%	Reduce cross slope to be no steeper than 1:50 (2.00%).	1

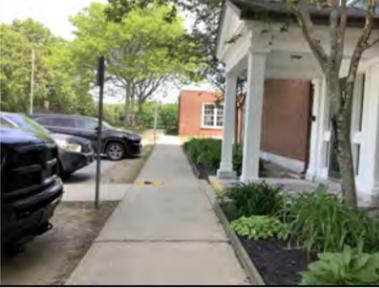
ID	Location	Floor	Room	Element	Type	Photo	Issues	Current Measure	Recommendations	Quantity	Notes
6	Building C, Town Hall, North Egress, Secondary Entrance to Building D, Recreation Department	Ext.		Exterior Access Route	Walkway

Cross slope > 1:50 (2.00%)	5.8%	Reduce cross slope to be no steeper than 1:50 (2.00%).	1	
7	Northwest Accessible Parking to Building D, Recreation Department	Ext.		Exterior Access Route	Walkway

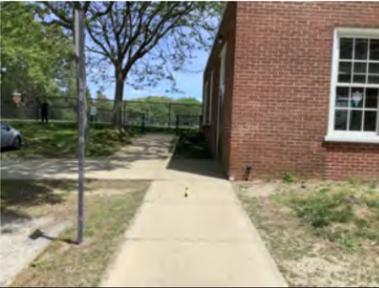
Running slope > 1:20 (5.00%)	6.2%	Reduce running slope to be no steeper than 1:20 (5.00%).	1	
8	Building D, Route From Entrance to the Sports Field	Ext.		Exterior Access Route	Exterior

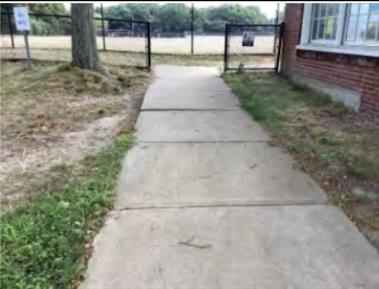
Level changes > 1/4"	2"	Alter change in level to be 1/4" high max.	1	
9	Building A, Senior Center, Route to Main Entrance	Ext.		Exterior Access Route	Walkway

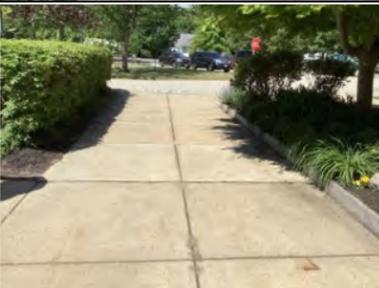
Level changes > 1/4" Surface is not stable, firm, and slip-resistant	.5" -	Alter change in level to be 1/4" high max. Repair surface.	1

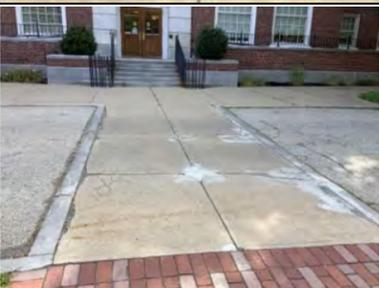
10	Building C, Town Hall, Front Entrance Crosswalk	Ext.		Exterior Access Route	Walkway

Surface is not stable, firm, and slip-resistant	-	Repair surface.	1

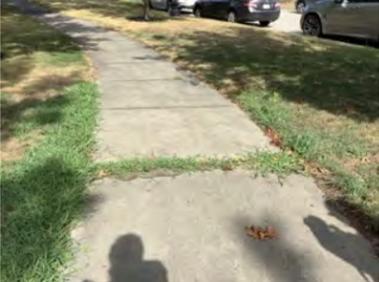
ID	Location	Floor	Room	Element	Type	Photo	Issues	Current Measure	Recommendations	Quantity	Notes
11	Building C, Town Hall, Curved North Walkway From Flag Pole to Central Street	Ext.		Exterior Access Route	Walkway

Surface is not stable, firm, and slip-resistant	-	Repair surface.	1	
12	Plaza Between Building D and C	Ext.		Exterior Access Route	Walkway

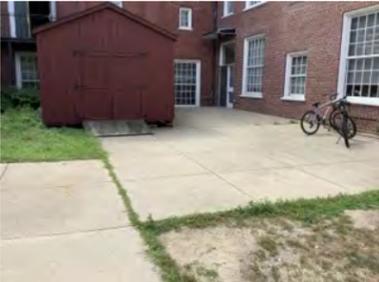
Surface is not stable, firm, and slip-resistant	-	Repair the surface at the joint.	1	
13	Building C, Route by Central Auditorium Stair	Ext.		Exterior Access Route	Walkway

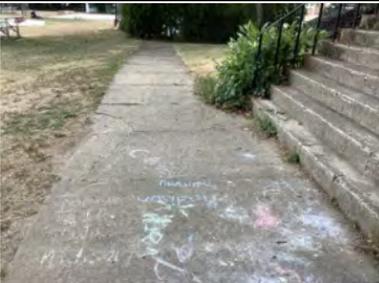
Surface is not stable, firm, and slip-resistant	-	Repair surface.	1	
14	Building C, Route From Central Auditorium Stair South	Ext.		Exterior Access Route	Walkway

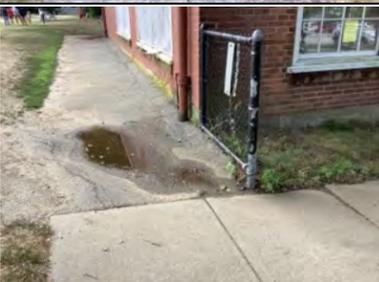
Surface is not stable, firm, and slip-resistant		Repair surface.	1	
15	Building D, Route to the Sports Field	Ext.		Exterior Access Route	Walkway

Does not prevent accumulation of water	-	Repair surface.	1

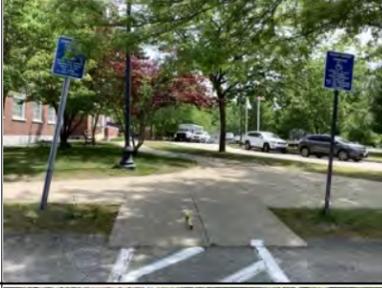
Running slope > 1:12 (8.33%)	11.5%	Reduce running slope to be no steeper than 1:12 (8.33%).	1	
18	North Accessible Parking by Building C, Town Hall, North Egress, Secondary Entrance	Ext.		Curb Ramp	N/A

Running slope > 1:12 (8.33%)	9.3%	Reduce running slope to be no steeper than 1:12 (8.33%).	1	
19	North Parking to Building C, Town Hall, Main Entrance	Ext.		Curb Ramp	N/A

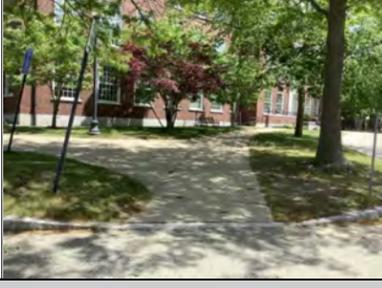
Transition from curb ramp to street not flush	.5"	Ensure transition from curb ramp to street is flush or free of changes in level.	1

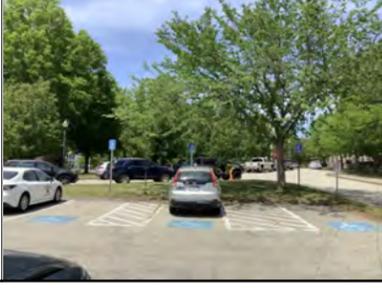
Off-Street Parking Lot or Garage											
20	South Accessible Parking by Building A, Senior Center	Ext.		Off-Street Parking Lot or Garage	Visitor

Total # of parking Total # of designated accessible parking spaces Total # of designated van accessible spaces Sign does not have the designation "Van Accessible"	18 2 - -	Add the designation "Van Accessible" to the sign located at the van accessible space.	1

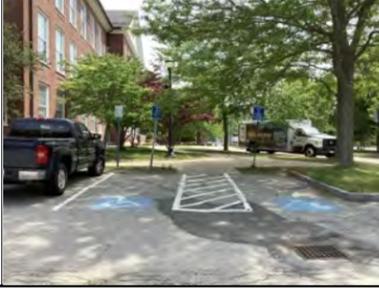
ID	Location	Floor	Room	Element	Type	Photo	Issues	Current Measure	Recommendations	Quantity	Notes
21	North Accessible Parking by Building C, Town Hall, North Egress, Secondary Entrance	Ext.		Off-Street Parking Lot or Garage	Visitor

Total # of parking Total # of designated accessible parking spaces Total # of designated van accessible spaces	141 4 0	Provide one (1) van accessible parking space with signage with the International Symbol of Accessibility (ISA) and the designation "Van Accessible".	1	
Exterior Ramp											
22	Building C, Town Hall, North Ramp at Main Entrance	Ext.		Exterior Ramp	N/A

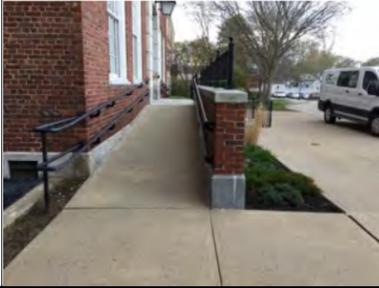
Handrails do not extend 12" past top & bottom Edge protection < 4" high	-	Alter handrails to extend horizontally above the landing for 12" min. beyond the top and bottom of ramp runs. Provide edge protection at the base of the ramp on the right side of the photograph that prevents the passage of a 4" diameter sphere, where any portion of the sphere is within 4" of the finished floor or ground surface.	1

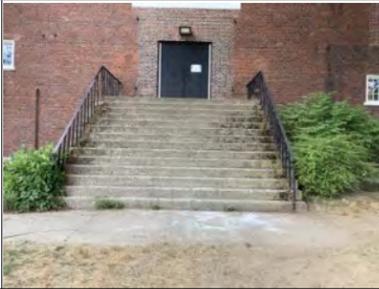
Exterior Stair											
23	Building C, Central Stairs From Auditorium to Field	Ext.		Exterior Stair	N/A

Handrails do not extend 12" from stair Cross section of handrail is not compliant	- -	Top: Ensure handrails extend horizontally above the landing for 12" min. beginning above the first riser nosing. Bottom: Ensure that the sloped bottom extension extends one tread depth min. beyond last riser nosing in same direction as stair flight. Provide handrails with 1 1/4" - 2" circular cross sections.	1	
24	Building D, Recreation Department, East Egress Stairs From the Game Room to the Field	1		Exterior Stair	N/A

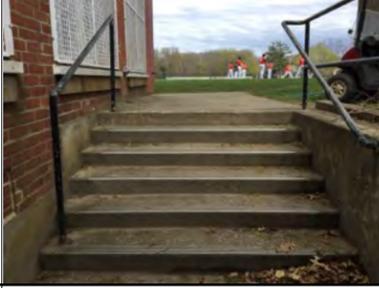
Handrails do not extend 12" from stair Not maintained in operable working condition	- -	Top: Ensure handrails extend horizontally above the landing for 12" min. beginning above the first riser nosing. Bottom: Ensure that the sloped bottom extension extends one tread depth min. beyond last riser nosing in same direction as stair flight. Ensure stairs are maintained in operable working condition and kept clear of leaves.	1

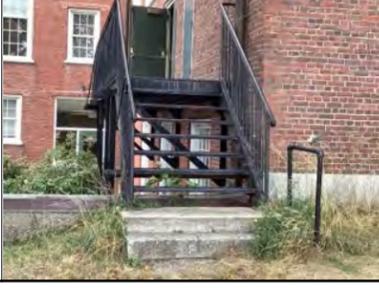
25	Building C, Auditorium South Stepped Exit to Field	Ext.		Exterior Stair	N/A

Handrails do not extend 12" from stair Stair has open risers	- -	Bottom: Ensure that the sloped bottom extension extends one tread depth min. beyond last riser nosing in same direction as stair flight. Ensure stairs have closed risers.	1

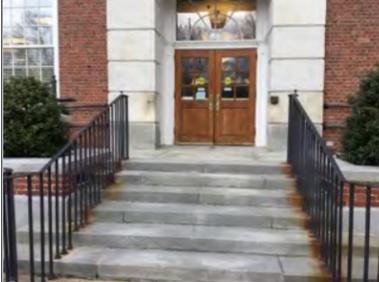
ID	Location	Floor	Room	Element	Type	Photo	Issues	Current Measure	Recommendations	Quantity	Notes
26	Building C, Town Hall, Main Entrance Stair	Ext.		Exterior Stair	N/A

Cross section of handrail is not compliant	-	Provide handrails with 1 1/4" - 2" circular cross sections.	2	
27	Building C, Central Stairs From Auditorium to Field	Ext.		Exterior Stair	N/A

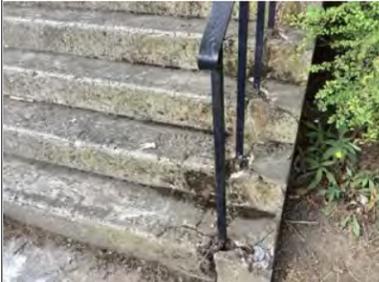
Not maintained in operable working condition	-	Ensure stairs are maintained in operable working condition.	1	
28	Building C, Auditorium North Stepped Exit to Field	Ext.		Exterior Stair	N/A

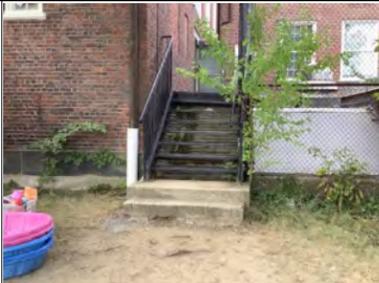
Stair has open risers Handrails do not extend 12" from stair	- -	Top: Ensure handrails extend horizontally above the landing for 12" min. beginning above the first riser nosing. Bottom: Ensure that the sloped bottom extension extends one tread depth min. beyond last riser nosing in same direction as stair flight. Ensure stairs have closed risers.	1

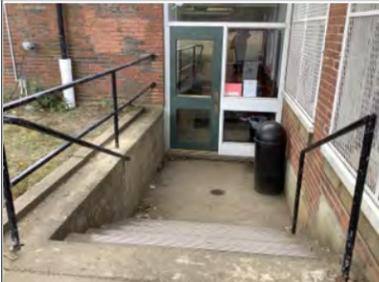
Entrance											
29	Building D, East Entrance to the Recreation Department From the Field	Ext.		Entrance	Secondary Entrance

Entrance not on an accessible route Directional sign to accessible entrance not provided	- -	Provide a directional sign indicating the location of the nearest accessible entrance. Where a directional sign is required, it should be located to minimize backtracking. In some cases, this could mean locating a sign at the beginning of a route, not just at the inaccessible entrances to a building.	1	
30	Building C, Town Hall, Northwest Secondary Entrance	1		Entrance	Secondary Entrance

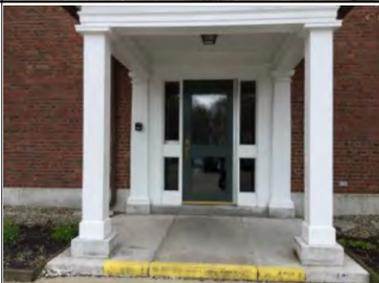
Directional sign to accessible entrance not provided	-	Provide a directional sign indicating the location of the nearest accessible entrance. Where a directional sign is required, it should be located to minimize backtracking. In some cases, this could mean locating a sign at the beginning of a route, not just at the inaccessible entrances to a building.	1

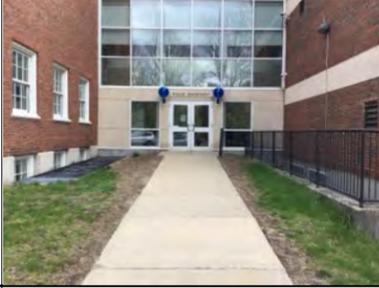
ID	Location	Floor	Room	Element	Type	Photo	Issues	Current Measure	Recommendations	Quantity	Notes
31	Building B, Police Station, Main Entrance	1		Entrance	Main Entrance

International Symbol of Accessibility not provided	-	Provide a sign with the International Symbol of Accessibility (ISA). Recommend locating the directional sign over the tactile designation sign that is required in addition at this door.	1	
32	Building B, School Department, Main Entrance	1		Entrance	Main Entrance

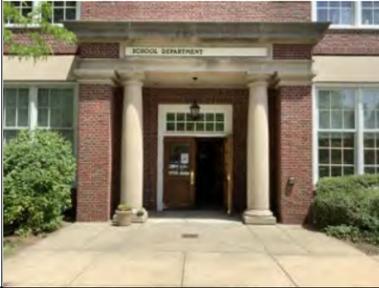
International Symbol of Accessibility not provided	-	Provide a sign with the International Symbol of Accessibility (ISA). Recommend locating the ISA sign over the tactile designation sign that is required in addition at this door.	1	
33	Building D, Recreation Department, North Egress, Main Entrance	1		Entrance	Main Entrance

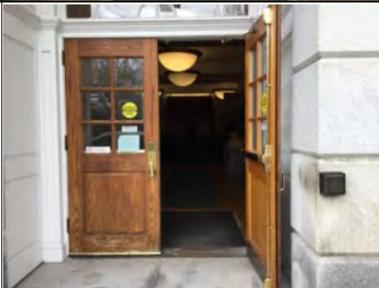
34	Building C, Town Hall, Main Entrance, West Side	Ext.		Entrance	Main Entrance

International Symbol of Accessibility not provided	-	Provide a sign with the International Symbol of Accessibility (ISA). Recommend locating the ISA sign above the automatic door opener on the right.	1	
35	Building A, Senior Center, Main Entrance	Ext.		Entrance	Main Entrance

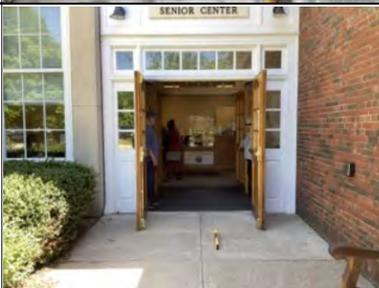
International Symbol of Accessibility not provided	-	Provide a sign with the International Symbol of Accessibility (ISA). Recommend locating the ISA sign over the tactile designation sign that is required in addition at this door.	1

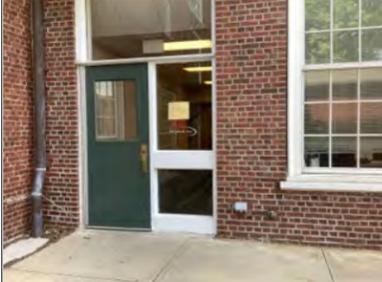
ID	Location	Floor	Room	Element	Type	Photo	Issues	Current Measure	Recommendations	Quantity	Notes
36	Building C, Town Hall, East Entrance/ Egress Door	Ext.		Entrance	Secondary Entrance

International Symbol of Accessibility not provided	-	Provide a sign with the International Symbol of Accessibility (ISA). Recommend locating the ISA sign over the tactile designation sign that is required in addition at this door.	1	
37	Building C, Town Hall, Northwest Secondary Entrance	1		Entrance	Secondary Entrance

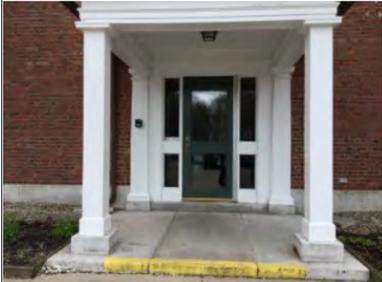
Door requires > 15 lbs. of force to open	20 lbs	Adjust closers so doors do not require more than 15 pounds of force.	1	
Emergency Exit											
38	Building D, Recreation Department, East Egress to Fields	1		Emergency Exit	N/A

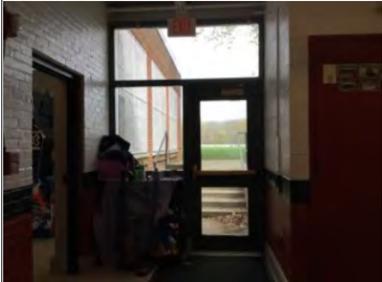
Door requires > 15 lbs. of force to open	20 lbs	Adjust closers of exterior doors so doors do not require more than 15 pounds of force. Note: Fire doors shall have a minimum opening force allowable by the appropriate administrative authority.	1

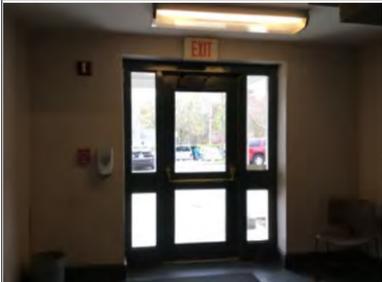
Tactile exit sign not provided	-	Ensure tactile exit signs with raised characters and braille are provided at exit doors. Mount signs between 48"- 60" above the finished floor located on the latch side of the door.	1	
40	Building C, Town Hall, Southeast Egress Through Southeast Stairwell by Private Toilet Rooms	1		Means of Egress	N/A

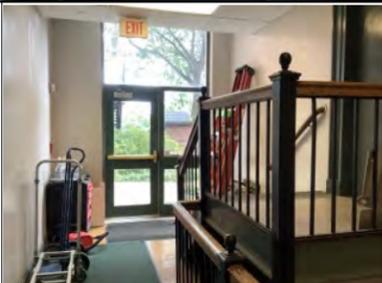
Tactile exit sign not provided	-	Ensure tactile exit signs with raised characters and braille are provided at exit doors. Mount signs between 48"- 60" above the finished floor located on the latch side of the door. Where a tactile sign is provided at double doors with two active leaves, the sign shall be located to the right of the right hand door.	1

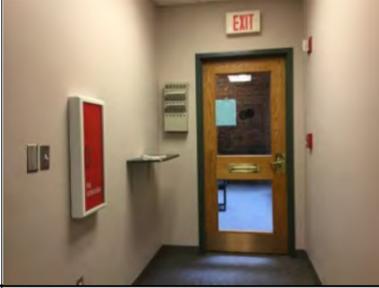
ID	Location	Floor	Room	Element	Type	Photo	Issues	Current Measure	Recommendations	Quantity	Notes
41	Building B, Police Department, Records & Administration, to Police Department Central Stair	2		Means of Egress	N/A

Tactile exit sign not provided	-	Ensure tactile exit signs with raised characters and braille are provided at exit doors. Mount signs between 48"- 60" above the finished floor located on the latch side of the door.	1	
42	Building C, Town Hall, Connecting Stair to Building B	2		Means of Egress	N/A

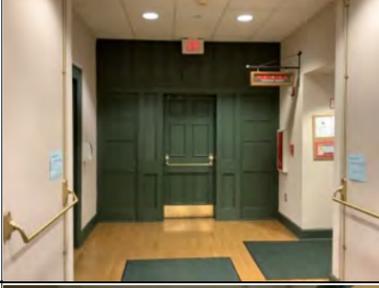
Tactile exit sign not provided	-	Ensure tactile exit signs with raised characters and braille are provided at exit doors. Mount signs between 48"- 60" above the finished floor located on the latch side of the door.	1	
43	Building B, School Department, to Police Department Central Stair	3		Means of Egress	N/A

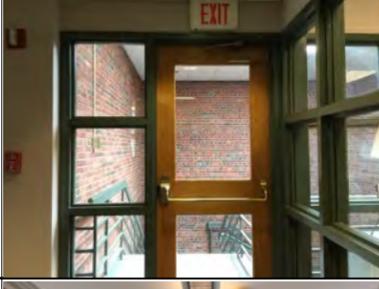
Tactile exit sign not provided	-	Ensure tactile exit signs with raised characters and braille are provided at exit doors. Mount signs between 48"- 60" above the finished floor located on the latch side of the door.	1

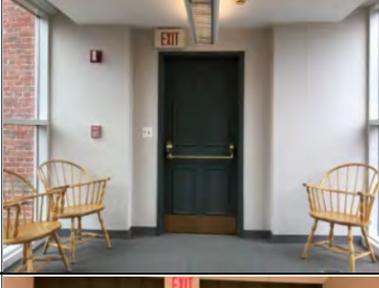
44	Building B, School Department, Corridor to Staircase on the South Side of Building C	3		Means of Egress	N/A

Tactile exit sign not provided	-	Ensure tactile exit signs with raised characters and braille are provided at exit doors. Mount signs between 48"- 60" above the finished floor located on the latch side of the door.	1	
45	Building C, Town Hall, North Stair	3		Means of Egress	N/A

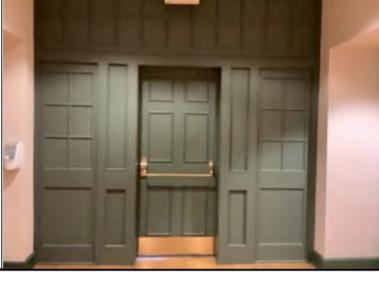
Tactile exit sign not provided	-	Ensure tactile exit signs with raised characters and braille are provided at exit doors. Mount signs between 48"- 60" above the finished floor located on the latch side of the door.	1

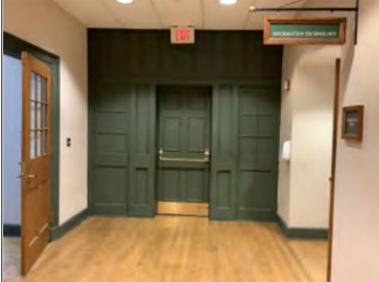
ID	Location	Floor	Room	Element	Type	Photo	Issues	Current Measure	Recommendations	Quantity	Notes
46	Building C, Town Hall, Connecting Stair to Building B	3		Means of Egress	N/A

Tactile exit sign not provided	-	Ensure tactile exit signs with raised characters and braille are provided at exit doors. Mount signs between 48"- 60" above the finished floor located on the latch side of the door.	1	
47	Building B, Police Department, West Egress, Main Entrance	1		Means of Egress	N/A

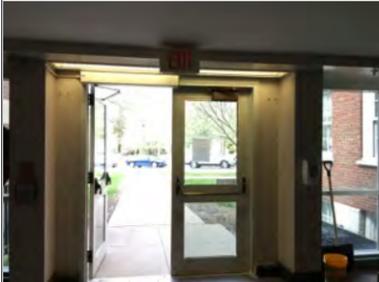
Tactile exit sign not provided Illuminated ISA symbol not provided (MAAB)		Provide tactile exit signs with raised characters and braille at exit doors. Mount signs between 48"- 60" above the finished floor located on the latch side of the door. Where a tactile sign is provided at double doors with two active leaves, the sign shall be located to the right of the right hand door. Provide an illuminated sign with the International Symbol of Accessibility (ISA).	1

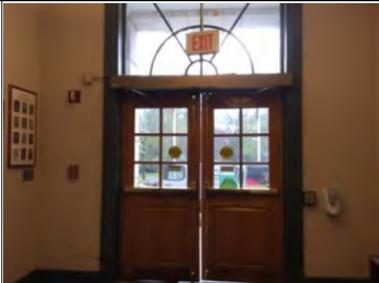
48	Building C, Town Hall, Main Entrance/ Egress on West	1		Means of Egress	N/A

Tactile exit sign not provided Illuminated ISA symbol not provided (MAAB)	- -	Ensure tactile exit signs with raised characters and braille are provided at exit doors. Mount signs between 48"- 60" above the finished floor located on the latch side of the door. Where a tactile sign is provided at double doors with two active leaves, the sign shall be located to the right of the right hand door. Provide an illuminated sign with the International Symbol of Accessibility (ISA).	1	
49	Building D, Recreation Department, North Egress, Main Entrance	1		Means of Egress	N/A

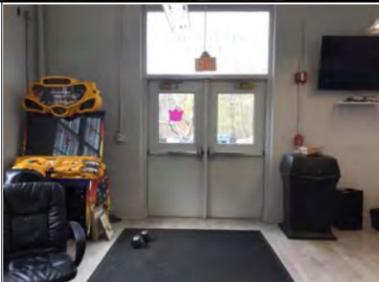
Tactile exit sign not provided Illuminated ISA symbol not provided (MAAB)	- -	Ensure tactile exit signs with raised characters and braille are provided at exit doors. Mount signs between 48"- 60" above the finished floor located on the latch side of the door. Where a tactile sign is provided at double doors with two active leaves, the sign shall be located to the right of the right hand door. Provide an illuminated sign with the International Symbol of Accessibility (ISA).	1

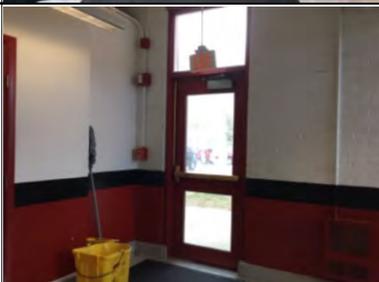
50	Building D, Recreation Department, Northwest Egress Door From the Game Room	1		Means of Egress	N/A

Tactile exit sign not provided Illuminated ISA symbol not provided (MAAB)	- -	Ensure tactile exit signs with raised characters and braille are provided at exit doors. Mount signs between 48"- 60" above the finished floor located on the latch side of the door. Provide an illuminated sign with the International Symbol of Accessibility (ISA).	1

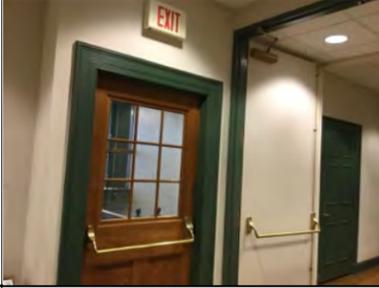
ID	Location	Floor	Room	Element	Type	Photo	Issues	Current Measure	Recommendations	Quantity	Notes
51	Building C, Town Hall, Southeast Egress Through Southeast Stairwell by Private Toilet Rooms	1		Means of Egress	N/A

Tactile exit sign not provided Illuminated ISA symbol not provided (MAAB)	- -	Ensure tactile exit signs with raised characters and braille are provided at exit doors. Mount signs between 48"- 60" above the finished floor located on the latch side of the door. After the rear path is brought into compliance, provide an illuminated sign with the International Symbol of Accessibility (ISA).	1	
52	Building A, Senior Center, Multi-Purpose Room, (2 Sets of Doors)	1		Means of Egress	N/A

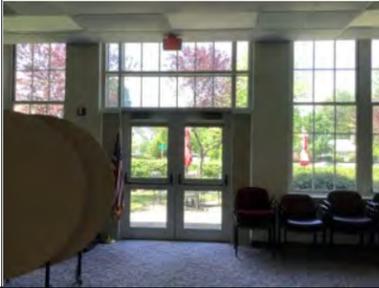
Tactile exit sign not provided Illuminated ISA symbol not provided (MAAB)	- -	Ensure tactile exit signs with raised characters and braille are provided at exit doors. Mount signs between 48"- 60" above the finished floor located on the latch side of the door. Where a tactile sign is provided at double doors with two active leaves, the sign shall be located to the right of the right hand door. Provide an illuminated sign with the International Symbol of Accessibility (ISA).	2

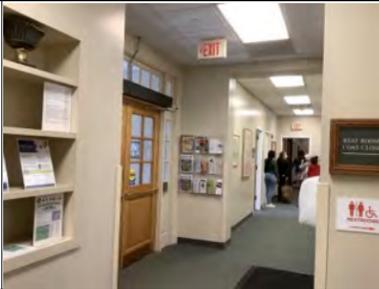
53	Building A, Senior Center, Main Entrance/ Egress	1		Means of Egress	N/A

Tactile exit sign not provided Illuminated ISA symbol not provided (MAAB)	- -	Ensure tactile exit signs with raised characters and braille are provided at exit doors. Mount signs between 48"- 60" above the finished floor located on the latch side of the door. Provide an illuminated sign with the International Symbol of Accessibility (ISA).	1	
54	Building C, Exit to Northeast Plaza by the Elevator	Ext.		Means of Egress	N/A

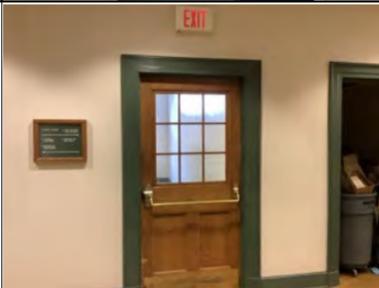
Tactile exit sign not provided Illuminated ISA symbol not provided (MAAB)	- -	Ensure tactile exit signs with raised characters and braille are provided at exit doors. Mount signs between 48"- 60" above the finished floor located on the latch side of the door. Provide an illuminated sign with the International Symbol of Accessibility (ISA).	1	
55	Building C, Town Hall, Northwest Egress to Stair	1		Means of Egress	N/A

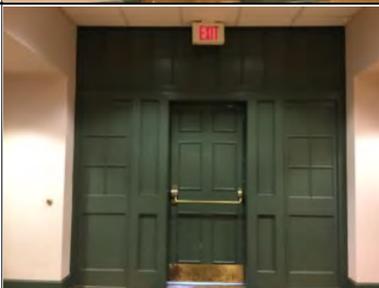
Tactile exit sign not provided Directional sign to accessible emergency exit not provided	- -	Ensure tactile exit signs with raised characters and braille are provided at exit doors. Mount signs between 48"- 60" above the finished floor located on the latch side of the door. Provide a directional sign indicating the location of the nearest accessible emergency exit. Recommend locating the directional sign over the tactile sign.	1

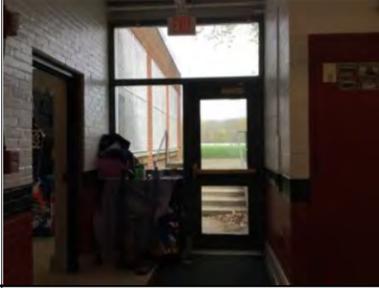
ID	Location	Floor	Room	Element	Type	Photo	Issues	Current Measure	Recommendations	Quantity	Notes
56	Building D, Recreation Department, East Egress to Fields	1		Means of Egress	N/A

Tactile exit sign not provided Directional sign to accessible emergency exit not provided	- -	Ensure tactile exit signs with raised characters and braille are provided at exit doors. Mount signs between 48"- 60" above the finished floor located on the latch side of the door. Provide a directional sign indicating the location of the nearest accessible emergency exit. Recommend locating the directional sign over the tactile sign.	1	
57	Building C, Sanborn Auditorium North and South Exits to Stairs	2		Means of Egress	N/A

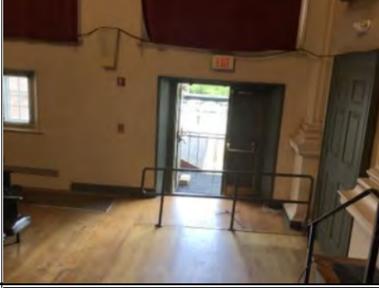
Tactile exit sign not provided Directional sign to accessible emergency exit not provided	- -	Ensure tactile exit signs with raised characters and braille are provided at exit doors. Mount signs between 48"- 60" above the finished floor located on the latch side of the door. Provide a directional sign indicating the location of the nearest accessible emergency exit. Recommend locating the directional sign over the tactile sign.	2

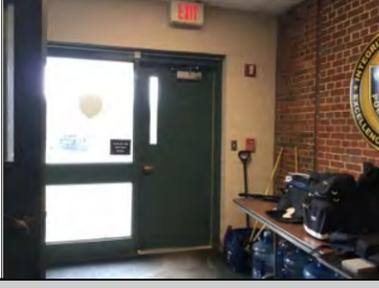
Tactile sign not provided at exit Illuminated Int. Symbol of Acc. not provided (MAAB 2006)	- -	Provide tactile exit signs with raised characters and braille at exit doors. Mount signs between 48"- 60" above the finished floor located on the latch side of the door. Provide an illuminated sign with the International Symbol of Accessibility (ISA).	1

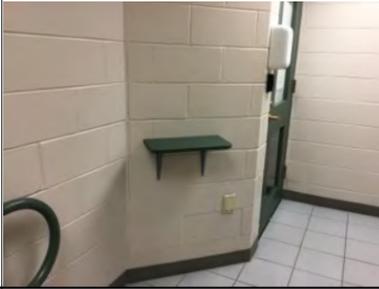
Interior Access Route											
60	Building B, Police Department, Route to Licensing	1		Interior Access Route	N/A

Obstructed by protruding objects	9.6"	Remove shelf from the circulation path.	1

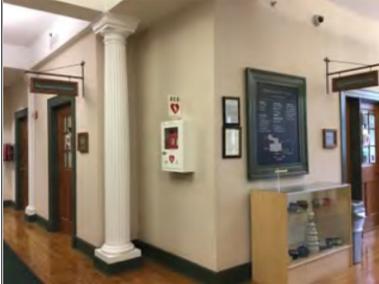
ID	Location	Floor	Room	Element	Type	Photo	Issues	Current Measure	Recommendations	Quantity	Notes
61	Building C, Town Hall, By North Directory and Treasurer/Collector	1		Interior Access Route	N/A

Obstructed by protruding objects	6"	Provide a cane-detectable barrier underneath the defibrillator.	1	
62	Building B, Police Department, Police Department Central Stair, to Records & Administration	2		Interior Access Route	N/A

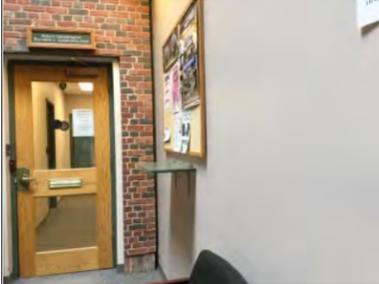
Obstructed by protruding objects	11.3"	Remove the shelf.	1	
63	Building B, Police Department, Records & Administration, to Police Department Central Stair	2		Interior Access Route	N/A

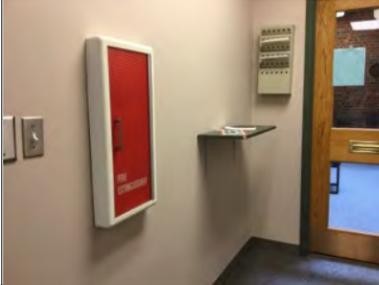
Obstructed by protruding objects	11.5"	Remove the shelf.	1	
64	Building C, Men's Toilet Room	2		Interior Access Route	N/A

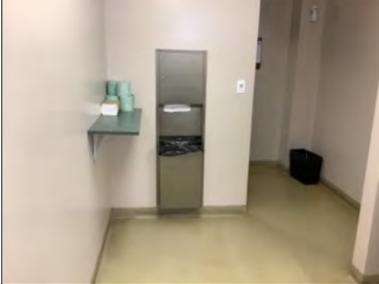
Obstructed by protruding objects	11"	Remove the shelf.	1	
65	Building C, Central Meeting Room North Door	2		Interior Access Route	N/A

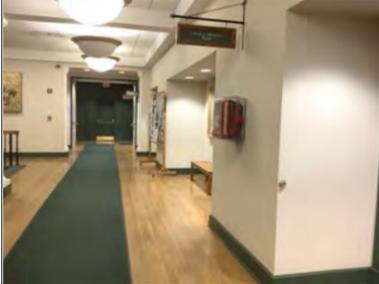
Obstructed by protruding objects	11"	Relocate the defibrillator out of the circulation path.	1

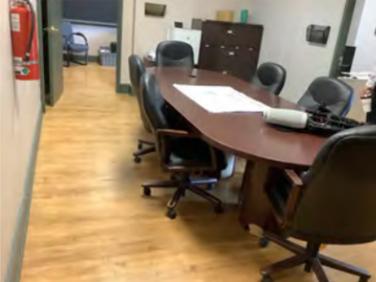
ID	Location	Floor	Room	Element	Type	Photo	Issues	Current Measure	Recommendations	Quantity	Notes
66	Building C, Committee Room	3		Interior Access Route	N/A

Obstructed by protruding objects	5"	Relocate fire extinguisher out of the circulation path.	1	
67	Building C, Recreation Department, Spinning Classroom (Southeast Side of Building)	B		Interior Access Route	N/A

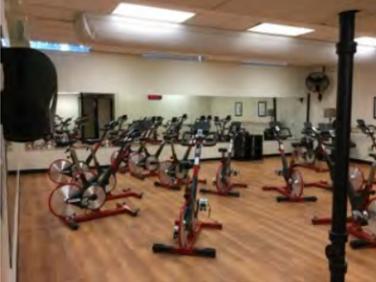
Obstructed by protruding objects	8.5"	Relocate the paper towel dispenser out of the circulation path.	1	
68	Building C, Recreation Department, Fitness Room	B		Interior Access Route	N/A

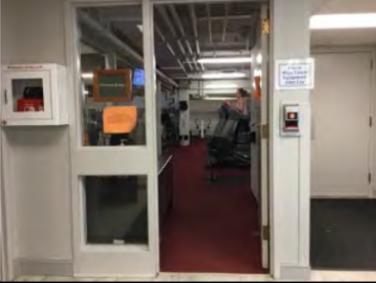
Obstructed by protruding objects	6.7"	Provide a cane-detectable barrier under the defibrillator.	1	
69	Building C, Recreation Department, Fitness Room	B		Interior Access Route	N/A

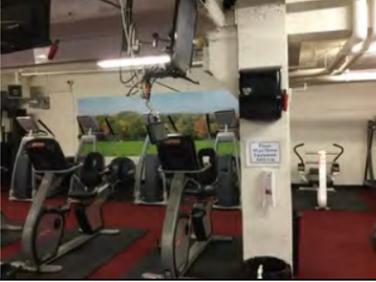
Obstructed by protruding objects	10"	Relocate the paper towel dispenser out of the circulation path.	1	
70	Building D, Recreation Department, South Egress to the Gym in the Basement of Town Hall	1		Interior Access Route	N/A

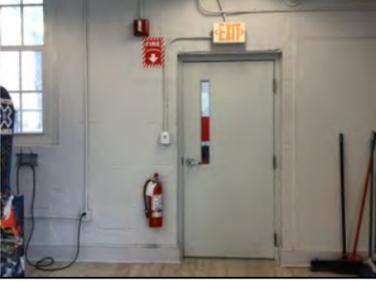
Accessible route not provided	-	Provide a 2-stop limited use limited application (LULA) elevator (or other interior accessible route) between the levels of Building C and Building D.	1

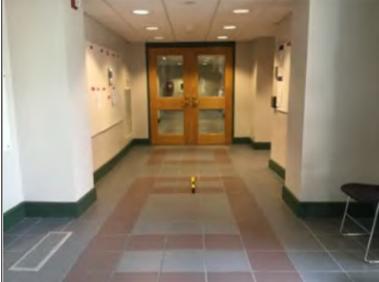
ID	Location	Floor	Room	Element	Type	Photo	Issues	Current Measure	Recommendations	Quantity	Notes
71	Building B, Police Department, Lobby to Toilet Rooms	1		Interior Access Route	N/A

Running slope > 1:20 (5.00%)	6.1%	Provide compliant handrails with 1 1/4"- 2" circular cross sections.	2	
72	Building C, Recreation Department, Gym, Northwest Egress Stair	B		Interior Access Route	N/A

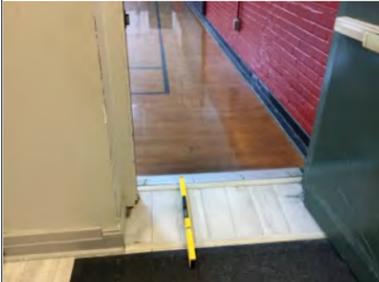
Running slope > 1:20 (5.00%)	7.1%	It may be technically infeasible to make this route accessible.	1	
73	Building B: Stair by Senior Center	1		Interior Access Route	N/A

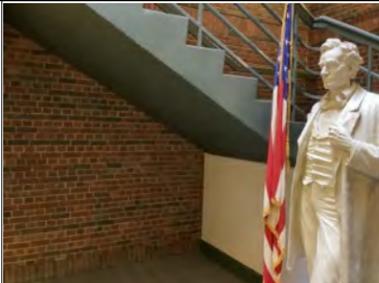
Vertical clearance < 80" above finished floor	-	Provide a cane-detectable barrier under the entire portion of the stair that is less than 80" high. Fixed barriers, such as guardrails, are required where the vertical clearance is less than 80" such as at open stairways. Barriers must have leading edges no higher than 27" so that they are within cane sweep. Fixed planters, benches, and other elements can be used instead of guardrails.	1

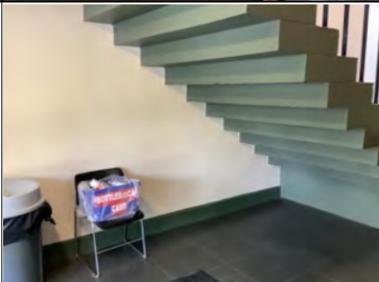
74	Building C, Town Hall, Underside of Stair at the Stepped Inaccessible North Entrance	1		Interior Access Route	N/A

Vertical clearance < 80" above finished floor	-	Provide a cane-detectable barrier under the entire portion of the stair that is less than 80" high. Fixed barriers, such as guardrails, are required where the vertical clearance is less than 80" such as at open stairways. Barriers must have leading edges no higher than 27" so that they are within cane sweep. Fixed planters, benches, and other elements can be used instead of guardrails.	1	
75	Building B, School Department, Entrance	3		Interior Access Route	N/A

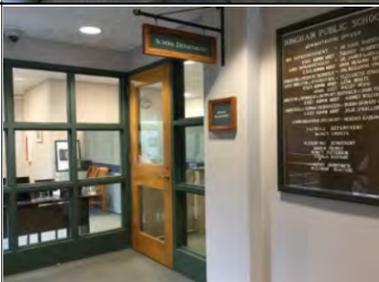
Vertical clearance < 80" above finished floor	75.5"	Relocate hanging sign so that it is no lower than 80" above the finished floor.	1

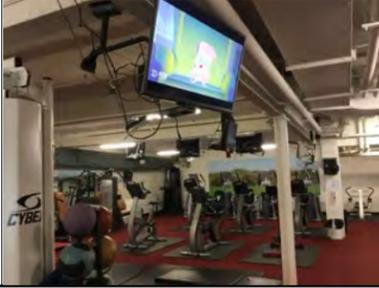
ID	Location	Floor	Room	Element	Type	Photo	Issues	Current Measure	Recommendations	Quantity	Notes
76	Building C, Recreation Department, Fitness Room	B		Interior Access Route	N/A

Vertical clearance < 80" above finished floor	69"	Relocate the television so that it is higher than 80" above the finished floor.	1	
Doors, Doorways, & Gates											
77	Building C, Recreation Department, Gym, Northwest Egress Stair, Route From Elevator Lobby	B		Doors, Doorways, & Gates	Circulation

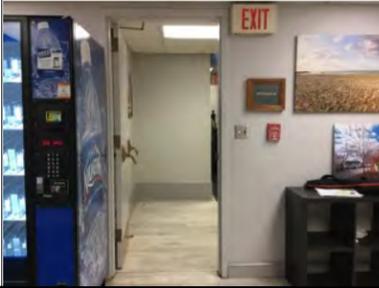
Clear width at door < 32"	29"	Widen the door so that there is 32" min. clear width.	1	
78	Building C, Recreation Department, Gym, Southwest Egress Stair, Route From Elevator Lobby	B		Doors, Doorways, & Gates	Emergency Egress

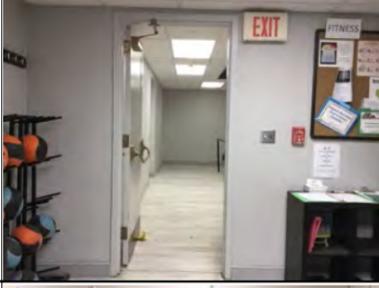
Clear width at door < 32"	29"	Widen the door so that there is 32" min. clear width.	1	
79	Building A, Senior Center, Kitchen	1		Doors, Doorways, & Gates	Circulation

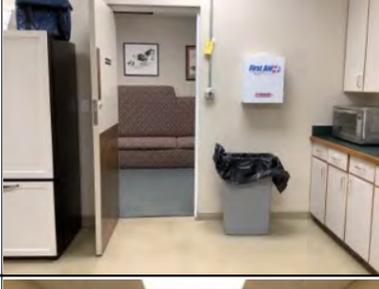
Maneuvering clearance(s) not provided	-	Ensure that trash bin is located 18" min. from the latch side of the door.	1

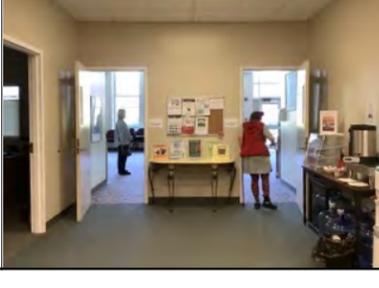
80	Building A, Senior Center. Multi-Purpose Room (2 Doors)	1		Doors, Doorways, & Gates	Meeting Room

Maneuvering clearance(s) not provided	-	Relocate the table to ensure that there is 18" on the latch pull side of each of the two doors.	2

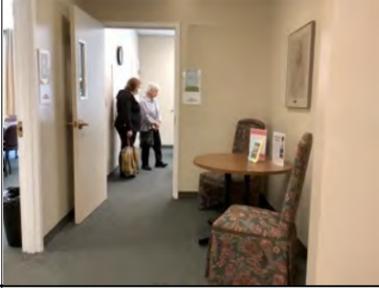
ID	Location	Floor	Room	Element	Type	Photo	Issues	Current Measure	Recommendations	Quantity	Notes
81	Building A, Senior Center, Small Classroom	1		Doors, Doorways, & Gates	Classroom

Maneuvering clearance(s) not provided	-	Relocate furniture to ensure there is 18" min. on the latch pull side of the door.	1	
82	Building C, Historical Commission	2		Doors, Doorways, & Gates	Office

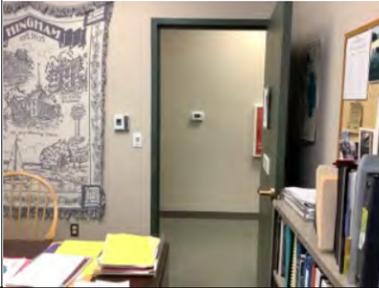
Maneuvering clearance(s) not provided	-	Relocate furniture so that there is 60" clear deep min. on the pull side of the door.	1	
83	Building C, Building Department/ Fire Prevention	2		Doors, Doorways, & Gates	Other

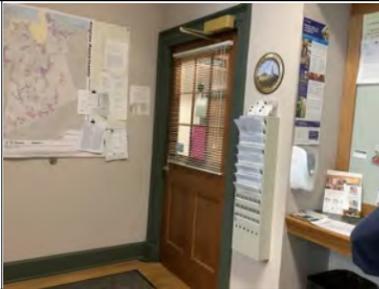
Maneuvering clearance(s) not provided	7"	Relocate literature holder away from the pull side of the door. Ensure that there is 18" clear on the latch side of the door.	1	
84	Building C, Women's Toilet Room	2		Doors, Doorways, & Gates	Toilet Room

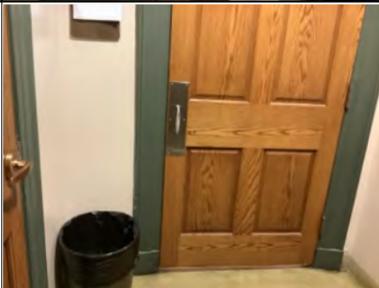
Maneuvering clearance(s) not provided	-	Relocate the trash bin. 18" min. should be clear on the latch pull side of the door.	1

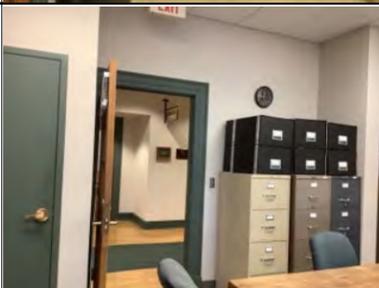
85	Building C, Zoning Board of Appeals	2		Doors, Doorways, & Gates	Office

Maneuvering clearance(s) not provided	12"	Relocate file cabinets so that there is 18" min. on the latch side of the door. 18" min. should be clear on the latch pull side of the door.	1

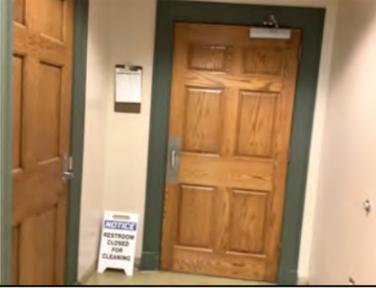
ID	Location	Floor	Room	Element	Type	Photo	Issues	Current Measure	Recommendations	Quantity	Notes
86	Building C, Women's Toilet Room	3		Doors, Doorways, & Gates	Toilet Room

Maneuvering clearance(s) not provided	-	Relocate the sign out of the door maneuvering clearance. 18" min. should be clear on the latch pull side of the door.	1	
87	Building C, South Hearing Room	3		Doors, Doorways, & Gates	Meeting Room

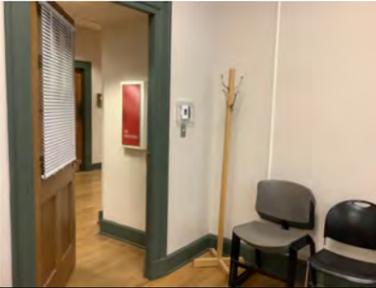
Maneuvering clearance(s) not provided	-	Relocate furniture so that there is 12" clear min. on the push latch side of the door.	1	
88	Building C, Men's Toilet Room	3		Doors, Doorways, & Gates	Toilet Room

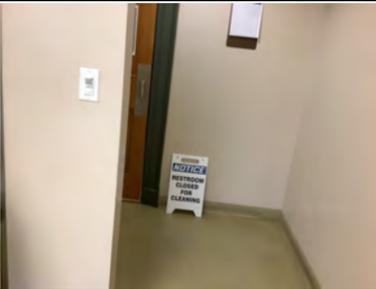
Maneuvering clearance(s) not provided	-	Relocate the sign out of the door maneuvering clearance.	1	
89	Building C, Select Board, Town Administrator - Conference Room	3		Doors, Doorways, & Gates	Office

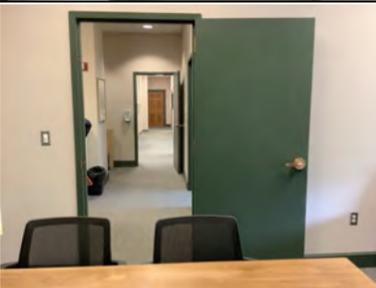
Maneuvering clearance(s) not provided	36" to 52"	Relocate table and chairs so that there is 60" min. clear on the pull side of the door.	1

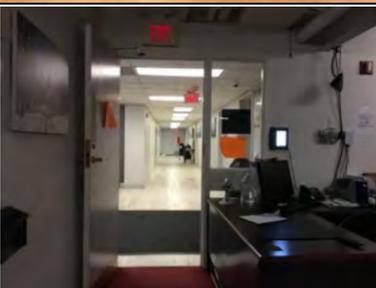
90	Building C, Recreation Department, Fitness Room, Northwest Egress Door	B		Doors, Doorways, & Gates	Circulation

Maneuvering clearance(s) not provided	-	Relocate the desk so that there is 18" clear on the latch pull side of the door.	1
