Central Fire Station

Town of Hingham ADA Transition Plan

October 2023

Institute for Human Centered Design

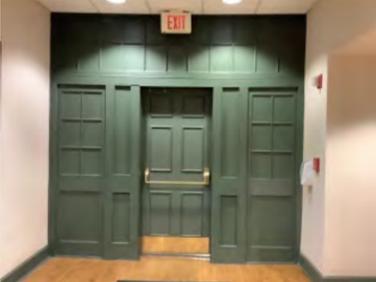
ID	Location	Floor	Room	Element	Type	Photo	Issues	Current Measure	Recommendations	Quantity	Notes
91	Building C, Town Hall, Door to Ramp That Connects to Building B	1		Doors, Doorways, & Gates	Circulation

Maneuvering clearance not provided at recess > 6"	8"	The door is recessed greater than 6" deep. Install an automatic door opener or renovate the door and wall so that it is flush with the wall on both sides.	1	
92	Building C, Sanborn Auditorium, North and South Doors to Corridor	2		Doors, Doorways, & Gates	Other

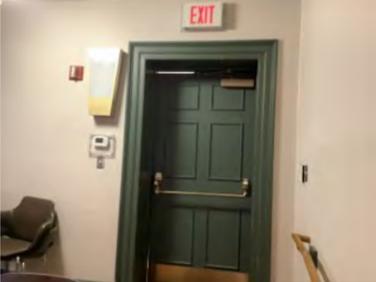
Maneuvering clearance not provided at recess > 6"	14"	The door is recessed greater than 6" deep. Install an automatic door opener.	2	
93	Building D, Recreation Department, Office	1		Doors, Doorways, & Gates	Office

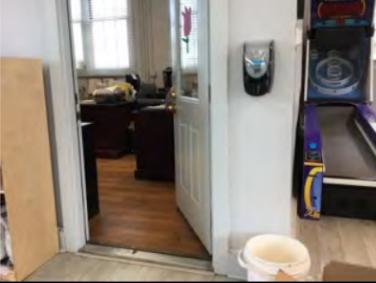
Threshold > 1/2" high	0.75"	Alter the threshold to be 1/2" high max.	1	
94	Building B, Police Department, West Egress, Main Entrance	1		Doors, Doorways, & Gates	Other

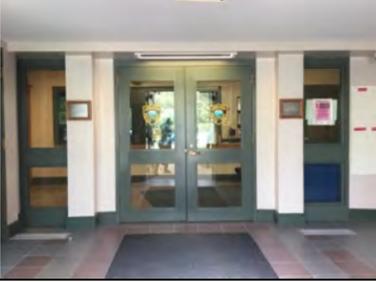
Door requires > 5 lbs. of force to open	8 lbs	Adjust closers so doors do not require more than 5 pounds of force to open.	1

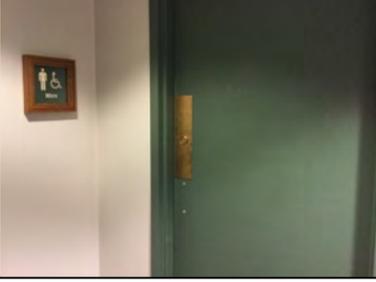
95	Building B, Police Department, Lobby, Women's and Men's Toilet Rooms	1		Doors, Doorways, & Gates	Toilet Room

Door requires > 5 lbs. of force to open	7 lbs	Adjust closers so doors do not require more than 5 pounds of force to open.	2

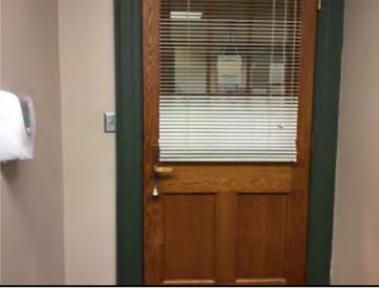
Door requires > 5 lbs. of force to open	10 lbs	Adjust closers so doors do not require more than 5 pounds of force to open.	1	
97	Building C, Town Hall, Board of Health	1		Doors, Doorways, & Gates	Office

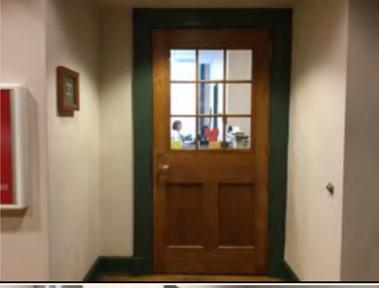
Door requires > 5 lbs. of force to open	10 lbs	Adjust closers so doors do not require more than 5 pounds of force to open.	1	
98	Building A, Senior Center, Women's Toilet Room	1		Doors, Doorways, & Gates	Toilet Room

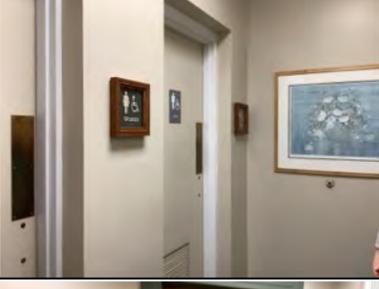
Door requires > 5 lbs. of force to open	8 lbs	Adjust closers so doors do not require more than 5 pounds of force to open.	1	
99	Building C, Men's Toilet Room	2		Doors, Doorways, & Gates	Toilet Room

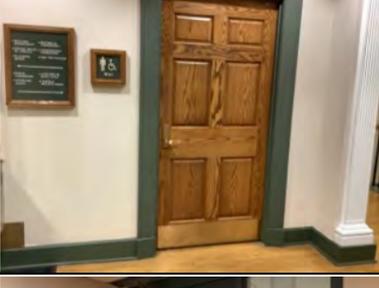
Door requires > 5 lbs. of force to open	17 lbs	Adjust closers so doors do not require more than 5 pounds of force to open.	1

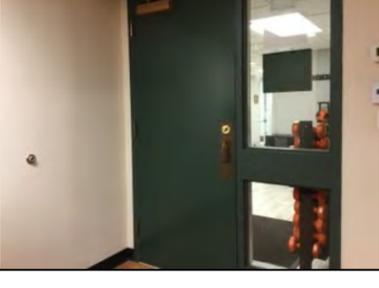
100	Building C, Recreation Department, Spinning Classroom (Southeast Side of Building)	B		Doors, Doorways, & Gates	Classroom

Door requires > 5 lbs. of force to open	8 lbs	Adjust closers so doors do not require more than 5 pounds of force to open.	1

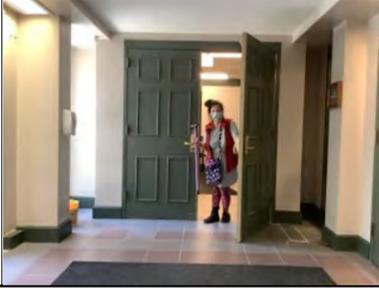
Automatic door opener not operable	-	Repair or replace the door opener.	1	
Ramps											
102	Building C, Town Hall, Ramp That Connects to Building B	1		Ramps	Interior

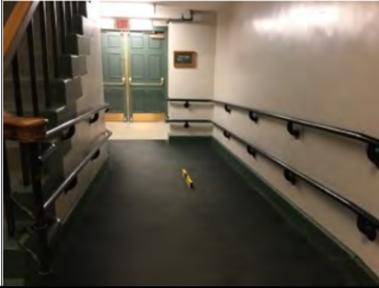
Running slope >1:12 (8.33%) Handrails < 34" or > 38" above ramp surface	9.3%-10% 29"	Repair to this ramp's running slope might be technically infeasible. Alter so that the top handrails are located 34"-38" high above the floor.	1	
103	Building B, Police Station to Building C, Town Hall	1		Ramps	Interior

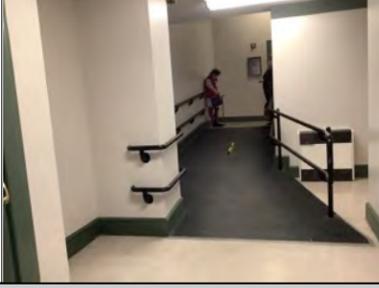
Handrails do not extend 12" past top & bottom	-	Alter handrails to extend horizontally above the landing for 12" min. beyond the top and bottom of ramp runs.	1	
Stairways											
104	Building C, Town Hall, Central Stair, South Side	1		Stairways	Egress

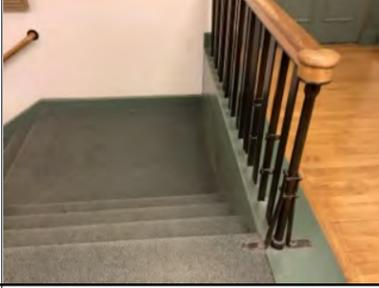
Handrail not provided on both sides	-	Provide handrails on both sides of the stair.	1

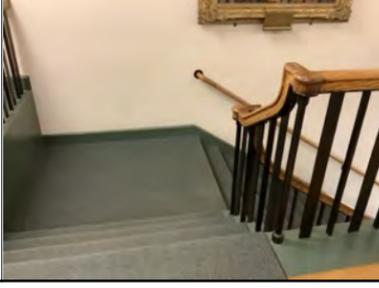
105	Building C, Town Hall, Central Stair, North Side	1		Stairways	Egress

Handrail not provided on both sides	-	Provide handrails on both sides of the stair.	1

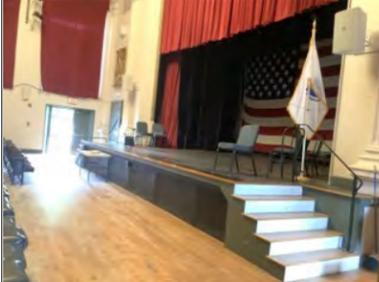
Handrail not provided on both sides Handrails do not extend 12" from stairs	- -	Provide handrails on each side. Top: Ensure handrails extend horizontally above the landing for 12" min. beginning above the first riser nosing. Bottom: Ensure handrails extend to one tread depth beyond the last riser.	2	
107	Building C, Recreation Department, Gym, Northwest Egress Stair	B		Stairways	Egress

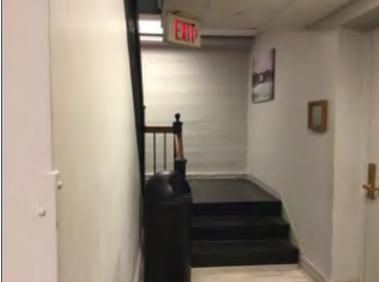
Handrail not provided on both sides Handrails do not extend 12" from stairs	- -	Provide handrails on both sides of the stair. Top: Ensure handrails extend horizontally above the landing for 12" min. beginning above the first riser nosing. Bottom: Ensure handrails extend to one tread depth beyond the last riser.	1	
108	Building C, Town Hall, Northwest Stair	1		Stairways	Egress

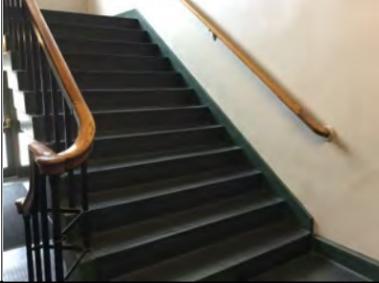
Handrails do not extend 12" from stairs	-	Top: Ensure handrails extend horizontally above the landing for 12" min. beginning above the first riser nosing. Bottom: Ensure handrails extend to one tread depth beyond the last riser.	1

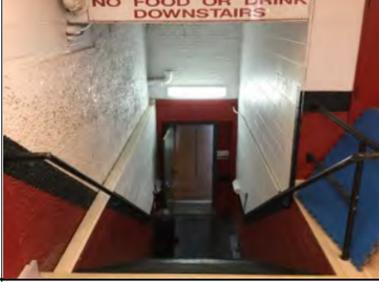
109	Building D, Recreation Department, Stairs to Gym in the Basement of Building C	1		Stairways	Egress

Handrails do not extend 12" from stairs	-	Top: Ensure handrails extend horizontally above the landing for 12" min. beginning above the first riser nosing. Bottom: Ensure handrails extend to one tread depth beyond the last riser.	1	
110	Building C, Town Hall, Central Stair	1		Stairways	Egress

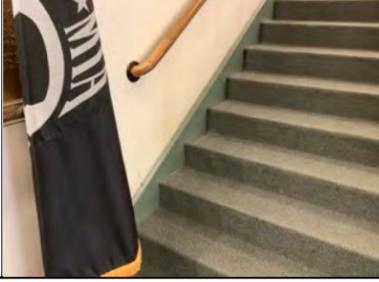
Handrails do not extend 12" from stairs	-	Bottom: Ensure handrails extend to one tread depth beyond the last riser.	2

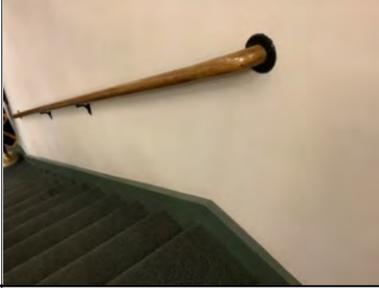
Handrails do not extend 12" from stairs	-	Top: Ensure handrails extend horizontally above the landing for 12" min. beginning above the first riser nosing.	2	
112	Building C, Town Hall, Northwest Stair	2		Stairways	Egress

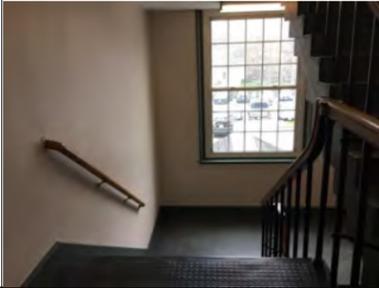
Handrails do not extend 12" from stairs		Top: Ensure handrails extend horizontally above the landing for 12" min. beginning above the first riser nosing. Bottom: Ensure handrails extend to one tread depth beyond the last riser.	1	
113	Building C, Town Hall, Northwest Stair	2		Stairways	Egress

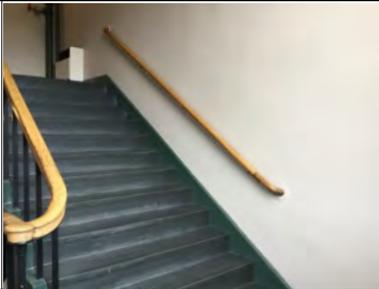
Handrails do not extend 12" from stairs	-	Top: Ensure handrails extend horizontally above the landing for 12" min. beginning above the first riser nosing. Bottom: Ensure handrails extend to one tread depth beyond the last riser.	2

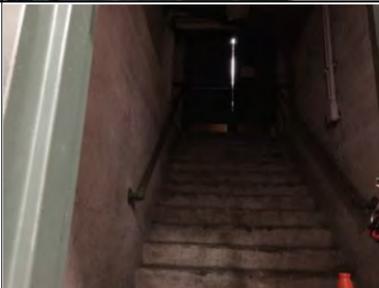
114	Building C, Recreation Department, Gym, Southeast Egress to Stairs	B		Stairways	Egress

Handrails do not extend 12" from stairs	-	Top: Ensure handrails extend horizontally above the landing for 12" min. beginning above the first riser nosing. Bottom: Ensure handrails extend to one tread depth beyond the last riser.	1	
115	Building B, Police Department Central Stair	1		Stairways	Egress

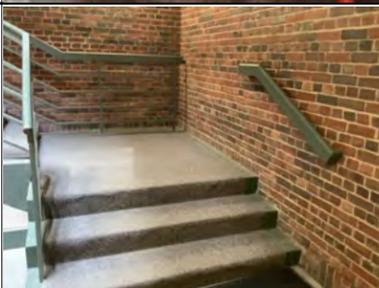
Handrails do not extend 12" from stairs Handrails have non-compliant cross section	- -	Provide handrails with 1 1/4" - 2" circular cross sections. Handrail to the right is not circular. Top: Ensure handrails extend horizontally above the landing for 12" min. beginning above the first riser nosing. Bottom: Ensure handrails extend to one tread depth beyond the last riser.	1

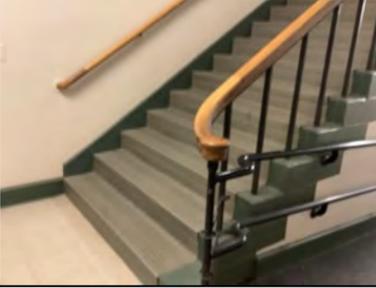
Handrails do not extend 12" from stairs Handrails have non-compliant cross section	- -	At the side handrails: Ensure handrails extend horizontally above the landing for 12" min. beginning above the first riser nosing. Bottom: Ensure handrails extend to one tread depth beyond the last riser. At the central handrail: provide a handrail with a 1 1/4" - 2" circular cross section.	1	
117	Building C, Town Hall, Northwest Entrance Stair	1		Stairways	Egress

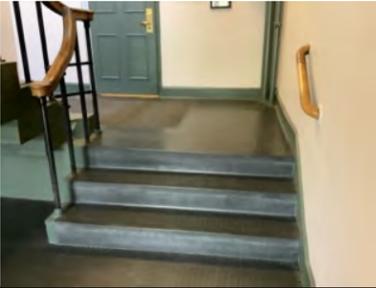
Handrails do not extend 12" from stairs Handrails have non-compliant cross section		At the side handrails: Ensure handrails extend horizontally above the landing for 12" min. beginning above the first riser nosing. Bottom: Ensure handrails extend to one tread depth beyond the last riser. At the central handrail: provide a handrail with a 1 1/4" - 2" circular cross section.	1

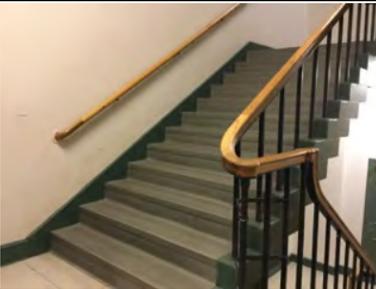
118	Building C, Town Hall, South Stairwell by Building B	2		Stairways	Egress

Handrails do not extend 12" from stairs Handrails have non-compliant cross section	- -	Top: Ensure handrails extend horizontally above the landing for 12" min. beginning above the first riser nosing. Bottom: Ensure handrails extend to one tread depth beyond the last riser. Provide handrails with 1 1/4" - 2" circular cross sections. Central handrail has a noncompliant cross section.	1	
119	Building C, Town Hall, Stairs Connecting Stair to Building B	2		Stairways	Egress

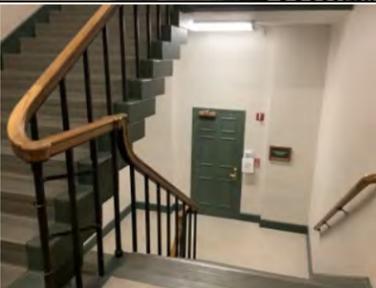
Handrails do not extend 12" from stairs Handrails have non-compliant cross section	- -	At the side handrails: Ensure handrails extend horizontally above the landing for 12" min. beginning above the first riser nosing. Bottom: Ensure handrails extend to one tread depth beyond the last riser. At the central handrail: provide a handrail with a 1 1/4" - 2" circular cross section.	1

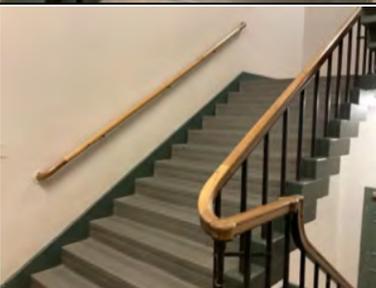
120	Building C, Town Hall, Stairs to the Third Floor	2		Stairways	Egress

Handrails do not extend 12" from stairs Handrails have non-compliant cross section	- -	At the side handrails: Ensure handrails extend horizontally above the landing for 12" min. beginning above the first riser nosing. Bottom: Ensure handrails extend to one tread depth beyond the last riser. At the central handrail: provide a handrail with a 1 1/4" - 2" circular cross section.	1

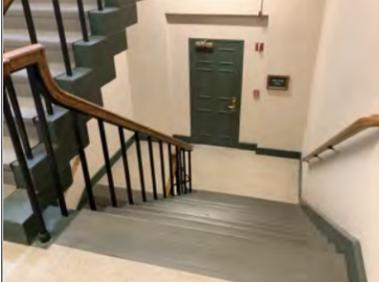
Handrails do not extend 12" from stairs Handrails have non-compliant cross section	- -	At the side handrails: Ensure handrails extend horizontally above the landing for 12" min. beginning above the first riser nosing. Bottom: Ensure handrails extend to one tread depth beyond the last riser. At the central handrail: provide a handrail with a 1 1/4" - 2" circular cross section.	1	
122	Building C, Recreation Department, Gym, Southwest Egress Stair	B		Stairways	Egress

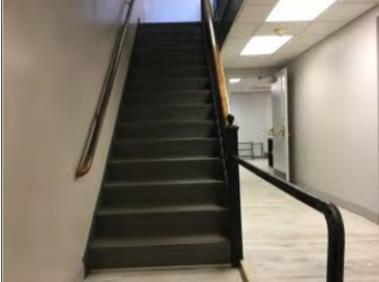
Handrails do not extend 12" from stairs Handrails have non-compliant cross section	- -	On the rail on the left side of the photo: Ensure handrails extend horizontally above the landing for 12" min. beginning above the first riser nosing. Ensure handrails extend to one tread depth beyond the last riser. At the rail on the right side of the photo, provide a handrail with a 1 1/4" - 2" circular cross section that extends at the top and bottom of the stair run.	1

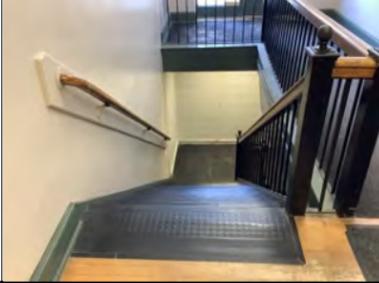
123	Building C, Recreation Department, Gym, Northwest Egress Stair by Elevator	Ext.		Stairways	Egress

Handrails do not extend 12" from stairs Handrails have non-compliant cross section	- -	At the side handrails: Ensure handrails extend horizontally above the landing for 12" min. beginning above the first riser nosing. Bottom: Ensure handrails extend to one tread depth beyond the last riser. At the central handrail: provide a handrail with a 1 1/4" - 2" circular cross section.	1	
124	Building C, Town Hall, Northwest Stair	2		Stairways	Egress

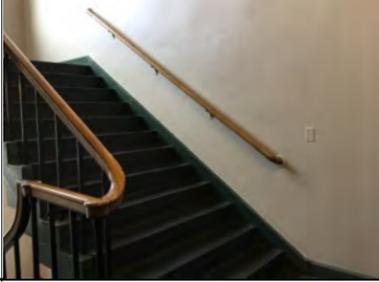
Handrails have non-compliant cross section	-	Central handrail has a non-compliant cross section. Provide handrails with 1 1/4" - 2" circular cross sections.	1	
125	Building C, Town Hall, Central Stair	1		Stairways	Egress

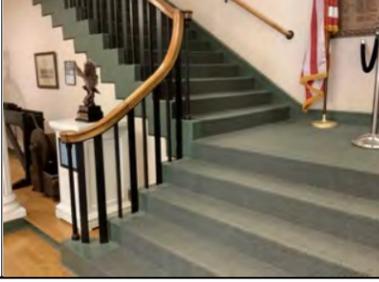
Handrails have non-compliant cross section Handrails do not extend 12" from stairs	- -	Bottom: Ensure handrails extend to one tread depth beyond the last riser. Provide handrails with 1 1/4" - 2" circular cross sections.	2

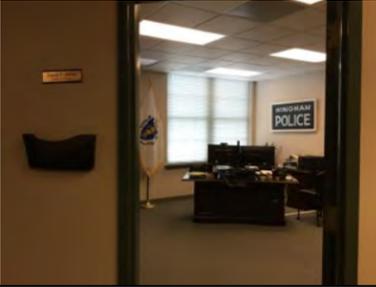
Raised characters not provided on sign Braille not provided on sign	- -	Provide text with raised characters duplicated in braille on sign.	5	
127	Building B, School Department, Conference Room	3		Signage	Designation

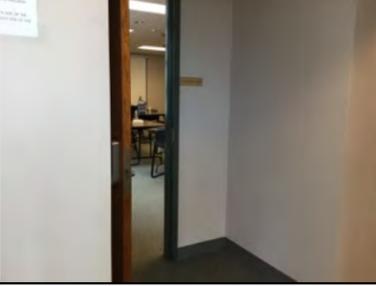
Raised characters not provided on sign Braille not provided on sign	- -	Provide text with raised characters duplicated in braille on sign.	1	
128	Building C, Select Board, Town Administrator	3		Signage	Designation

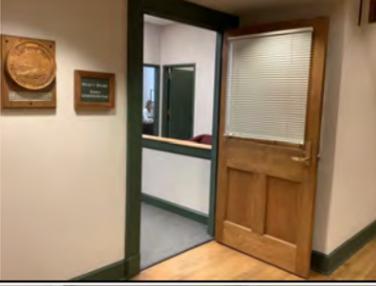
Raised characters not provided on sign Braille not provided on sign	- -	Provide text with raised characters duplicated in braille on sign.	1	
129	Building C, Recreation Department, Storage Room	B		Signage	Designation

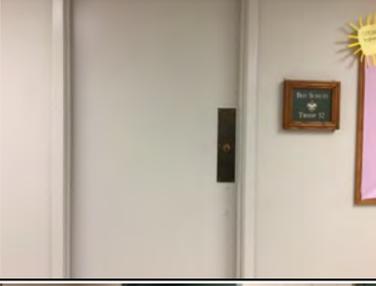
Raised characters not provided on sign Braille not provided on sign	- -	Provide text with raised characters duplicated in braille on sign. Best practice: the sign is for a boy' scout troop. We recommend updating the sign to the current use.	1

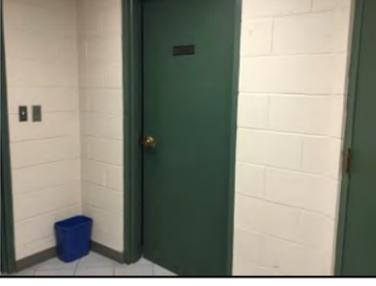
130	Building B, Police Department, Licensing	1		Signage	Designation

Raised characters not provided on sign Braille not provided on sign Sign not located on the latch side of the door	- - -	Provide text with raised characters duplicated in braille on sign. Locate the sign at permanent rooms alongside the door on the latch side.	1

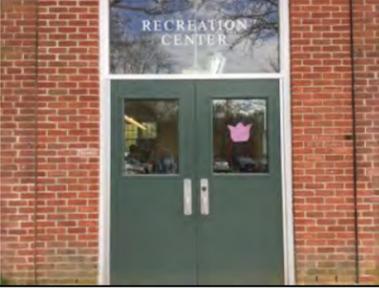
ID	Location	Floor	Room	Element	Type	Photo	Issues	Current Measure	Recommendations	Quantity	Notes
131	Building D, Recreation Department, North Egress, Main Entrance	1		Signage	Designation

<p>Raised characters not provided on sign Braille not provided on sign Sign not located on the latch side of the door Non-glare finish and contrast not provided on sign</p>	<ul style="list-style-type: none"> - - - - 	<p>Provide text with raised characters duplicated in braille on sign. Locate the sign at permanent rooms alongside the door on the latch side. Where a tactile sign is provided at double doors with two active leaves, the sign shall be located to the right of the right hand door. Install a sign with a non-glare finish.</p>	1	
132	Building C, Town Hall, Door to South Stair and Ramp That Connects to Building B	1		Signage	Egress

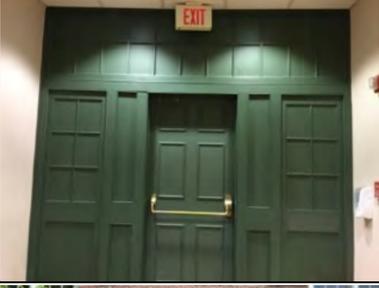
<p>Raised characters not provided on sign Braille not provided on sign Sign not located on the latch side of the door</p>	<ul style="list-style-type: none"> - - - 	<p>Provide text with raised characters duplicated in braille on sign. Locate the sign at permanent rooms alongside the door on the latch side.</p>	1

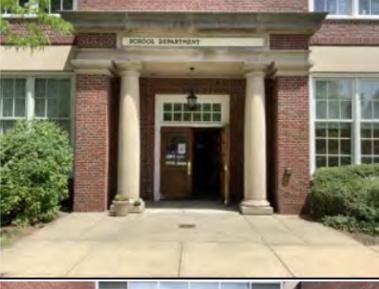
133	Building B, School Department, Main Entrance	1		Signage	Designation

<p>Raised characters not provided on sign Braille not provided on sign Sign not located on the latch side of the door</p>	<ul style="list-style-type: none"> - - - 	<p>Provide text with raised characters duplicated in braille on sign. Locate the sign at permanent rooms alongside the door on the latch side. Where a tactile sign is provided at double doors with two active leaves, the sign shall be located to the right of the right hand door.</p>	1	
134	Building B, Police Station, Main Entrance	1		Signage	Designation

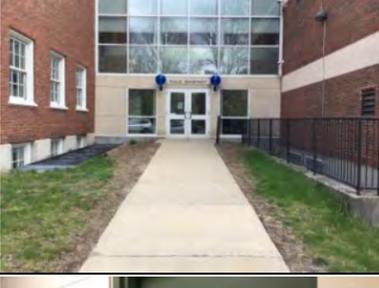
<p>Raised characters not provided on sign Braille not provided on sign Sign not located on the latch side of the door</p>	<ul style="list-style-type: none"> - - - 	<p>Provide text with raised characters duplicated in braille on sign. Provide braille on the sign. Locate the sign at permanent rooms alongside the door on the latch side. Where a tactile sign is provided at double doors with two active leaves, the sign shall be located to the right of the right hand door.</p>	1

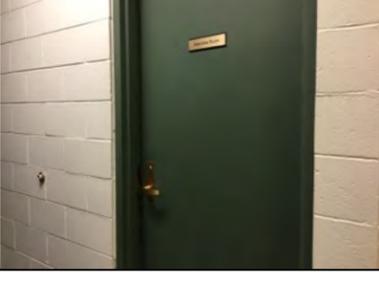
135	Building A, Police Station, Interview Room	1, Lower Portion		Signage	Designation

<p>Raised characters not provided on sign Braille not provided on sign Sign not located on the latch side of the door</p>	<ul style="list-style-type: none"> - - - 	<p>Provide text with raised characters duplicated in braille on sign. Locate the sign at permanent rooms alongside the door on the latch side.</p>	1

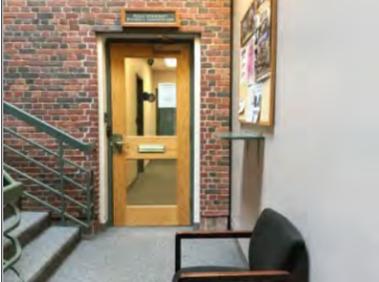
ID	Location	Floor	Room	Element	Type	Photo	Issues	Current Measure	Recommendations	Quantity	Notes
136	Building B, Police Department, Police Department Central Stair, to Records & Administration	2		Signage	Designation

Raised characters not provided on sign Braille not provided on sign Sign not located on the latch side of the door	- - -	Provide text with raised characters duplicated in braille on sign. Locate the sign at permanent rooms alongside the door on the latch side.	1	
137	Building C, Conservation & Historical Commission	2		Signage	Designation

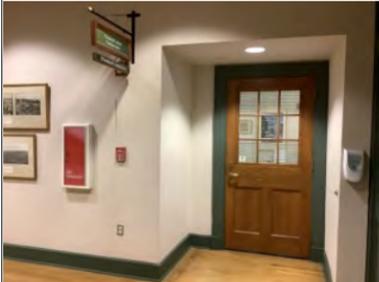
Raised characters not provided on sign Braille not provided on sign Sign not located on the latch side of the door	- - -	Provide text with raised characters duplicated in braille on sign. Locate the sign at permanent rooms alongside the door on the latch side.	1	
138	Building C, Human Resources & Benefits	2		Signage	Designation

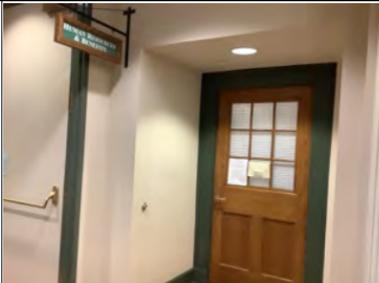
Raised characters not provided on sign Braille not provided on sign Sign not located on the latch side of the door	- - -	Provide text with raised characters duplicated in braille on sign. Locate the sign at permanent rooms alongside the door on the latch side.	1

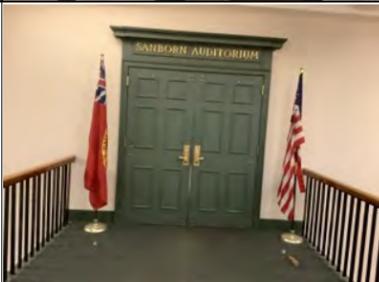
139	Building C, Sanborn Auditorium	2		Signage	Designation

Raised characters not provided on sign Braille not provided on sign Sign not located on the latch side of the door	- - -	Provide text with raised characters duplicated in braille on sign. Locate the sign at permanent rooms alongside the door on the latch side. Where a tactile sign is provided at double doors with two active leafs, the sign shall be located to the right of the right hand door.	1	
140	Building C, Recreation Department, Gym, Northeast Egress to Stairs to Building D	B		Signage	Egress

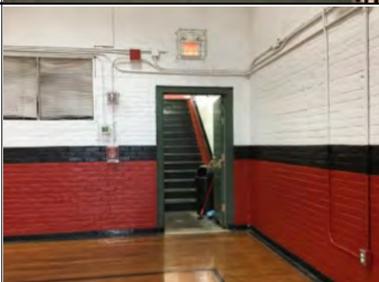
Raised characters not provided on sign Braille not provided on sign Sign not located on the latch side of the door	- - -	Provide text with raised characters duplicated in braille on sign. Locate the sign at permanent rooms alongside the door on the latch side.	1

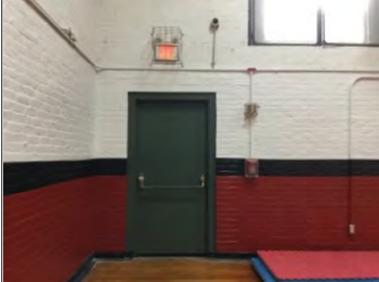
ID	Location	Floor	Room	Element	Type	Photo	Issues	Current Measure	Recommendations	Quantity	Notes
141	Building C, Recreation Department, Gym, Southeast Egress to Stairs	B		Signage	Egress

<ul style="list-style-type: none"> Raised characters not provided on sign Braille not provided on sign Sign not located on the latch side of the door 	<ul style="list-style-type: none"> - - - 	<ul style="list-style-type: none"> Provide text with raised characters duplicated in braille on sign. Provide braille on the sign. Locate the sign at permanent rooms alongside the door on the latch side. 	1	
142	Building C, Recreation Department, Gym, Southwest Egress Stair	B		Signage	Egress

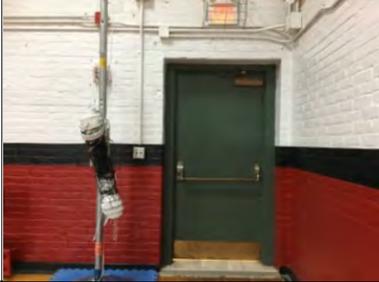
<ul style="list-style-type: none"> Raised characters not provided on sign Braille not provided on sign Sign not located on the latch side of the door 	<ul style="list-style-type: none"> - - - 	<ul style="list-style-type: none"> Provide text with raised characters duplicated in braille on sign. Locate the sign at permanent rooms alongside the door on the latch side. 	1

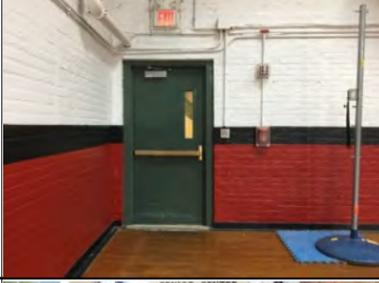
143	Building C, Recreation Department, Gym, Northwest Egress Stair	B		Signage	Egress

<ul style="list-style-type: none"> Raised characters not provided on sign Braille not provided on sign Sign not located on the latch side of the door 	<ul style="list-style-type: none"> - - - - 	<ul style="list-style-type: none"> Provide text with raised characters duplicated in braille on sign. Locate the sign at permanent rooms alongside the door on the latch side. 	1	
144	Building A, Senior Center, Main Entrance	Ext.		Signage	Designation

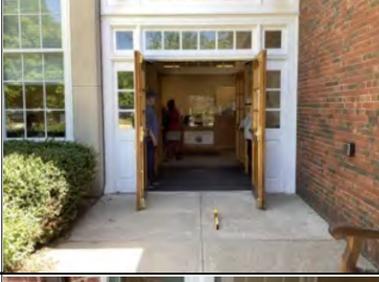
<ul style="list-style-type: none"> Raised characters not provided on sign Braille not provided on sign Sign not located on the latch side of the door 	<ul style="list-style-type: none"> - - - 	<ul style="list-style-type: none"> Provide text with raised characters duplicated in braille on sign. Locate the sign at permanent rooms alongside the door on the latch side. Where a tactile sign is provided at double doors with two active leaves, the sign shall be located to the right of the right hand door. 	1

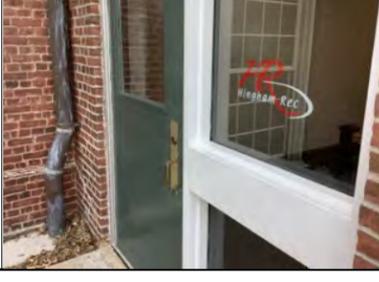
145	Building C, Town Hall, Entrance From Northeast Plaza by the Elevator	Ext.		Signage	Designation

<ul style="list-style-type: none"> Raised characters not provided on sign Braille not provided on sign Sign not located on the latch side of the door 	<ul style="list-style-type: none"> - - - 	<ul style="list-style-type: none"> Provide text with raised characters duplicated in braille on sign denoting "Hingham Rec". Locate the sign at permanent rooms alongside the door on the latch side. 	1

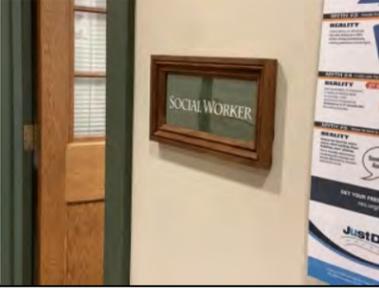
ID	Location	Floor	Room	Element	Type	Photo	Issues	Current Measure	Recommendations	Quantity	Notes
146	Building C, Town Hall, Social Worker	1		Signage	Designation

Raised characters not provided on sign Braille not provided on sign Non-glare finish and contrast not provided on sign	- - -	Provide text with raised characters duplicated in braille on sign. Install a sign with a non-glare finish with characters that have a high contrast to the background.	1	
147	Building A, Senior Center, Small Classroom	1		Signage	Designation

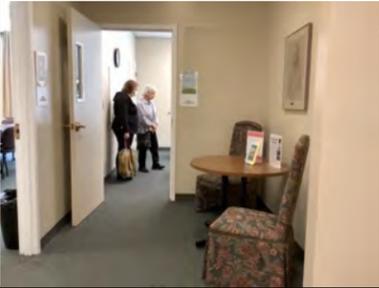
Raised characters < 48" or > 60" above ground	40"	Mount signs so that the baseline of the lowest tactile character is 48" min. above finished floor and the baseline of the highest tactile character is 60" max. above the finished floor.	1	
148	Building B, Police Department, Lobby Toilet Rooms	1		Signage	Designation

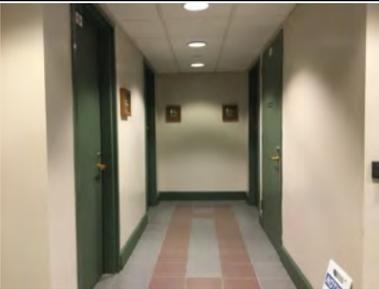
Sign not located on the latch side of the door	-	Locate the toilet room signs alongside the door on the latch side.	2

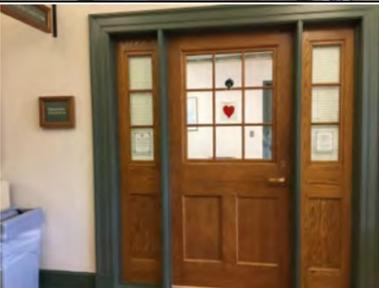
149	Building C, Town Hall, Treasurer/Collector's Office	1		Signage	Designation

Sign not located on the latch side of the door	-	Locate the sign at permanent rooms alongside the door on the latch side.	1	
150	Building C, Town Hall, Town Clerk's Office	1		Signage	Designation

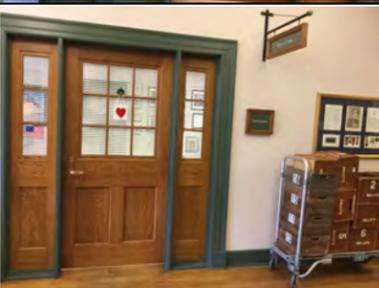
Sign not located on the latch side of the door	-	Locate the sign at permanent rooms alongside the door on the latch side.	1

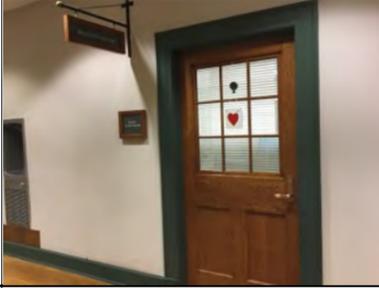
ID	Location	Floor	Room	Element	Type	Photo	Issues	Current Measure	Recommendations	Quantity	Notes
151	Building C, Town Hall, Board of Assessors	1		Signage	Designation

Sign not located on the latch side of the door	-	Locate the sign at permanent rooms alongside the door on the latch side.	1	
152	Building C, Town Hall, Board of Health	1		Signage	Designation

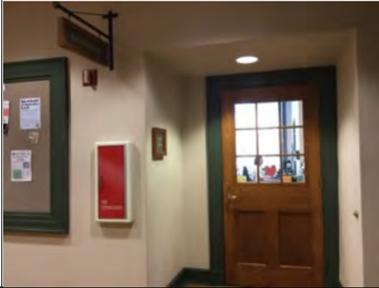
Sign not located on the latch side of the door	-	Locate the sign at permanent rooms alongside the door on the latch side.	1	
153	Building A, Senior Center, Office	1		Signage	Designation

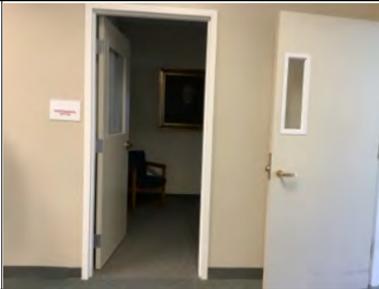
Sign not located on the latch side of the door	-	Locate the sign at permanent rooms alongside the door on the latch side.	1	
154	Building C, Building Department/ Fire Prevention	2		Signage	Designation

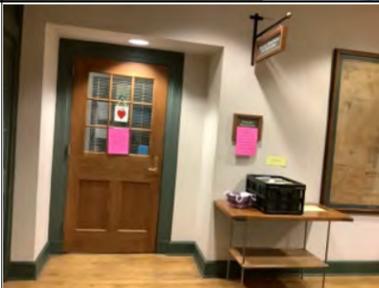
Sign not located on the latch side of the door Designation sign has serif font	- -	Locate the sign at permanent rooms alongside the door on the latch side. Ensure that raised characters are sans serif.	1

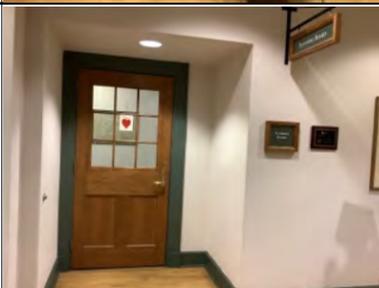
155	Building C, Planning Board	2		Signage	Designation

Sign not located on the latch side of the door Designation sign has serif font	- -	Locate the sign at permanent rooms alongside the door on the latch side. Ensure that raised characters are sans serif.	1

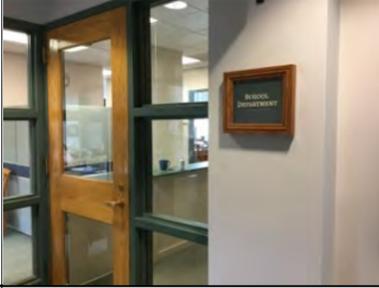
ID	Location	Floor	Room	Element	Type	Photo	Issues	Current Measure	Recommendations	Quantity	Notes
156	Building B, School Department, Entrance	3		Signage	Designation

Sign not located on the latch side of the door Designation sign has serif font	- -	Locate the sign at permanent rooms alongside the door on the latch side. Ensure that raised characters are sans serif.	1	
157	Building C, Committee Room and IT Department	3		Signage	Designation

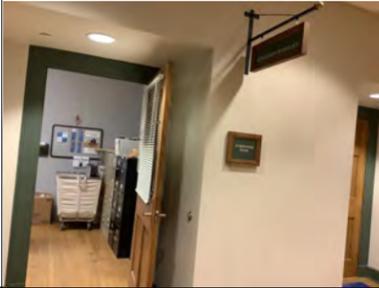
Sign not located on the latch side of the door Designation sign has serif font	- -	Locate the sign at permanent rooms alongside the door on the latch side. Ensure that raised characters are sans serif.	1	
158	Building C, South Hearing Room	3		Signage	Designation

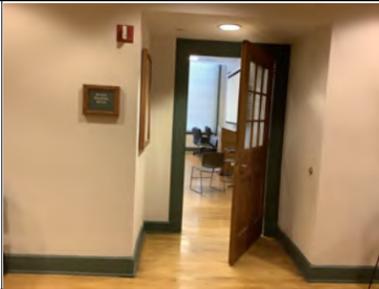
Sign not located on the latch side of the door Designation sign has serif font	- -	Locate the sign at permanent rooms alongside the door on the latch side. Ensure that raised characters are sans serif.	1

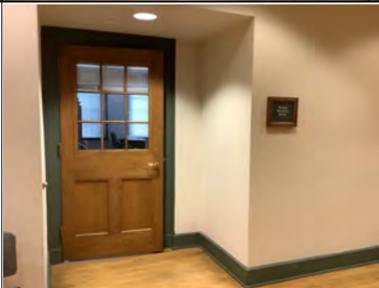
159	Building C, North Hearing Room	3		Signage	Designation

Sign not located on the latch side of the door Designation sign has serif font	- -	Locate the sign at permanent rooms alongside the door on the latch side. Ensure that raised characters are sans serif.	1	
160	Building C, Town Hall, by Ramp That Connects to Building B	1		Signage	Informational

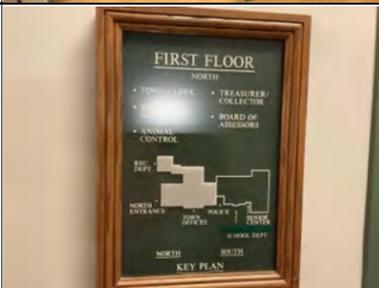
Non-glare finish and contrast not provided on sign	-	Install a sign with a non-glare finish.	1

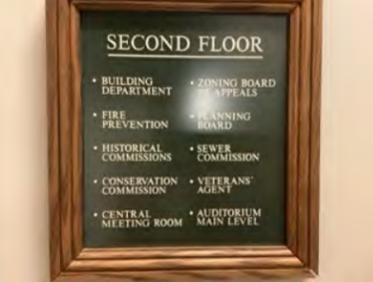
ID	Location	Floor	Room	Element	Type	Photo	Issues	Current Measure	Recommendations	Quantity	Notes
161	Building C, Town Hall, Connecting Stair to Building B Directory	2		Signage	Informational

Non-glare finish and contrast not provided on sign	-	Install a sign with a non-glare finish.	1	
162	Building C, Town Hall, Connecting Stair to Building B Directory	3		Signage	Informational

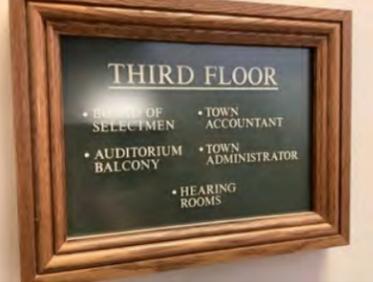
Non-glare finish and contrast not provided on sign	-	Install a sign with a non-glare finish.	1	
163	Building C, Recreation Department, Yoga Classroom	B		Signage	Designation

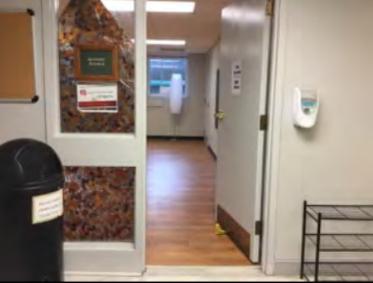
Signage lacks 18" by 18" clear floor space Designation sign has serif font	-	Relocate the trash bin to provide a clear floor space of 18" min. by 18" min. Ensure that raised characters are sans serif.	1	
164	Building B, Police Department, Lobby, Women's and Men's Toilet Rooms	1		Signage	Designation

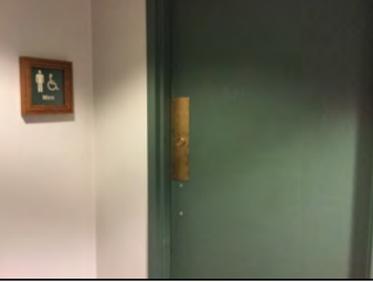
Designation sign has serif font	-	Ensure that raised characters are sans serif.	2

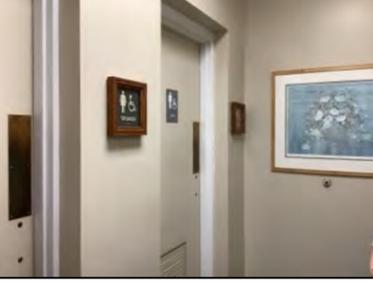
165	Building A, Senior Center, Women's and Men's Toilet Rooms	1		Signage	Designation

Designation sign has serif font	-	Ensure that raised characters are sans serif.	2

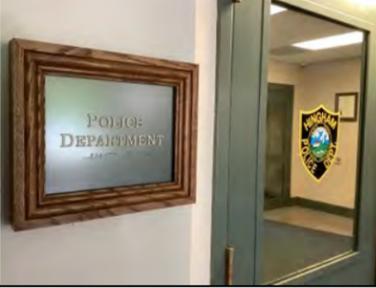
ID	Location	Floor	Room	Element	Type	Photo	Issues	Current Measure	Recommendations	Quantity	Notes
166	Building B, Police Department	1		Signage	Designation

Designation sign has serif font	-	Ensure that raised characters are sans serif on the designation sign on the latch side of the door to the police department.	1	
167	Building C, Typical Designation Signage in Building	1, 2, 3		Signage	Designation

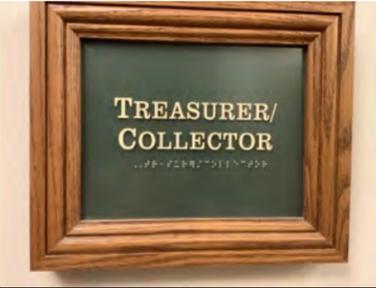
Designation sign has serif font	-	Ensure that raised characters are sans serif.	25	
168	Building C, Recreation Department, Gym, Northwest Egress Stair, Route From Elevator Lobby	B		Signage	Designation

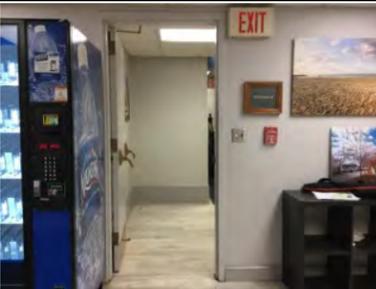
Designation sign has serif font	-	Ensure that raised characters are sans serif.	1	
169	Building C, Recreation Department, Men's and Women's Toilet Rooms	B		Signage	Designation

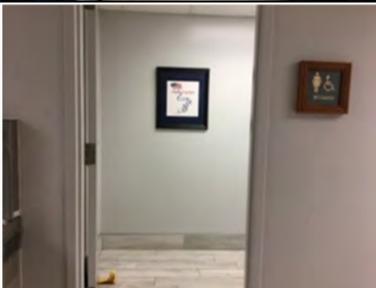
Designation sign has serif font	-	Ensure that raised characters are sans serif.	2	
170	Building B, Senior Center Designation Signage From Lobby	L		Signage	Designation

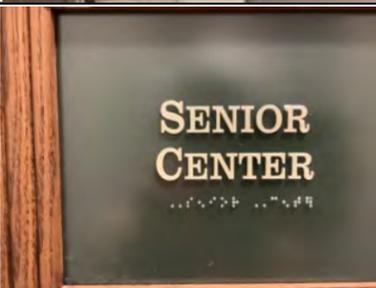
Designation sign has serif font	-	Ensure that raised characters are sans serif.	1

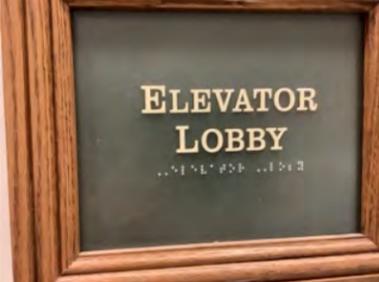
ID	Location	Floor	Room	Element	Type	Photo	Issues	Current Measure	Recommendations	Quantity	Notes
171	Building B, Elevator Lobby Across From Senior Center	L		Signage	Designation

Designation sign has serif font	-	Ensure that raised characters are sans serif.	1	
172	Building C, Recreation Department, Spinning Classroom	B		Signage	Designation

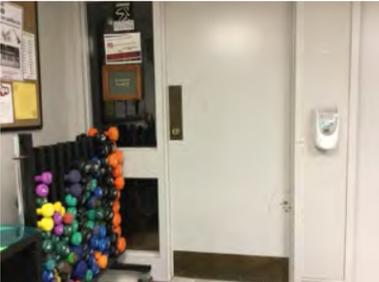
Designation sign has serif font Signage lacks 18" by 18" clear floor space	-	Relocate weights to provide a clear floor space of 18" min. by 18" min. Ensure that raised characters are sans serif.	1	
Service Counter											
173	Building A, Police Department, Booking Area, Fingerprint Counter	1, Lower Portion		Service Counter	N/A

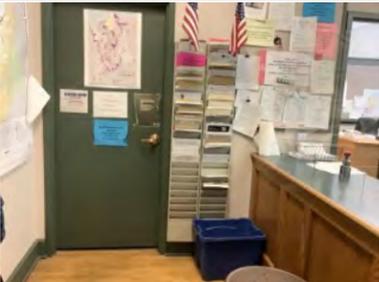
Operable Parts											
175	Building C, Building Department/ Fire Prevention	2		Operable Parts	Other

Clear floor space is not provided Reach < 15" or > 48"(forward/side approach)	- 72"	Relocate the recycling bin away from the literature holder. Ensure that one of each form is located no higher than 48" above the finished floor. Recommend not providing brochure holders higher than 48" above the finished floor.	1

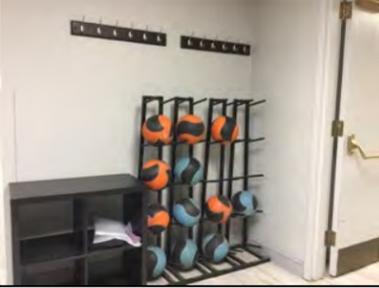
ID	Location	Floor	Room	Element	Type	Photo	Issues	Current Measure	Recommendations	Quantity	Notes
176	Building C, Recreation Department, Gym, Southwest Egress Stair, Route From Elevator Lobby	B		Operable Parts	Clothes Rod/Hooks

Clear floor space is not provided Reach < 15" or > 48"(forward/side approach)	- 67"	Ensure that 5 percent of coat hooks have 30" min. by 48" min. clear floor space at them and are located between 15"- 48" above the finished floor.	1	
177	Building B, Police Department, West Egress, Main Entrance, Southwest of Door	1		Operable Parts	Other

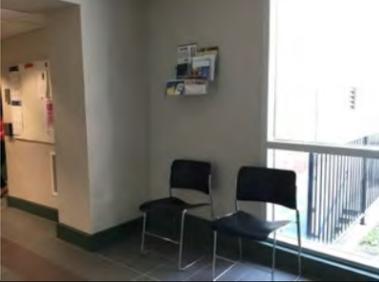
Reach < 15" or > 48"(forward/side approach)	61.5"	Relocate pamphlets between 15"- 48" above the finished floor and ensure that they are not blocked by chairs.	1	
178	Building B, Police Department, Reception Area	1		Operable Parts	Other

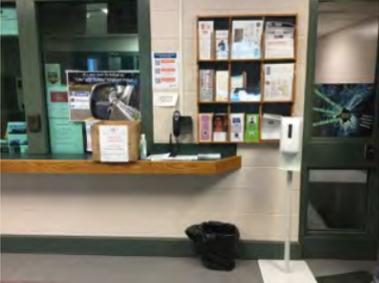
Reach < 15" or > 48"(forward/side approach)	72.5"	Ensure that one of each pamphlet or brochure is located between 15" and 48" above the finished floor.	1

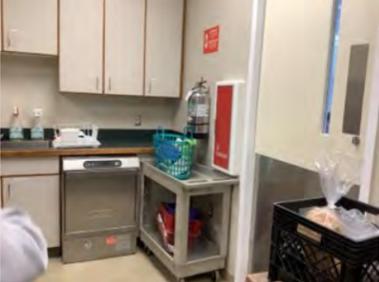
179	Building A, Senior Center, Kitchen	1		Operable Parts	Equipment

Reach < 15" or > 48"(forward/side approach)	59"	Relocate the fire extinguisher between 15"- 48" above the finished floor.	1	
180	Building C, Building Department/ Fire Prevention	2		Operable Parts	Other

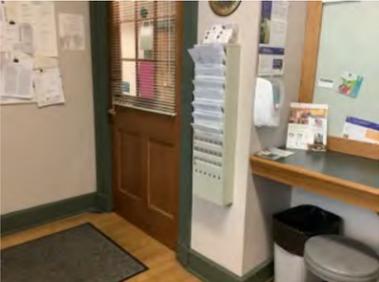
Reach < 15" or > 48"(forward/side approach)	59.5"	Ensure that one of each form is located no higher than 48" above the finished floor.	1

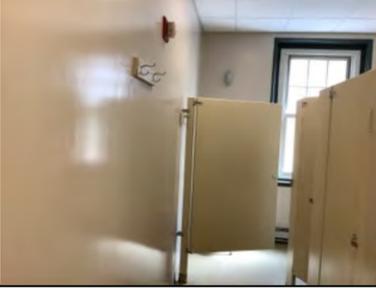
ID	Location	Floor	Room	Element	Type	Photo	Issues	Current Measure	Recommendations	Quantity	Notes
181	Building C, Women's Toilet Room	2		Operable Parts	Clothes Rod/Hooks

Reach < 15" or > 48"(forward/side approach)	70"	Relocate coat hooks no higher than 48" above the finished floor.	1	
182	Building C, Veterans Agent	2		Operable Parts	Other

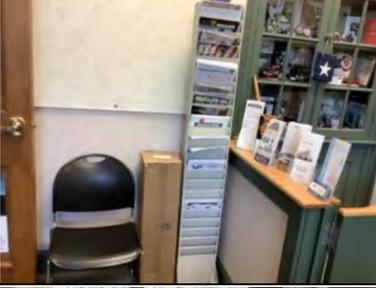
Reach < 15" or > 48"(forward/side approach)	66"	Ensure that one of each form is located no higher than 48" above the finished floor.	1	
183	Building B, School Department, Coat Rack by Conference Room	3		Operable Parts	Clothes Rod/Hooks

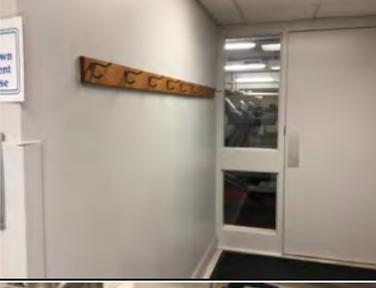
Reach < 15" or > 48"(forward/side approach)	62"	Ensure that five (5) percent of coat hooks are located between 15"- 48" above the finished floor.	1

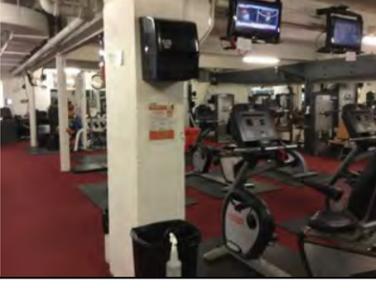
185	Building C, Recreation Department, Fitness Room	B		Operable Parts	Paper Towel Dispenser

Reach < 15" or > 48"(forward/side approach) Dispenser is a protruding object	60" 10"	Relocate paper towel dispenser so that controls are between 15"- 48" above the finished floor. Relocate dispenser out of the circulation path.	1

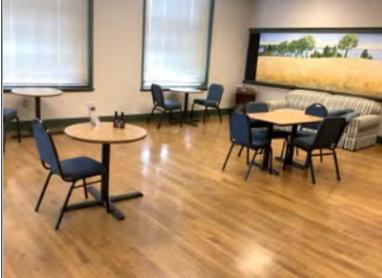
Knee or toe clearance not provided	-	Provide at least one dining surface with 27" min. knee and toe clearance.	1

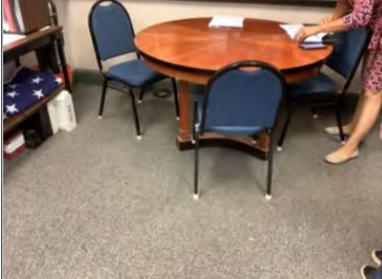
190	Building C, Veterans Agent	2		Dining or Work Surfaces	Work Surface

Knee or toe clearance not provided	-	Provide at least one work surface with 27" min. knee and toe clearance.	1

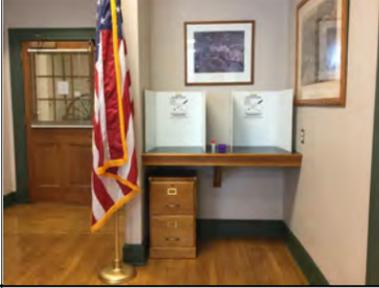
ID	Location	Floor	Room	Element	Type	Photo	Issues	Current Measure	Recommendations	Quantity	Notes
191	Building C, Town Hall, Voting Area by North Stair	1		Dining or Work Surfaces	Work Surface

Top of dining/work surface < 28" or > 34"	36"	Provide at least one accessible work surface with tops between 28"- 34" above the floor and 27" clear height underneath in an area with equal privacy.	1	
192	Building C, Town Hall, Board of Assessors	1		Dining or Work Surfaces	Work Surface

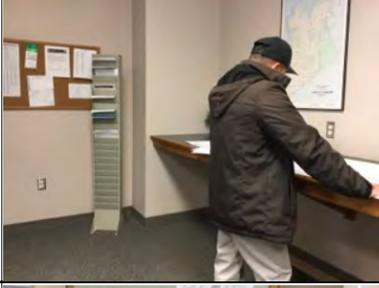
Top of dining/work surface < 28" or > 34"	36"	Provide at least one work surface with tops between 28"- 34" above the floor and 27" clear height underneath.	1	
193	Building C, Building Department/ Fire Prevention	2		Dining or Work Surfaces	Work Surface

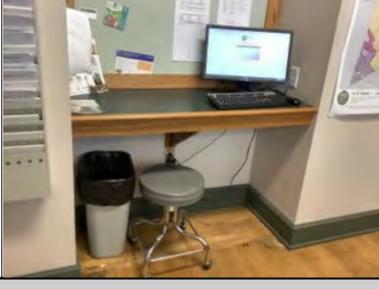
Top of dining/work surface < 28" or > 34"	36"	Provide at least one work surface with tops between 28"- 34" above the floor and 27" clear height underneath.	1

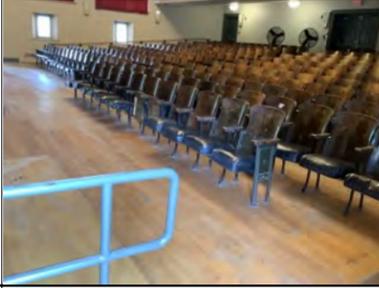
Assembly Area											
194	Building C, Sanborn Auditorium and Balcony	2		Assembly Area	N/A

Number of seats Designated aisle seats < 5%	408 68 total	At least 5% of the total number of aisle seats provided (4 total) must be identified by a sign or marker and have folding or retractable armrests.	4	
195	Building C, Sanborn Auditorium	2		Assembly Area	N/A

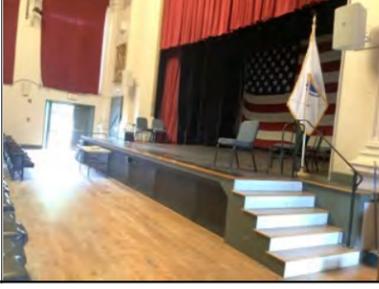
Accessible route to stage not provided	-	Provide an accessible route to the stage. Provide an interior lift to the stage.	1

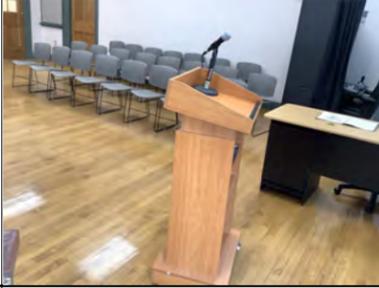
ID	Location	Floor	Room	Element	Type	Photo	Issues	Current Measure	Recommendations	Quantity	Notes
196	Building C, North and South Hearing Rooms	3		Assembly Area	N/A

Assistive listening devices not provided	-	If audible communication is integral to the use of the space, provide an assistive listening system.	2	
197	Building C, Sanborn Auditorium	2		Assembly Area	N/A

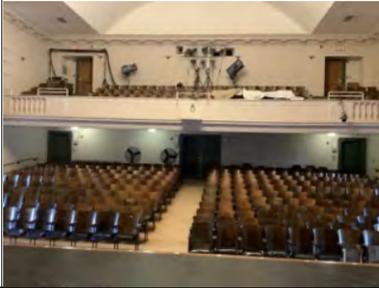
Signage denoting assistive listening system not provided	-	In each assembly area where audible communication is integral to the use of the space, an assistive listening system shall be provided, and the assistive listening system shall be identified by a sign with the International Symbol of Access for Hearing Loss.	1	
Detention Facilities											
198	Building A, Police Department, Juvenile Cell, Women's Cell and Men's Cell	1, Lower Portion		Detention Facilities	Juveniles

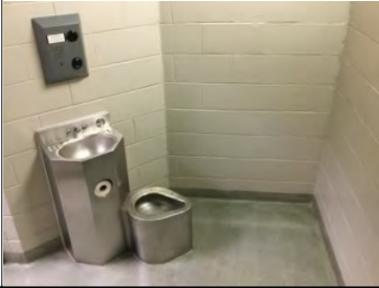
Mobility cell lacks 60" turning space Mobility cell lacks access to accessible toilet/lavatory	- -	The Town can achieve program access by making arrangements to transfer men, women and juveniles who need a mobility accessible holding cell to another Town or County holding cell that is accessible.	3

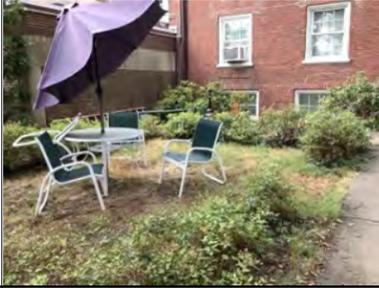
Picnic Tables											
199	Building C, Patio on Southeast Side of Auditorium	Ext.		Picnic Tables	N/A

Surface not stable, firm and slip-resistant Toe or knee clearance at tables not provided Picnic table not on an accessible route	- - -	Provide a stable, firm and slip-resistant surface at the picnic table. Ensure that the picnic table is connected to an accessible route. Provide at least 1 picnic table (or ensure that 5% of picnic tables) have toe and knee clearance.	1	
200	Building A, Senior Center, Patio	Ext.		Picnic Tables	N/A

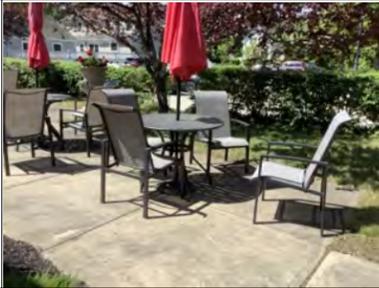
Toe or knee clearance at tables not provided Clear floor space not provided	- -	Provide at least 1 picnic table (or ensure that 5% of picnic tables) have toe and knee clearance. Ensure that at a 30" by 48" clear floor space positioned for a forward approach is provided at the picnic table.	1

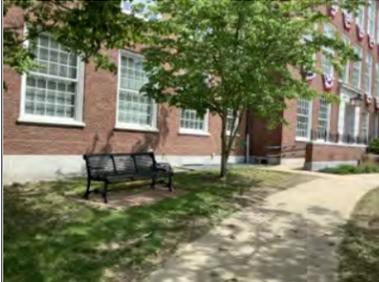
ID	Location	Floor	Room	Element	Type	Photo	Issues	Current Measure	Recommendations	Quantity	Notes
Exterior Benches											
201	Building C, Town Hall, Main Entrance	Ext.		Exterior Benches	N/A

No accessible route to one bench in area	-	Provide an accessible route to one bench in this area.	1	
202	Central Street Bus Stop Bench	Ext.		Exterior Benches	N/A

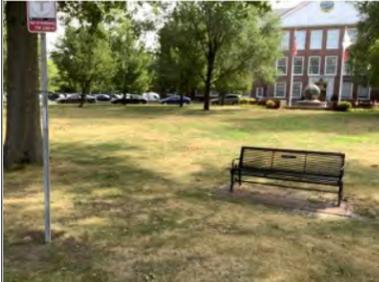
No accessible route to one bench in area	-	Provide an accessible route to one bench in this area.	1	
Toilet & Bathing Rooms											
Lavatory											
203	Building B, Police Department, Lobby, Women's Toilet Room	1		Lavatory	N/A

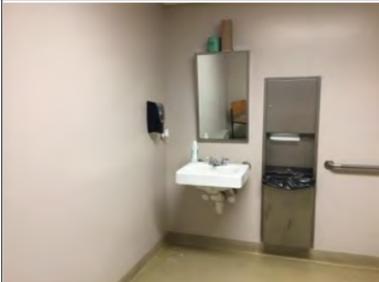
Toe or knee clearances not provided	24.9"	Provide at least one lavatory with knee and toe clearance positioned for a forward approach.	1	
204	Building C, Men's Toilet Room	2		Lavatory	N/A

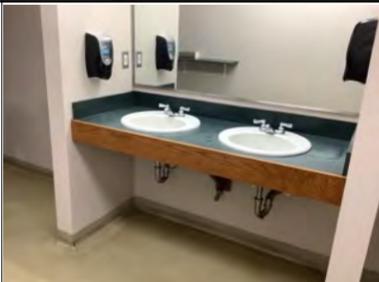
Plumbing underneath is exposed	-	Insulate or otherwise configure pipes to prevent contact for at least one lavatory.	1

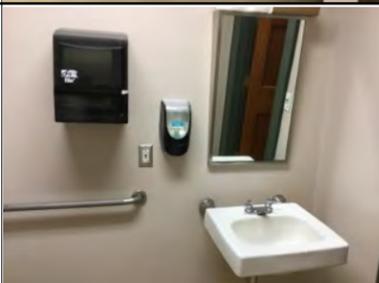
205	Building C, Town Hall, Women's Toilet Room	1		Lavatory	N/A

Plumbing underneath is exposed Toe or knee clearances not provided Dispensers not within reach range	25" - 55.5"	Provide at least one lavatory with knee and toe clearance positioned for a forward approach. Insulate or otherwise configure pipes to prevent contact at the lavatory. Lower paper towel dispenser to 48" max. above the finished floor and ensure that no dispensers are mounted over the grab bars.	1

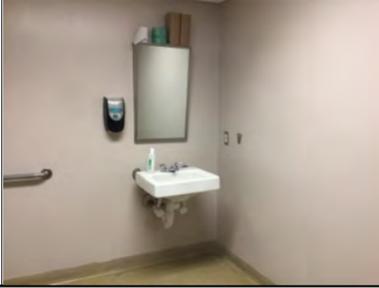
ID	Location	Floor	Room	Element	Type	Photo	Issues	Current Measure	Recommendations	Quantity	Notes
206	Building B, Police Department, Lobby, Men's Toilet Room	1		Lavatory	N/A

Mirror above lavatory w/reflective surface > 40"	42"	Lower mirror so that the bottom of the reflectign surface is at 40" max. above the finished floor.	1	
Single-User Toilet											
207	Building C, Town Hall, Women's Toilet Room	1		Single-User Toilet	N/A

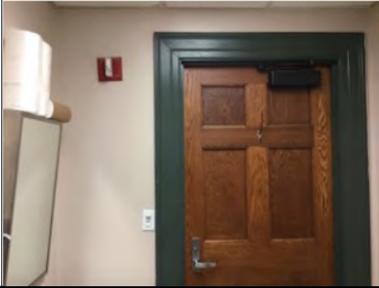
Hook located > 54" high	68"	Locate the coat hook no higher than 48" above the finished floor.	1	
Toilet Compartment											
208	Building C, Women's Toilet Room	2		Toilet Compartment	Accessible Compartment

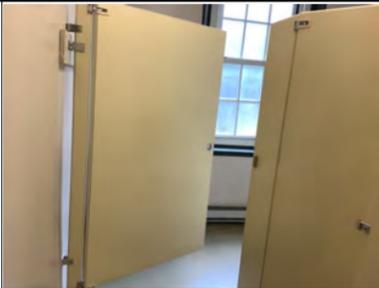
209	Building C, Women's Toilet Room	3		Toilet Compartment	Accessible Compartment

Door has malfunctioning self-closing hinge	-	Repair hinge.	1	
210	Building A, Senior Center, Men's Toilet Rooms	1		Toilet Compartment	Accessible Compartment

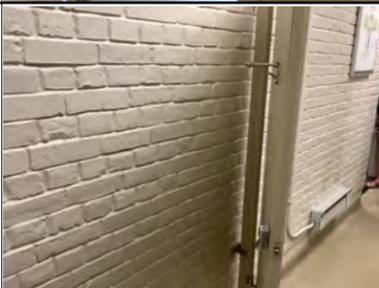
Door has malfunctioning self-closing hinge Door pull not provided	- -	Repair hinge. Provide a door pull on each side of the door between 34" to 48" above the finished floor that does not require tight grasping, pinching or twisting of the wrist.	1

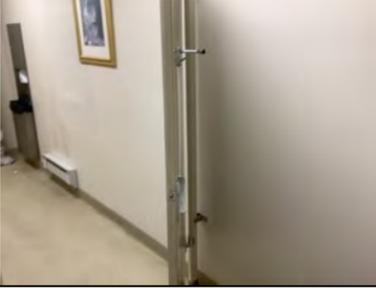
ID	Location	Floor	Room	Element	Type	Photo	Issues	Current Measure	Recommendations	Quantity	Notes
211	Building A, Senior Center, Women's Toilet Rooms	1		Toilet Compartment	Accessible Compartment

Door has malfunctioning self-closing hinge Door pull not provided	- -	Repair hinge. Provide a door pull on each side of the door between 34" to 48" above the finished floor that does not require tight grasping, pinching or twisting of the wrist.	1	
212	Building A, Senior Center, Men's Toilet Room	1		Toilet Compartment	Accessible Compartment
