Central Fire Station

Town of Hingham ADA Transition Plan

October 2023

Institute for Human Centered Design

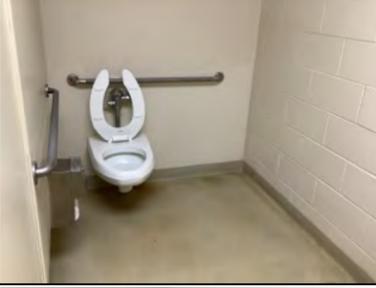
Flush control not on open side	-	Provide the flush control on the open side of the toilet (transfer side).	1	
213	Building C, Recreation Department, Women's Toilet Room	B		Toilet Compartment	Accessible Compartment

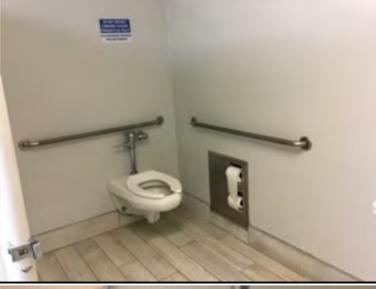
Clearance at toilet < 60" clear width	51"	Provide a wheelchair accessible compartment that is 60" wide min.	1	
214	Building C, Men's Toilet Room	2		Toilet Compartment	Accessible Compartment

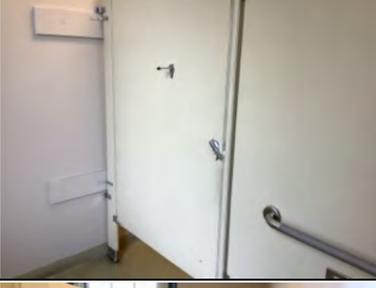
Door pull not provided	-	Provide a door pull on each side of the door between 34" to 48" above the finished floor that does not require tight grasping, pinching or twisting of the wrist.	2

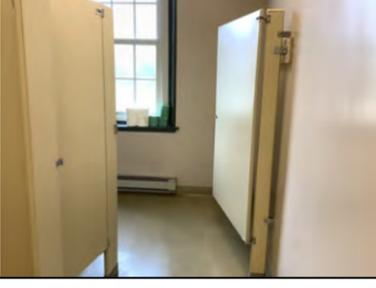
215	Building C, Men's Toilet Room	3		Toilet Compartment	Accessible Compartment

Door pull not provided	-	Provide a door pull on each side of the door between 34" to 48" above the finished floor that does not require tight grasping, pinching or twisting of the wrist.	2

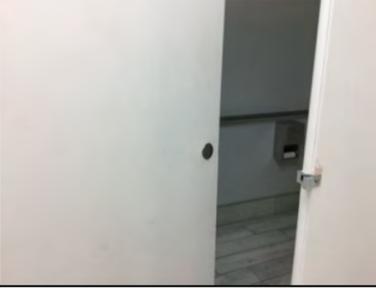
Door pull not provided	-	Provide a door pull on each side of the door between 34" to 48" above the finished floor that does not require tight grasping, pinching or twisting of the wrist.	1	
217	Building C, Recreation Department, Men's and Women's Toilet Rooms	B		Toilet Compartment	Accessible Compartment

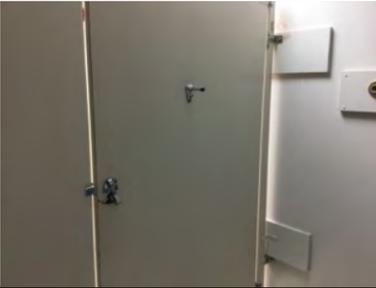
Door pull not provided	-	Provide a door pull on each side of the door between 34" to 48" above the finished floor that does not require tight grasping, pinching or twisting of the wrist.	2	
218	Building C, Recreation Department, Women's Toilet Room	B		Toilet Compartment	Accessible Compartment

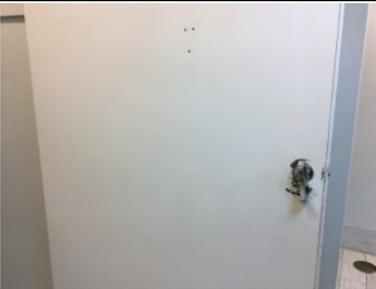
Door pull not provided	-	Provide a door pull on each side of the door between 34" to 48" above the finished floor that does not require tight grasping, pinching or twisting of the wrist.	1

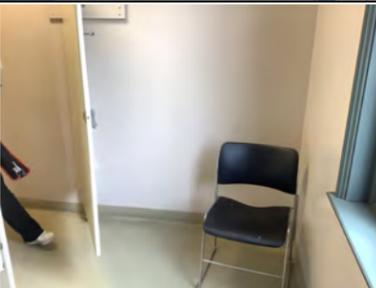
219	Building C, Women's Toilet Room	3		Toilet Compartment	Accessible Compartment

Door pull not provided Door has inadequate maneuvering clearance	- -	Remove chair from accessible toilet compartment. Provide a door pull on each side of the door between 34" to 48" above the finished floor that does not require tight grasping, pinching or twisting of the wrist.	2	
Dispensers											
220	Building C, Recreation Department, Men's and Women's Toilet Rooms	B		Dispensers	Paper Towel Dispenser

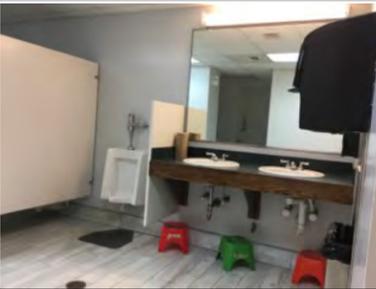
Dispenser acts as a protruding object	10"	Relocate paper towel dispenser out of the circulation path.	2	
Additional Access

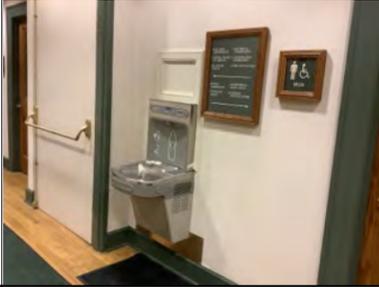
No drinking fountain provided for standing users	-	Provide an additional drinking fountain for standing users.	1	
222	Building C, By East Hearing Room Entrance	3		Drinking Fountains	Low

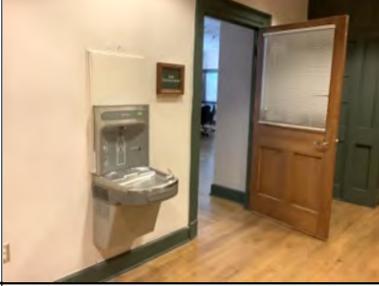
No drinking fountain provided for standing users	-	Provide an additional drinking fountain for standing users.	1	
223	Building C, Recreation Department, Drinking Fountain Between Toilet Rooms	B		Drinking Fountains	Low

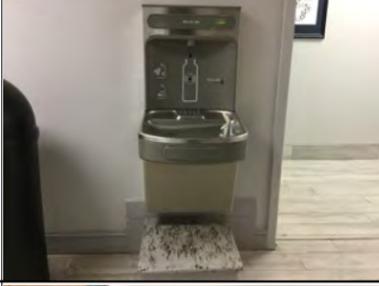
No drinking fountain provided for standing users	-	Provide an additional drinking fountain for standing users.	1	
224	Building C, Town Hall, By Women's Toilet Room	1		Drinking Fountains	High

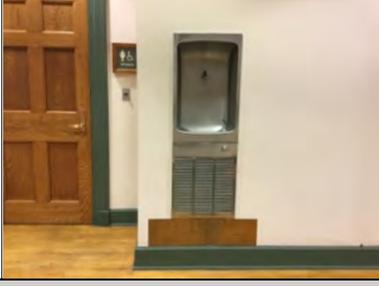
No drinking fountain provided for seated users	-	Provide an additional drinking fountain for seated users with knee and toe clearance and a spout that is no higher than 36" above the finished floor.	1

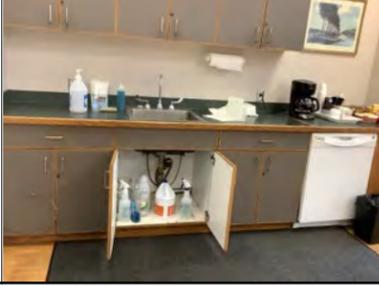
Toe and knee clearances not provided Rim or counter > 34" Exposed plumbing underneath sink	- 36" -	Ensure there is a 27" min. knee clearance positioned for a forward approach. Relocate sink with the front of the rim or counter no higher than 34" above the finished floor. Insulate or otherwise configure pipes at sink.	1

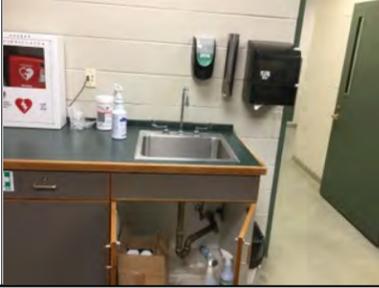
Toe and knee clearances not provided Rim or counter > 34" Exposed plumbing underneath sink Dispenser not within reach range	- 42" - 58"	For program access, ensure that the public can be accompanied to an accessible sink in the police station. Alternately, the sink could be renovated to ensure there is a 27" min. knee clearance, relocated so that the front of the rim/counter is no higher than 34" max.; the pipes could be insulated or otherwise configured; and the soap dispenser relocated no higher than 44" if mounted over the sink.	1	
Play and Sport Areas											
Exercise Machines											
227	Building C, Recreation Department, Fitness Room	B		Exercise Machines	N/A

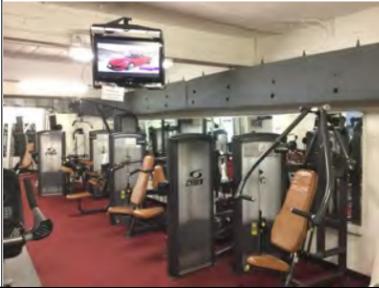
Clear floor space not provided	-	Ensure that one of each type of equipment has a 30" by 48" clear floor space positioned for transfer or for use by an individual seated in a wheelchair. Clear floor space required at exercise machines and equipment shall be permitted to overlap.	1

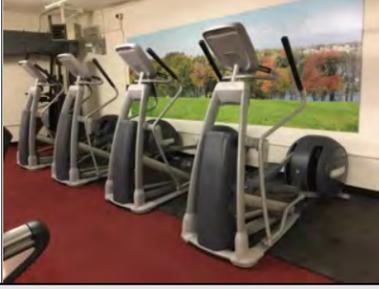
228	Building C, Recreation Department, Fitness Room	B		Exercise Machines	N/A

Clear floor space not provided	-	Ensure that one of each type of equipment has a 30" by 48" clear floor space positioned for transfer or for use by an individual seated in a wheelchair. Clear floor space required at exercise machines and equipment shall be permitted to overlap.	1	
Overall Review											
229	Building C, Sanborn Auditorium Door	3

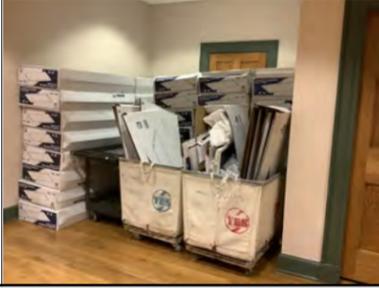
Note: This door to the auditorium was unable to be surveyed due to stored items.	1	
Best Practice

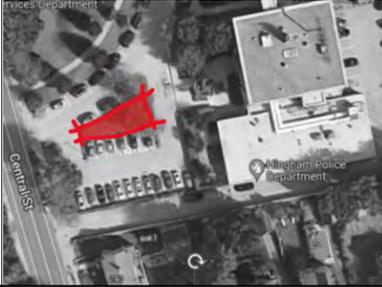
The senior center parking lot is often full and people must park a great distance away from the building. IHCD recommends providing additional perpendicular or angled parking in the red highlighted area by the senior center.	1	
231	Building B, Police Department, Stairs to Booking/Cells	1

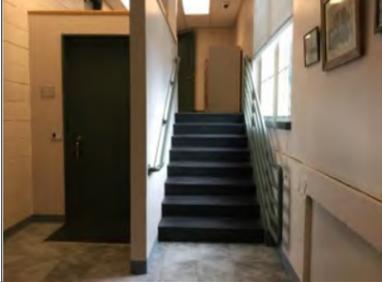
Recommend providing visually contrasting strips on each stair tread.	1	
232	Building A, Senior Center, Kitchen	1

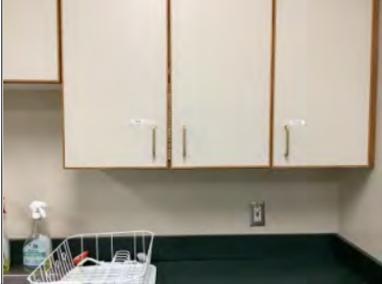
-	Recommend using a larger font on the signage that identifies the cabinets.	1	
233	Building A, Senior Center, Kitchen	1

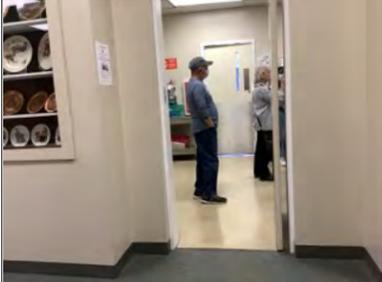
-	Recommend providing signage with raised characters and braille on the latch side of the door to all permanent rooms that lack designation signage.	1	
234	Building C, Town Hall, Lobby	1

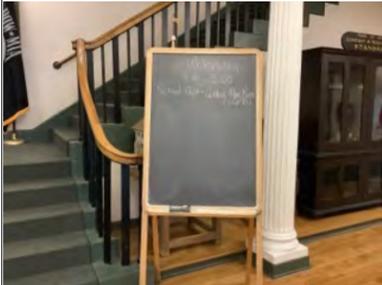
The chalkboard announcing the location of meetings is handwritten and tough to read. IHCD recommends providing a computer screen that has visual characters that comply with 2010 ADA Standards 703.5; including providing contrast, providing a non-glare finish, and providing characters in a conventional form (not italic, oblique, script, highly decorative, or of other unusual forms).	1

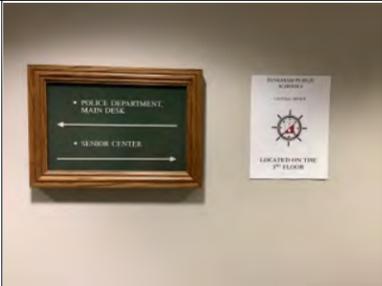
Wayfinding was a major concern of representatives from the Commission on Disabilities. Wayfinding is an inclusive design concern, and not addressed in accessibility standards or regulations. A full wayfinding analysis of the facility is recommended.	1	
236	Building C, Town Hall, South Stairwell by Building B	2

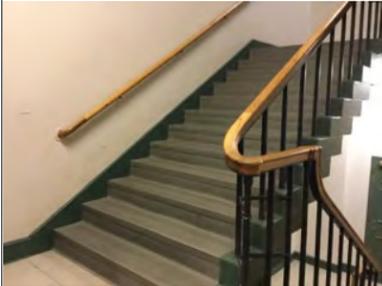
Recommend providing visually contrasting strips on all stair treads in the building.	1	
237	Building C, South and North Hearing Rooms	3

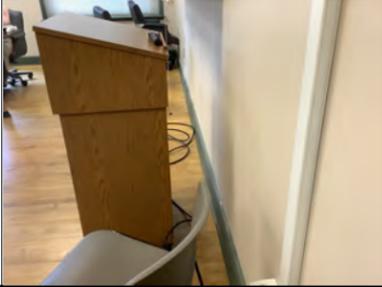
Recommend providing an adjustable height podium with knee and toe clearance.	2	
238	Building A, Senior Center, Parking Drop-Off	Ext.

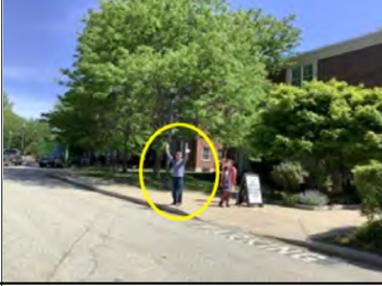
Recommend placing a sign at this location denoting the main entrance to the senior center.	1	
239	Building A, Senior Center, Parking Drop-Off	Ext.

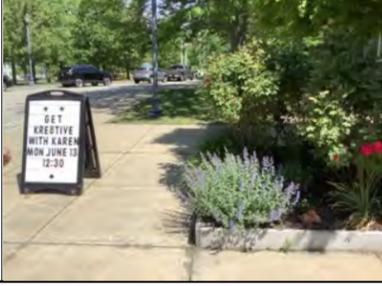
Recommend providing a bench by the drop off area for the senior center so that people are able to see when their ride arrives. Recommend providing an enclosure for inclement weather.	1

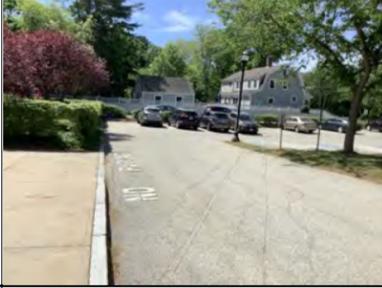
Recommend creating a compliant passenger loading zone in this area. Provide a marked access aisle that is at least 60" wide and that extends the full length of the vehicle. Provide a sign that includes the International Symbol of Accessibility (ISA) at the head of the space. Locate the sign so that the bottom is 60" min. above the ground and the top is 96" max. above the ground.	1	
241	Building C, Town Hall, Main Entrance	Ext.

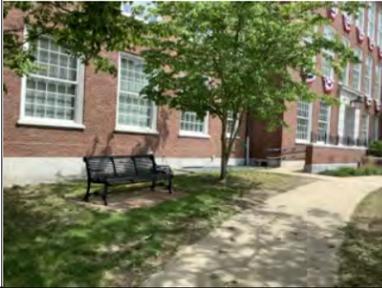
Recommend providing a 36" min. by 48" min. stable, firm and slip-resistant surface adjacent to at least one exterior bench per area in a manner that is substantially similar to what is shown in Figure 4 in the narrative report.	1	
242	Parallel Parking by the Main Entrance to Town Hall, Building C	Ext.

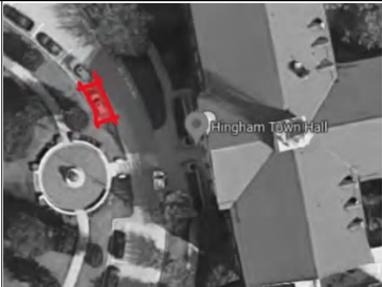
Recommend providing one (1) accessible parallel parking space by the main entrance to Town Hall. Provide signage with the International Symbol of Accessibility (ISA) at the head of the parking space to reserve it for people using HP plates or placards.	1

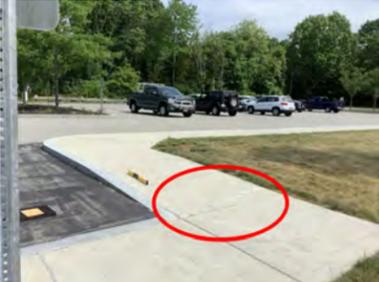
There is damage to the pavement in one (1) area leading to the public entrance.

Route not maintained in operable working condition	-	Ensure the accessible route is maintained in operable working condition. Repair the cracked pavement in this area.	1	
Curb Ramp											
2	Main Entrance	Ext.		Curb Ramp	N/A

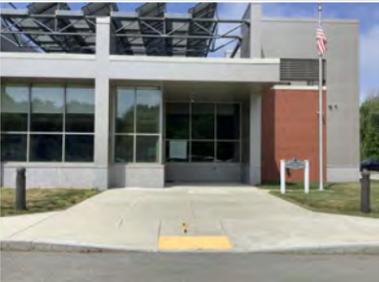
Running slope > 1:12 (8.33%)	10%	Reduce running slope to be no steeper than 1:12 (8.33%).	1	
Off-Street Parking Lot or Garage											
3	Parking by Main Entrance	Ext.		Off-Street Parking Lot or Garage	N/A

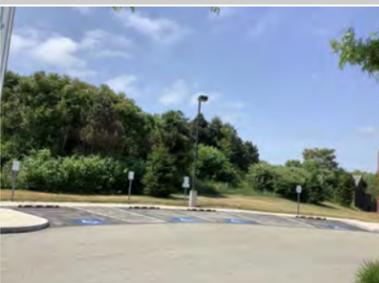
Accessible parking signage is deteriorated and mounted lower than allowed.

Total # of parking Total # of designated accessible parking spaces Total # of designated van accessible spaces Sign bottom < 60" above finished grade	28 3 1 57"	Recommend replacing signs as they are deteriorated and difficult to read. Locate new signs with the bottom of the sign 60" min. above the ground.	1

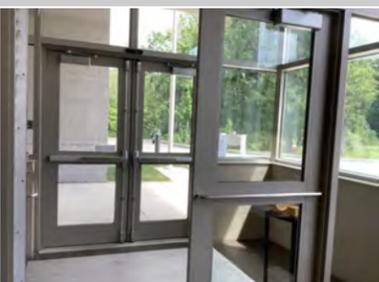
Access to Goods and Services											
Means of Egress											
4	Main Entrance, Egress Door	1	101	Means of Egress	N/A

Tactile exit sign not provided	- -	Ensure tactile exit signs with raised characters and braille are provided at exit doors. Mount signs between 48"- 60" above the finished floor located on the latch side of the door.	1

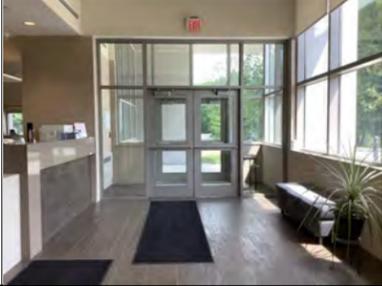
Tactile exit sign not provided Illuminated ISA symbol not provided (MAAB)	- -	Ensure tactile exit signs with raised characters and braille are provided at exit doors. Mount signs between 48"- 60" above the finished floor located on the latch side of the door. Provide an illuminated sign with the International Symbol of Accessibility (ISA). Secure all mats.	1

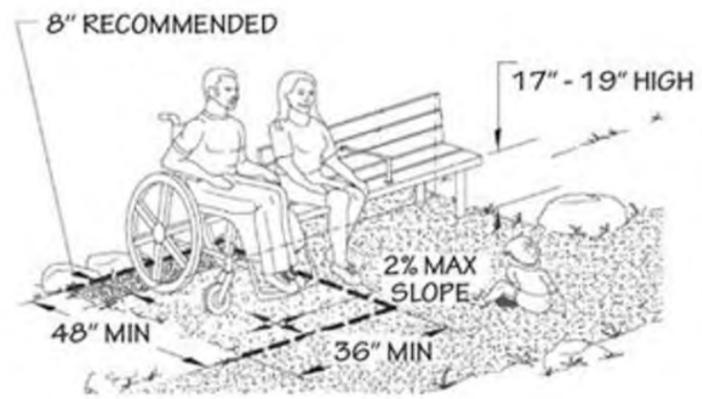
mobility device and a person sitting on the bench to have their shoulders aligned:

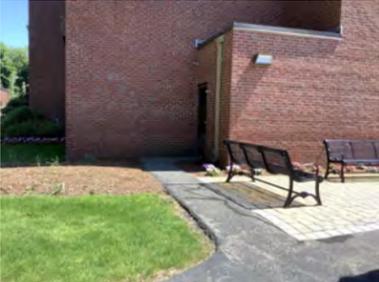
Exterior route < 36" wide	30"	Ensure that a clear width of 36" min. is maintained at the accessible route.	1	
2	Elm Street Parking to Northwest Entrance/ Egress Door	Ext.		Exterior Access Route	Exterior

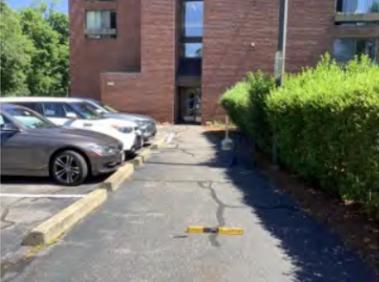
Cross slope > 1:50 (2.00%)	2.5%	Reduce cross slope to be no steeper than 1:50 (2.00%).	1	
3	Elm Street Parking to Northwest Entrance/ Egress Door	Ext.		Exterior Access Route	Walkway

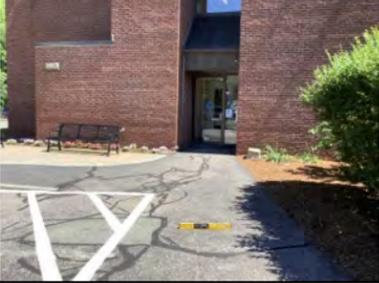
Cross slope > 1:50 (2.00%)	3.2%	Reduce cross slope to be no steeper than 1:50 (2.00%).	1	
4	West Central Street Parking to Main Entrance, West Egress	Ext.		Exterior Access Route	Walkway

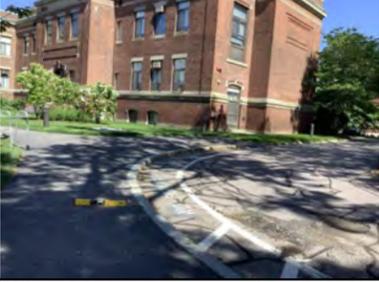
Cross slope > 1:50 (2.00%)	8.6%	Reduce cross slope to be no steeper than 1:50 (2.00%).	1	
5	By Northwest Egress Door	Ext.		Exterior Access Route

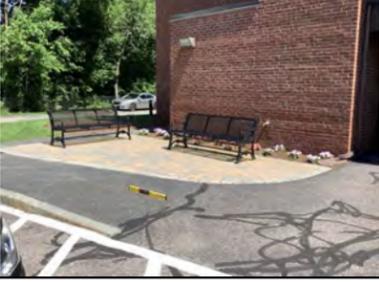
Cross slope > 1:50 (2.00%) Running slope > 1:20 (5.00%)	4.7% 6.7%	Reduce cross slope to be no steeper than 1:50 (2.00%). Reduce running slope to be no steeper than 1:20 (5.00%).	1

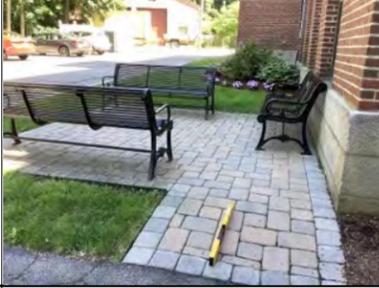
Running slope > 1:20 (5.00%)	11.4%	Reduce running slope to be no steeper than 1:20 (5.00%) to ensure that there is an accessible route to at least one bench in this area.	1	
7	South Central Street Parking to Elm Street	Ext.		Exterior Access Route	Sidewalk

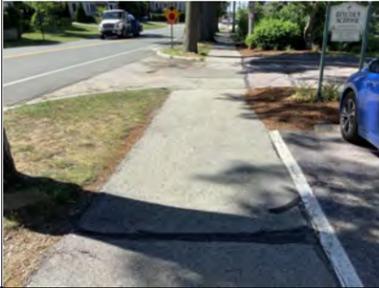
Route not maintained in operable working condition	-	Ensure the accessible route is maintained in operable working condition. Repair surface.	1	
8	South Central Street Parking to Elm Street	Ext.		Exterior Access Route	Sidewalk

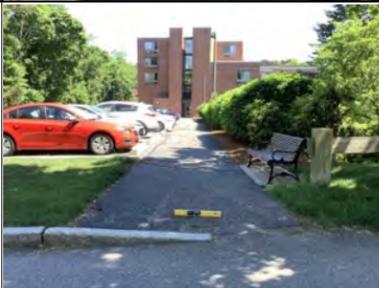
Route not maintained in operable working condition Cross slope > 1:50 (2.00%)	7.5% -	Reduce cross slope to be no steeper than 1:50 (2.00%). Ensure the accessible route is maintained in operable working condition.	1

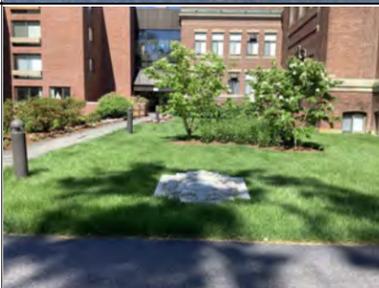
10	School Plaque by the Central Street Entrance	Ext.		Exterior Access Route	Walkway

Accessible route not provided	-	Ensure an accessible route is provided to the school plaque.	1

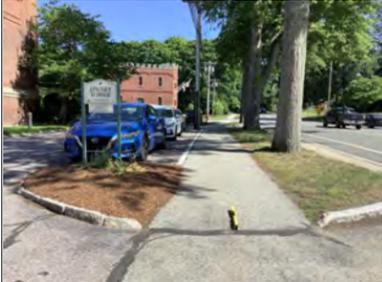
Running slope > 1:12 (8.33%)	10.8%	Reduce running slope to be no steeper than 1:12 (8.33%).	1	
12	West Central Street Parking to Main Entrance, West Egress	Ext.		Curb Ramp	N/A

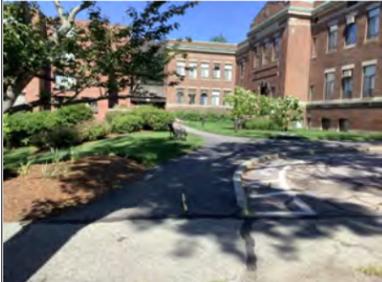
Running slope > 1:12 (8.33%)	16%	Provide a compliant curb ramp with a running slope that is no steeper than 1:12 (8.33%).	1	
13	Elm Street to Elm Street Parking	Ext.		Curb Ramp	N/A

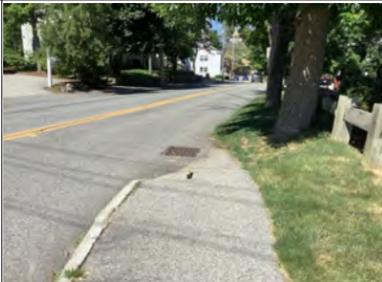
Running slope > 1:12 (8.33%) Curb ramp flares > 1:10 (10%) Cross slope > 1:50 (2.00%) (MAAB)	19% 29% 6%	Reduce running slope to be no steeper than 1:12 (8.33%). Reduce slope at curb ramp flares to be no steeper than 1:10 (10%). Reduce cross slope at curb ramp to be no steeper than 1:50 (2.00%).	1	
14	Central Street and Elm Street	Ext.		Curb Ramp	N/A

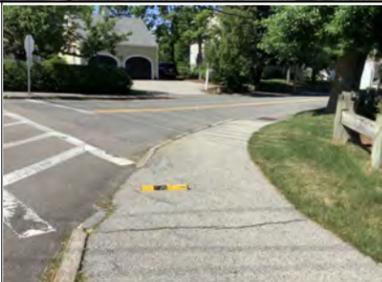
Running slope > 1:12 (8.33%) Curb ramp flares > 1:12 (8.33%) (if no landing)	11.3% 19.7%	Reduce running slope to be no steeper than 1:12 (8.33%). Reduce slope at curb ramp flares to be no steeper than 1:12 (8.33%).	1

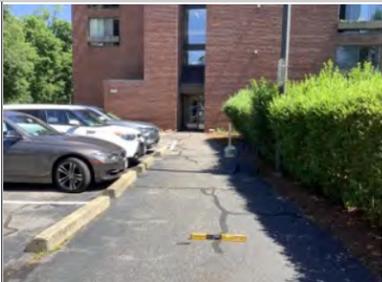
Off-Street Parking Lot or Garage											
15	Rear Parking Lot for Residents	Ext.		Off-Street Parking Lot or Garage	N/A

Total # of parking Total # of designated accessible parking spaces Total # of designated van accessible spaces	45 0 0	Provide one (1) car and one (1) van accessible parking space.	1

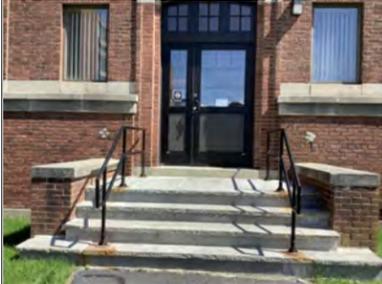
Handrails do not extend 12" from stair	-	Bottom: Ensure that the sloped bottom extension extends one tread depth min. beyond last riser nosing in same direction as stair flight.	2	
Entrance											
17	Southwest Entrance/ Egress Door	Ext.		Entrance	Secondary Entrance

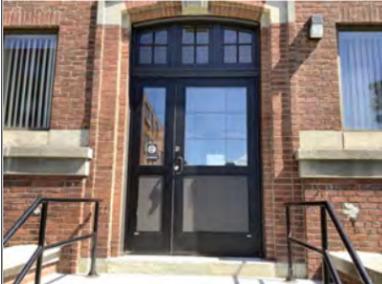
Entrance not on an accessible route Directional sign to accessible entrance not provided	- -	Provide a directional sign indicating the location of the nearest accessible entrance.	1	
18	Southeast Entrance/ Egress	Ext.		Entrance	Secondary Entrance

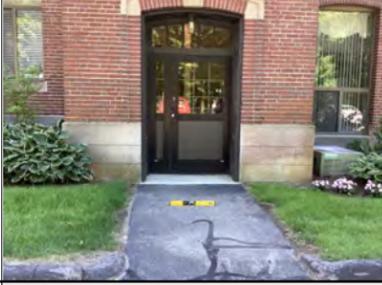
Directional sign to accessible entrance not provided		Provide a directional sign indicating the location of the nearest accessible entrance.	1	
19	Main Entrance, West Egress	Ext.		Entrance	Main Entrance

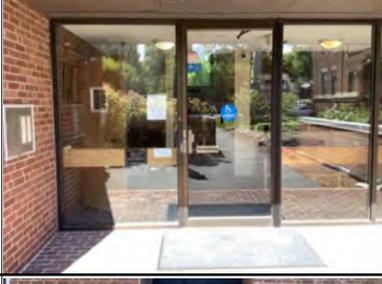
Mat not securely attached		Secure the mat.	1

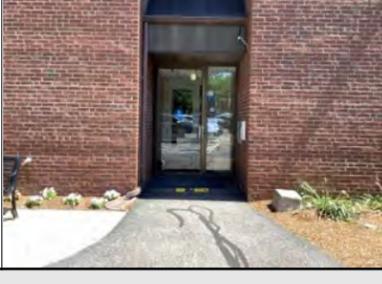
20	Northwest Entrance/ Egress Door	Ext.		Entrance	Secondary Entrance

Mat not securely attached	-	Secure the mat.	1	
Access to Goods and Services

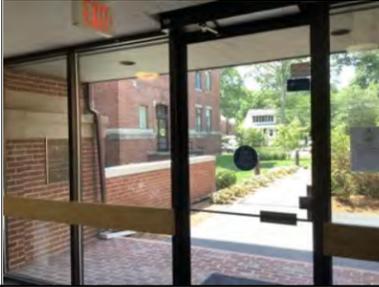
Illuminated ISA symbol not provided (MAAB)	-	Provide an illuminated sign with the International Symbol of Accessibility (ISA).	1	
22	Northwest Egress Door	1		Means of Egress	N/A

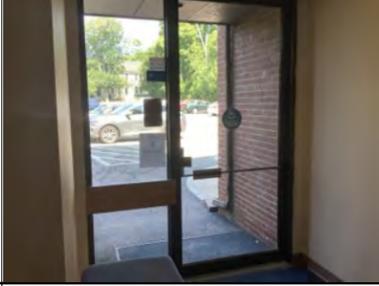
Illuminated ISA symbol not provided (MAAB)	-	Provide an illuminated sign with the International Symbol of Accessibility (ISA).	1	
23	East Secondary Entrance	B		Means of Egress	N/A

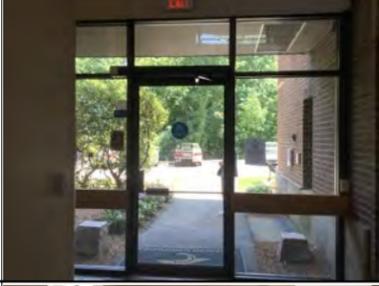
Illuminated ISA symbol not provided (MAAB)	-	Provide an illuminated sign with the International Symbol of Accessibility (ISA).	1	
24	Southeast Egress Door (Signs at Two Doors)	1		Means of Egress	N/A

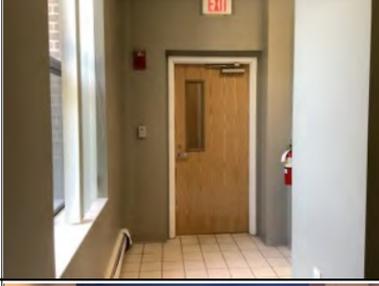
Directional sign to accessible emergency exit not provided	-	Provide a directional sign indicating the location of the nearest accessible emergency exit.	2

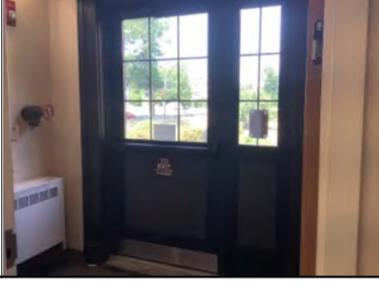
25	Southwest Egress Door	2, 1		Means of Egress	N/A

Directional sign to accessible emergency exit not provided	-	Provide a directional sign indicating the location of the nearest accessible emergency exit.	1

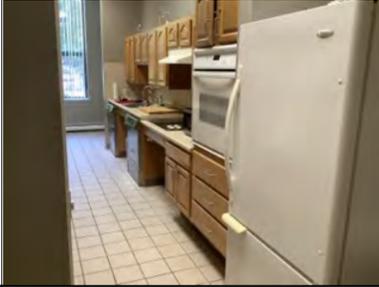
Route < 36" wide	29"	Ensure that a clear width of 36" min. is maintained at the accessible route. Relocate the refrigerator.	1	
27	Laundry Room	1		Interior Access Route	N/A

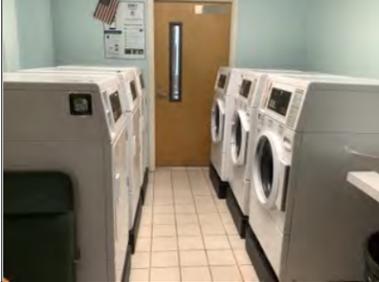
Route < 36" wide	28"	Ensure that a clear width of 36" min. is maintained at the accessible route through the laundry room. and that 32" clear width is maintained at the door,	1	
28	Storage Room	1		Interior Access Route	N/A

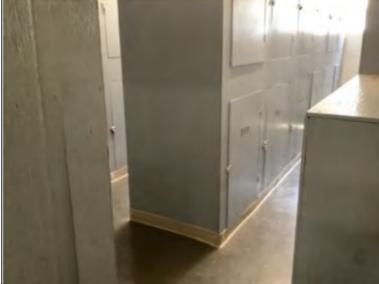
Route < 36" wide	28"	Ensure that a clear width of 36" min. is maintained at the accessible route. (Cost would need to be determined based on renovation.)	1	
29	To Patio Deck	4		Interior Access Route	N/A

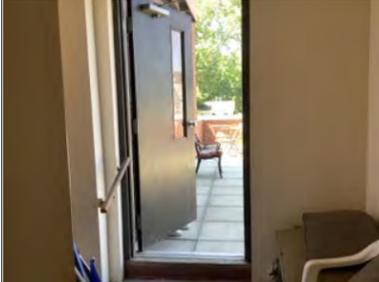
Accessible route not provided	6"	Provide an accessible route to the patio. Install a ramp. (Cost based on a wood ramp with a 5' run.)	1

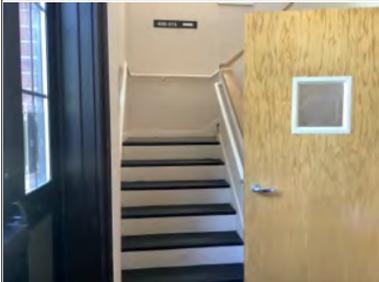
Doors, Doorways, & Gates											
30	Staircase by Central Street	3		Doors, Doorways, & Gates	Circulation

Clear width at door < 32"	31"	Install offset hinges to ensure that the door has a clear width of 32 inches.	1

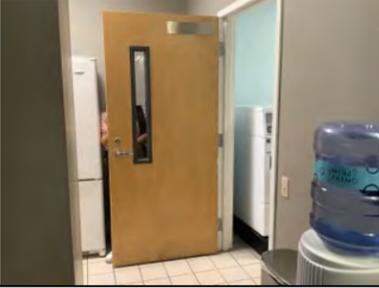
Maneuvering clearance(s) not provided	45"	Provide an automatic door opener./Reverse the swing of the door to provide maneuvering clearance.	1	
32	Unit 307, Entry Door	3	307	Doors, Doorways, & Gates	Other

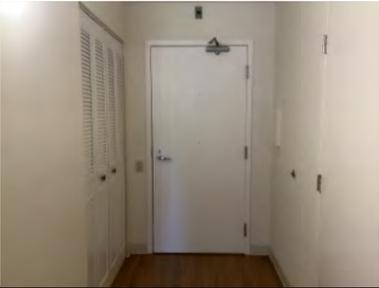
Maneuvering clearance(s) not provided Door requires > 5 lbs. of force to open	7" 14 lbs	Provide an automatic door opener. Adjust closers so doors do not require more than 5 pounds of force to open.	1	
33	Kersey Community Room, Kitchen Storage	1		Doors, Doorways, & Gates	Other

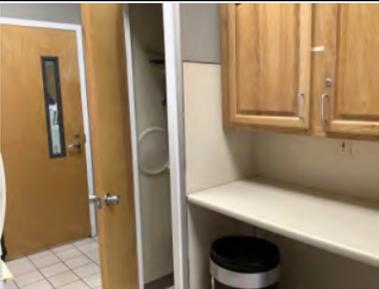
Hardware not operable with a closed fist	-	Provide hardware that can be operable with one hand and not require tight grasping, pinching, or twisting of the wrist.	2	
34	To Patio Deck	4		Doors, Doorways, & Gates	Circulation

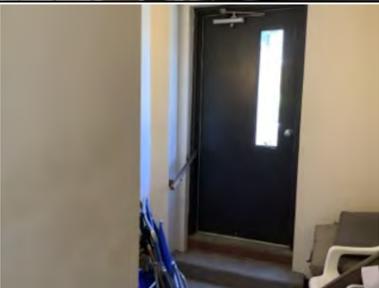
Hardware not operable with a closed fist	-	Provide hardware that can be operable with one hand and not require tight grasping, pinching, or twisting of the wrist.	1

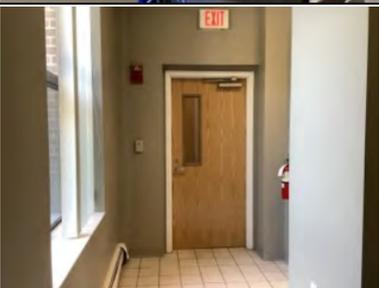
35	To Southeast Egress Door	1		Doors, Doorways, & Gates	Other

Door requires > 5 lbs. of force to open	15 lbs.	Adjust closers so doors do not require more than 5 pounds of force to open.	1

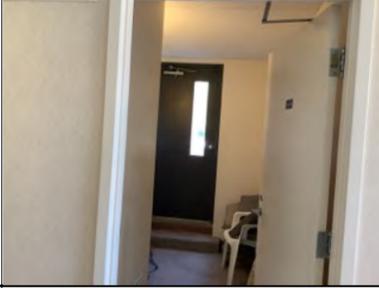
Door requires > 5 lbs. of force to open	15 lbs.	Adjust closers so doors do not require more than 5 pounds of force to open.	1	
37	Single-User Toilet Room	B		Doors, Doorways, & Gates	Toilet Room

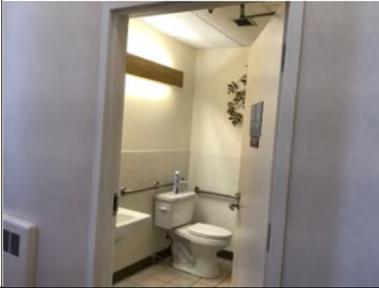
Door requires > 5 lbs. of force to open	15 lbs.	Adjust closers so doors do not require more than 5 pounds of force to open.	1	
Stairways											
38	Stairs by Laundry	1		Stairways	Egress

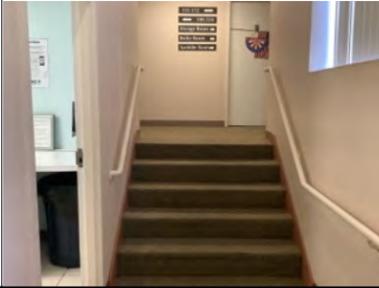
Handrail height < 34" or > 38"	30"	Alter so the handrails are 34"- 38" high above the floor.	1	
39	Staircase by Main Entrance, West Egress	B		Stairways	Other

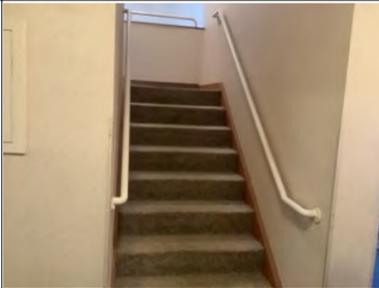
Handrail height < 34" or > 38"	31"	Alter so the handrails are 34"- 38" high above the floor.	1	
40	Staircase by Central Street	2		Stairways	Egress

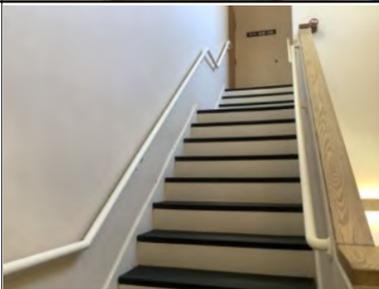
Handrail height < 34" or > 38" Handrails not continuous where required	30" -	Alter so the handrails are 34"- 38" high above the floor. Provide continuous handrails at the inside handrail at switchback and dogleg turns.	1

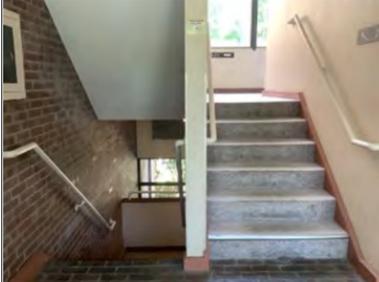
Handrails not continuous where required	-	Provide continuous handrails at the inside handrail at switchback and dogleg turns.	1	
42	North Staircase	2		Stairways	Egress

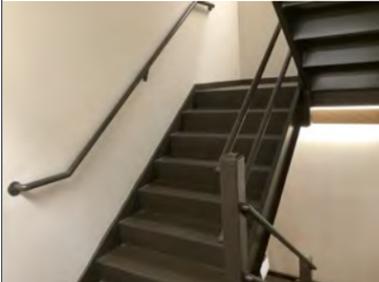
Handrails not continuous where required	-	Provide continuous handrails at the inside handrail at switchback and dogleg turns.	1	
43	North Staircase	3		Stairways	Egress

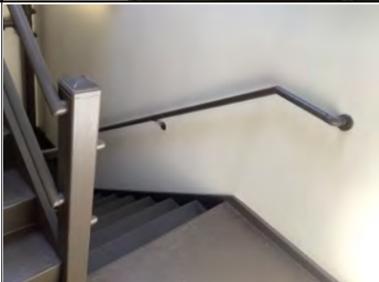
Handrails not continuous where required	-	Provide continuous handrails at the inside handrail at switchback and dogleg turns.	1	
44	North Staircase	4		Stairways	Egress

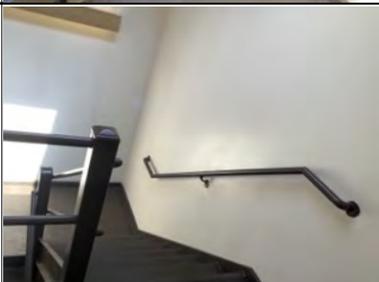
Handrails not continuous where required	-	Provide continuous handrails at the inside handrail at switchback and dogleg turns.	1	
45	North Staircase	5		Stairways	Egress

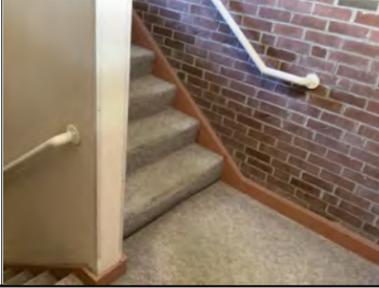
ID	Location	Floor	Room	Element	Type	Photo	Issues	Current Measure	Recommendations	Quantity	Notes
46	Staircase by Main Entrance, West Egress	B		Stairways	Egress

Handrails not continuous where required	-	Provide continuous handrails at the inside handrail at switchback and dogleg turns.	1	
Signage											
47	Unit 211 and Units Throughout the Building	2		Signage	Designation

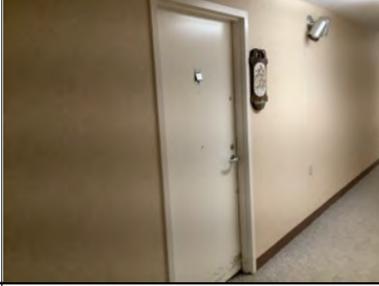
Raised characters not provided on sign Braille not provided on sign Sign not located on the latch side of the door	- - -	At each apartment in the building: Provide text with raised characters duplicated in braille on sign. Locate the sign at permanent rooms alongside the door on the latch side.	60	
48	Office	B		Signage	Designation

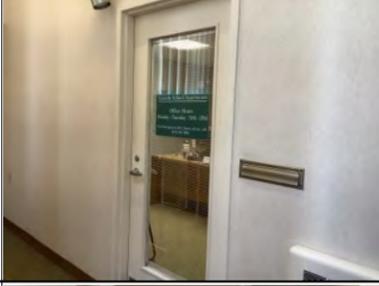
Raised characters not provided on sign Braille not provided on sign Sign not located on the latch side of the door	- - -	Provide text with raised characters duplicated in braille on sign. Locate the sign at permanent rooms alongside the door on the latch side.	1

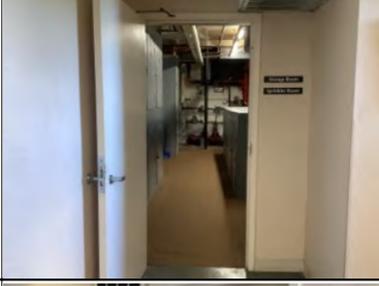
49	Storage Room	1		Signage	Designation

Braille not provided on sign	-	Provide braille on the sign.	1	
50	Patio Deck	4		Signage	Designation

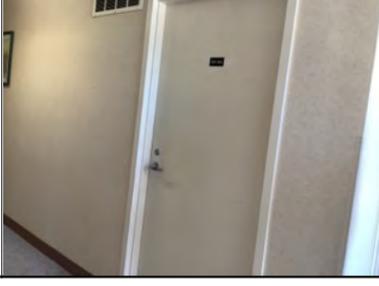
Braille not provided on sign Sign not located on the latch side of the door	- -	Provide braille on the sign. Locate the sign at permanent rooms alongside the door on the latch side.	1

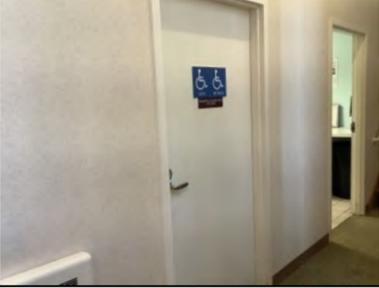
ID	Location	Floor	Room	Element	Type	Photo	Issues	Current Measure	Recommendations	Quantity	Notes
51	Single-User Toilet Room	B		Signage	Designation

Braille misplaced on sign Sign not located on the latch side of the door	- -	Position the braille below the corresponding text. If text is multi-lined place braille below the entire text. Locate the sign at permanent rooms alongside the door on the latch side.	1	
52	By Staircase by Main Entrance, West Egress, Sign Indicating Location of Main Office	1		Signage	Directional

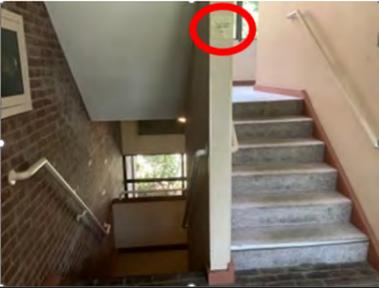
Non-glare finish and contrast not provided on sign	-	Install a sign with a non-glare finish with characters that have a high contrast to the background.	1	
53	Main Entrance, West Egress,	Ext.		Signage	Informational

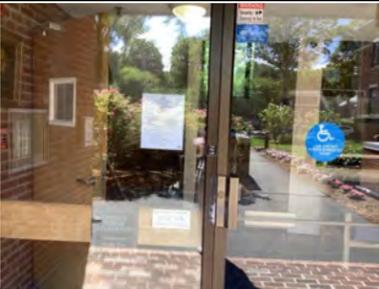
Non-glare finish and contrast not provided on sign	-	Install a sign with a non-glare finish with characters that have a high contrast to the background.	1

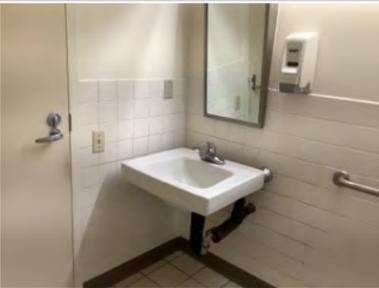
Operable Parts											
54	Single-User Toilet Room	B		Operable Parts	Other

Forward reach if obstruction > 20"- 25" deep is > 44" high	48"	Ensure that the soap dispenser is not higher than 44" above the finished floor.	1	
55	By East Secondary Entrance, Rear Parking	Ext.		Operable Parts	Other

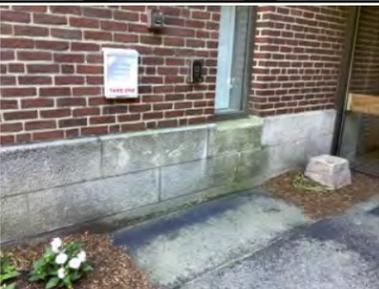
Not operable with a closed fist	-	Ensure that the application information receptacle does not need to be operable with one hand and does not require tight grasping, pinching, or twisting of the wrist.	1

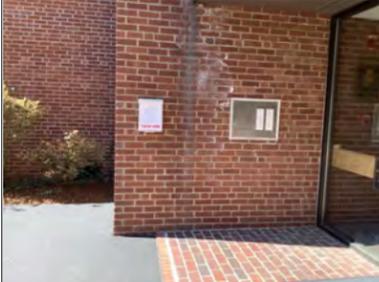
ID	Location	Floor	Room	Element	Type	Photo	Issues	Current Measure	Recommendations	Quantity	Notes
56	By Main Entrance, West Egress,	Ext.		Operable Parts	Other

Not operable with a closed fist		Ensure that the application information receptacle does not need to be operable with one hand and does not require tight grasping, pinching, or twisting of the wrist.	1	
57	Northwest Entrance/ Egress Door	Ext.		Operable Parts	Equipment

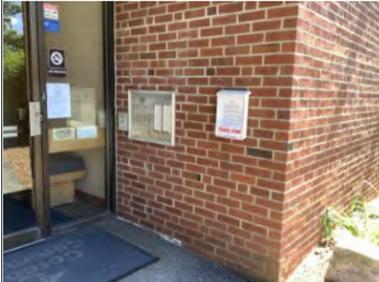
Not operable with a closed fist	-	Provide hardware at the application Information receptacle that can be operable with one hand and not require tight grasping, pinching, or twisting of the wrist.	1	
Dining or Work Surfaces											
58	Patio Deck	Ext.		Dining or Work Surfaces	Dining Surface

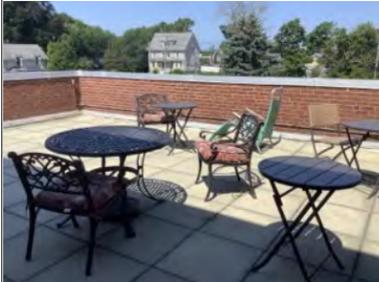
Knee and toe clearance not provided Top of dining/work surface < 28" or > 34"	- 23"	Provide at least one dining surface with tops between 28"- 34" above the floor and 27" clear height underneath.	1

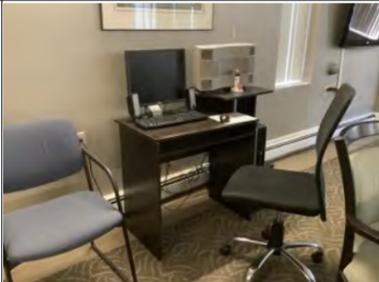
59	Kersey Community Room	1		Dining or Work Surfaces	Work Surface

Knee or toe clearance not provided	24"	Provide at least one work surface with 27" min. knee and toe clearance.	1	
60	Kersey Community Room	1		Dining or Work Surfaces	Dining Surface

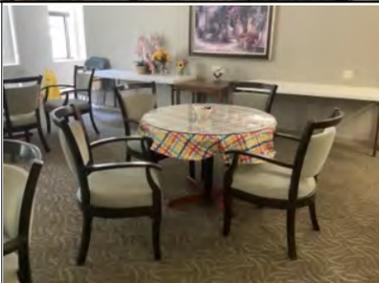
Toe clearance not provided	-	Provide at least one dining surface with 27" min. knee and toe clearance.	1

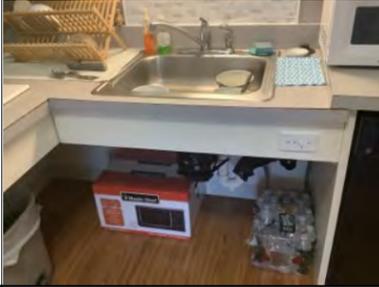
ID	Location	Floor	Room	Element	Type	Photo	Issues	Current Measure	Recommendations	Quantity	Notes
Kitchens and Kitchenettes											
61	Unit 307, Kitchen	3	307	Kitchens and Kitchenettes	Other

Knee/toe clearance not provided at sink	26"	Provide a sink with knee and toe clearance positioned for a forward approach.	1	
62	Unit 411, Kitchen	4	411	Kitchens and Kitchenettes	N/A

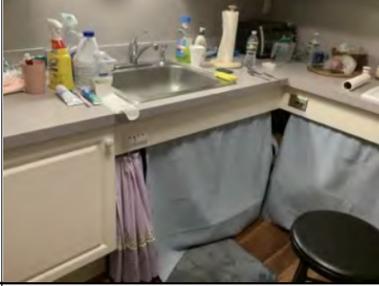
Knee/toe clearance not provided at sink	26"	Provide a sink with knee and toe clearance positioned for a forward approach.	1	
63	Kersey Community Room, Kitchen	1		Kitchens and Kitchenettes	Other

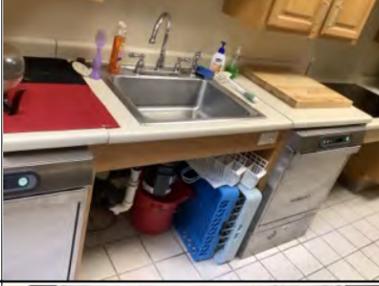
Sink > 34" high Countertop next to sink < 15" wide	36" -	Lower sink to be no higher than 34" positioned for a forward approach. Ensure a countertop that is at least 15" wide is provided next to the sink that has a 27" high min. clear space underneath.	1	
64	Unit 307, Kitchen	3	307	Kitchens and Kitchenettes	Other

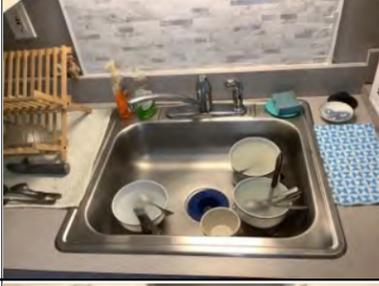
Countertop next to sink < 15" wide	5"	Ensure a countertop that is at least 15" wide is provided next to the sink.	1

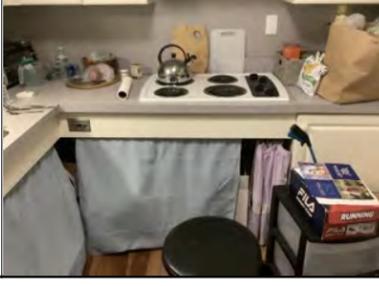
65	Unit 411, Kitchen	4	411	Kitchens and Kitchenettes	N/A

Knee/toe clearance not provided at cooktop	26"	Provide a cooktop with knee and toe clearance positioned for a forward approach.	1

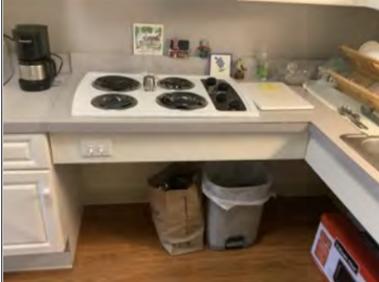
ID	Location	Floor	Room	Element	Type	Photo	Issues	Current Measure	Recommendations	Quantity	Notes
66	Unit 307, Kitchen	3	307	Kitchens and Kitchenettes	Other

Knee/toe clearance not provided at cooktop Countertop next to cooktop < 15" wide	26" 8"	Provide a cooktop with knee and toe clearance positioned for a forward approach. Ensure a countertop that is at least 15" wide is provided next to the cooktop.	1	
67	Kersey Community Room, Kitchen	1		Kitchens and Kitchenettes	Other

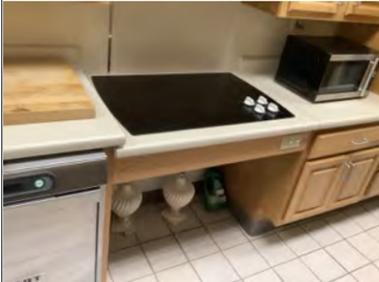
Countertop next to cooktop < 15" wide	7.5"	Ensure a countertop that is at least 15" wide is provided next to the cooktop that has a 27" high min. clear space underneath.	1	
68	Kersey Community Room, Kitchen	1		Kitchens and Kitchenettes	Other

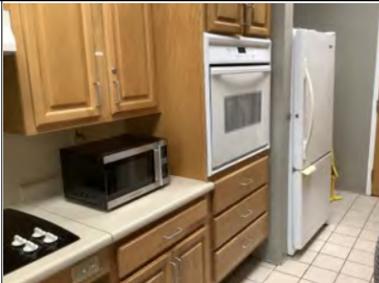
Bottom of oven doors > 30" high Retractable bread board not provided	37" -	Locate oven so the bottom of the door is located 30" max. above the finished floor. If Provide a retractable bread board adjacent to the oven door.	1

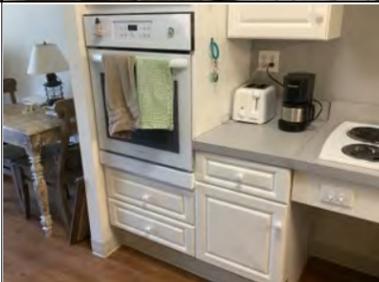
69	Unit 307, Kitchen	3	307	Kitchens and Kitchenettes	Other

Retractable bread board not provided	-	Provide a retractable bread board adjacent to the door.	1	
70	Unit 411, Kitchen	4	411	Kitchens and Kitchenettes	Other

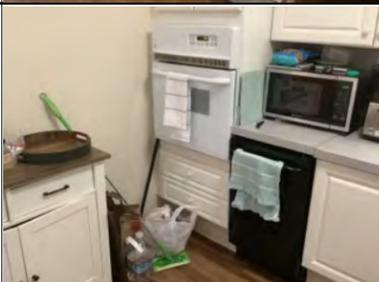
Retractable bread board not provided	-	Provide a retractable bread board adjacent to the door.	1

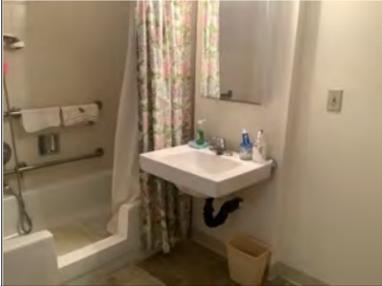
Mirror above lavatory w/reflective surface > 40"	44"	Lower mirror so that the bottom surface is at 40" max. above the finished floor.	1	
Single-User Toilet

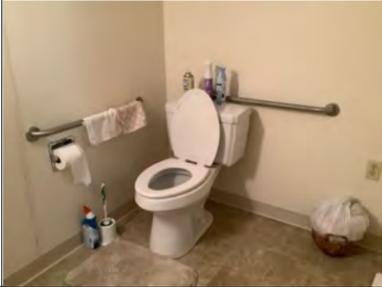
73	Unit 307, Toilet Room	3	307	Single-User Toilet	N/A

Flush control not on open side	-	Relocate the flush control to the open side.	1	
74	Single-User Toilet Room	1		Single-User Toilet	N/A

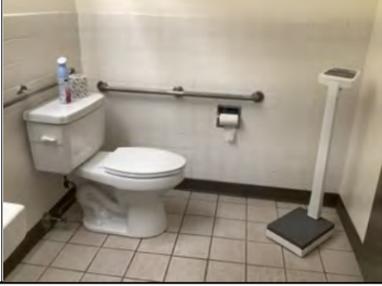
Side or rear grab bar < 33" or > 36" high Clearance at toilet < 72" clear depth	30" 18"	Mount the side grab bar 33"- 36" above the finished floor. Relocate the scale in the toilet room to ensure that there is 72" deep min. clear floor space at the toilet.	1

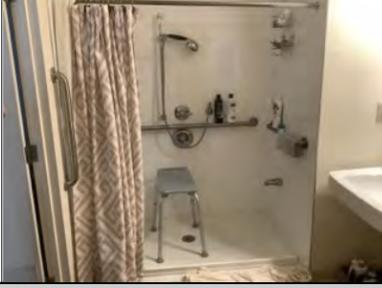
Roll-in type shower has a curb (MAAB)	4"	Ensure there is no curb at the roll-in shower.	1	
Bathtub											
77	Unit 307, Toilet Room	3	307	Bathtub	Tub With Permanent Seat

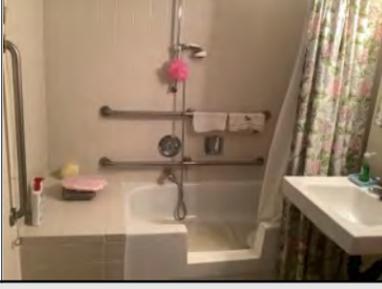
Controls are not compliant Controls are not on the end wall before the centerline	- -	Provide controls that are operable with one hand and do not require tight grasping, pinching, or twisting of the wrist. Provide an additional set of controls on the end wall. Locate controls between the bathtub rim and grab bar and between the open side of the bathtub and the centerline of the width of the bathtub. Plumbing cost will need to be determined.	1

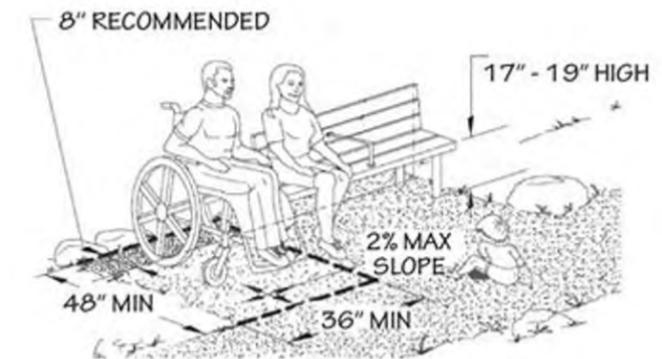
Figure 1 shows a stable, firm and slip-resistant surface adjacent to a bench positioned to allow a person in a wheeled mobility device and a person sitting on the bench to have their shoulders aligned:

- Recommend providing a 36" min. by 48" min. stable, firm and slip-resistant surface adjacent to at least one bench in a manner that is substantially similar to what is shown in Figure 1.

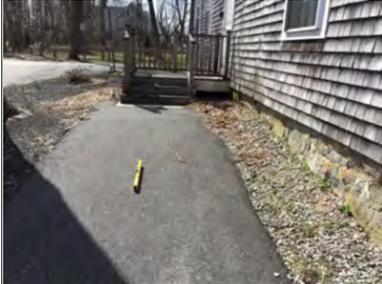
ID	Location	Floor	Room	Element	Type	Photo	Issues	Current Measure	Recommendations	Quantity	Notes
Approach and Entrance											
Exterior Access Route											
1	Route From Upper Stairs	Ext.		Exterior Access Route	Walkway

Running slope > 1:20 (5.00%)	7%	Reduce the running slope to be no steeper than 1:20 (5.00%).	1	
2	Walkway	Ext.		Exterior Access Route	Walkway

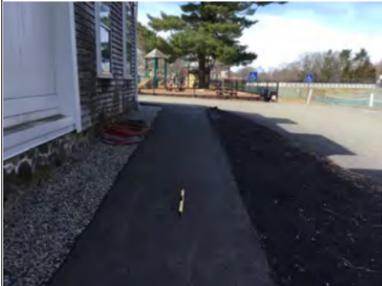
Running slope > 1:20 (5.00%)	6.3%	Reduce the running slope to be no steeper than 1:20 (5.00%).	1	
3	Route by Ramp	Ext.		Exterior Access Route	Walkway

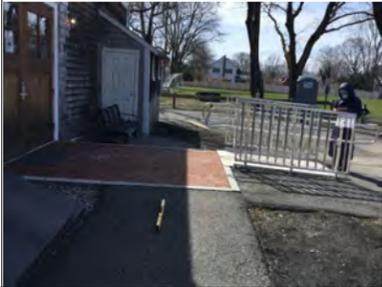
Running slope > 1:20 (5.00%)	5.8%	Reduce the running slope to be no steeper than 1:20 (5.00%).	1	
4	Outside of Accessible Exit	Ext.		Exterior Access Route	Exterior

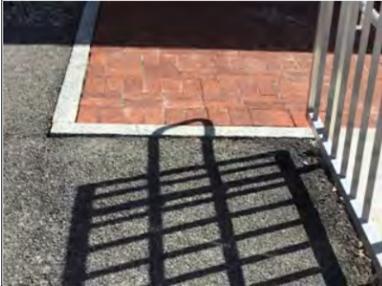
Level changes > 1/4"	.75"	Alter the change in level between the transition of materials to be 1/4" high max.	1	
Emergency Exit											
5	Exit to Back Stairs	1		Emergency Exit	N/A

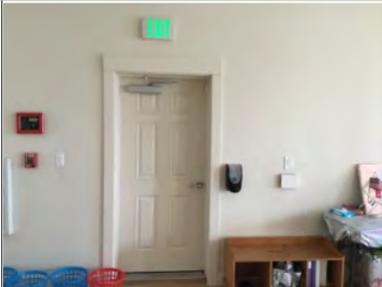
Tactile sign not provided at emergency exit Directional sign to accessible emergency exit not provided	- -	Provide a sign with raised characters and braille at the emergency exit. Mount signs between 48"-60" above the finished floor located on the latch side of the door. Provide a directional sign indicating the location of the nearest accessible emergency exit.	1

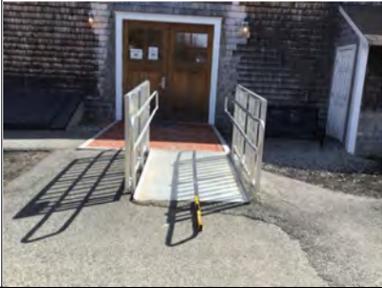
Ramp < 48" wide (MAAB) Running slope >1:12 (8.33%)	44" 8.6%	Enlarge the ramp to provide 48" min. clear per the MAAB. Reduce running slope to be no steeper than 1:12 (8.33%). Ensure that the bottom platform is sloped no greater than 1:50 (2.00%).	1

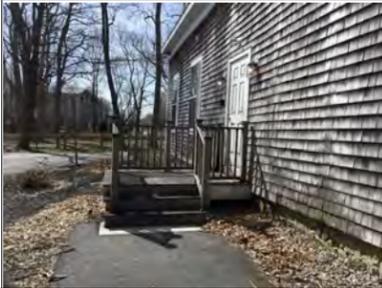
Stairways											
8	Upper Stairs	Ext.		Stairways	Exterior

Handrails have non-compliant cross section	-	Handrails lack a circular cross section and return to posts. Provide handrails with a 1 1/4" - 2" circular cross section.	1	
9	Back Egress	Ext.		Stairways	Exterior

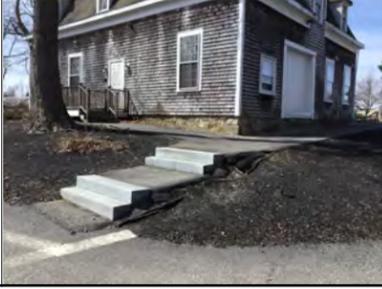
Handrails not provided	-	Provide handrails.	1

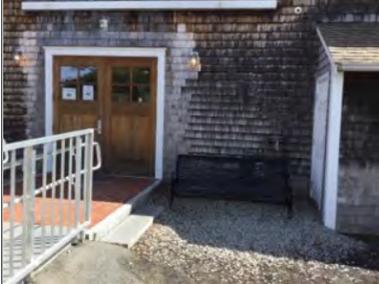
No accessible route to one bench in this area		Provide an accessible route to at least one bench in this area. To achieve program access, IHCD recommends providing an accessible route to at least one bench in each distinct location where benches are provided.	1	
Toilet & Bathing Rooms											
Single-User Toilet											
12	Single-User Toilet Room	1		Single-User Toilet	N/A

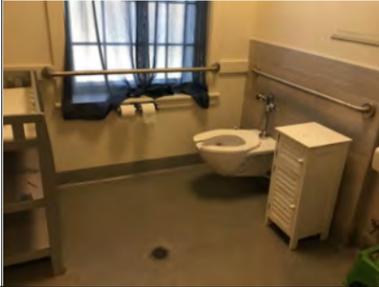
Clearance at toilet < 72" clear depth (MAAB)	-	Relocate baby changing table so that there is 72" clear in front of the rear toilet wall.	1

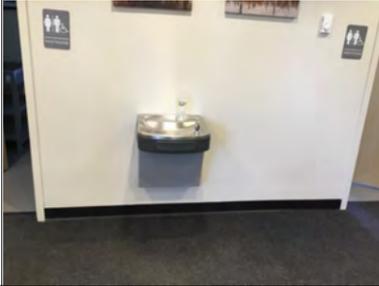
Additional Access											
Drinking Fountains											
13	Drinking Fountain	1		Drinking Fountains	Seated

No drinking fountain provided for standing users		Provide an additional drinking fountain for standing users. Per ADA 211.2, no fewer than two (2) drinking fountains must be provided, one for seated users and one for standing users.	1	
Best Practice

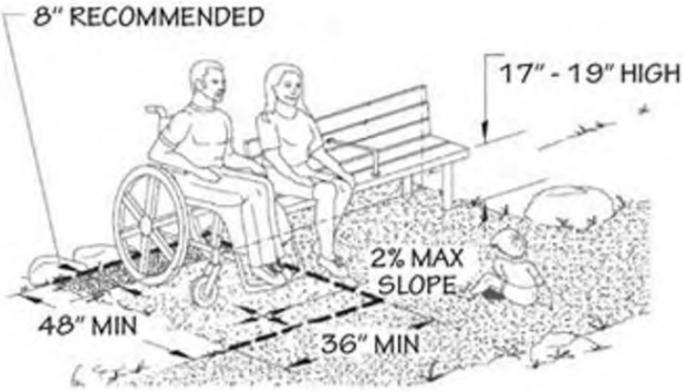
Figure 1 shows a stable, firm and slip-resistant surface adjacent to a bench positioned to allow a person in a wheeled mobility device and a person sitting on the bench to have their shoulders aligned:

- Recommend providing signage with raised characters and braille on the latch side of the door to all permanent rooms that lack designation signage.
- Recommend providing a 36" min. by 48" min. stable, firm and slip-resistant surface adjacent to at least one bench in the park in a manner that is substantially similar to what is shown in Figure 1.

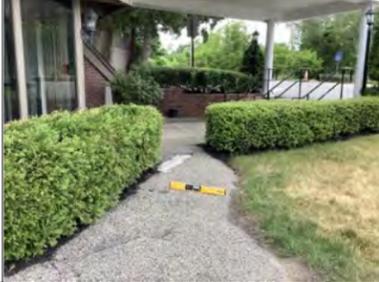
Exterior route < 36" wide Cross slope > 1:50 (2.00%)	32" 8%	Ensure that a clear width of 36" min. is maintained at the accessible route (48" wide is preferred). Reduce cross slope to be no steeper than 1:50 (2.00%).	1	
2	Greenside Grille, Egress Door 3 to Events Tent on the East	Ext.		Exterior Access Route	Exterior

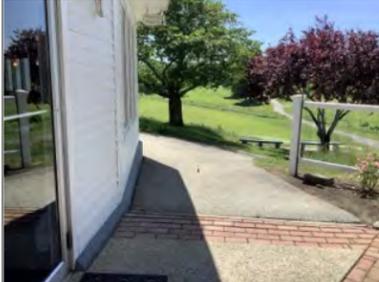
Surface openings > 1/2" Running slope > 1:20 (5.00%)	2" 8.4%	Replace or reposition so that openings are 1/2" max. and the long opening dimension is perpendicular to the dominant direction of travel. Reduce running slope to be no steeper than 1:20 (5.00%).	1	
3	Pro Shop, South Egress Door to North Accessible Parking	Ext.		Exterior Access Route	Exterior
