Central Fire Station

Town of Hingham ADA Transition Plan

October 2023

Institute for Human Centered Design

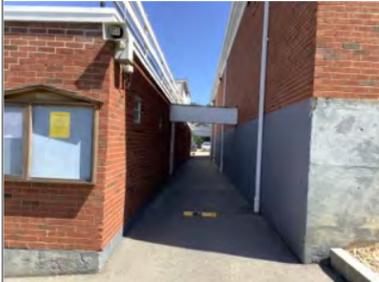
Cross slope > 1:50 (2.00%)	3.6%	Reduce cross slope to be no steeper than 1:50 (2.00%).	1

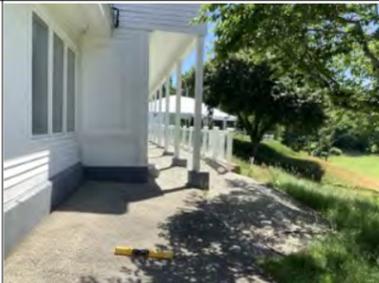
4	Greenside Grille, Egress Door 3 to Events Tent on the East	Ext.		Exterior Access Route	Walkway

Cross slope > 1:50 (2.00%)	11.5%	Reduce cross slope to be no steeper than 1:50 (2.00%).	1	
5	Tennis Court	Ext.		Exterior Access Route	Exterior

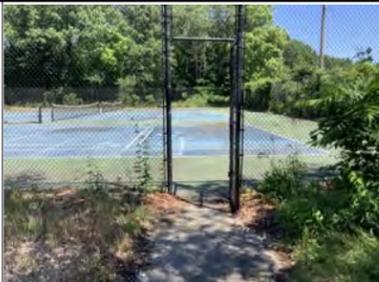
Cross slope > 1:50 (2.00%) Exterior route < 36" wide Route not maintained in operable working condition	6.1% 25" -	Note: Tennis court is planned to be renovated. or removed.	1

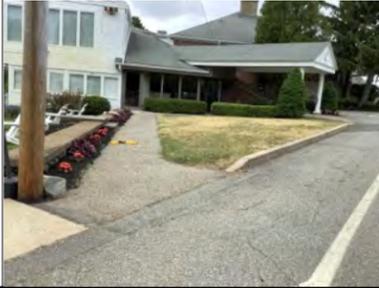
Cross slope > 1:50 (2.00%) Route not maintained in operable working condition	6.6% -	Reduce cross slope to be no steeper than 1:50 (2.00%). Ensure the accessible route is maintained in operable working condition.	1	
8	Route to Pro Shop	Ext.		Exterior Access Route	Exterior

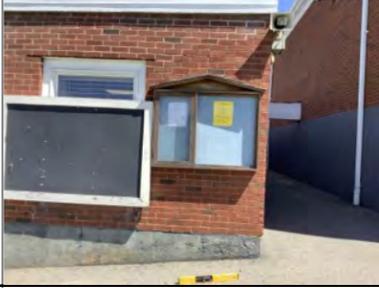
Running slope > 1:20 (5.00%)	11%	It may not be technically feasible to reduce the running slope to 1:20 (5.00%).	1

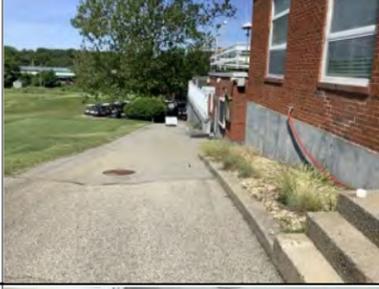
9	Egress Door 5 From Bowling Alley to Pro Shop, South Egress Door	Ext.		Exterior Access Route	Exterior

Running slope > 1:20 (5.00%)	15.8%	It may be technically infeasible to reduce the running slope to 1:20 (5.00%), however the route should be made accessible to the maximum extent feasible. The Town does not need to confirm that it is technically infeasible, but if a member of the public were to file a complaint with the Department of Justice, the Town should be prepared to do an analysis.	1	
10	Route to East Egress Door	Ext.		Exterior Access Route	Walkway

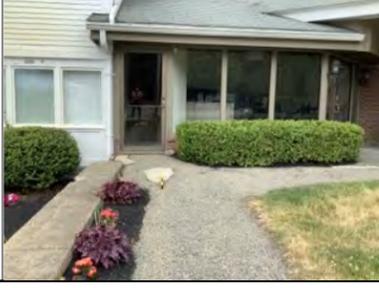
Running slope > 1:20 (5.00%)	6.5%	Reduce running slope to be no steeper than 1:20 (5.00%).	1

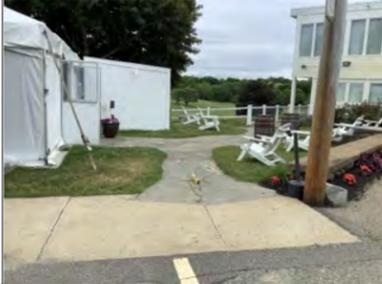
Running slope > 1:20 (5.00%) Surface is not stable, firm, and slip-resistant	7.2% -	Reduce running slope to be no steeper than 1:20 (5.00%). Repair surface.	1	
13	North Walkway to Country Club, Main Entrance	Ext.		Exterior Access Route	Walkway

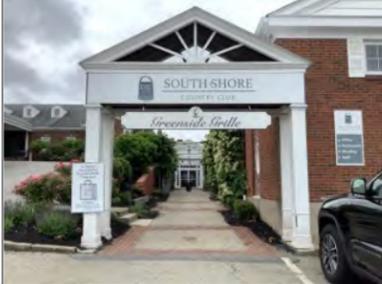
Level changes > 1/4"	1/2"	Alter change in level to be 1/4" high max. at the transition between brick and concrete.	1	
14	Pro Shop, South Egress Door to North Accessible Parking	Ext.		Exterior Access Route	Exterior

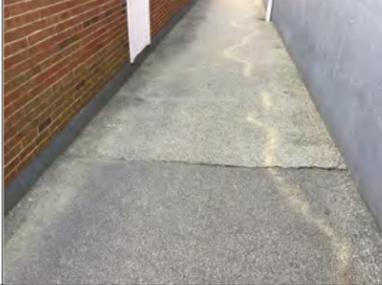
Route not maintained in operable working condition	-	Ensure the accessible route is maintained in operable working condition. Repair the surface where it is cracked.	1

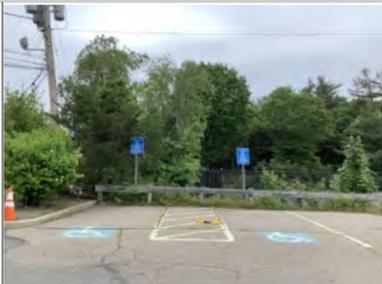
Off-Street Parking Lot or Garage											
15	East Parking Lot across From Lincoln Room, Main Entrance	Ext.		Off-Street Parking Lot or Garage	Visitor

Total # of parking Total # of designated accessible parking spaces Total # of designated van accessible spaces Access aisle < 60" wide at car/van space	28 2 1 58.5"	The east parking lot has a greater number of accessible parking spaces than required. At the parking spaces in the photograph: provide a marked access aisle that is at least 60" wide.	1

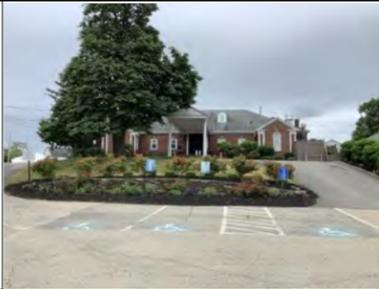
ID	Location	Floor	Room	Element	Type	Photo	Issues	Current Measure	Recommendations	Quantity	Notes
16	North Parking by Greenside Grille	Ext.		Off-Street Parking Lot or Garage	Visitor

Total # of parking Total # of designated accessible parking spaces Total # of designated van accessible spaces Access aisle < 60" wide at car/van space Running or cross slope at access aisle > 1:50 (2.00%) Sign bottom < 60" above finished grade	203 7 1 57" 6% 41.5"	Provide one (1) additional van accessible parking space in the north parking lot. Five (5) car accessible parking spaces and two (2) van accessible parking spaces are required. In the three spaces shown: provide a marked access aisle that is at least 60" wide at each space. Reduce running or cross slope to be no steeper than 1:50 (2.00%). Locate the signs with the bottom of the sign 60" above the ground.	1	
17	East Parking Lot by Lincoln Room, Main Entrance	Ext.		Off-Street Parking Lot or Garage	Visitor

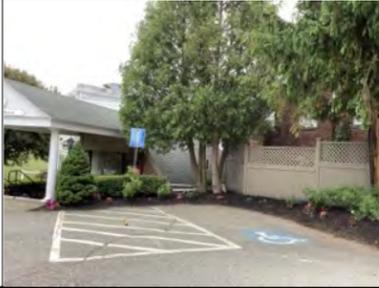
Van space < 132" or <96" wide Running or cross slope at space > 1:50 (2.00%) Running or cross slope at access aisle > 1:50 (2.00%)	90" 3.4% 4.5%	Provide a van accessible space that is at least 96" wide. Reduce running and cross slope at space and access aisle to be no steeper than 1:50 (2.00%).	1

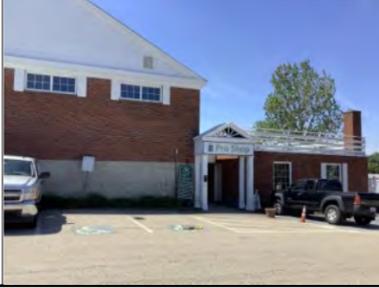
18	North Accessible Parking Lot by the Pro Shop	Ext.		Off-Street Parking Lot or Garage	Visitor

Running or cross slope at space > 1:50 (2.00%) Access aisle not provided Running or cross slope at access aisle > 1:50 (2.00%) Sign not provided Sign does not have the designation "Van Accessible" Sign bottom < 60" above finished grade	4.5% - 3.6% - 58"	Reduce running and cross slope at spaces and access aisles to be no steeper than 1:50 (2%). Provide a marked access aisle that is at least 60" wide at the car accessible parking space (on left). Provide a sign with the International Symbol of Accessibility (ISA) and the designation "Van Accessible" at the van accessible space on the right. Locate the bottom of signs 60" above the ground.	1	
Exterior Ramp											
19	Ramp to Upper Function Room, North Entrance Door	Ext.		Exterior Ramp	N/A

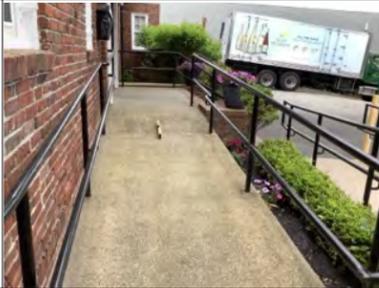
Running slope > 1:12 (8.33%)	9.9%	Reduce running slope to be no steeper than 1:12 (8.33%).	1

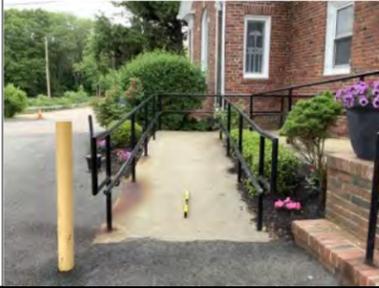
20	Ramp to Upper Function Room, North Entrance Door	Ext.		Exterior Ramp	N/A

Edge protection < 4" high	-	Provide edge protection that prevents the passage of a 4" diameter sphere, where any portion of the sphere is within 4" of the finished floor or ground surface.	1

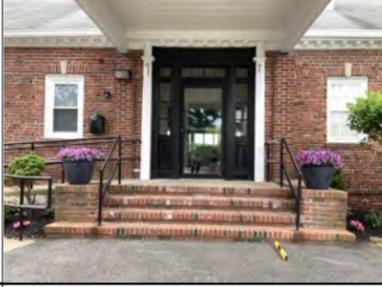
Handrails do not extend 12" from stair	-	Top: Ensure handrails extend horizontally above the landing for 12" min. beginning above the first riser nosing. Bottom: Ensure that the sloped bottom extension extends one tread depth min. beyond last riser nosing in same direction as stair flight.	1	
23	Bowling Alley, Entrance Door 5	Ext.		Exterior Stair	N/A

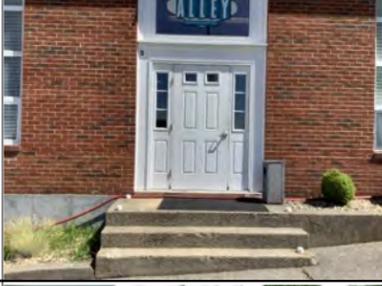
Handrail not provided on both sides	-	Provide a handrail on each side of the stair.	1	
24	Events Tent to Lincoln Dining Room	Ext.		Exterior Stair	N/A

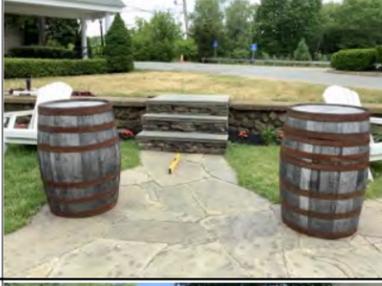
Risers > 7" high Handrails not provided	8.5" -	Repair to this stairway's risers might be technically infeasible. Provide a handrail on each side of the stair.	1

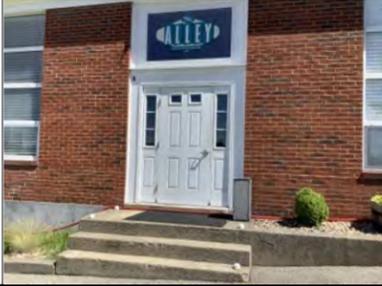
Entrance not on an accessible route Directional sign to accessible entrance not provided	-	Provide a directional sign indicating the location of the nearest accessible entrance above the tactile designation sign. Recommend locating the directional sign above the tactile designation sign. In addition, where a directional sign is required, it should be located to minimize backtracking. In some cases, this could mean locating a sign at the beginning of a route, not just at the inaccessible entrances to a building.	1	
27	Lincoln Dining Room, East Entrance/ Egress Door (Interior Stairs)	Ext.		Entrance	Secondary Entrance

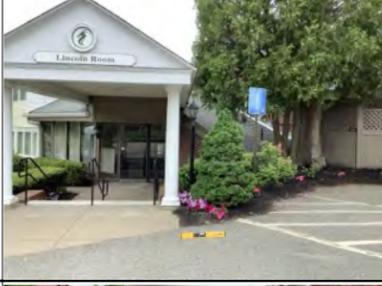
28	Parking by Lincoln Dining Room Main Entrance, Egress Door 2 and the Main Ballroom	Ext.		Entrance	Main Entrance

Directional sign to accessible entrance not provided	-	Provide a directional sign indicating the location of the nearest accessible entrance above the tactile designation sign. In addition, where a directional sign is required, it should be located to minimize backtracking. In some cases, this could mean locating a sign at the beginning of a route, not just at the inaccessible entrances to a building.	1	
29	Main Entrance From Alley	Ext.		Entrance	Main Entrance

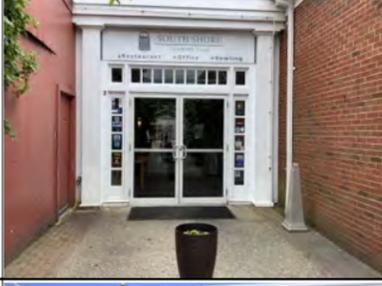
International Symbol of Accessibility not provided	-	Provide a sign with the International Symbol of Accessibility (ISA). Recommend providing sign with the ISA above the tactile designation sign that is required at this door.	1	
30	Pro Shop, South Egress Door	Ext.		Entrance	Main Entrance

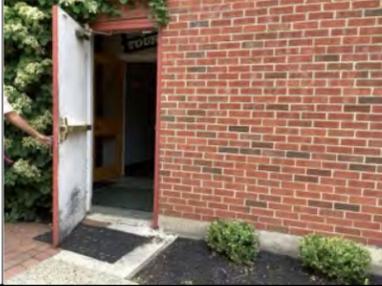
International Symbol of Accessibility not provided Mat not securely attached	- -	Provide a sign with the International Symbol of Accessibility (ISA) on the right side of the latch. Secure the mat.	1	
33	Pro Shop, South Egress Door	Ext.		Entrance	Main Entrance

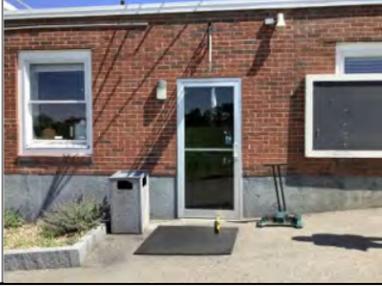
Maneuvering clearance at door > 1:50 (2.00%) Hardware not operable with a closed fist	4.3% -	Alter so that the slope in all directions is no greater than 1:50 (2.00%). The maneuvering clearance must be 60" deep and extend 18" on the latch side of the door. Alternatively, an automatic door opener could be provided. Provide hardware that can be operable with one hand and not require tight grasping, pinching, or twisting of the wrist.	1

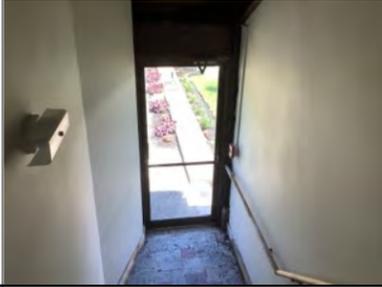
Access to Goods and Services											
Means of Egress											
34	East Egress Door	1		Means of Egress	N/A

Tactile exit sign not provided	-	Ensure tactile exit signs with raised characters and braille are provided at exit doors. Mount signs between 48"- 60" above the finished floor located on the latch side of the door.	1	
35	Pro Shop, South Egress Door	1		Means of Egress	N/A

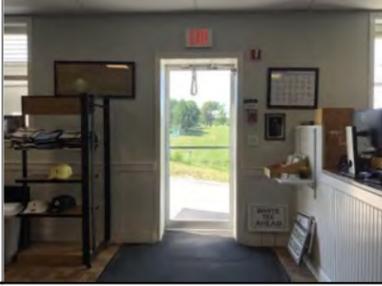
Tactile exit sign not provided	- -	Ensure tactile exit signs with raised characters and braille are provided at exit doors. Mount signs between 48"- 60" above the finished floor located on the latch side of the door.	1

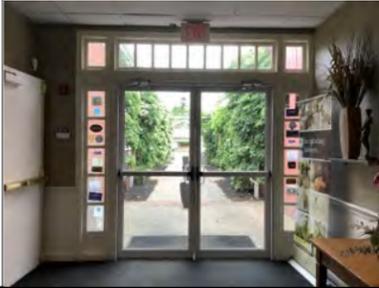
Tactile exit sign not provided Illuminated ISA symbol not provided (MAAB)	- -	Ensure tactile exit signs with raised characters and braille are provided at exit doors. Mount signs between 48"- 60" above the finished floor located on the latch side of the door. Provide an illuminated sign with the International Symbol of Accessibility (ISA).	1	
38	Greenside Grille,	1		Means of Egress	N/A

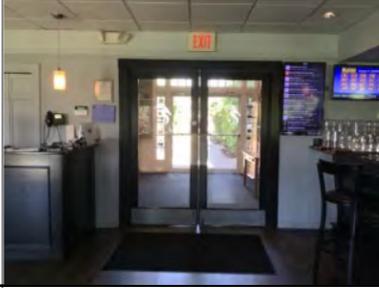
Tactile exit sign not provided Illuminated ISA symbol not provided (MAAB)	- -	Ensure tactile exit signs with raised characters and braille are provided at exit doors. Mount signs between 48"- 60" above the finished floor located on the latch side of the door. Provide an illuminated sign with the International Symbol of Accessibility (ISA).	1

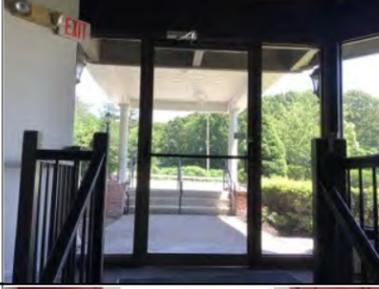
39	Lincoln Dining Room, Main Entrance, Egress Door 2	1		Means of Egress	N/A

Tactile exit sign not provided Illuminated ISA symbol not provided (MAAB)	- -	Ensure tactile exit signs with raised characters and braille are provided at exit doors. Mount signs between 48"- 60" above the finished floor located on the latch side of the door. Provide an illuminated sign with the International Symbol of Accessibility (ISA).	1	
40	Bowling Alley, Egress Door 5	1		Means of Egress	N/A

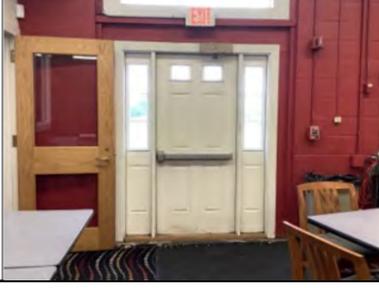
Tactile exit sign not provided Directional sign to accessible emergency exit not provided	- -	Ensure tactile exit signs with raised characters and braille are provided at exit doors. Mount signs between 48"- 60" above the finished floor located on the latch side of the door. Provide a directional sign indicating the location of the nearest accessible emergency exit.	1

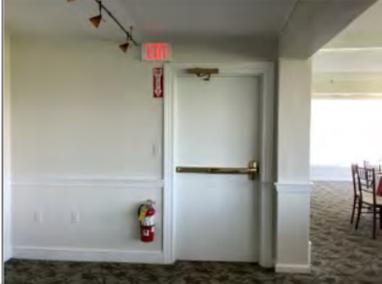
Tactile exit sign not provided Directional sign to accessible emergency exit not provided	- -	Ensure tactile exit signs with raised characters and braille are provided at exit doors. Mount signs between 48"- 60" above the finished floor located on the latch side of the door. Provide a directional sign indicating the location of the nearest accessible emergency exit.	1

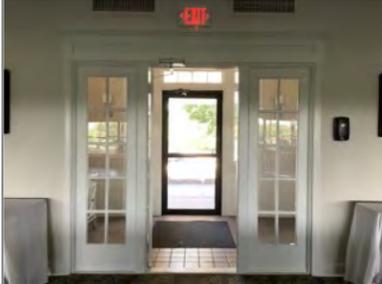
43	Upper Function Room, North Egress Door Vestibule	1		Means of Egress	N/A

Illuminated ISA symbol not provided (MAAB)	-	Provide an illuminated sign with the International Symbol of Accessibility (ISA) where the illuminated sign is currently located.	1	
44	Pub Room and the Tour (Golf Simulators) to Northwest Egress Door	1		Means of Egress	N/A

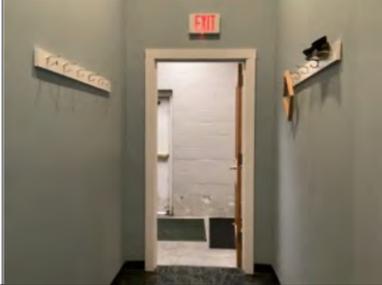
Illuminated ISA symbol not provided (MAAB) Tactile exit sign not provided	- -	At the northwest egress door that goes directly to the exterior beyond this door: Ensure tactile exit signs with raised characters and braille are provided at exit doors. Mount signs between 48"- 60" above the finished floor located on the latch side of the door. Provide an illuminated sign with the International Symbol of Accessibility (ISA).	1	
45	Egress Door 4 From Hall to South Side	1		Means of Egress	N/A

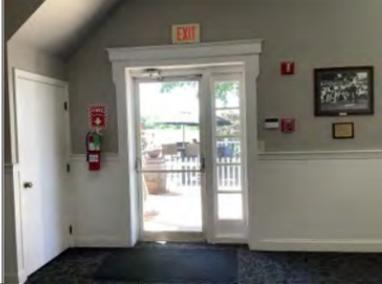
Directional sign to accessible emergency exit not provided Tactile exit sign not provided	- -	Ensure tactile exit signs with raised characters and braille are provided at exit doors. Mount signs between 48"- 60" above the finished floor located on the latch side of the door. Provide a directional sign indicating the location of the nearest accessible emergency exit.	1

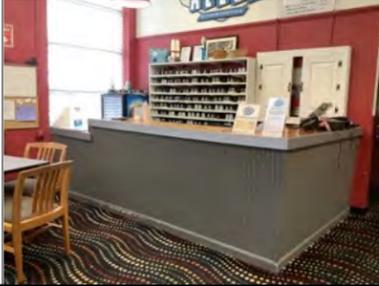
ID	Location	Floor	Room	Element	Type	Photo	Issues	Current Measure	Recommendations	Quantity	Notes
Interior Access Route											
46	Bowling Alley Service Counter	1		Interior Access Route	N/A

Route < 36" wide	19.6"	Ensure that a clear width of 36" min. is maintained at the accessible route by the portion of the lower counter. Relocate the table.	1	
47	Bowling Alley, Accessible Lane	1		Interior Access Route	N/A

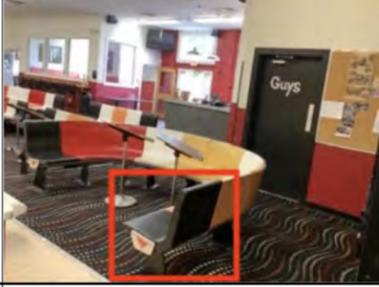
Route < 36" wide	18"	Ensure that a clear width of 36" min. is maintained at the accessible route alongside the seat. Remove a portion of the bench.	1	
48	Bowling Alley, Party Room	1		Interior Access Route	N/A

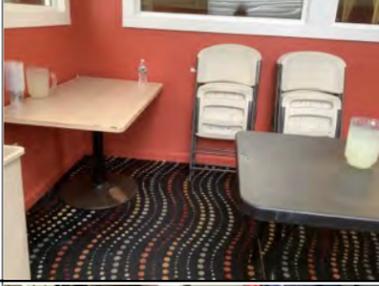
Route < 36" wide	23.1"	Ensure that a clear width of 36" min. is maintained at the accessible route. Relocate furniture.	1	
49	Pro Shop	1		Interior Access Route	N/A

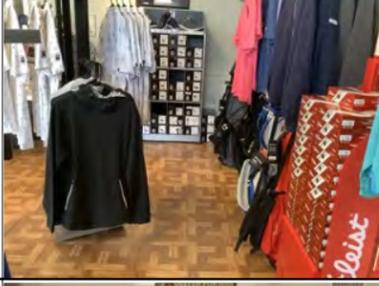
Route < 36" wide	31"	Ensure that a clear width of 36" min. is maintained at the accessible route. Relocate merchandise to maintain a 36" min. wide route.	1

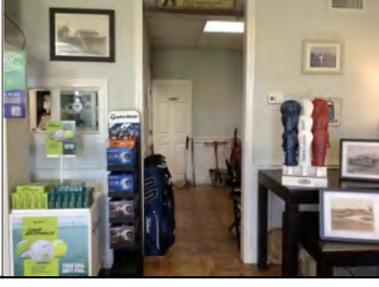
50	Pro Shop to Computer	1		Interior Access Route	N/A

Route < 36" wide	25.9"	Ensure that a clear width of 36" min. is maintained at the accessible route. Relocate bags.	1

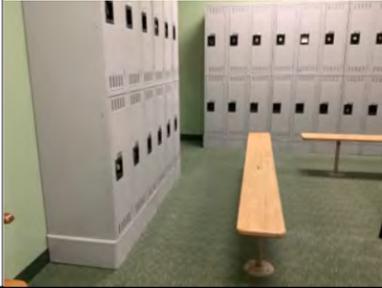
Route < 36" wide	28.9"	Relocate bench to ensure that a clear width of 36" min. is maintained at the accessible route.	1	
53	By Office	1		Interior Access Route	N/A

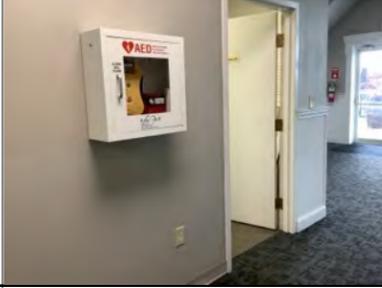
Obstructed by protruding objects	7"	Relocate defibrillator out of the circulation path.	1	
54	Egress Door 4 From Hall	1		Interior Access Route	N/A

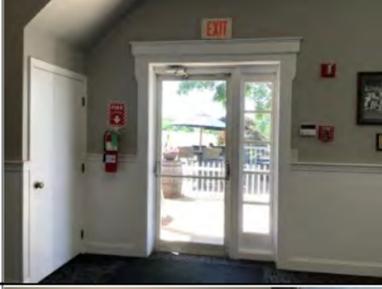
Obstructed by protruding objects	6.6"	Relocate the fire extinguisher out of the circulation path.	1	
55	Pub Room and the Tour (Golf Simulators)	1		Interior Access Route	N/A

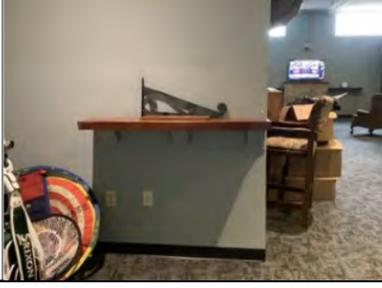
Obstructed by protruding objects	11"	Provide a cane-detectable barrier under the shelf.	1

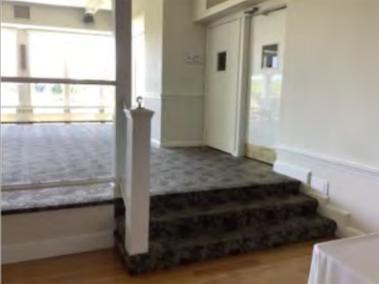
Accessible route not provided	-	If the public must travel between the first and second floors as part of the program, provide an accessible interior route. (Cost estimate for a two stop limited use limited application (LULA) elevator).	1	
Doors, Doorways, & Gates											
58	Lincoln Dining Room, Men's Toilet Room	1		Doors, Doorways, & Gates	Toilet Room

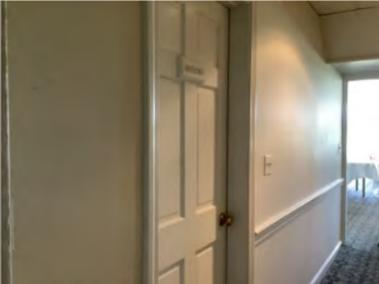
Clear width at door < 32"	27.6"	Provide signage directing users to an accessible toilet room. Locate the sign above the room designation sign.	1	
59	Lincoln Dining Room, Women's Toilet Room	1		Doors, Doorways, & Gates	Toilet Room

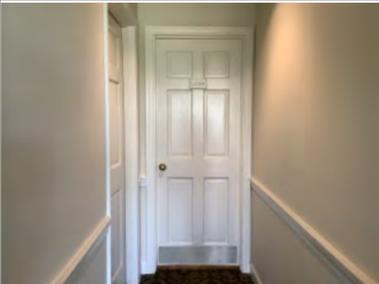
Clear width at door < 32"	28"	Provide signage directing users to an accessible toilet room. Locate directional sign above the room designation sign.	1

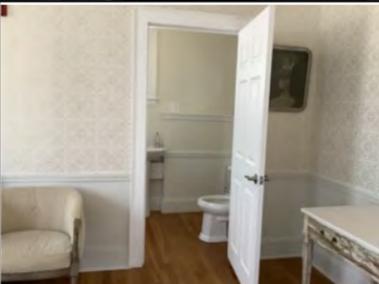
60	Bridal Room, Single-User Toilet Room	2		Doors, Doorways, & Gates	Toilet Room

Clear width at door < 32"	22.8"	Widen the door so that there is 32" min. clear width.	1

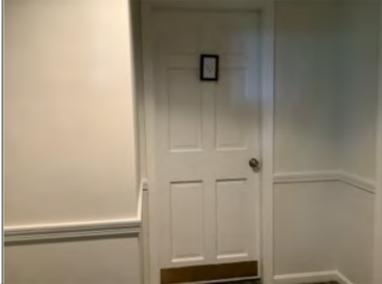
Clear width at door < 32"	22.8"	Provide signage directing users to an accessible toilet room.	1	
63	Upper Function Room, to East Egress Door	2		Doors, Doorways, & Gates	Emergency Egress

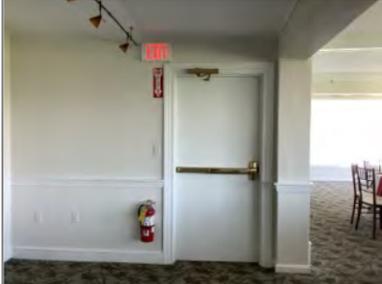
Clear width at door < 32" Door requires > 5 lbs. of force to open	30.2" 8 lbs.	Widen the door so that there is 32" min. clear width. Adjust closers so doors do not require more than 5 pounds of force to open.	1	
64	Bowling Alley, Men's Toilet Room	1		Doors, Doorways, & Gates	Toilet Room

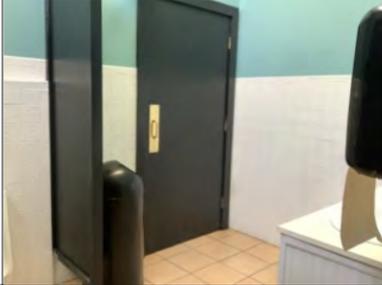
Maneuvering clearance(s) not provided	-	Relocate the trash bin so that there is 18" clear min. on the latch side of the door.	1

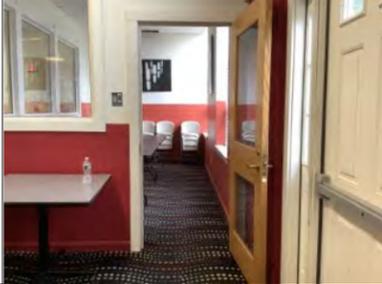
65	Bowling Alley, Party Room	1		Doors, Doorways, & Gates	Other

Maneuvering clearance(s) not provided	9"	Relocate the table so that there is 18" min. on the latch side of the door.	1

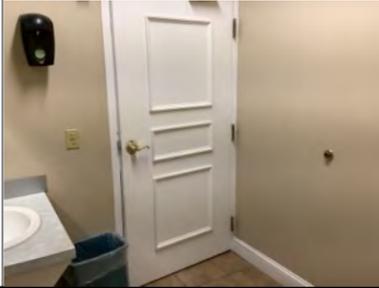
Maneuvering clearance(s) not provided	-	Relocate the trash bin so that there is 18" clear min. on the latch side of the door.	2	
68	Upper Function Room, Single-User Toilet Room	2		Doors, Doorways, & Gates	Toilet Room

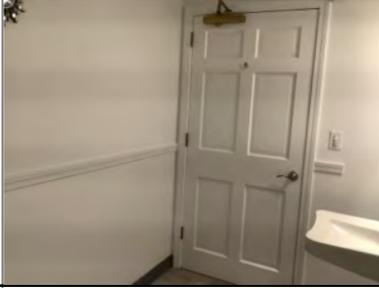
Maneuvering clearance(s) not provided	3"	Provide an automatic door opener. 18" is required on the latch pull side of the door.	1	
69	Lincoln Dining Room, Single-User Toilet Room	1		Doors, Doorways, & Gates	Toilet Room

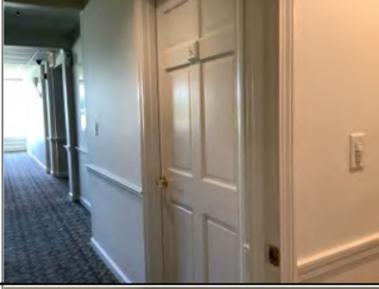
Hardware not operable with a closed fist	-	Provide hardware that can be operable with one hand and not require tight grasping, pinching, or twisting of the wrist.	1

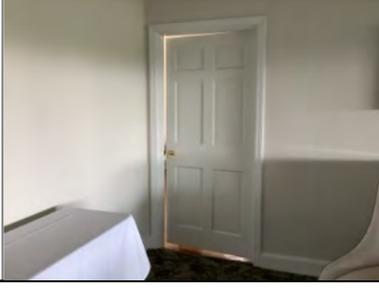
70	Bridal Room	2		Doors, Doorways, & Gates	N/A

Hardware not operable with a closed fist		Provide hardware that can be operable with one hand and not require tight grasping, pinching, or twisting of the wrist.	1

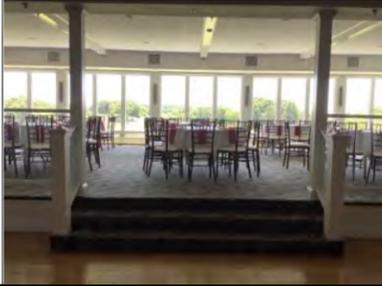
ID	Location	Floor	Room	Element	Type	Photo	Issues	Current Measure	Recommendations	Quantity	Notes
Stairways											
71	Dance Floor to Upper Function Room	2		Stairways	Other

Handrail height < 34" or > 38" Handrails do not extend 12" from stairs	33" -	Alter so the handrails are 34"- 38" high above the floor. Top: Ensure handrails extend horizontally above the landing for 12" min. beginning above the first riser nosing. Bottom: Ensure handrails extend to one tread depth beyond the last riser.	1	
72	Lincoln Dining Room, Lobby Stair to Lincoln Dining Room, Main Entrance, Egress Door 2	1		Stairways	Egress

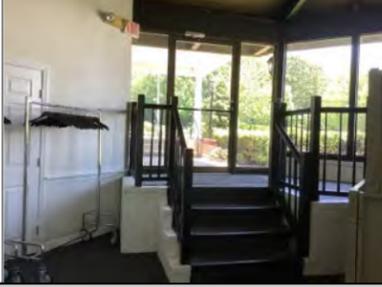
Handrail height < 34" or > 38" Handrails have non-compliant cross section Handrails do not extend 12" from stairs	39.7" - -	Locate handrails are 34"- 38" high above the floor. Top: Ensure handrails extend horizontally above the landing for 12" min. beginning above the first riser nosing. Bottom: Ensure handrails extend to one tread depth beyond the last riser. Extensions shall return to a wall, guard, or the landing surface, or shall be continuous to the handrail of an adjacent ramp run. Provide handrails with 1 1/4" - 2" circular cross sections.	1

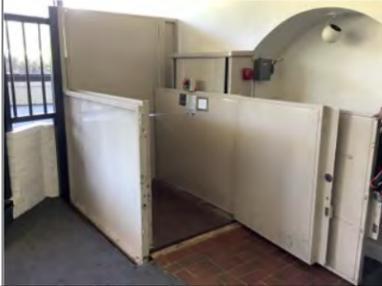
Platform Lift or LULA Elevator											
73	Lincoln Dining Room, Lobby Lift	1		Platform Lift or LULA Elevator	Interior

36" x 54" clear floor space not provided	34"	Providing a 36" by 54" clear floor space might be technically infeasible until the lift is replaced.	1	
Signage											
74	Bowling Alley	1		Signage	Designation

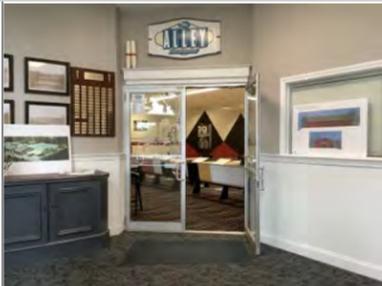
Raised characters not provided on sign Raised characters < 48" or > 60" above ground Braille not provided on sign	- - - -	Provide text with raised characters duplicated in braille on sign. Mount signs so that the baseline of the lowest tactile character is 48" min. above finished floor and the baseline of the highest tactile character is 60" max. above the finished floor. Where a tactile sign is provided at double doors with two active leaves, the sign shall be located to the right of the right hand door.	1	
75	Greenside Grille From Entry	1		Signage	Designation

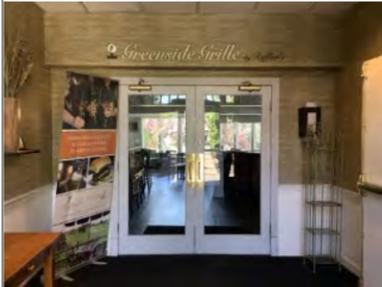
Raised characters not provided on sign Raised characters < 48" or > 60" above ground Braille not provided on sign Sign not located on the latch side of the door	- - - -	Provide text with raised characters duplicated in braille on sign. Mount signs so that the baseline of the lowest tactile character is 48" min. above finished floor and the baseline of the highest tactile character is 60" max. Locate the sign at permanent rooms alongside the door on the latch side. Where a tactile sign is provided at double doors with two active leaves, the sign shall be located to the right of the right hand	1

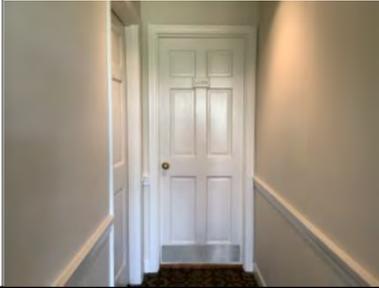
<p>Raised characters not provided on sign Raised characters < 48" or > 60" above ground Braille not provided on sign Sign not located on the latch side of the door</p>	<ul style="list-style-type: none"> - - - - 	<p>Provide text with raised characters duplicated in braille on sign. Mount signs so that the baseline of the lowest tactile character is 48" min. above finished floor and the baseline of the highest tactile character is 60" max. above the finished floor. Locate the sign at permanent rooms alongside the door on the latch side.</p>	1

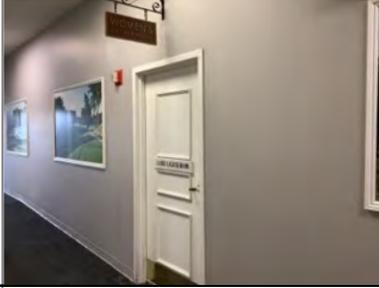
78	Women's Locker Rooms	1		Signage	Designation

<p>Raised characters not provided on sign Raised characters < 48" or > 60" above ground Braille not provided on sign Sign not located on the latch side of the door</p>	<ul style="list-style-type: none"> - - - - 	<p>Provide text with raised characters duplicated in braille on sign. Mount signs so that the baseline of the lowest tactile character is 48" min. above finished floor and the baseline of the highest tactile character is 60" max. above the finished floor. Provide braille on the sign. Locate the sign at permanent rooms alongside the door on the latch side.</p>	1	
79	Pro Shop, South Egress Door	Ext.		Signage	Designation

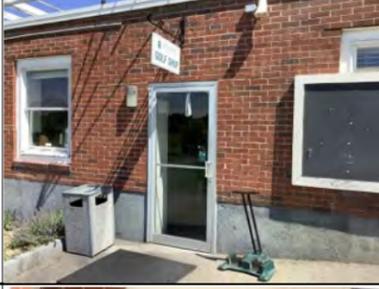
<p>Raised characters not provided on sign Raised characters < 48" or > 60" above ground Braille not provided on sign Sign not located on the latch side of the door</p>	<ul style="list-style-type: none"> - - - 	<p>Provide text with raised characters duplicated in braille on sign. Mount signs so that the baseline of the lowest tactile character is 48" min. above ground and the baseline of the highest tactile character is 60" max. above the ground. Locate the sign at permanent rooms alongside the door on the latch side.</p>	1

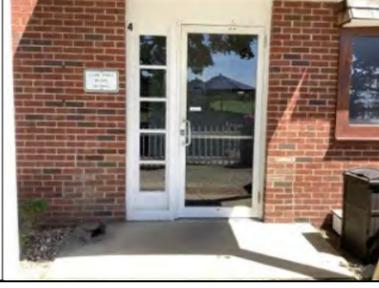
80	Egress Door 4 From Hall	Ext.		Signage	Designation

<p>Raised characters not provided on sign Braille not provided on sign Raised characters < 48" or > 60" above ground Sign not located on the latch side of the door</p>	<ul style="list-style-type: none"> - - - - 	<p>Provide text with raised characters duplicated in braille on sign. Mount signs so that the baseline of the lowest tactile character is 48" min. above ground and the baseline of the highest tactile character is 60" max. above the ground. Locate the sign at permanent rooms alongside the door on the latch side.</p>	1

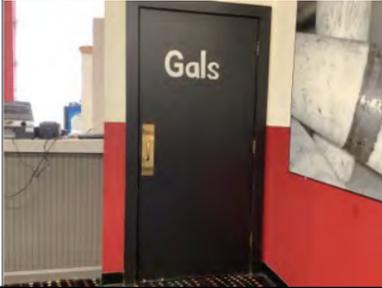
<p>Raised characters not provided on sign</p> <p>Braille not provided on sign</p> <p>Sign not located on the latch side of the door</p> <p>Raised characters < 48" or > 60" above ground</p> <p>International Symbol of Acc. not provided</p>	<ul style="list-style-type: none"> - - - - 	<p>Provide text with raised characters duplicated in braille on sign. Mount signs so that the baseline of the lowest tactile character is 48" min. above finished floor and the baseline of the highest tactile character is 60" max. above the finished floor. Locate the sign at permanent rooms alongside the door on the latch side.</p> <p>Replace the sign with a sign containing the International Symbol of Accessibility (ISA).</p>	1

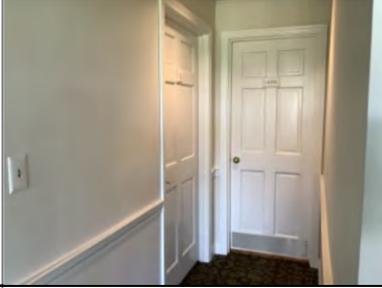
83	Lincoln Dining Room, Single-User Toilet Room	1		Signage	Designation

<p>Raised characters not provided on sign</p> <p>Braille not provided on sign</p> <p>Sign not located on the latch side of the door</p> <p>Raised characters < 48" or > 60" above ground</p> <p>International Symbol of Acc. not provided</p>	<ul style="list-style-type: none"> - - - - 	<p>Provide text with raised characters duplicated in braille on sign. Mount signs so that the baseline of the lowest tactile character is 48" min. above finished floor and the baseline of the highest tactile character is 60" max. above the finished floor. Locate the sign at permanent rooms alongside the door on the latch side.</p> <p>Replace the sign with a sign containing the International Symbol of Accessibility (ISA).</p>	1	
84	Men's Locker Room	1		Signage	Designation

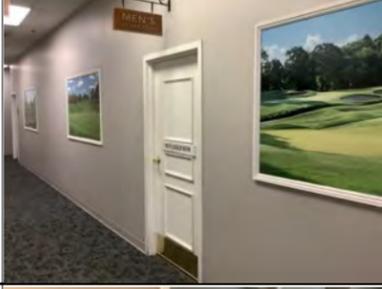
<p>Raised characters not provided on sign</p> <p>Braille not provided on sign</p> <p>Sign not located on the latch side of the door</p> <p>Raised characters < 48" or > 60" above ground</p>	<ul style="list-style-type: none"> - - - 	<p>Provide text with raised characters duplicated in braille on sign.</p> <p>Mount signs so that the baseline of the lowest tactile character is 48" min. above finished floor and the baseline of the highest tactile character is 60" max. above the finished floor.</p> <p>Locate the sign at permanent rooms alongside the door on the latch side.</p>	1

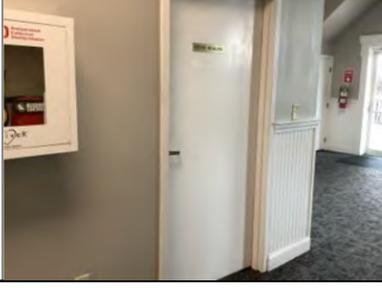
85	Office	1		Signage	Designation

<p>Raised characters not provided on sign</p> <p>Braille not provided on sign</p> <p>Sign not located on the latch side of the door</p> <p>Raised characters < 48" or > 60" above ground</p>	<ul style="list-style-type: none"> - - - 	<p>Provide text with raised characters duplicated in braille on sign.</p> <p>Mount signs so that the baseline of the lowest tactile character is 48" min. above finished floor and the baseline of the highest tactile character is 60" max. above the finished floor.</p> <p>Locate the sign at permanent rooms alongside the door on the latch side.</p>	1

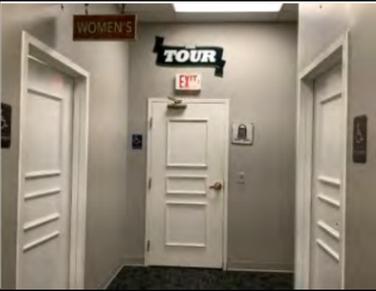
ID	Location	Floor	Room	Element	Type	Photo	Issues	Current Measure	Recommendations	Quantity	Notes
86	Pub Room and the Tour (Golf Simulators)	1		Signage	Designation

<ul style="list-style-type: none"> Raised characters not provided on sign Braille not provided on sign Sign not located on the latch side of the door Raised characters < 48" or > 60" above ground 	<ul style="list-style-type: none"> - - - 	<ul style="list-style-type: none"> Provide text with raised characters duplicated in braille on sign. Mount signs so that the baseline of the lowest tactile character is 48" min. above finished floor and the baseline of the highest tactile character is 60" max. above the finished floor. Locate the sign at permanent rooms alongside the door on the latch side. 	1	
87	Pub Room and the Tour (Golf Simulators)	1		Signage	Designation

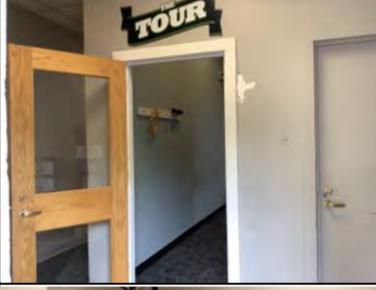
<ul style="list-style-type: none"> Raised characters not provided on sign Braille not provided on sign Sign not located on the latch side of the door Raised characters < 48" or > 60" above ground 	<ul style="list-style-type: none"> - - - 	<ul style="list-style-type: none"> Provide text with raised characters duplicated in braille on sign. Mount signs so that the baseline of the lowest tactile character is 48" min. above finished floor and the baseline of the highest tactile character is 60" max. above the finished floor. Locate the sign at permanent rooms alongside the door on the latch side. 	1

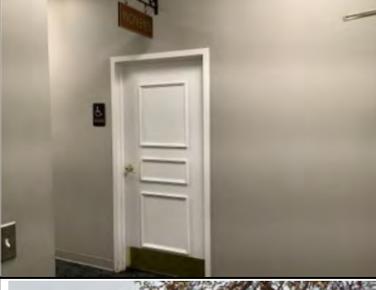
88	Women's Single-User Toilet Room by the Women's Locker Room	1		Signage	Designation

<ul style="list-style-type: none"> Raised characters not provided on sign Braille not provided on sign Sign not located on the latch side of the door 	<ul style="list-style-type: none"> - - 	<ul style="list-style-type: none"> The sign over the door states "Women", however the designation sign alongside the door just states the word "Accessible" with the corresponding braille. The designation sign must also state "Women" to match the overhead sign. This text must be duplicated in braille on sign and provided alongside the door on the latch side. 	1	
89	Upper Function Room Entrance With Visual "Reception" Sign	2		Signage	Designation

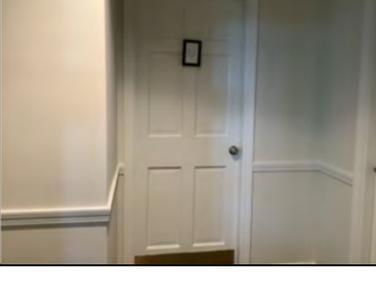
90	Upper Function Room Women's Toilet Room	2		Signage	Designation

<ul style="list-style-type: none"> Raised characters not provided on sign Braille not provided on sign Sign not located on the latch side of the door Raised characters < 48" or > 60" above ground 	<ul style="list-style-type: none"> - - - - 	<ul style="list-style-type: none"> Provide text with raised characters duplicated in braille on sign. Mount signs so that the baseline of the lowest tactile character is 48" min. above finished floor and the baseline of the highest tactile character is 60" max. above the finished floor. Locate the sign at permanent rooms alongside the door on the latch side. 	1

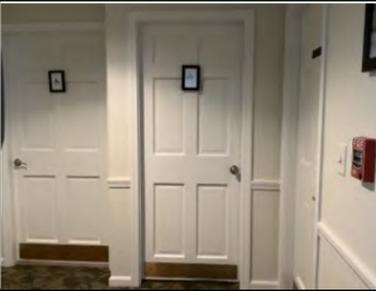
ID	Location	Floor	Room	Element	Type	Photo	Issues	Current Measure	Recommendations	Quantity	Notes
91	Upper Function Room, Men's Toilet Room	2		Signage	Designation

<ul style="list-style-type: none"> Raised characters not provided on sign Braille not provided on sign Sign not located on the latch side of the door Raised characters < 48" or > 60" above ground 	<ul style="list-style-type: none"> - - - 	<ul style="list-style-type: none"> Provide text with raised characters duplicated in braille on sign. Mount signs so that the baseline of the lowest tactile character is 48" min. above finished floor and the baseline of the highest tactile character is 60" max. above the finished floor. Locate the sign at permanent rooms alongside the door on the latch side. 	1	
92	Upper Function Room, Single-User Toilet Room	2		Signage	Designation

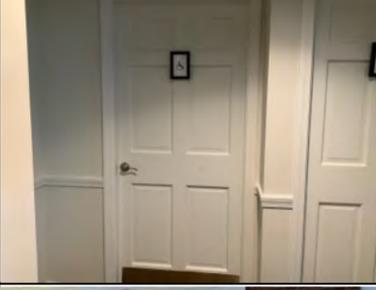
<ul style="list-style-type: none"> Raised characters not provided on sign Braille not provided on sign Sign not located on the latch side of the door Raised characters < 48" or > 60" above ground 	<ul style="list-style-type: none"> - - - 	<ul style="list-style-type: none"> Provide text with raised characters duplicated in braille on sign. Mount signs so that the baseline of the lowest tactile character is 48" min. above finished floor and the baseline of the highest tactile character is 60" max. above the finished floor. Locate the sign at permanent rooms alongside the door on the latch side. 	1

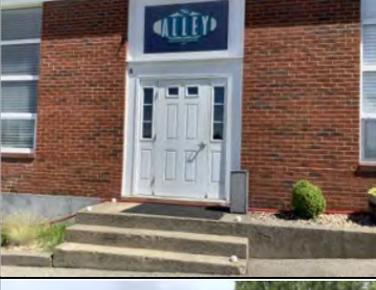
93	Bowling Alley, Entrance Door 5	Ext.		Signage	Designation

<ul style="list-style-type: none"> Raised characters not provided on sign Braille not provided on sign Sign not located on the latch side of the door Raised characters < 48" or > 60" above ground 	<ul style="list-style-type: none"> - - - 	<ul style="list-style-type: none"> Provide text with raised characters duplicated in braille on sign. Mount signs so that the baseline of the lowest tactile character is 48" min. above finished floor and the baseline of the highest tactile character is 60" max. above the finished floor. Locate the sign at permanent rooms alongside the door on the latch side. 	1	
94	Lincoln Dining Room, Main Entrance, Egress Door 2	Ext.		Signage	Designation

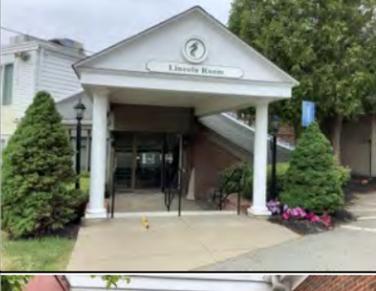
<ul style="list-style-type: none"> Raised characters not provided on sign Braille not provided on sign Sign not located on the latch side of the door Raised characters < 48" or > 60" above ground 	<ul style="list-style-type: none"> - - - 	<ul style="list-style-type: none"> Provide text with raised characters duplicated in braille on sign. Mount signs so that the baseline of the lowest tactile character is 48" min. above finished floor and the baseline of the highest tactile character is 60" max. Locate the sign at permanent rooms alongside the door on the latch side. Where a tactile sign is provided at double doors with two active leaves, the sign shall be located to the right of the right hand 	1

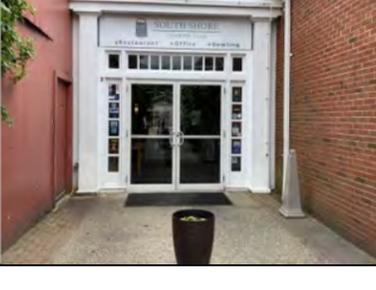
95	Main Entrance From Alley	Ext.		Signage	Designation

<ul style="list-style-type: none"> Raised characters not provided on sign Braille not provided on sign Sign not located on the latch side of the door Raised characters < 48" or > 60" above ground 	<ul style="list-style-type: none"> - - - 	<ul style="list-style-type: none"> Provide text with raised characters duplicated in braille on sign. Mount signs so that the baseline of the lowest tactile character is 48" min. above ground and the baseline of the highest tactile character is 60" max. Locate the sign at permanent rooms alongside the door on the latch side. Where a tactile sign is provided at double doors with two active leaves, the sign shall be located to the right of the right hand 	1

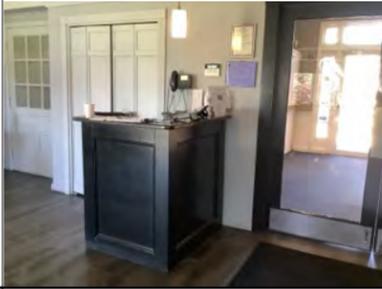
Counter > 36" high	43.5"	Provide a counter that is 36" max. above the finished floor. Note: If the town is leasing or contracting with the restaurant for the convenience of the club's users, the Town must ensure that the restaurant is operated in a manner that enables the Town to meet its Title II obligations, even though the restaurant is not directly subject to Title II.	1	
98	Pro Shop	1		Service Counter	N/A

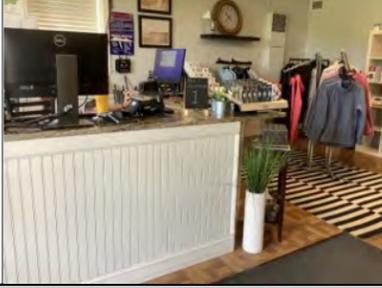
Counter > 36" high	39.6"	Provide a counter that is 36" max. above the finished floor.	1

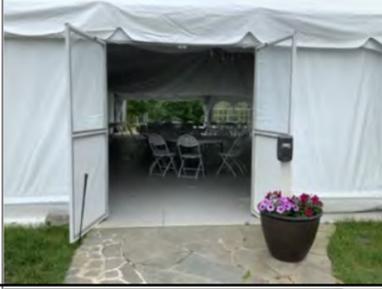
Operable Parts											
99	Events Tent Entrance	Ext.		Operable Parts	Other

Clear floor space is not provided	-	Relocate the planter to provide clear floor space at the hand sanitizer.	1	
100	Club Room	1		Operable Parts	Clothes Rod/Hooks

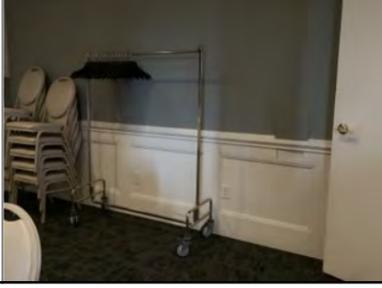
Reach < 15" or > 48"(forward/side approach)	63.3"	Provide a clothes rod that is no higher than 48" high.	1

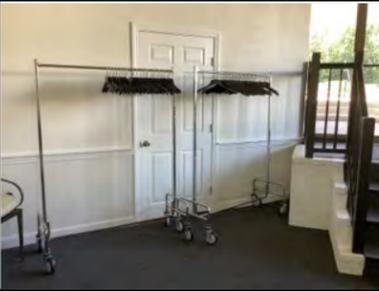
ID	Location	Floor	Room	Element	Type	Photo	Issues	Current Measure	Recommendations	Quantity	Notes
101	Lincoln Dining Room, Lobby	1		Operable Parts	Clothes Rod/Hooks

Reach < 15" or > 48"(forward/side approach)	63.3"	Provide compliant clothes racks that are located no higher than 48" above the finished floor.	2	
102	Men's Locker Room, Showers	1		Operable Parts	Clothes Rod/Hooks

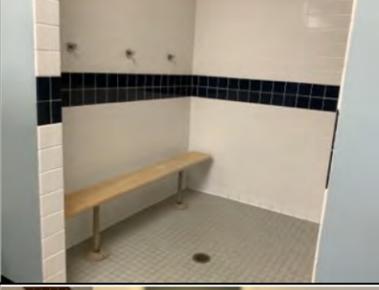
Reach < 15" or > 48"(forward/side approach)	53.7"	Relocate at least one hook so that controls are between 15"- 48" above the finished floor.	1	
103	Pub Room and the Tour (Golf Simulators) to Northwest Egress Door	1		Operable Parts	Clothes Rod/Hooks

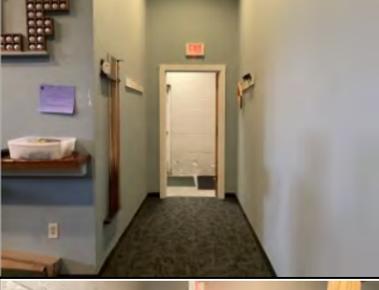
Reach < 15" or > 48"(forward/side approach)	69"	Relocate five (5) percent of hooks to be no higher than 48" above the finished floor.	1	
104	Pub Room and the Tour (Golf Simulators), Boxes for Paying Dues	1		Operable Parts	Other

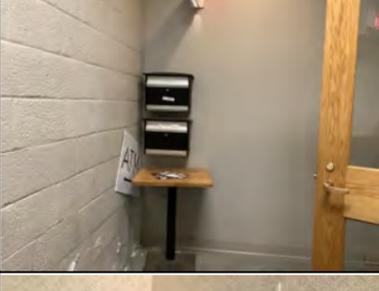
Reach < 15" or > 48"(forward/side approach)	60"	Ensure that controls for boxes where members and the public pay their dues is located no higher than 48" above the finished floor.	1

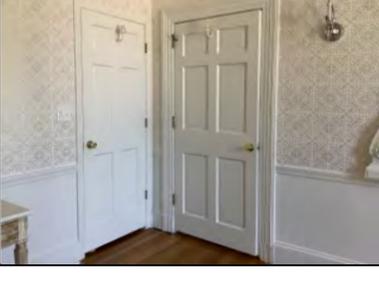
105	Bridal Room to Main Ballroom	2		Operable Parts	Clothes Rod/Hooks

Reach < 15" or > 48"(forward/side approach)	74.6"	Relocate hook no higher than 48" above the finished floor.	1

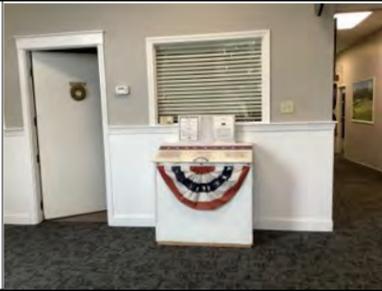
ID	Location	Floor	Room	Element	Type	Photo	Issues	Current Measure	Recommendations	Quantity	Notes
106	Flag Donation by Bowling Alley	1		Operable Parts	Equipment

Not operable with a closed fist	-	Provide hardware at the ballot voting drop-off box that can be operable with one hand and not require tight grasping, pinching, or twisting of the wrist.	1	
Dining or Work Surfaces											
107	Pro Shop Computer	1		Dining or Work Surfaces	Work Surface

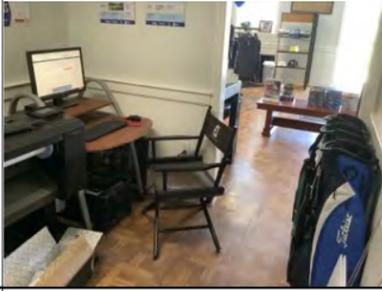
Knee or toe clearance not provided Top of dining/work surface < 28" or > 34"	25.8 26.8"	Provide at least one work surface with tops between 28"- 34" above the floor and 27" clear height underneath.	1	
108	Pub Room and the Tour (Golf Simulators), Simulator C	1		Dining or Work Surfaces	Work Surface

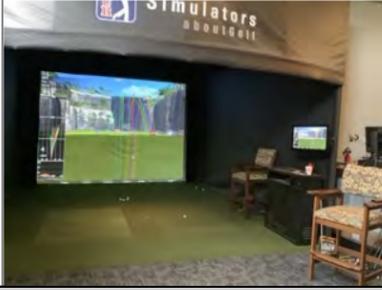
Knee or toe clearance not provided Top of dining/work surface < 28" or > 34"	- 37"	Provide at least one work surface with tops between 28"- 34" above the floor and 27" clear height underneath.	1

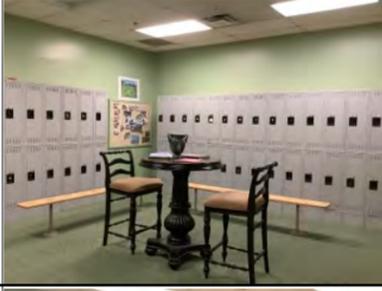
Locker Room											
109	Women's Locker Room	1		Locker Room	Women's

Back support not provided at bench	-	Provide at least one bench with back support or that is affixed to a wall with clear floor space alongside the bench so that wheelchair users can transfer.	1	
110	Men's Locker Room	1		Locker Room	Men's

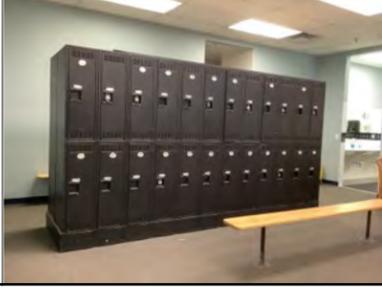
Back support not provided at bench Bench < 24" deep	- -	Provide at least one bench with back support or that is affixed to a wall with clear floor space alongside the bench so that wheelchair users can transfer. Provide a bench that is 24" deep.	1

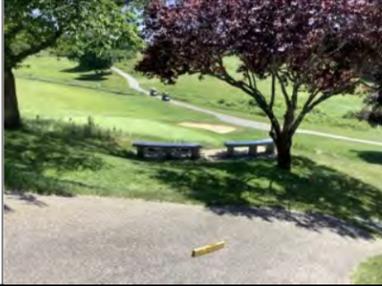
ID	Location	Floor	Room	Element	Type	Photo	Issues	Current Measure	Recommendations	Quantity	Notes
Exterior Benches											
111	Greenside Grille, Egress Door 3 to Practice Facility	Ext.		Exterior Benches	N/A

No accessible route to one bench in area	26.3%	Relocate one bench in this area to an accessible route.	1	
Toilet & Bathing Rooms											
Overall Access											
112	Bridal Room, Single-User Toilet Room	2		Overall Access	Toilet Room

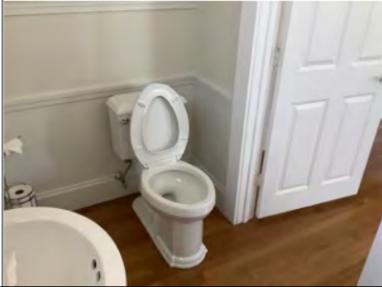
Turning space not provided Accessible plumbing fixtures or stalls not provided	- -	This is a unique program. Renovate toilet room to provide turning space and an accessible single-user toilet room.	1	
Lavatory											
113	Single-User Toilet Room by the Men's Locker Room	1		Lavatory	N/A

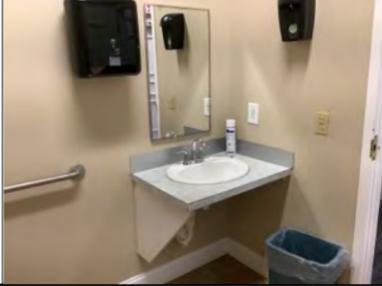
Clear floor space not provided at lavatory Dispensers not within reach range	- 64.2", 55"	Provide a 30" min. by 48" min. clear floor space positioned for a forward approach at the lavatory by relocating the trash bin. Lower the paper towel and soap dispensers to 48" max. above the finished floor.	1

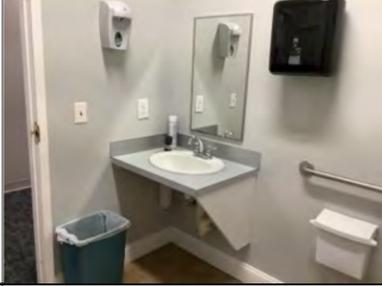
114	Women's Single-User Toilet Room by the Women's Locker Room	1		Lavatory	N/A

Clear floor space not provided at lavatory Dispensers not within reach range	- 56", 65"	Provide a 30" min. by 48" min. clear floor space positioned for a forward approach at the lavatory by relocating the trash bin. Lower paper towel and soap dispensers to 48" max. above the finished floor.	1	
115	Bowling Alley, Men's Toilet Room	1		Lavatory	N/A

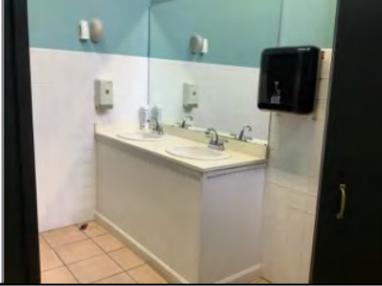
Toe or knee clearances not provided	-	Provide at least one lavatory with knee and toe clearance positioned for a forward approach.	1

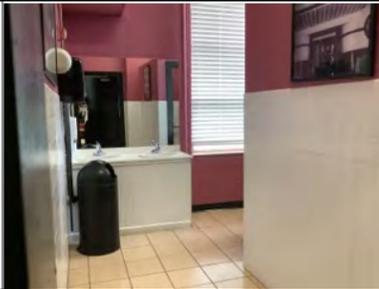
ID	Location	Floor	Room	Element	Type	Photo	Issues	Current Measure	Recommendations	Quantity	Notes
116	Bowling Alley, Women's Toilet Room	1		Lavatory	N/A

Toe or knee clearances not provided	-	Provide at least one lavatory with knee and toe clearance positioned for a forward approach.	1	
117	Lincoln Dining Room, Single-User Toilet Room	1		Lavatory	N/A

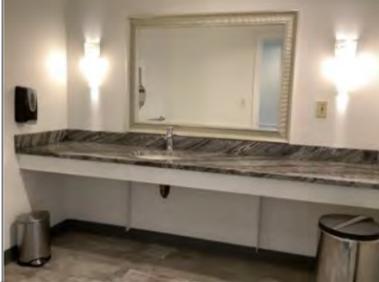
Toe or knee clearances not provided Plumbing underneath is exposed	25.9" -	Provide at least one lavatory with knee and toe clearance positioned for a forward approach. Insulate or otherwise configure pipes to prevent contact for at least one lavatory.	1	
118	Men's Locker Room, Toilet Room	1		Lavatory	N/A

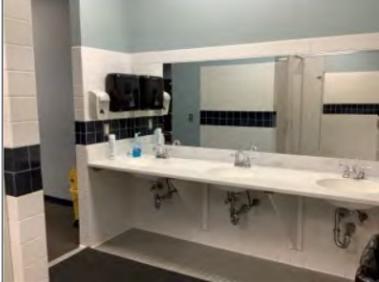
Plumbing underneath is exposed Dispensers not within reach range	- 55.4"	Insulate or otherwise configure pipes to prevent contact for at least one lavatory. Lower soap dispenser to 48" max. above the finished floor.	1	
Single-User Toilet

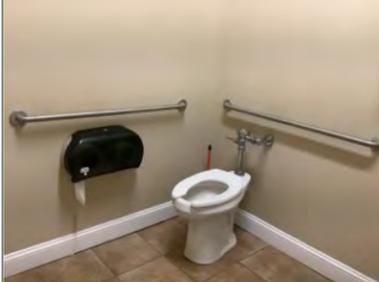
119	Single-User Toilet Room by the Men's Locker Room	1		Single-User Toilet	N/A

Flush control not on open side Centerline < 16" or > 18"	- 21.5"	Relocate the flush control to the open side. Relocate toilet so that the centerline is 18" from the side wall.	1	
120	Lincoln Dining Room, Single-User Toilet Room	1		Single-User Toilet	N/A

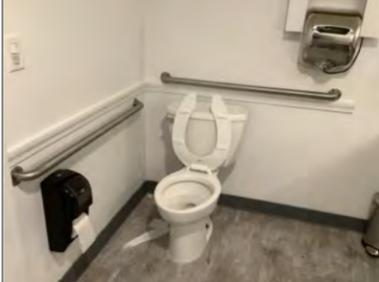
Flush control not on open side Side or rear grab bar < 33" or > 36" high Hand dryer is located above the grab bar	- 30.4" -	Relocate the flush control to the open side. Mount the side grab bar 33"- 36" above the finished floor. Relocate the hand dryer so that it is not located over the grab bar. 521 CMR does not allow any dispensers to be located over the grab bars.	1

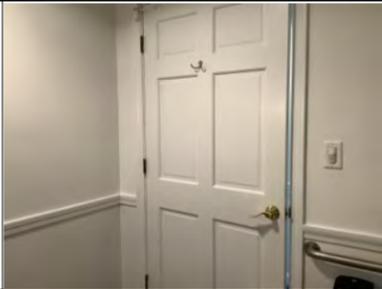
ID	Location	Floor	Room	Element	Type	Photo	Issues	Current Measure	Recommendations	Quantity	Notes
121	Lincoln Dining Room, Single-User Toilet Room	1		Single-User Toilet	N/A

Hook located > 48" high (2010 ADA)	64.7"	Locate the coat hook no higher than 48" above the finished floor.	1	
122	Upper Function Room, Single-User Toilet Room	2		Single-User Toilet	N/A

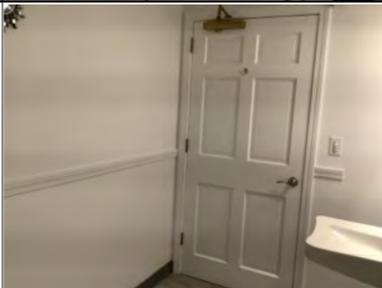
Hook located > 48" high (2010 ADA)	65.9"	Locate the coat hook no higher than 48" above the finished floor.	1	
Toilet Compartment											
123	Bowling Alley, Women's Toilet Room	1		Toilet Compartment	Accessible Compartment

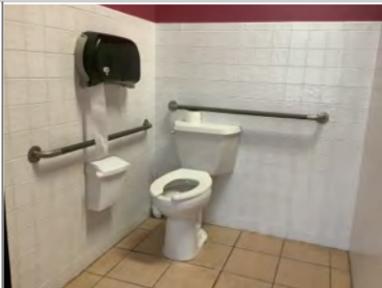
Side or rear grab bar < 33" or >36" high Non-compliant toilet paper dispenser	31.7" -	Locate the side wall grab bar between 33"- 36" above the finished floor. Relocate toilet paper so that it is 24" min high, located under the grab bar, and between 7" and 9" from the front of the toilet.	1	
124	Bowling Alley, Men's Toilet Room	1		Toilet Compartment	Accessible Compartment

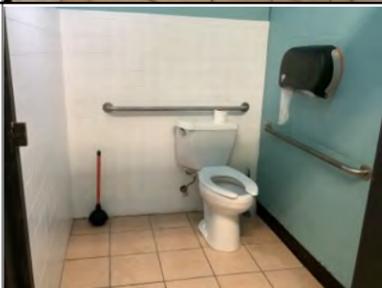
Side or rear grab bar < 33" or >36" high Non-compliant toilet paper dispenser	31.3" -	Relocate the side grab bar between 33"- 36" above the finished floor. Relocate toilet paper so that it is 24" min high, located under the grab bar, and between 7" and 9" from the front of the toilet.	1
