Central Fire Station

Town of Hingham ADA Transition Plan

October 2023

Institute for Human Centered Design

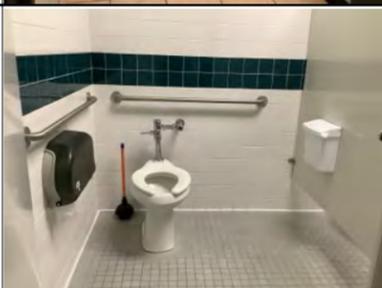
125	Women's Locker Room Toilet Room	1		Toilet Compartment	Accessible Compartment

Flush control not on open side Centerline < or > 18" (MAAB)	- 20"	Provide the flush control on the open side of the toilet (transfer side). Relocate toilet so the centerline is 18" from the side wall.	1

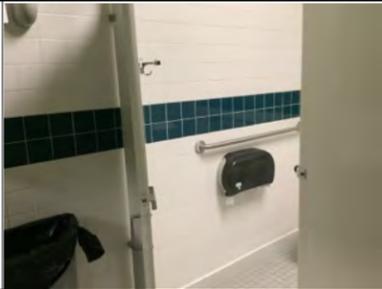
ID	Location	Floor	Room	Element	Type	Photo	Issues	Current Measure	Recommendations	Quantity	Notes
126	Women's Locker Room Toilet Room	1		Toilet Compartment	Accessible Compartment

Coat hook > 48" (2010 ADA)	54.7"	Locate the coat hook no higher than 48" above the finished floor.	1	
127	Bowling Alley, Women's Toilet Room	1		Toilet Compartment	Accessible Compartment

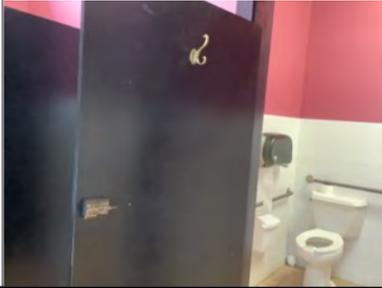
Coat hook > 48" (2010 ADA) Door pull not provided	65.7" -	Locate the coat hook no higher than 48" above the finished floor. Provide a door pull on each side of the door between 34" to 48" above the finished floor that does not require tight grasping, pinching or twisting of the wrist.	1	
128	Bowling Alley, Men's Toilet Room	1		Toilet Compartment	Accessible Compartment

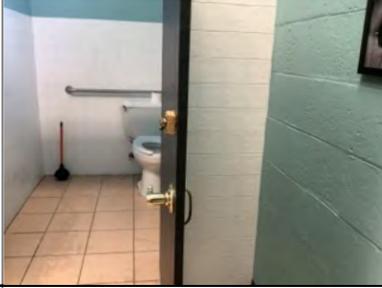
Door pull not provided	-	Provide a door pull on each side of the door between 34" to 48" above the finished floor that does not require tight grasping, pinching or twisting of the wrist.	1

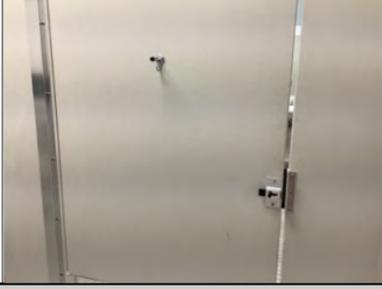
129	Men's Locker Room, Toilet Room	1		Toilet Compartment	Accessible Compartment

Door pull not provided	-	Provide a door pull on each side of the door between 34" to 48" above the finished floor that does not require tight grasping, pinching or twisting of the wrist.	1	
Urinal											
130	Men's Locker Room, Toilet Room	1		Urinal	N/A

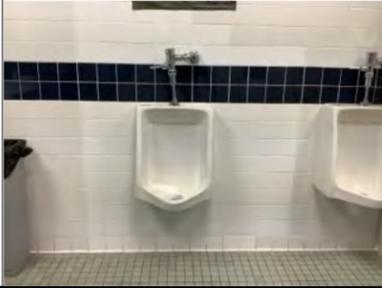
Rim > 17" high	20.3"	Provide at least one urinal with the rim no higher than 17" above the finished floor.	1

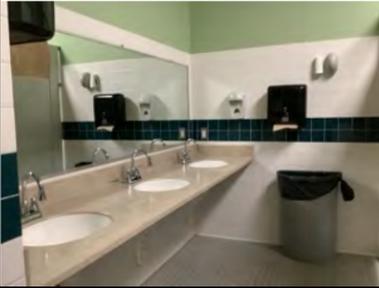
ID	Location	Floor	Room	Element	Type	Photo	Issues	Current Measure	Recommendations	Quantity	Notes
Dispensers											
131	Women's Locker Room Toilet Room	1		Dispensers	Soap Dispenser

Controls > 48" high	54"	Relocate the soap dispenser so the operable part is 48" max. above the finished floor.	1	
132	Bowling Alley, Women's Toilet Room	1		Dispensers	Paper Towel Dispenser

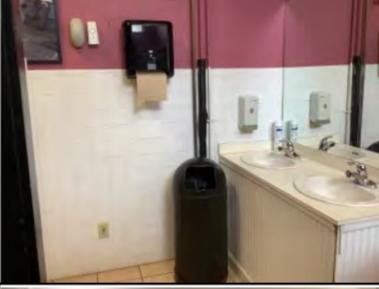
Controls > 48" high Dispenser acts as a protruding object	58.6" 8.3"	Relocate the paper towel dispenser so the operable part is 48" max. above the finished floor. Relocate dispenser out of the circulation path.	1	
133	Lincoln Dining Room, Women's Toilet Room	1		Dispensers	Hand Dryer

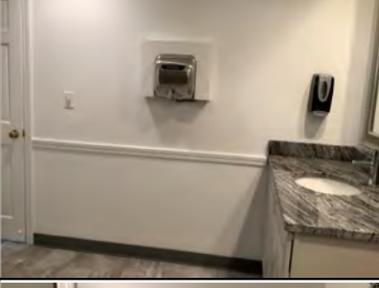
Controls > 48" high Dispenser acts as a protruding object	50.3" 5"	Relocate the hand dryer so the operable part is 48" max. above the finished floor. Relocate hand dryer out of the circulation path.	1	
134	Upper Function Room, Single-User Toilet Room	2		Dispensers	Paper Towel Dispenser

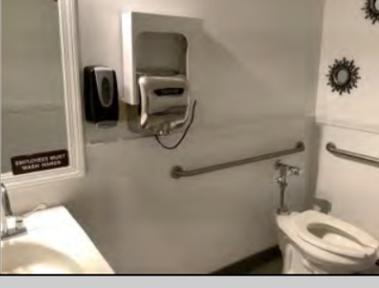
Dispenser acts as a protruding object	5"	Relocate dispenser out of the circulation path. Ensure that the paper towel dispenser is not located over the grab bar.	1

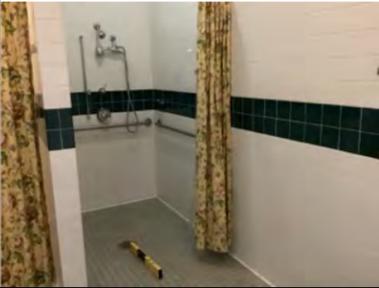
Shower Compartment											
135	Women's Locker Room Showers	1		Shower Compartment	Transfer Type

Size of shower compartment not compliant Seat not provided (transfer compartment) Control height < 38" or > 48" Slope in shower > 1:50 (2.00%)	- - 63.2" 10.7%	Provide a transfer shower that is 36" by 36". Provide a padded folding seat. Relocate controls at 48" max. above the finished floor. Ensure that the slope in the accessible shower does not exceed 1:50 (2.00%)	1

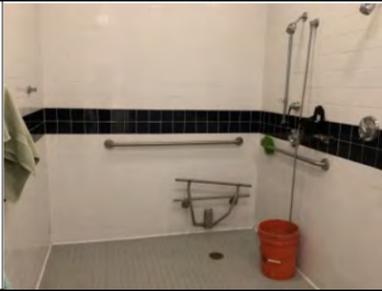
ID	Location	Floor	Room	Element	Type	Photo	Issues	Current Measure	Recommendations	Quantity	Notes
136	Men's Locker Room, Showers	1		Shower Compartment	Roll-In Type

<ul style="list-style-type: none"> Controls not adjacent to seat (roll-in type) Seat is not between 17"- 19" high Seat is not padded (MAAB) Control height < 38" or > 48" Controls on the wrong wall (MAAB) 	<ul style="list-style-type: none"> - 15.6" - 72.4" - 	Provide a compliant roll-in shower. Relocate controls above the grab bars no higher than 48" above the finished floor. Also based on a roll-in shower in the MAAB 521 CMR, the controls must be located in the center of the long wall. Remove the existing seat. Mount the seat on the back wall between 17"- 19" above the finished floor. Provide a padded shower seat.	1	
Best Practice											
137	Club Room	1

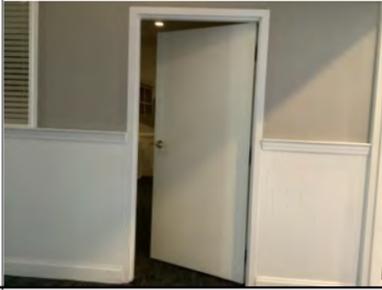
-	Recommend providing signage with raised characters and braille on the latch side of the door to all permanent rooms that lack designation signage.	1

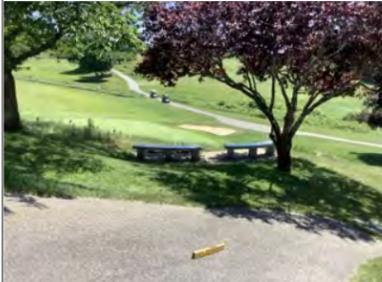
138	Greenside Grille, Egress Door 3 to Practice Facility	Ext.

Recommend providing a 36" min. by 48" min. stable, firm and slip-resistant surface adjacent to at least one bench in this area in a manner that is substantially similar to what is shown in Figure 1 in the narrative report.	1

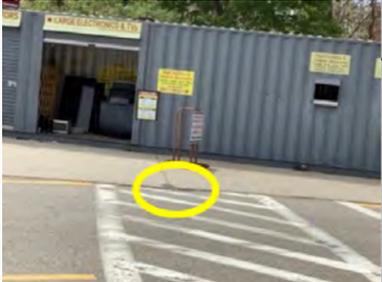
ID	Location	Floor	Room	Element	Type	Photo	Issues	Current Measure	Recommendations	Quantity	Notes
Approach and Entrance											
Exterior Access Route											
1	Large Electronics, Televisions and Computer Disposal Area			Exterior Access Route	Exterior

Surface is not stable, firm, and slip-resistant Route not maintained in operable working condition	- -	Repair the surface where the concrete is broken up at the transfer to asphalt. Ensure that the accessible route is maintained in operable working condition.	1	
Off-Street Parking Lot or Garage											
2	Parking Near Office and Recycling Area			Off-Street Parking Lot or Garage	Visitor

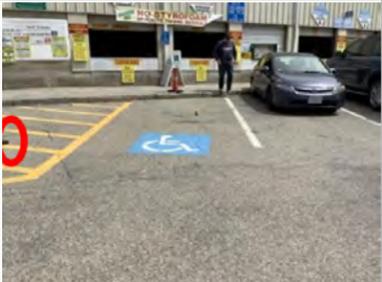
Total # of parking Total # of designated accessible parking spaces Running or cross slope at space > 1:50 (2.00%) Access aisle < 96" wide at van space	10 1 4.9% -	Reduce running and cross slope to be no steeper than 1:50 (2.00%). Provide a marked access aisle that is at least 96" wide. Ensure that bins, signs and other items are not stored in the access aisle.	1

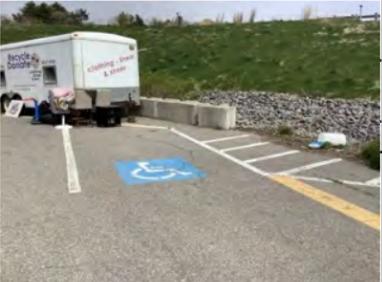
3	By Clothing, Textiles, and Shoe Donations			Off-Street Parking Lot or Garage	Visitor

Total # of parking Total # of designated van accessible spaces Access aisle < 96" wide at van space Sign not provided Sign does not have the designation "Van Accessible"	10 1 - - -	Provide one (1) van accessible spaces. Because the van accessible parking space is 108" wide, provide a marked access aisle that is at least 96" wide. Provide a sign with the bottom of the sign 60" min. above the ground and the top 96" max. above the ground. Add the designation "Van Accessible" to the sign located at the van accessible space.	1	
4	Parking Lot by Accessible Route to Cans, Glass, and Paper Disposal Bins South of Office			Off-Street Parking Lot or Garage	Visitor

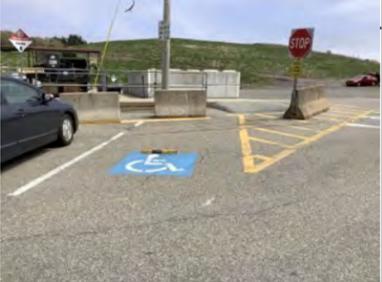
Sign not provided Access aisle < 60" wide at car/van space	- -	Provide a sign with the bottom of the sign 60" min. above the ground and the top 96" max. above the ground. Current access aisle narrows to a point. Provide a marked access aisle that is at least 60" wide.	1

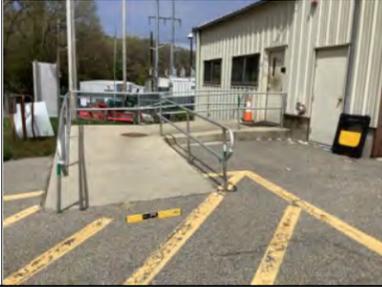
ID	Location	Floor	Room	Element	Type	Photo	Issues	Current Measure	Recommendations	Quantity	Notes
Ramps											
5	Landing at Ramp to Office			Ramps	Exterior

Landing has a slope > 1:50 (2.00%) (MAAB) Edge protection < 4" high	6% -	Alter so that the slope in all directions is no greater than 1:50 (2.00%) at the base of the ramp. Provide edge protection on each side of the ramp that prevents the passage of a 4" diameter sphere, where any portion of the sphere is within 4" of the finished floor or ground surface.	1	
Signage											
6	Office			Signage	Designation

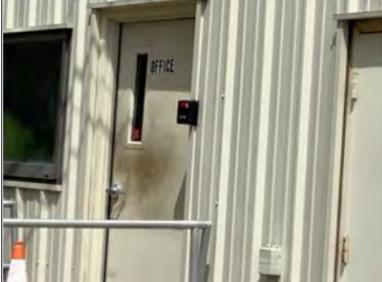
Raised characters not provided Braille not provided Sign not located on the latch side of the door	- - -	Provide text with raised characters duplicated in braille. Locate signs at permanent rooms alongside the door on the latch side.	1	
Operable Parts											
7	Book Recycling Bins			Operable Parts

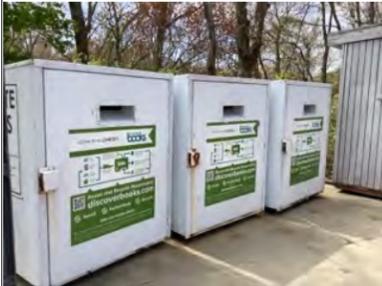
Reach < 15" or > 48"(forward/side approach)	56"	Ensure that controls are between 15"- 48" above the ground.	1

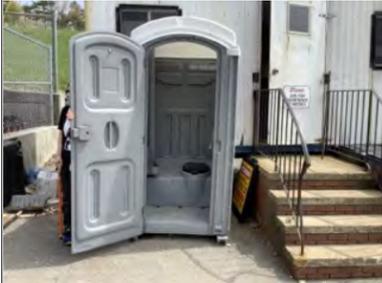
Toilet & Bathing Rooms											
Portable Toilet											
8	Household Trash Area			Portable Toilet	N/A

Not located on an accessible route Accessible portable toilets not provided	5" -	Locate portable toilet on an accessible route. Ensure that at least 5% of portable toilets (with a minimum of one) are accessible.	1	
Best Practice

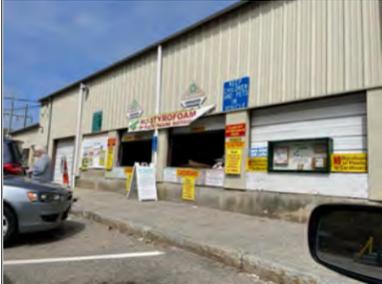
ID	Location	Floor	Room	Element	Type	Photo	Issues	Current Measure	Recommendations	Quantity	Notes
9	Recycling Area

Recommend locating all informational signs no lower than 40" above the ground.	1
