0 Station Street Parking Lot

Town of Hingham ADA Transition Plan

October 2023

Institute for Human Centered Design

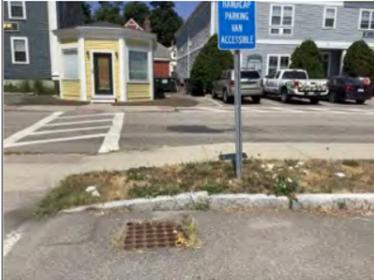
Surface openings > 1/2"	2"	At the grate in the accessible parking space, replace or reposition so that openings are 1/2" max. and the long opening dimension is perpendicular to the dominant direction of travel.	1	
2	Bike Rack at MBTA Bus Stop	Ext.		Exterior Access Route	Walkway

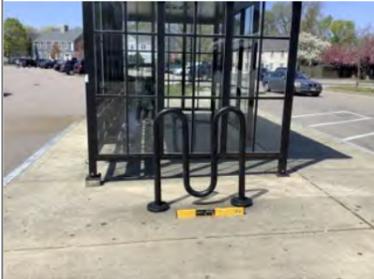
Cross slope > 1:50 (2.00%)	4.3%	Reduce the cross slope to be no steeper than 1:50 (2.00%).	1	
3	Water Street at Station Street Van Accessible Parking Spaces	Ext.		Exterior Access Route	Exterior

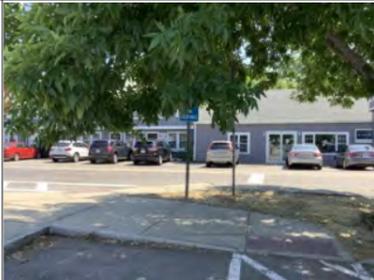
Vertical clearance < 80" above ground	-	Trim the low hanging tree branches so that they do not have a vertical clearance lower than 80" above the ground and do not block the accessible parking sign.	1

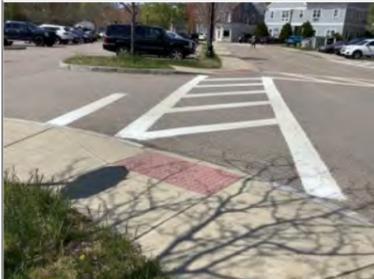
Curb Ramp											
4	West of MBTA Bus Stop	Ext.		Curb Ramp	N/A

Landing not provided at top of curb ramp	24"	Provide landing at top of curb ramp or reconfigure ramp.	1	
5	Curb Ramp by William Raveis, 40 North Street	Ext.		Curb Ramp	N/A

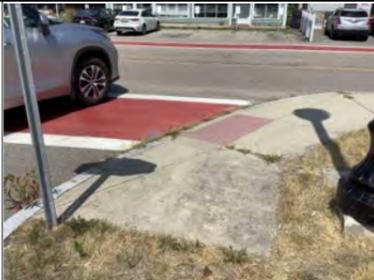
Landing not provided at top of curb ramp	24"	Provide landing at top of curb ramp or reconfigure ramp.	1

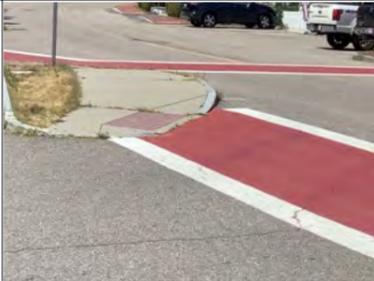
Landing not provided at top of curb ramp	21"	Provide landing at top of curb ramp or reconfigure ramp.	1	
7	Curb Ramps From Van Accessible Parking Space by 59 Station Street	Ext.		Curb Ramp	N/A

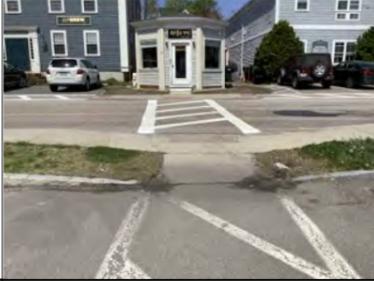
Surface not stable, firm and slip-resistant	-	Repair the surface. Ensure that the curb ramps are kept clear of sand.	2	
8	Commuter Rail Train Crossing on Water Street, Curb Ramp by Parking Lot	Ext.		Curb Ramp	N/A

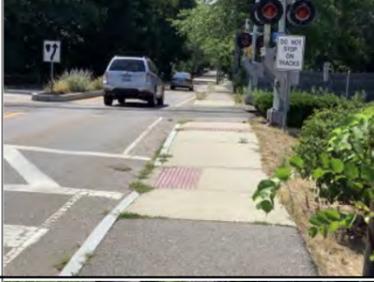
Surface not stable, firm and slip-resistant		Repair surface at curb ramp. Remove weeds.	1	
9	Commuter Rail Train Crossing on Water Street, Curb Ramp Across From Parking Lot	Ext.		Curb Ramp	N/A

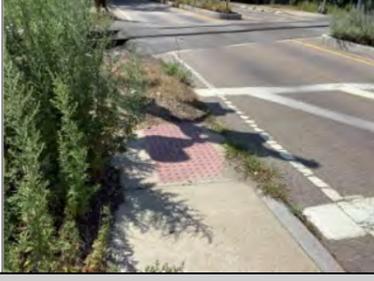
Surface not stable, firm and slip-resistant Landing not provided at top of curb ramp	- -	Provide landing at top of curb ramp or reconfigure ramp. Trim overgrowth.	1

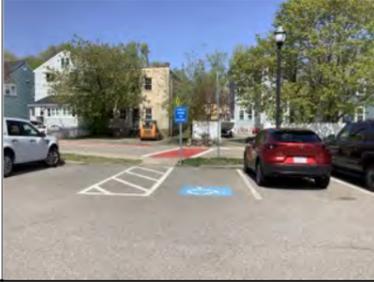
Total # of parking Total # of designated van accessible spaces Van space < 132" or < 96" wide Sign not located properly Sign with an ISA not provided	267 1 120" - -	Based on the overall parking count, the parking lot requires 2 (two) van accessible parking spaces and 5 (five) car accessible parking spaces. Three (3) additional car accessible parking spaces much be provided. At the space in the photo, enlarge the van space to be at least 132" wide. Locate the "Van Accessible" sign at the head of the space. Provide a sign with the International Symbol of Accessibility (ISA).	1	
11	Van Accessible Parking Space by 60 Station Street	Ext.		Off-Street Parking Lot or Garage	N/A

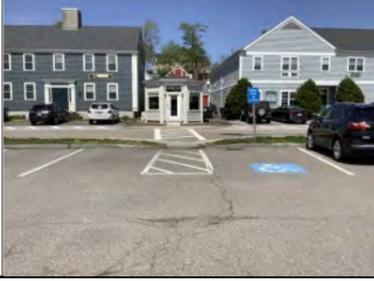
Total # of designated van accessible spaces Van space < 132" or < 96" wide Sign with an ISA not provided	1 124" -	Provide a van accessible space that is at least 132" wide. Provide a sign with the International Symbol of Accessibility (ISA) with the bottom of the sign 60" min. above the ground and the top 96" max. above the ground.	1

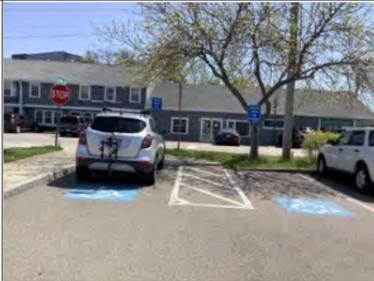
Total # of designated van accessible spaces Access aisle < 96" wide at van space Sign with an ISA is not provided	2 - -	Provide a sign with the International Symbol of Accessibility (ISA) at each space. As best practice, enlarge both spaces so that they are at least 96" wide with a 96" access aisle and can be used as van accessible parking spaces. If the spaces are not enlarged, remove the "Van Accessible" signage.	2	
Best Practice											
13	MBTA Bus Stop	Ext.

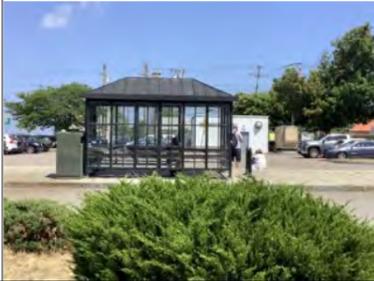
- On a hot summer day, the metal and glass shelter was too hot for many people to use. To avoid overheating, people sat on the sidewalk curb to wait for the bus. In the hot weather, people gather under the trees and sit at the curbs of the two (2) accessible parking spaces by Water Street. IHCD recommends that the Town work with the MBTA to create a more comfortable summer bus stop. IHCD recommends providing benches located on an accessible route under the trees and recommends providing trees that cast shade upon the bus stop.

On a hot summer day, the metal and glass shelter was too hot for many people to use. To avoid overheating, people sat on the sidewalk curb to wait for the bus.	1	
14	Shade of the Tree by the Accessible Parking Spaces and MBTA Bus Stop	Ext.

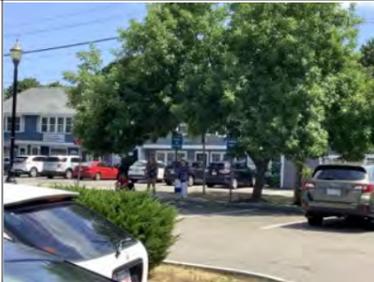
In the hot weather, people gather under the trees and sit at the curbs of the two (2) accessible parking spaces by Water Street. IHCD recommends that the Town work with the MBTA to create a more comfortable summer bus stop. IHCD recommends providing benches located on an accessible route under the trees and recommends providing trees that cast shade upon the bus stop.	1

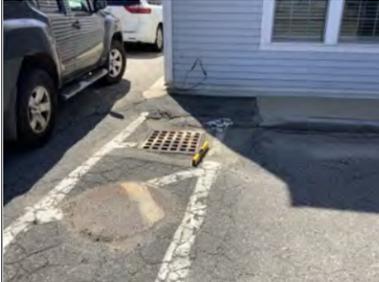
Surface openings > 1/2"	-	Ensure drain is not located in the access aisle. (Note: IHCD recommends relocating this parking space and access aisle.)	1	
2	8 North Street Parking Area - Walkway	Ext.		Exterior Access Route	Sidewalk

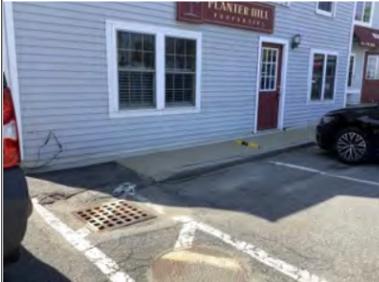
Cross slope > 1:50 (2.00%)	4.7%	Reduce the cross slope of the walkway to be no steeper than 1:50 (2.00%).	1	
Curb Ramp											
3	8 North Street Parking Area - Access Aisle at Accessible Space	Ext.		Curb Ramp	N/A

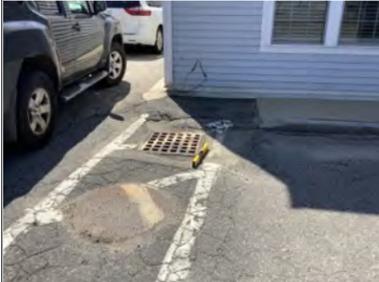
Curb ramp not provided	- -	Provide a compliant curb ramp at the start of the walkway. Ensure the drain is not in the accessible route. (Note: IHCD recommends relocating this parking space and access aisle.)	1

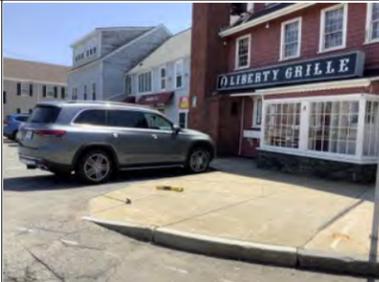
4	8 North Street Parking Area - Near Liberty Grille	Ext.		Curb Ramp	N/A

Cross slope > 1:50 (2.00%) (MAAB)	6%	Reduce cross slope at curb ramp to be no steeper than 1:50 (2.00%). (Cost estimate for a new concrete curb ramp.)	1

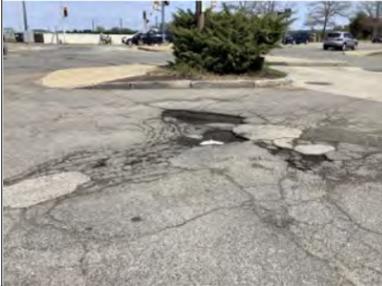
- The 8 North Street lot is not maintained in operable working condition (multiple large potholes are present in the lot).
- The walkway is not maintained in operable working condition by the three (3) parking spaces at the 6 Mill Street parking area.

Surface not stable, firm, and slip-resistant	-	Repair surface. (Note: Some recommendations for the 6 Mill Street parking area are provided in the Best Practice section of the narrative report.)	1

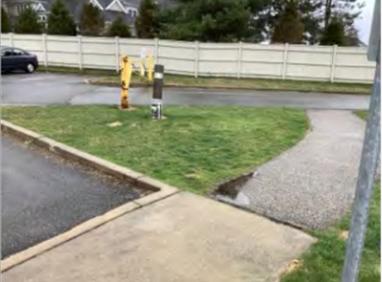
Level changes > 1/4"	1.5"	Alter the change in level to be 1/4" high max.	1	
2	Carlson Athletic Fields Route to Basketball by Skate Park	Ext.		Exterior Access Route	Walkway

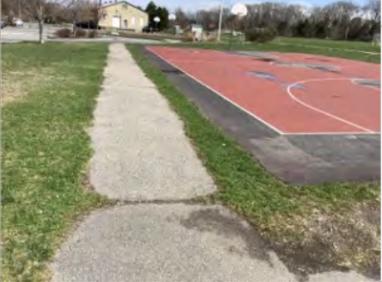
Route not maintained in operable working condition	-	Ensure that the accessible route is maintained in operable working condition.	1	
3	Fire Museum Entrance	Ext.		Exterior Access Route	Exterior

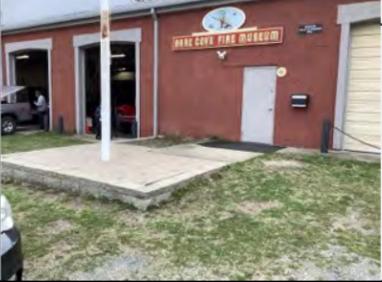
Accessible route not provided	-	Ensure an accessible route is provided to the entrance.	1	
4	Route to Scull Storage Area Near Green Dock House Military Museum	Ext.		Exterior Access Route	Exterior

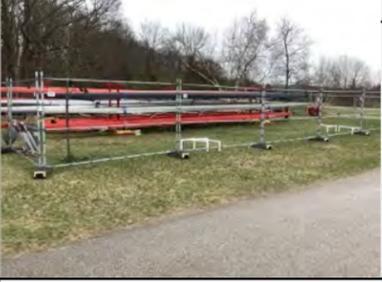
Accessible route not provided	-	Ensure an accessible route is provided to the gate entry at the rowing scull storage area.	1

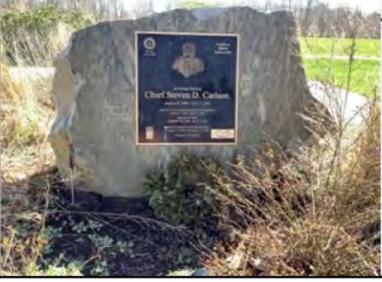
5	Carlson Athletic Fields Memorial	Ext.		Exterior Access Route	Exterior

Accessible route not provided	-	Ensure an accessible route is provided to the memorial.	1

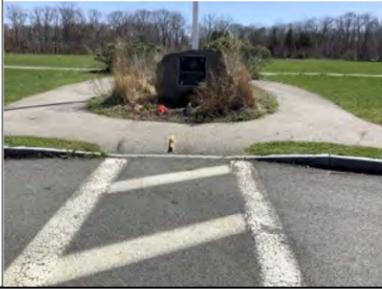
Landing not provided at top of curb ramp Running slope > 1:12 (8.33%)	10.3% -	Reduce the running slope to be no steeper than 1:12 (8.33%). Provide landing at top of curb ramp.	1	
Off-Street Parking Lot or Garage											
8	Fire Museum Parking	Ext.		Off-Street Parking Lot or Garage	N/A

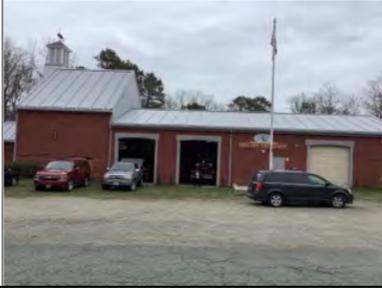
Total # of parking Total # of designated accessible parking spaces Total # of designated van accessible spaces Access aisle not provided Sign not provided Sign does not have the designation "Van Accessible"	6 - - - -	Provide one van accessible parking space. Provide a marked access aisle. Provide a sign with an International Symbol of Accessibility (ISA) with the bottom of the sign 60" min. above the ground and the top 96" max. above the ground. Add the designation "Van Accessible" to the sign . (See Figure 3 in the report narrative for one possible solution.)	1

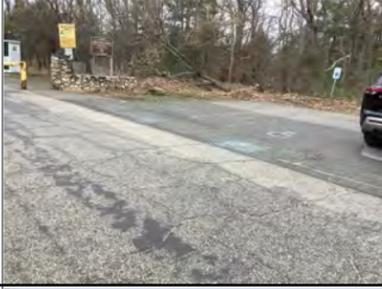
9	Parking by Bare Cove Park Entrance Near The Railway Museum Lot	Ext.		Off-Street Parking Lot or Garage	N/A

Total # of parking Total # of designated accessible parking spaces Total # of designated van accessible spaces Access aisle < 96" wide at van space Sign does not have the designation "Van Accessible" Sign bottom < 60" above finished grade	15 1 1 60" - 34"	Provide a marked access aisle that is at least 96" wide at the van accessible parking space. Add the designation "Van Accessible" to the sign located at the van accessible space. Locate sign with the bottom of the sign 60" above the ground.	1	
10	Carlson Athletic Fields Complex Parking	Ext.		Off-Street Parking Lot or Garage	Visitor

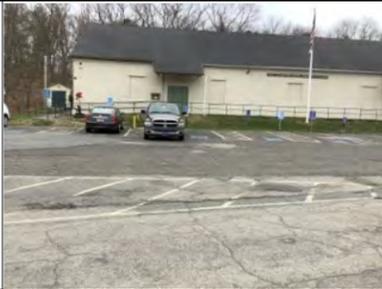
Total # of parking Total # of designated van accessible spaces Total # of designated accessible parking spaces Running or cross slope at access aisle > 1:50 (2.00%) Sign does not have the designation "Van Accessible" Sign bottom < 60" above finished grade	50 6 1 4.3% - 40"	Reduce running or cross slope to be no steeper than 1:50 (2.00%) at the parking spaces. Add the designation "Van Accessible" to the sign located at the van accessible space. Locate all signs with the bottom of the sign 60" above the ground.	1	
12	Carlson Athletic Fields, Parking	Ext.		Off-Street Parking Lot or Garage	Visitor

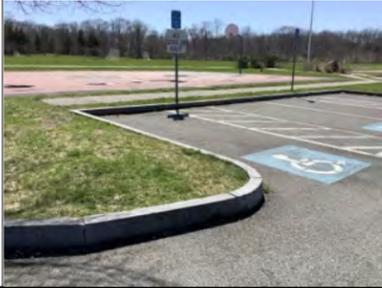
Access aisle does not adjoin an accessible route	- -	Ensure the access aisles adjoins an accessible route to the sidewalk (provide a curb ramp at the access aisles).	1

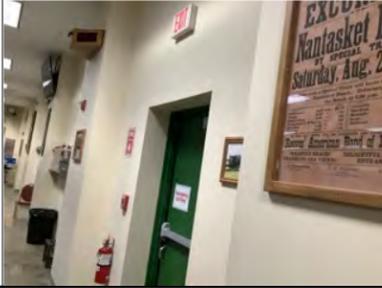
Emergency Exit											
13	Railway Museum Train Room	1		Emergency Exit	N/A

Tactile sign not provided at emergency exit Directional sign to accessible emergency exit not provided	- -	Provide a sign with raised characters ad braille at the emergency exit. Mount signs between 48"-60" above the finished floor located on the latch side of the door. Provide a directional sign indicating the location of the nearest accessible emergency exit.	1	
14	Railway Museum Train Room	1		Emergency Exit	N/A

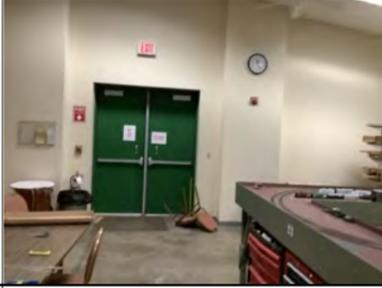
Tactile sign not provided at emergency exit Illuminated International Symbol of Acc. not provided (MAAB 2006)	- -	Provide a sign with raised characters ad braille at the emergency exit. Mount signs between 48"-60" above the finished floor located on the latch side of the door. Where a tactile sign is provided at double doors with two active leafs, the sign shall be located to the right of the right hand door. Provide an illuminated sign with the International Symbol of Accessibility (ISA).	1

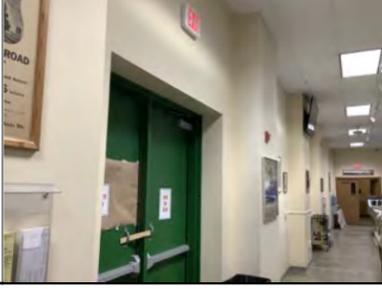
15	Railway Museum Train Room	1		Emergency Exit	N/A

Tactile sign not provided at emergency exit Illuminated International Symbol of Acc. not provided (MAAB 2006)	-	Provide a sign with raised characters ad braille at the emergency exit. Mount signs between 48"-60" above the finished floor located on the latch side of the door. Where a tactile sign is provided at double doors with two active leafs, the sign shall be located to the right of the right hand door. Provide an illuminated sign with the International Symbol of Accessibility (ISA).	1

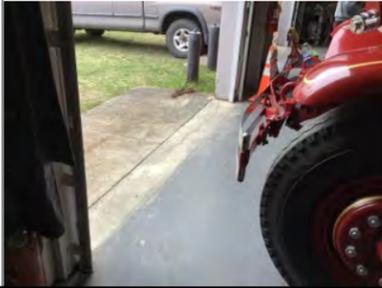
Route < 36" wide	26"	Ensure that a clear width of 36" min. is maintained at the accessible route. Relocate the fire engine.	1

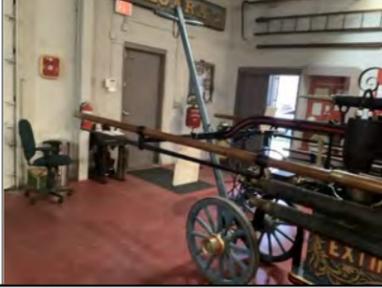
18	Fire Museum	1		Interior Access Route	Interior

Obstructed by protruding objects	43"	Provide a cane-detectable barrier around the protruding parts of the fire engine.	1	
Doors, Doorways, & Gates											
19	Fire Museum Women's Toilet Room	1		Doors, Doorways, & Gates	Toilet Room

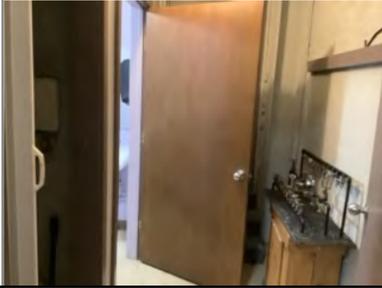
Maneuvering clearance(s) not provided	37"	Relocate stored items to provide 48" maneuvering clearance at the door or provide an automatic door opener.	1	
20	Fire Museum Door To the Bomb Manufacture Area	1		Doors, Doorways, & Gates	N/A

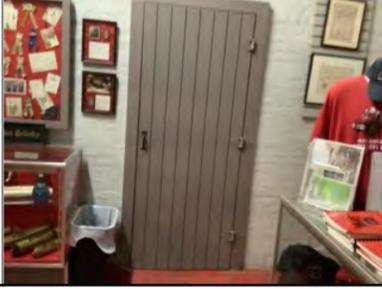
Hardware not operable with a closed fist	-	Provide hardware that can be operable with one hand and not require tight grasping, pinching, or twisting of the wrist.	1

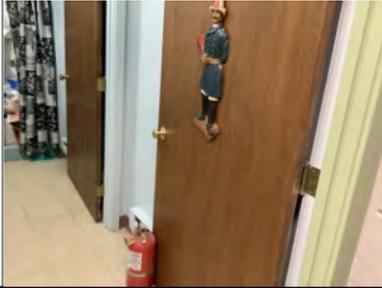
Hardware not operable with a closed fist	-	Provide hardware that can be operable with one hand and not require tight grasping, pinching, or twisting of the wrist.	1	
22	Fire Museum Main Room	1		Doors, Doorways, & Gates	Toilet Room

Hardware not operable with a closed fist	-	Provide hardware that can be operable with one hand and not require tight grasping, pinching, or twisting of the wrist.	1	
23	Fire Museum, Women's Toilet Room	1		Doors, Doorways, & Gates	Toilet Room

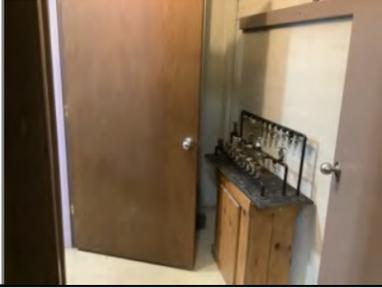
Hardware not operable with a closed fist	-	Provide hardware that can be operable with one hand and not require tight grasping, pinching, or twisting of the wrist.	1	
Ramps											
24	Fire Museum Between Main Sections	1		Ramps	Interior

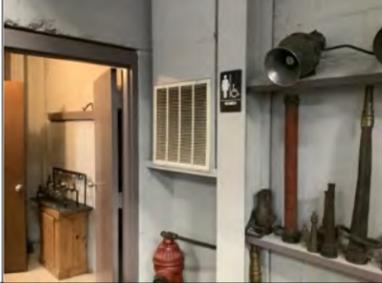
<ul style="list-style-type: none"> Raised characters < 48" or > 60 " above ground Sign not located on the latch side of the door 	68"	<ul style="list-style-type: none"> Mount signs so that the baseline of the lowest tactile character is 48" min. above the finished floor and the baseline of the highest tactile character is 60" max. above the finished floor. Locate signs at permanent rooms alongside the door on the latch side on the wall. 	1

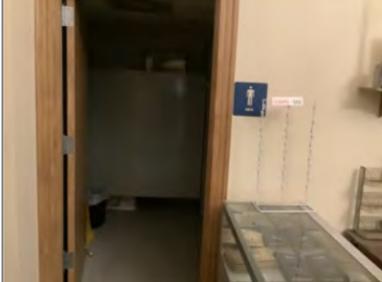
28	Railway Museum, Men's Toilet Room	1		Signage	Designation

<ul style="list-style-type: none"> Signage lacks 18" by 18" clear floor space 	-	<ul style="list-style-type: none"> Relocate the display case to provide a clear floor space of 18" min. by 18" min. 	1	
29	Railway Museum, All Gender Toilet Room	1		Signage	Designation

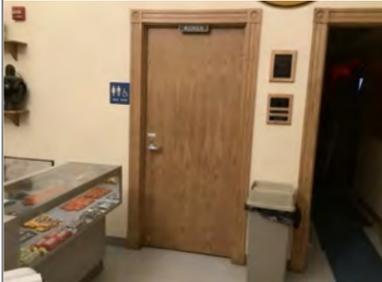
<ul style="list-style-type: none"> Signage lacks 18" by 18" clear floor space 	-	<ul style="list-style-type: none"> Relocate the display case to provide a clear floor space of 18" min. by 18" min. 	1	
Operable Parts											
30	In Park Just Past Gate Near Lynch Field	Ext.		Operable Parts	N/A

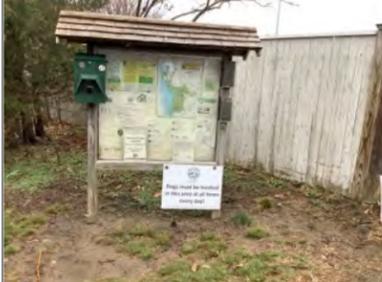
<ul style="list-style-type: none"> Element not on an accessible route 	-	<ul style="list-style-type: none"> Provide an accessible route to the wayside sign and to the dog waste bag dispenser. 	1

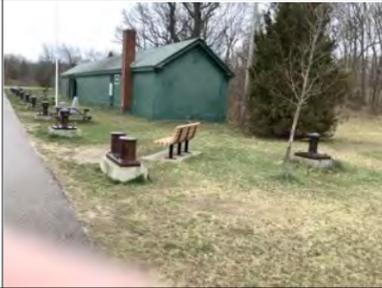
No accessible route to one bench in this area	-	Provide an accessible route to at least one bench in this area.	1

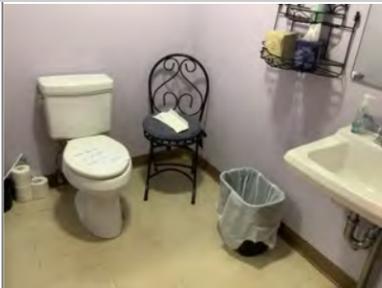
Toilet & Bathing Rooms											
Overall Access											
33	Fire Museum Women's Toilet Room	1		Overall Access	Toilet Room

Accessible plumbing fixtures or stalls not provided		Provide a directional sign to the accessible toilet. (Ensure that the men's toilet room is fully accessible and open to all genders.)	1	
34	Railway Museum Men's Toilet Room	1		Overall Access	Toilet Room

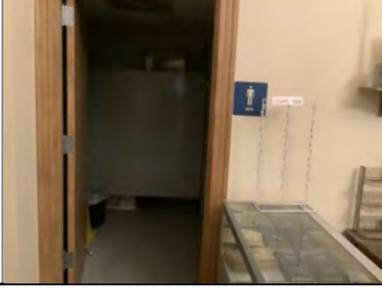
Sign to accessible toilet not provided	<ul style="list-style-type: none"> - - 	Provide a directional sign indicating the location of the nearest accessible toilet or bathing room.	1

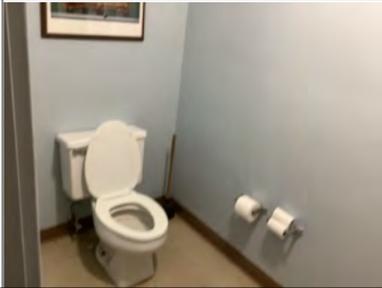
Grab bars not provided Clearance at toilet < 60" clear width	- 55"	Provide one grab bar on the side wall of the water closet and one on the rear wall. Provide a wheelchair accessible compartment that is 60" wide min.	1	
37	Fire Museum Men's Toilet Room	1		Toilet Compartment	Accessible Compartment

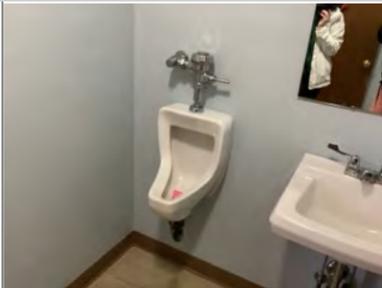
Urinal											
38	Fire Museum Men's Toilet Room	1		Urinal	N/A

Rim > 17" high	26"	Provide at least one urinal with the rim no higher than 17" above the finished floor.	1	
Portable Toilet											
39	Near Scull Rowing Boats	Ext.		Portable Toilet	N/A

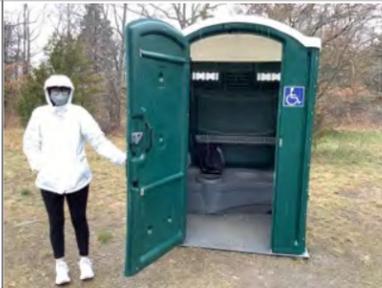
Not located on an accessible route Accessible portable toilets not provided	- -	Locate portable toilet on an accessible route. Ensure that at least 5% of portable toilets (with a minimum of one) are accessible.	1

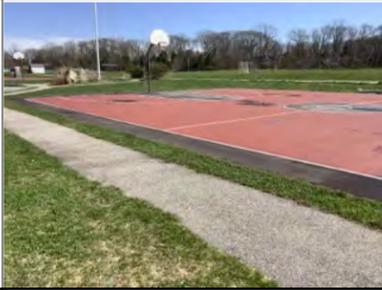
Court											
43	Carlson Athletic Fields Basketball by Skate Park	Ext.		Court	Basketball

No accessible route between all areas of sport activity	-	Install an accessible route between all areas of sport activity, including to the basketball court.	1	
Best Practice

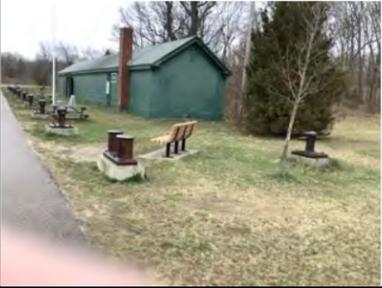
ID	Location	Floor	Room	Element	Type	Photo	Issues	Current Measure	Recommendations	Quantity	Notes
Bench											
44	Green Dock House Military Museum	Ext.		Bench	N/A

Recommend providing a 36" min. by 48" min. stable, firm and slip-resistant surface adjacent to at least one (1) bench in the park in each area where benches are provided.	1	
Picnic Table											
45	Green Dock House Military Museum	Ext.		Picnic Table	N/A

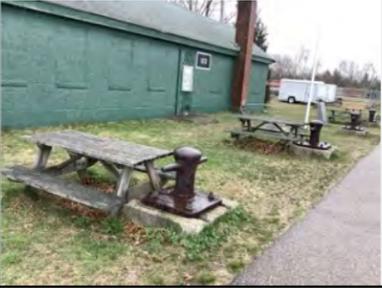
Recommend providing a 48" min. stable, firm, and slip-resistant surface around at least one (1) accessible picnic table in the park at each location where picnic tables are provided.	1

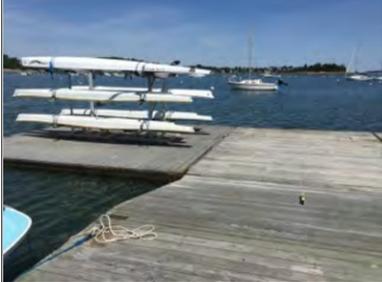
ID	Location	Floor	Room	Element	Type	Photo	Issues	Current Measure	Recommendations	Quantity	Notes
Approach and Entrance											
Exterior Access Route											
1	Route to Sculling Boats at the End of Dock	Ext.		Exterior Access Route	Exterior

Running slope > 1:20 (5.00%)	17%	In order to achieve program access, it should be ensured that sculling boats can be brought to a boat slip that is closer to the gangway before the steep slope occurs.	1	
2	Path to Boathouse Ramp	Ext.		Exterior Access Route	Walkway

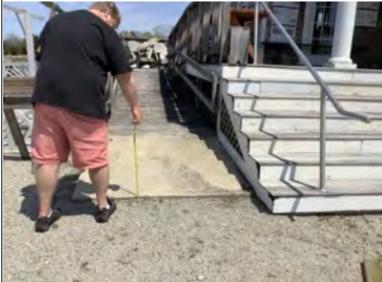
Level changes > 1/4"	2"	Alter the change in level at the transition of materials to be 1/4" high max.	1	
3	Entry at Parking	Ext.		Exterior Access Route	Exterior

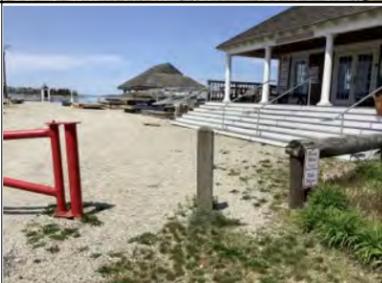
Surface is not stable, firm, and slip-resistant Accessible route not provided	- -	Repair the surface. Ensure an accessible route is provided from the parking to the boathouse, picnic pavilion and other amenities on the site. (The gravel ground surface is not firm, stable and slip resistant.)	1

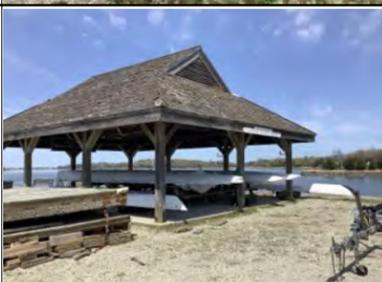
4	Picnic Pavilion	Ext.		Exterior Access Route	Exterior

Accessible route not provided	3"	Ensure a stable, firm and slip resistant accessible route is provided. Reduce change in level at entry to picnic pavilion to 1/2" max. beveled.	1	
5	Pier to Boat Slips	Ext.		Exterior Access Route	Exterior

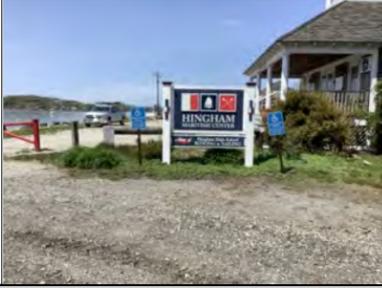
Accessible route not provided Level changes > 1/4"	2"	Alter the change in level to be 1/4" high max. Ensure an accessible route is provided.	1	
Off-Street Parking Lot or Garage											
7	Parking Lot	Ext.		Off-Street Parking Lot or Garage	Visitor

Total # of parking Total # of designated accessible parking spaces Total # of designated van accessible spaces Access aisle not provided Sign does not have the designation "Van Accessible" Sign bottom < 60" above finished grade	29 1 1 - - 36"	Provide a marked access aisle that is at least 96" wide for a compliant van accessible parking space. Add the designation "Van Accessible" to the sign located at the van accessible space. One compliant car accessible parking space is also required. Locate all signs with the bottom of the sign 60" above the ground. See Figure 1 in the narrative report.	1

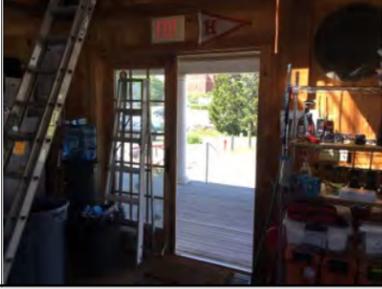
Emergency Exit											
8	Boathouse Exit	1		Emergency Exit

Tactile sign not provided at emergency exit Illuminated International Symbol of Acc. not provided (MAAB 2006)		Provide a sign with raised characters and braille at the emergency exit. Mount signs between 48"-60" above the finished floor located on the latch side of the door. Provide an illuminated sign with the International Symbol of Accessibility (ISA).	1	
Access to Goods and Services											
Ramps											
9	Boathouse	Ext.		Ramps	Exterior

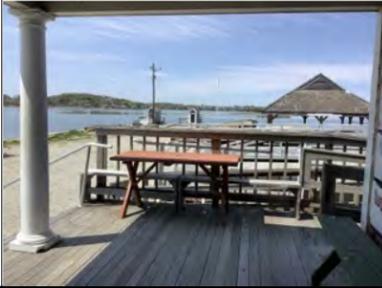
Landing has a slope > 1:50 (2.00%) (MAAB)	8%	Rebuild the ramp bottom landing to ensure that the slope of the landing does not exceed 1:50 (2.00%).	1	
Picnic Tables											
11	Boathouse	Ext.		Picnic Tables	N/A

Toe or knee clearance at table not provided	-	Provide at least one picnic table with top between 28"- 34" above the ground and 27" clear height underneath.	1	
Benches											
12	By Hingham Maritime Center	Ext.		Benches	N/A

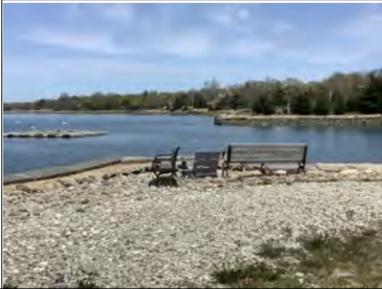
No accessible route to one bench in this area	-	Provide an accessible route to at least one bench in this area.	1	
Toilet & Bathing Rooms											
Portable Toilet											
13	By Building	Ext.		Portable Toilet	N/A

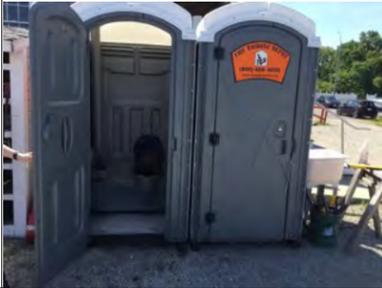
Accessible portable toilets not provided		Ensure that at least 5% of portable toilets (with a minimum of one) are accessible.	1

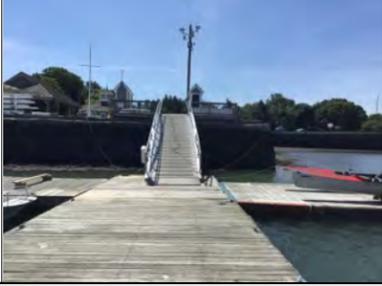
Edge protection at dock not provided		Provide detectable warnings that comply with 521 CMR on all sides of the dock.	1	
15	Dock	Ext.		Boating	N/A

Edge protection at dock not provided		Provide detectable warnings that comply with 521 CMR on all sides of the dock.	1	
Best Practice											
16	By Hingham Maritime Center	Ext.

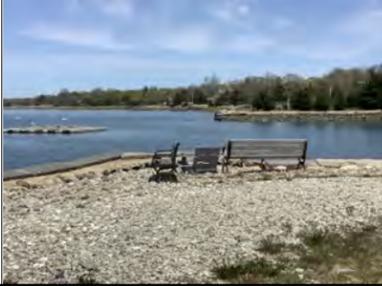
-	Recommend providing 36" wide by 48" deep clear floor space next to at least one bench in this area so that a wheelchair user is able to sit shoulder-to-shoulder with a person seated on the bench. See Figure 2 in the narrative report.	1

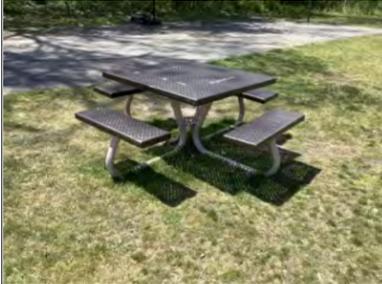
ID	Location	Floor	Room	Element	Type	Photo	Issues	Current Measure	Recommendations	Quantity	Notes
Access to Goods and Services											
Picnic Tables											
1	By Basketball Court And Playground	Ext.		Picnic Tables	N/A

Toe or knee clearance at table not provided Picnic table not on an accessible route	- -	Provide at least one picnic table with top between 28"- 34" above the ground and 27" clear height underneath. Ensure that the picnic table is connected to an accessible route.	1	
Benches											
2	By Playground	Ext.		Benches	N/A

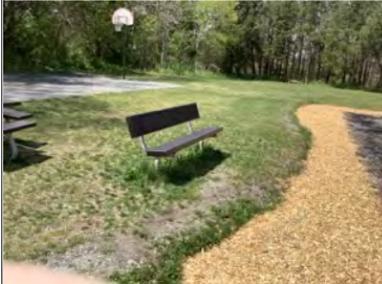
No accessible route to one bench in this area	-	Provide an accessible route to at least one bench in this area or relocate at least one bench to an accessible route.	1	
Trash / Recycling											
3	Playground	Ext.		Trash / Recycling	N/A

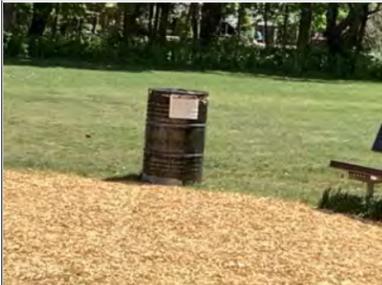
Trash container not connected to an accessible route	-	Ensure trash container is located on an accessible route.	1

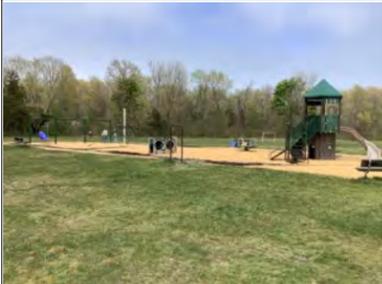
Play and Sport Areas											
Play Areas											
4	Playground	Ext.		Play Areas	N/A

Accessible route not provided around playground Not connected to an accessible route	- -	Install a stable, firm and slip-resistant accessible route from the parking area to and around the playground. Ensure the route is 48" wide min. If the route is less than 60" wide, provide a 60" x 60" passing space every 200 feet.	1

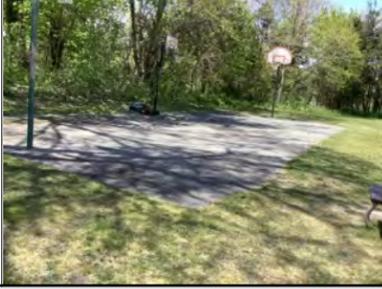
Not connected to accessible route No accessible route between all areas of sport activity	- -	Provide an accessible route to the boundary of sport activity at the basketball court. Install an accessible route between all areas of sport activity.	1

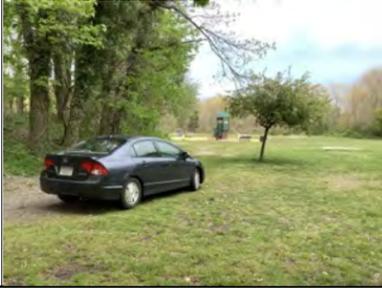
Best Practice											
8	Parking	Ext.

Recommend providing an accessible parking area by the field. Figure 1 in the narrative report shows one way to use posts, a painted wood rail and signs to designate accessible parking spaces and access aisle in an unpaved parking lot.	1

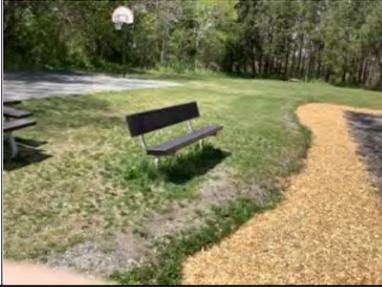
ID	Location	Floor	Room	Element	Type	Photo	Issues	Current Measure	Recommendations	Quantity	Notes
Bench											
9	By Playground	Ext.		Bench	N/A

Recommend providing a 36" x 48" min. stable, firm and slip resistant surface adjacent to at least one bench in this area once it is connected to an accessible route. Recommend extending the surface for 8" min. behind the back of the bench to allow for a person using a wheelchair to have shoulder alignment with a person seated on the bench. See Figure 2 in the narrative report.	1	
Park Sign											
10	Park Driving Entry at The Corner of Holly And Ivy Streets			Park Sign	N/A

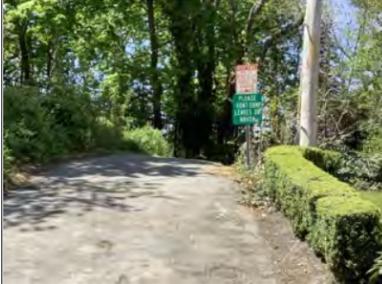
The park is difficult to find. Recommend a park entry identification and directional wayfinding sign. Additionally, IHCD recommends providing a street address for this park on the Hingham Recreation Department website and in any printed park materials.	1	
Picnic Table

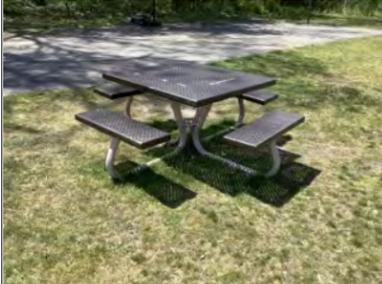
11	By Basketball Court And Playground	Ext.		Picnic Table	N/A

Recommend providing a 48" wide min. stable, firm and slip-resistant surface around the boundary of an accessible picnic table located on an accessible route. See Figure 3 in the narrative report.	1

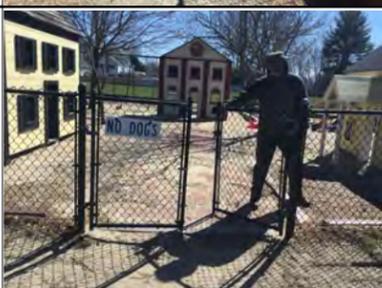
Level changes > 1/4"	2.5"	Alter the change in level to be 1/4" high max.	1

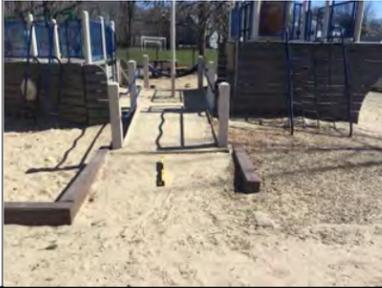
Level changes > 1/4"	1"	Alter the change in level to be 1/4" high max.	2	
8	Parking to Dugout Third Base Side	Ext.		Exterior Access Route	Exterior

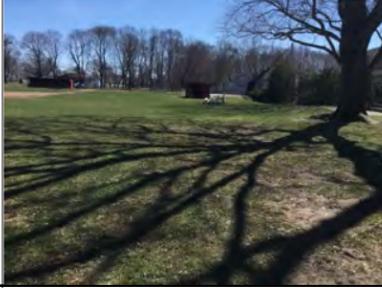
Surface is not stable, firm, and slip-resistant Accessible route not provided	- -	Ensure an accessible route is provided including to new dugout once it is installed.	1	
9	Plaque	Ext.		Exterior Access Route	Exterior

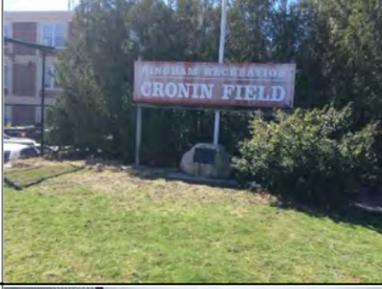
Surface is not stable, firm, and slip-resistant Accessible route not provided	- -	Ensure an accessible route is provided to the plaque.	1	
10	Basketball Court	Ext.		Exterior Access Route	Exterior

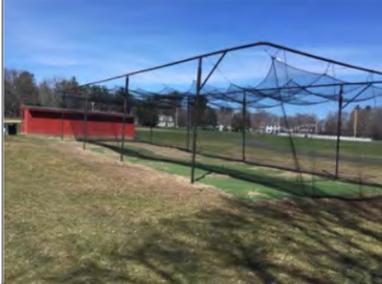
Accessible route not provided	-	Ensure an accessible route is provided to the old batting cage.	1	
13	Burr Road Parking to Basketball, Volleyball and Street Hockey	Ext.		Exterior Access Route	Exterior

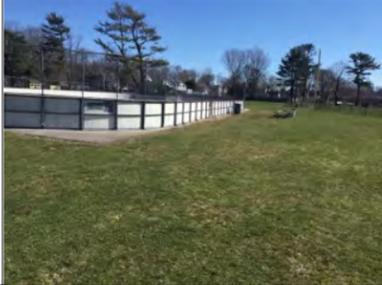
Accessible route not provided	-	Ensure an accessible route is provided to the street hockey court.	1	
Off-Street Parking Lot or Garage											
15	Parking by Playground and Tennis	Ext.		Off-Street Parking Lot or Garage	Visitor

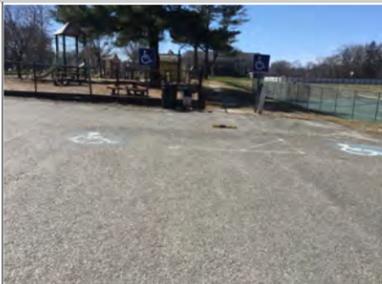
Total # of parking Total # of designated accessible parking spaces Total # of designated van accessible spaces Running or cross slope at access aisle > 1:50 (2.00%) Sign does not have the designation "Van Accessible"	35 2 0 3.3% -	Reduce running or cross slope to be no steeper than 1:50 (2.00%) in all directions. Add the designation "Van Accessible" to the sign located at the van accessible space.	1

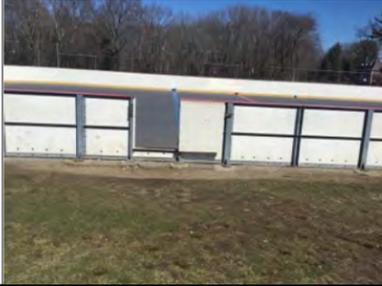
ID	Location	Floor	Room	Element	Type	Photo	Issues	Current Measure	Recommendations	Quantity	Notes
Doors, Doorways, & Gates											
16	Street Hockey	Ext.		Doors, Doorways, & Gates	Other

Clear width at door < 32" Threshold > 1/2" high	29" 12"	Widen the door so that there is 32" min. clear width. Alter the threshold to be 1/2" high max.	1	
17	Playground	Ext.		Doors, Doorways, & Gates	N/A

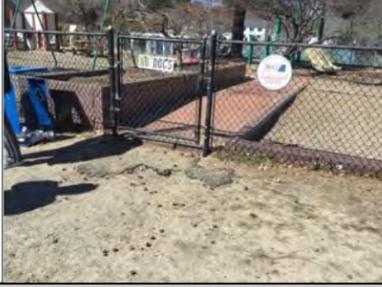
Threshold > 1/2" high	3"	Alter the threshold to be 1/2" high max.	1	
Stairways											
18	Towards Stairs and Burr Road Parking by Tennis, Volleyball and Basketball Court	Ext.		Stairways	Exterior

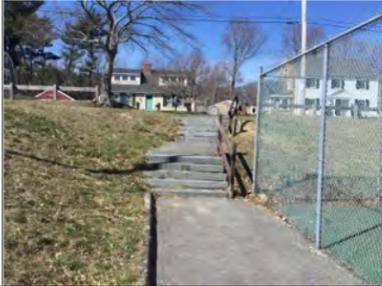
Handrails not provided	-	Provide handrails on both sides.	1	
Picnic Tables											
19	Shaded Picnic Table in Playground	Ext.		Picnic Tables	N/A

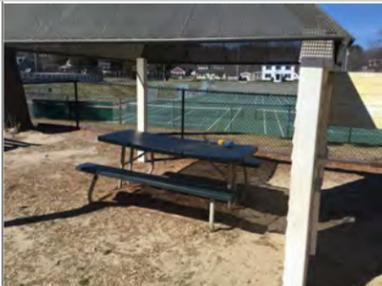
Surface not firm and stable Toe or knee clearance at table not provided Picnic table not on an accessible route	- - -	Provide at least one picnic table in this area with top between 28"- 34" above the ground and 27" clear height underneath. Ensure that the dining surface is located on an accessible route.	1

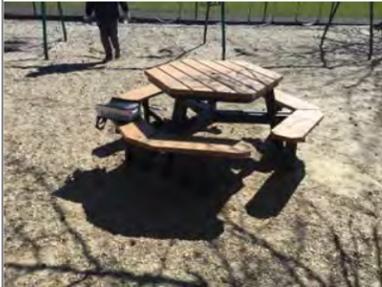
20	Children's Picnic Table in Playground	Ext.		Picnic Tables	N/A

Surface not firm and stable Toe or knee clearance at table not provided Picnic table not on an accessible route	- - -	Provide at least one picnic table in this area with top between 28"- 34" above the ground and 27" clear height underneath. Ensure that the dining surface is located on an accessible route.	1

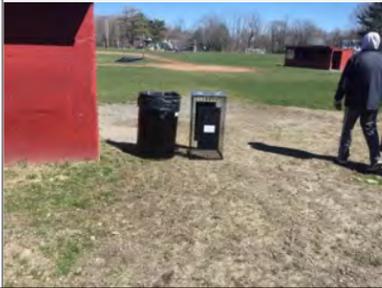
Surface not stable, firm, and slip-resistant at trash Trash container not connected to an accessible route	- -	Ensure the trash container is located on an accessible route.	1	
Toilet & Bathing Rooms											
Portable Toilet											
23	Portable Toilet	Ext.		Portable Toilet	N/A

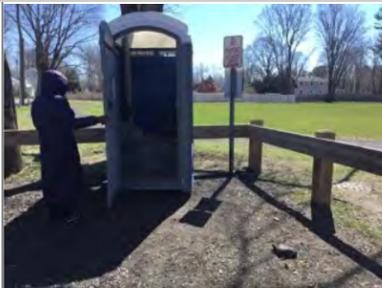
Not located on an accessible route Accessible portable toilets not provided	- -	Locate portable toilet on an accessible route. Ensure that at least 5% of portable toilets (with a minimum of one) is accessible.	1

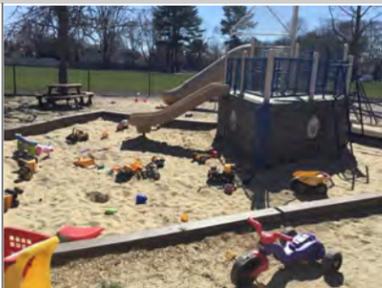
Play and Sport Areas											
Play Areas											
24	Playground	Ext.		Play Areas	N/A

Accessible route not provided at play components	-	Install an accessible route to and around at least one of each type of play component in the playground. Provide a compliant impact-attenuating surface to, under and around the play components.	1

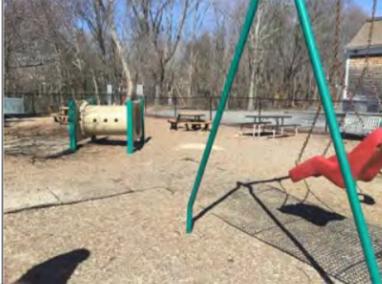
Play areas not maintained in operable working condition		Ensure that the play area is maintained in operable working condition. (Ensure engineered wood fiber is cleared from the rubber surface.)	1	
Field											
27	Baseball Field - Southwest Dugout	Ext.		Field	Baseball

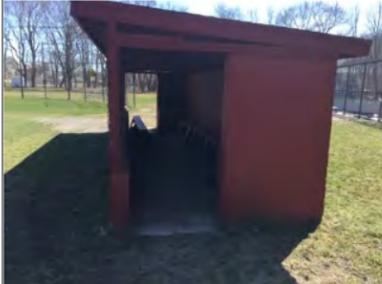
Accessible spaces are not provided at team seating Not connected to an accessible-route No accessible route to all areas of sport activity	- - -	Ensure that an accessible route to each team seating area is provided, that an accessible space is provided alongside the team seating bench in the dugout and that entry and exit from the new dugouts is accessible. (IHCD team was told that new dugouts are being provided on both base lines. Ensure new dugouts meet all accessibility requirements as described here.)	1

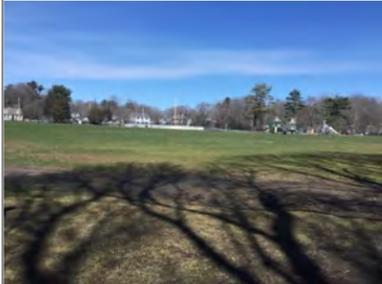
28	Track and Multipurpose Field	Ext.		Field	Soccer

Not connected to an accessible-route	-	Provide an accessible route to the track and multipurpose field.	1	
29	Baseball Field New Batting Cage	Ext.		Field	Multipurpose

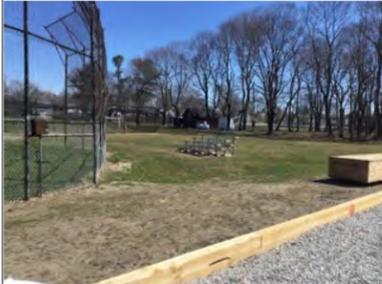
No accessible route to all areas of sport activity	-	Install an accessible route between new batting cage and the field.	1

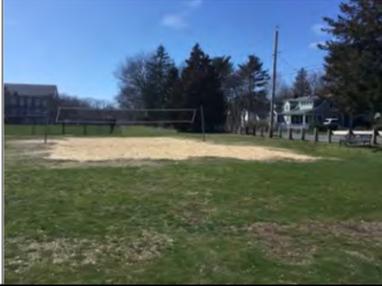
ID	Location	Floor	Room	Element	Type	Photo	Issues	Current Measure	Recommendations	Quantity	Notes
Court											
30	Volleyball Near Basketball Court	Ext.		Court	Volleyball

Not connected to accessible route No accessible route between all areas of sport activity	- -	Provide an accessible route to the boundary of sport activity at the volleyball court. Install an accessible route between all areas of sport activity.	1	
Bleachers											
31	Bleacher 3rd Base Side	Ext.		Bleachers	N/A

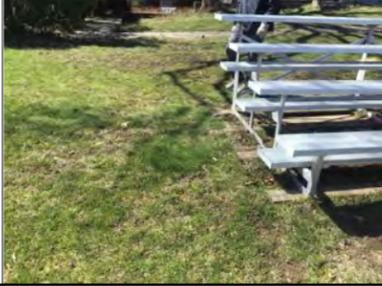
Seating spaces < 36" x 60" (side entry) (MAAB) Seats not connected by accessible route	- -	Provide a 36" by 60" stable and firm clear floor space alongside each side of the bleacher. Provide an accessible route to the seating area.	1	
32	Near Basketball Court	Ext.		Bleachers	N/A

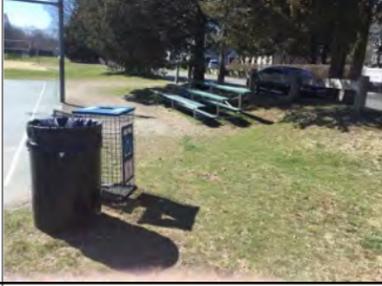
Seating spaces < 36" x 60" (side entry) (MAAB) Seats not connected by accessible route	- -	Provide a 36" by 60" stable and firm clear floor space. Provide an accessible route to the seating area.	1

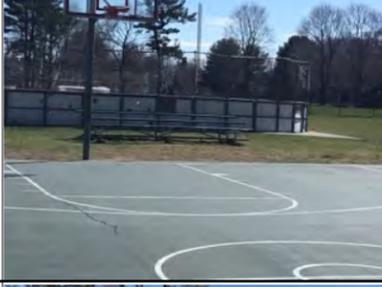
33	Bleachers at Basketball Court Towards Street Hockey Rink	Ext.		Bleachers	N/A

Seating spaces < 36" x 60" (side entry) (MAAB) Seats not connected by accessible route	- -	Provide a 36" by 60" stable and firm clear floor space. Provide an accessible route to the seating area.	1	
34	Street Hockey Spectator Seating	Ext.		Bleachers	N/A

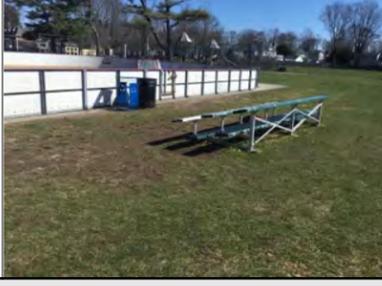
Seating spaces < 36" x 60" (side entry) (MAAB) Seats not connected by accessible route	- -	Provide a 36" by 60" stable and firm clear floor space on each side of the bleachers. Provide an accessible route to the seating area.	1	
Best Practice

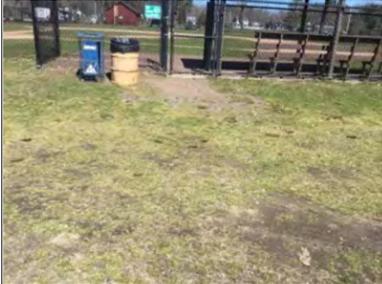
ID	Location	Floor	Room	Element	Type	Photo	Issues	Current Measure	Recommendations	Quantity	Notes
Approach and Entrance											
Exterior Access Route											
1	South Side Dugout	Ext.		Exterior Access Route	Exterior

Level changes > 1/4" Surface is not stable, firm, and slip-resistant	2.5" -	Alter the change in level to be 1/4" high max. Provide a surface that is stable, firm and slip-resistant.	1	
2	Parking	Ext.		Exterior Access Route	Exterior

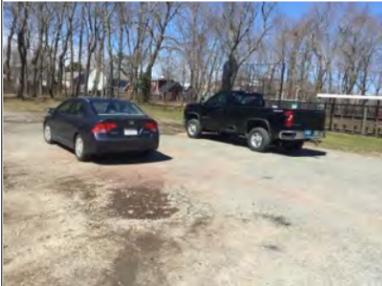
Surface is not stable, firm, and slip-resistant	-	Repair the surface in the parking lot.	1	
Off-Street Parking Lot or Garage											
3	Parking	Ext.		Off-Street Parking Lot or Garage	Visitor

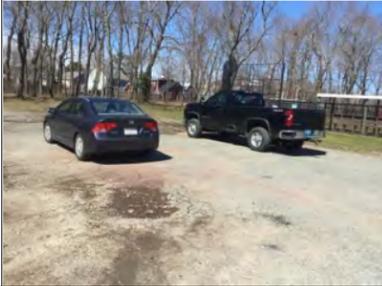
Total # of parking Total # of designated accessible parking spaces Total # of designated van accessible spaces	30 0 0	Provide a marked van accessible space that is at least 132" wide with a marked access aisle that is at least 60" wide. Provide 96" wide car accessible space adjacent to the van access aisle. Provide two (2) signs with the International Symbol of Accessibility (ISA) at the head of each space. Add the designation "Van Accessible" to the sign located at the van accessible space.	1

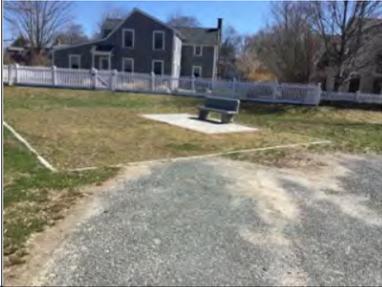
Access to Goods and Services											
Benches											
4	Bench Near Parking	Ext.		Benches	N/A

No accessible route to one bench in this area	-	Provide an accessible route to at least one bench in this area or relocate one bench to an accessible route.	1

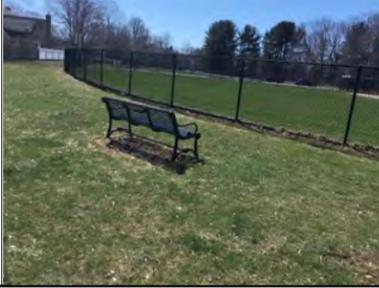
ID	Location	Floor	Room	Element	Type	Photo	Issues	Current Measure	Recommendations	Quantity	Notes
5	Outfield	Ext.		Benches	N/A

No accessible route to one bench in this area	-	Provide an accessible route to at least one bench in this area or relocate one bench on to accessible route.	1	
Trash / Recycling											
6	South Side Dugout	Ext.		Trash / Recycling	N/A

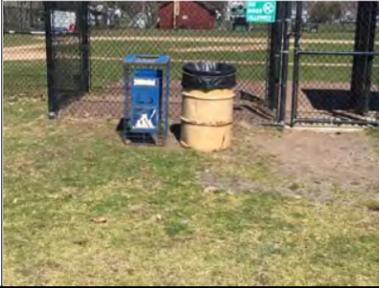
Trash container not connected to an accessible route	-	Ensure the trash container is located on an accessible route.	1	
Play and Sport Areas											
Field											
7	South Side Dugout	Ext.		Field	Baseball

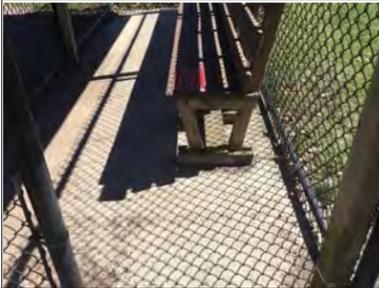
Accessible spaces are not provided at team seating Not connected to an accessible-route No accessible route to all areas of sport activity	- - -	Provide a 36" x 48" clear floor space at team seating. Provide an accessible route to the field. Install an accessible route between all areas of sport activity.	1	
8	West Side Dugout	Ext.		Field	Baseball

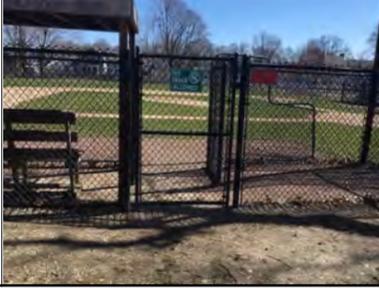
Accessible spaces are not provided at team seating Not connected to an accessible-route No accessible route to all areas of sport activity	- - -	Provide a 36" x 48" clear floor space at team seating. Provide an accessible route to the field. Install an accessible route between all areas of sport activity.	1

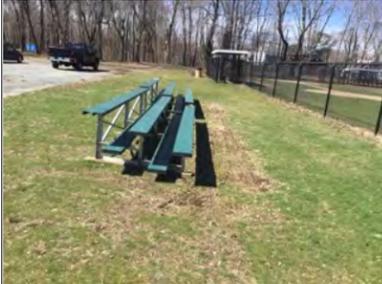
ID	Location	Floor	Room	Element	Type	Photo	Issues	Current Measure	Recommendations	Quantity	Notes
Bleachers											
9	Southeast of Field Near Parking	Ext.		Bleachers	N/A

Min. # of designated wheelchair spaces not provided Seating spaces < 36" x 60" (side entry) (MAAB) Seats not connected by accessible route	- - -	Provide accessible wheelchair spaces with a stable and firm 36" by 60" clear floor space adjacent to each side of each bleacher. Provide an accessible route to the seating area.	1	
10	Southwest of Field Near Parking	Ext.		Bleachers	N/A

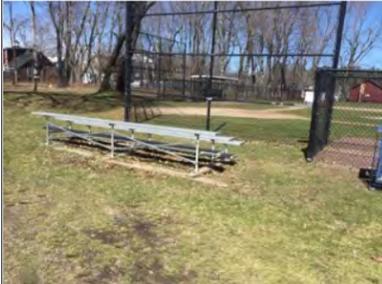
Min. # of designated wheelchair spaces not provided Seating spaces < 36" x 60" (side entry) (MAAB) Seats not connected by accessible route	- - -	Provide accessible wheelchair spaces with a stable and firm 36" by 60" clear floor space adjacent to each side of each bleacher. Provide an accessible route to the seating area.	1	
11	Outfield Bleachers	Ext.		Bleachers	N/A

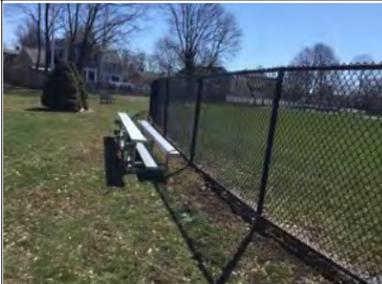
Min. # of designated wheelchair spaces not provided Seating spaces < 36" x 60" (side entry) (MAAB) Seats not connected by accessible route	- - -	Provide accessible wheelchair spaces with a stable and firm 36" by 60" clear floor space adjacent to each side of each bleacher. Provide an accessible route to the seating area. Note: Bleachers may be moved to Cronin soccer field. Whether they are located here or at Haley Field, the same requirements apply.	1

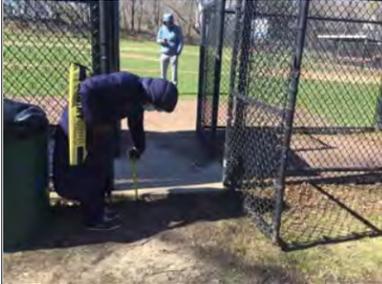
ID	Location	Floor	Room	Element	Type	Photo	Issues	Current Measure	Recommendations	Quantity	Notes
Approach and Entrance											
Exterior Access Route											
1	Baseball Field - Dugouts	Ext.		Exterior Access Route	Exterior

Level changes > 1/4" Accessible route not provided	3" -	Alter the change in level to be 1/4" high max. Ensure an accessible route is provided to each dugout.	2	
2	To Playground	Ext.		Exterior Access Route	Exterior

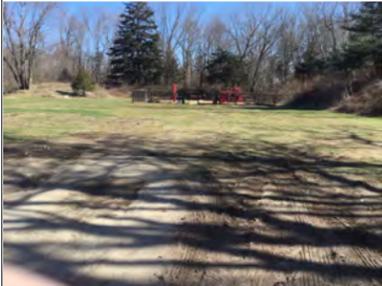
Accessible route not provided	-	Ensure an accessible route is provided to the playground.	1	
Off-Street Parking Lot or Garage											
3	Parking	Ext.		Off-Street Parking Lot or Garage	Visitor

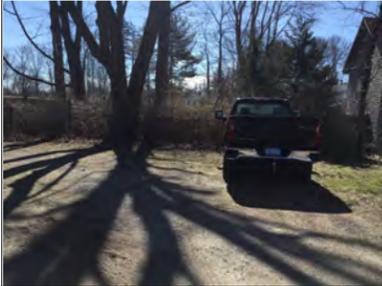
Total # of parking Total # of designated accessible parking spaces Total # of designated van accessible spaces	30 0 0	Provide a marked van accessible space that is at least 132" wide with a marked access aisle that is at least 60" wide. Provide 96" wide car accessible space adjacent to the van accessible access aisle. Provide two (2) signs with the International Symbol of Accessibility (ISA) at the head of each space. Add the designation "Van Accessible" to the sign located at the van accessible space.	1

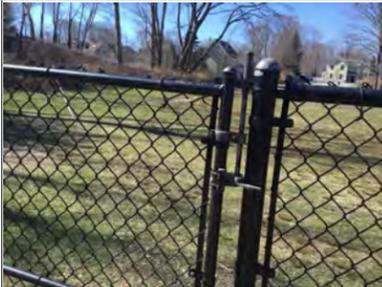
Access to Goods and Services											
Operable Parts											
4	Playground	Ext.		Operable Parts	N/A

Reach < 15" or > 48"(forward/side approach)	62"	Relocate safety lock so that controls are between 15"- 48" above the ground.	1

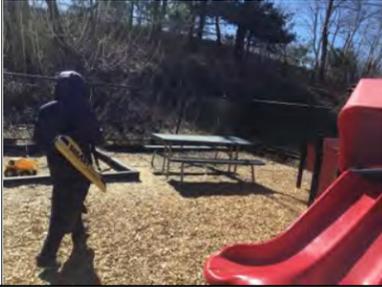
ID	Location	Floor	Room	Element	Type	Photo	Issues	Current Measure	Recommendations	Quantity	Notes
Picnic Tables											
5	Playground	Ext.		Picnic Tables	N/A

Clear floor space not provided Toe or knee clearance at table not provided Picnic table not on an accessible route	- - -	Ensure that at a 30" by 48" clear floor space positioned for a forward approach is provided at the picnic table. Provide at least one picnic table with top between 28"- 34" above the ground and 27" clear height underneath. Ensure that the picnic table is connected to an accessible route.	1	
Benches											
6	Playground	Ext.		Benches	N/A

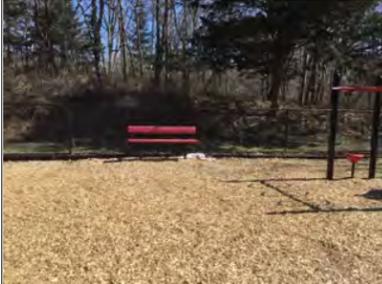
No accessible route to one bench in this area	-	Provide an accessible route to at least one bench in this area or relocate one bench to an accessible route.	1	
Trash / Recycling											
7	Playground	Ext.		Trash / Recycling	N/A

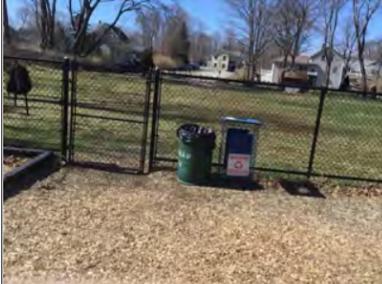
Trash container not connected to an accessible route	-	Ensure the trash container is located on an accessible route.	1
