0 Station Street Parking Lot

Town of Hingham ADA Transition Plan

October 2023

Institute for Human Centered Design

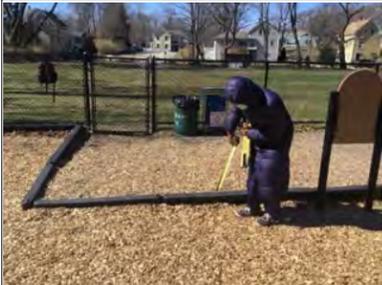
Play and Sport Areas											
Play Areas											
8	Playground	Ext.		Play Areas	N/A

Accessible route not provided around playground Accessible route not provided at play components Not connected to an accessible route Surface not stable, firm, and slip-resistant	- - - -	Install an accessible route to and around the playground. Provide a compliant impact-attenuating surface under and around the play components. Provide an accessible route to play areas. Repair the surface and ensure that surface is firm, stable and slip-resistant (to areas under and around play components).	1

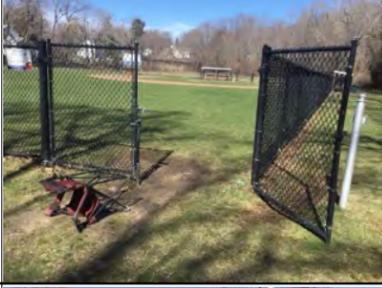
Not connected to an accessible-route No accessible route to all areas of sport activity	- -	Provide an accessible route to the field. Install an accessible route between all areas of sports activity.	1	
12	Batting Cage	Ext.		Field	Baseball

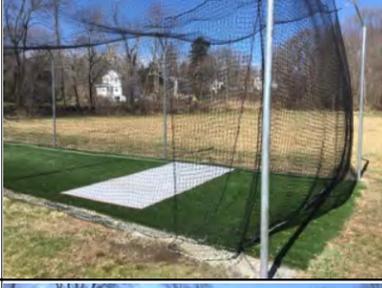
Practice areas are not on an accessible route	-	Provide an accessible route to practice areas.	1

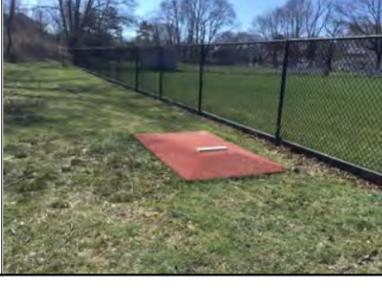
13	Baseball Field - Bullpen	Ext.		Field	Baseball

Practice areas are not on an accessible route	-	Provide an accessible route to practice areas.	1

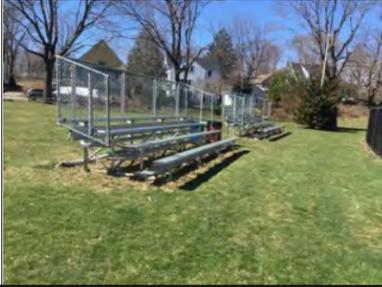
ID	Location	Floor	Room	Element	Type	Photo	Issues	Current Measure	Recommendations	Quantity	Notes
Bleachers											
14	Baseball Field	Ext.		Bleachers	N/A

Min. # of designated wheelchair spaces not provided Seating spaces < 36" x 60" (side entry) (MAAB) Seats not connected by accessible route	- - -	Provide accessible wheelchair spaces with a stable and firm 36" by 60" clear floor space adjacent to each side of each bleacher. Provide an accessible route to the seating area.	1	
15	Baseball Field	Ext.		Bleachers	N/A

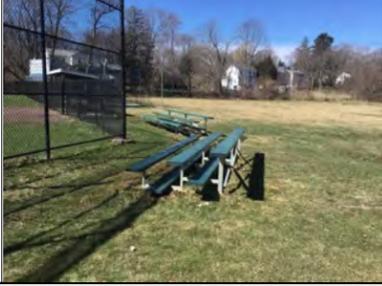
Min. # of designated wheelchair spaces not provided Seating spaces < 36" x 60" (side entry) (MAAB) Seats not connected by accessible route	- - -	Provide accessible wheelchair spaces with a stable and firm 36" by 60" clear floor space adjacent to each bleacher. Provide an accessible route to the seating area.	1	
Best Practice											
16	Playground	Ext.

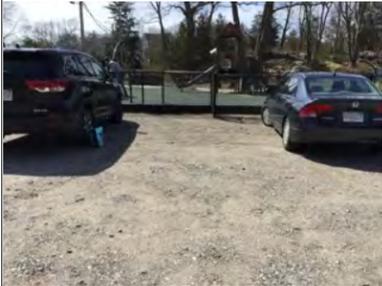
ID	Location	Floor	Room	Element	Type	Photo	Issues	Current Measure	Recommendations	Quantity	Notes
Approach and Entrance											
Off-Street Parking Lot or Garage											
1	Parking	Ext.		Off-Street Parking Lot or Garage	Visitor

Total # of parking Total # of designated accessible parking spaces Total # of designated van accessible spaces Access aisle not provided Sign not provided	5 0 0 - -	Provide a compliant van accessible parking space that is 8' wide min. with a marked access aisle that is also 8' wide min. Provide a sign with the International Symbol of Accessibility (ISA). Include the designation "Van Accessible" on the sign. Mount the sign 60" min. above the ground measured to the bottom of the sign and 96" min. above the ground measured to the top of the sign.	1	
Play and Sport Areas											
Play Areas											
2	Playground Entrance/Exit	Ext.		Play Areas	N/A

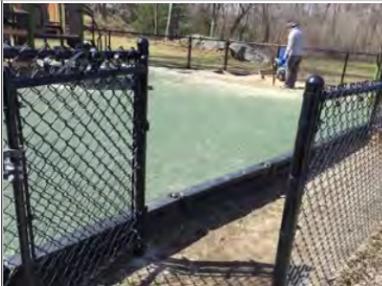
Not connected to an accessible route	10.5"	Provide an accessible route to play areas. (At present, the boundary around the playground means there is no accessible route to the play area.)	1

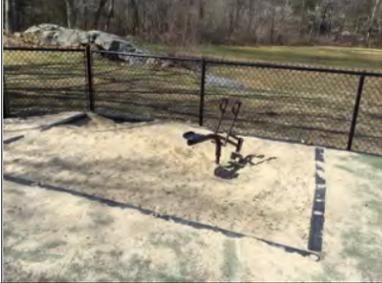
3	Playground - Sand Pit	Ext.		Play Areas	N/A

Play areas not maintained in operable working condition	-	Ensure that the accessible route around the sand pit and to other play elements where the route may get covered by Engineered Wood Fiber (EWF) chips is maintained in operable working condition. (Regularly remove excess sand and EWF chips from rubber surface.)	1

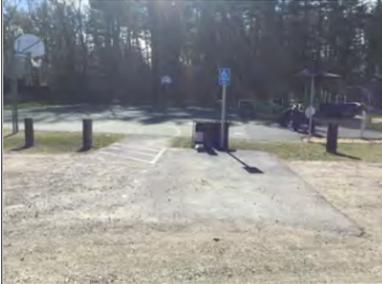
ID	Location	Floor	Room	Element	Type	Photo	Issues	Current Measure	Recommendations	Quantity	Notes
Approach and Entrance											
Off-Street Parking Lot or Garage											
1	Parking	Ext.		Off-Street Parking Lot or Garage	N/A

Van space < 132" or < 96" wide Sign does not have the designation "Van Accessible" Sign top > 96" above finished grade	114" - -	Provide a marked van accessible space that is at least 132" wide with a marked access aisle that is at least 60" wide. Add the designation "Van Accessible" to the sign located at the van accessible space. Ensure the bottom of the sign is 60" min. above the ground and the top 96" max. above the ground.	1	
Access to Goods and Services											
Picnic Tables											
2	Picnic Table Near Playground	Ext.		Picnic Tables	N/A

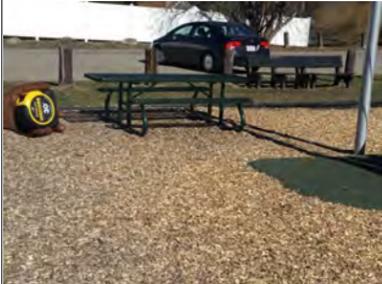
Surface not firm and stable Picnic table not on an accessible route	- -	Ensure surface is firm, stable and slip-resistant. Ensure that the dining surface is connected to an accessible route.	1

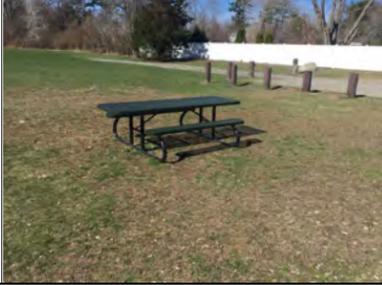
3	Picnic Table Near Softball Field	Ext.		Picnic Tables

Picnic table not on an accessible route	-	Ensure that at least one of the dining surfaces in this area is connected to an accessible route.	1	
Benches											
4	Bench Near Parking	Ext.		Benches	N/A

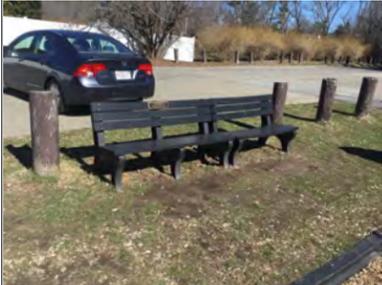
No accessible route to one bench in this area	-	Provide an accessible route to at least one bench in this area or relocate one bench to an accessible route.	1

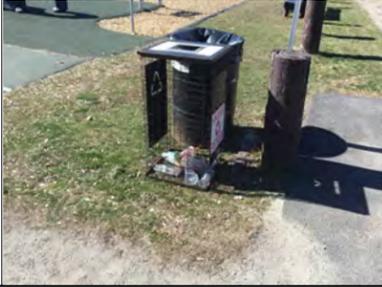
ID	Location	Floor	Room	Element	Type	Photo	Issues	Current Measure	Recommendations	Quantity	Notes
Trash / Recycling											
5	Trash Near Parking	Ext.		Trash / Recycling	N/A

Trash container not connected to an accessible route	-	Ensure trash container is located on an accessible route.	1	
Play and Sport Areas											
Play Areas											
6	Playground	Ext.		Play Areas

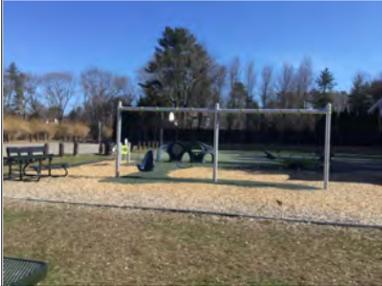
Accessible route not provided around playground	-	Install an accessible route to and around the playground.	1	
7	Playground - Swings	Ext.		Play Areas	N/A

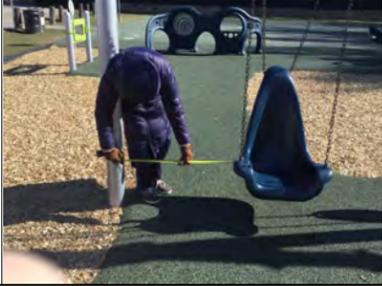
Accessible route < 60" wide at ground level	30"	Ensure that the clear width is no less than 36" at this point. The clear width of accessible routes is permitted to be 36 inches minimum for a distance of 60 inches maximum provided that multiple reduced width segments are separated by segments that are 60 inches wide minimum and 60 inches long minimum.	1	
Field

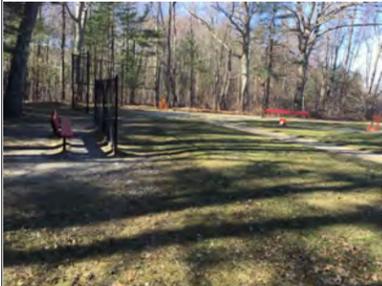
8	Softball Field	Ext.		Field	Baseball

Accessible spaces are not provided at team seating Not connected to an accessible-route No accessible route to all areas of sport activity	- - -	Provide a 36" x 48" clear floor space at team seating. Provide an accessible route to the field. Install an accessible route between all areas of sports activity.	1	
Best Practice

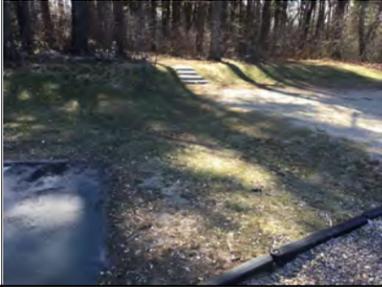
ID	Location	Floor	Room	Element	Type	Photo	Issues	Current Measure	Recommendations	Quantity	Notes
9	Near Playground	Ext.

-	Recommend either providing handrails on the stair or removing the stair.	1	
10	Picnic Table Near Softball Field	Ext.

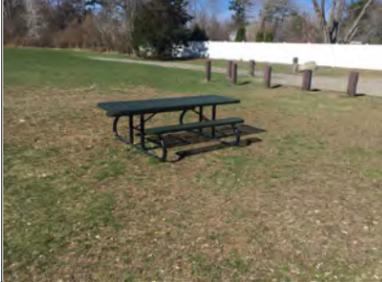
-	Recommend providing a 48" wide min. stable, firm and slip-resistant surface around the boundary of an accessible picnic table located on an accessible route. See Figure 1 in the narrative report for an example of the clear route around the picnic table.	1	
11	Bench Near Parking	Ext.

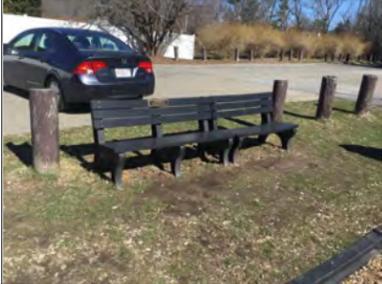
-	Recommend providing a 36" min. by 48" min. stable, firm and slip-resistant surface adjacent to at least one bench in the park in a manner that is substantially similar to what is shown in Figure 2 in the narrative report.	1

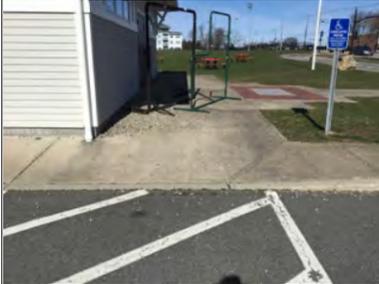
ID	Location	Floor	Room	Element	Type	Photo	Issues	Current Measure	Recommendations	Quantity	Notes
Approach and Entrance											
Exterior Access Route											
1	Near Concession Stand From Accessible Parking	Ext.		Exterior Access Route	Exterior

Exterior route < 48" wide	-	Relocate poles to ensure that a clear width of 48" min. is maintained at the accessible route.	1	
2	Accessible Parking Spaces South of Parking Lot	Ext.		Exterior Access Route	Exterior

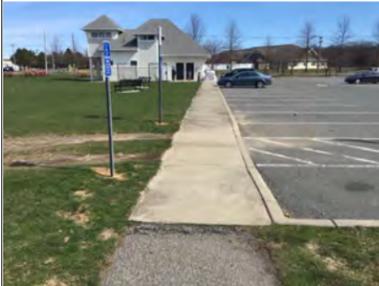
Surface openings > 1/2" Level changes > 1/4"	- 2"	Repair surface. Alter the change in level to be 1/4" high max.	1	
Off-Street Parking Lot or Garage											
3	Accessible Parking Near Concession Stand	Ext.		Off-Street Parking Lot or Garage	N/A

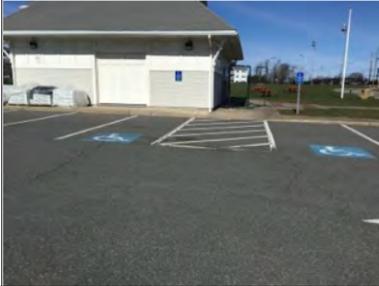
Total # of parking Total # of designated accessible parking spaces Total # of designated van accessible spaces Sign does not have the designation "Van Accessible" Sign bottom < 60" above finished grade	98 3 1 - 53"	Add the designation "Van Accessible" to the sign located at the van accessible space. Locate signs with the bottom of the sign 60" above the ground.	1

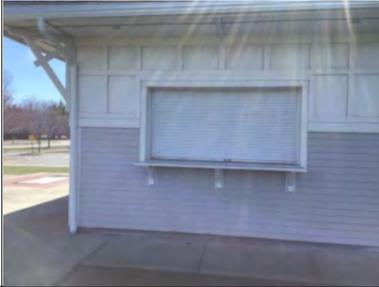
Access to Goods and Services											
Exterior Access Route											
4	Concession Stand	Ext.		Exterior Access Route	Exterior

Route obstructed by protruding objects	16.5"	Provide a cane-detectable barrier under the counter.	1

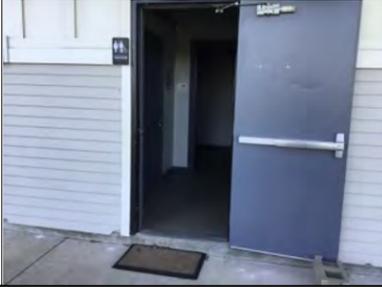
ID	Location	Floor	Room	Element	Type	Photo	Issues	Current Measure	Recommendations	Quantity	Notes
Doors, Doorways, & Gates											
5	Entry to Toilet Rooms	Ext.		Doors, Doorways, & Gates	Toilet Room

Threshold > 1/2" high	4.5"	Alter the threshold to be 1/2" high max.	1	
Stairways											
6	Near North Side Baseball Field	Ext.		Stairways	Exterior

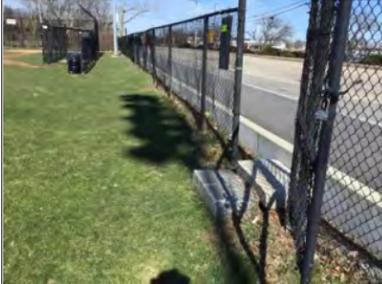
Handrails not provided Tread widths and/or riser heights are not uniform	- -	Provide handrails. It may not be technically feasible to adjust risers or treads, however stairs may be hazardous for users.	1	
Signage											
7	Women's and Men's Single-User Toilet Rooms	1		Signage	Designation

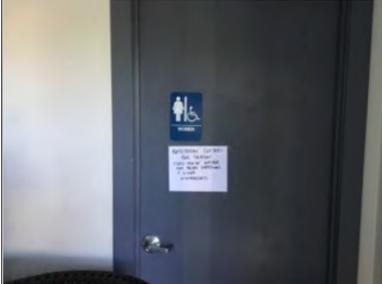
Sign not located on the latch side of the door	-	Locate signs at permanent rooms alongside the door on the latch side.	2	
Service Counter											
8	Concession Stand	Ext.		Service Counter

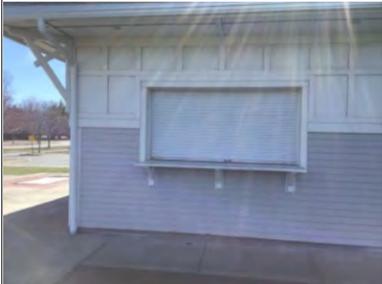
Counter > 36" high	45.4"	Provide a counter that is 36" max. above the ground.	1

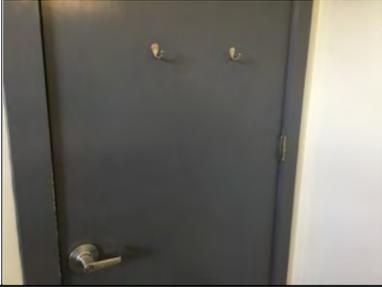
ID	Location	Floor	Room	Element	Type	Photo	Issues	Current Measure	Recommendations	Quantity	Notes
Operable Parts											
9	Women's and Men's Single-User Toilet Rooms	1		Operable Parts	N/A

Reach < 15" or > 48"(forward/side approach)	60"	Relocate at least one coat hook 48" above the finished floor.	2	
Picnic Tables											
10	Near Concession Stand	Ext.		Picnic Tables	N/A

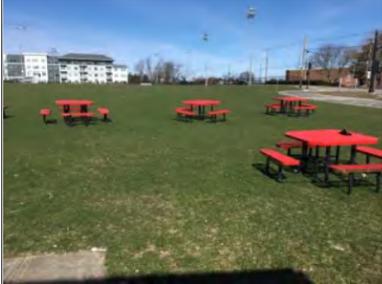
Toe or knee clearance at table not provided Picnic table not on an accessible route	- -	Provide at least one picnic table with top between 28"- 34" above the ground and 27" clear height underneath. Ensure that the dining surface is connected to an accessible route.	1	
Benches											
11	Near Parking Lot	Ext.		Benches	N/A

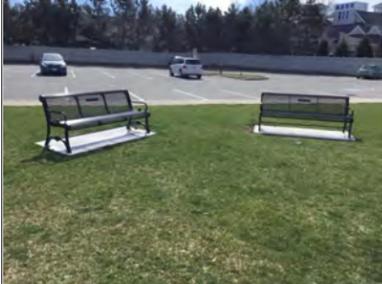
No accessible route to one bench in this area	-	Provide an accessible route to at least one bench in this area or relocate one bench to an accessible route.	1	
Trash / Recycling

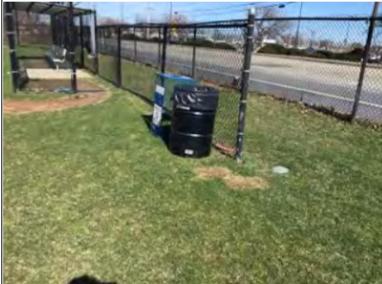
12	North and South Side Baseball Fields	Ext.		Trash / Recycling	N/A

Trash container not connected to an accessible route	-	Ensure trash container is located on an accessible route.	2	
Toilet & Bathing Rooms

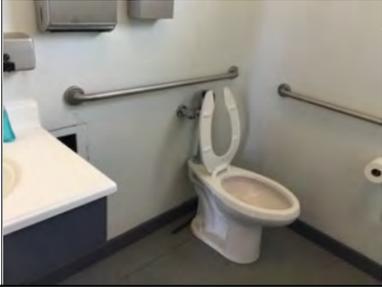
ID	Location	Floor	Room	Element	Type	Photo	Issues	Current Measure	Recommendations	Quantity	Notes
Overall Access											
13	Women's and Men's Single-User Toilet Room	1		Overall Access	Toilet Room

Audible and visible alarms not provided	-	When the fire system is updated, ensure that a visible and audible fire alarm is installed.	2	
Lavatory											
14	Women's and Men's Single-User Toilet Rooms	1		Lavatory	N/A

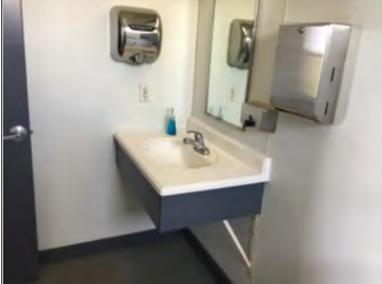
Toe or knee clearances not provided	25"	Provide at least one lavatory with knee and toe clearance positioned for a forward approach. (Provide a narrower lavatory in the women's toilet room to provide the required 60" clear width at the toilet.)	2	
Single-User Toilet											
15	Women's Single-User Toilet Room	1		Single-User Toilet	N/A

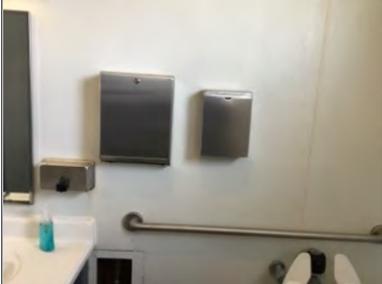
Side or rear grab bar < 33" or > 36" high Clearance at toilet < 60" clear width Item mounted over grab bar (MAAB)	38" 54" -	Mount grab bars 33"- 36" above the finished floor. See previous record regarding providing a narrower lavatory to provide 60" clear width at the toilet. Relocate dispensers so that it is not mounted over the grab bar.	1

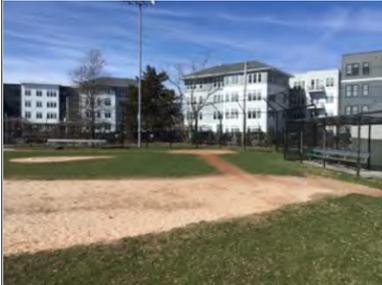
Play and Sport Areas											
Field											
16	North and South Side Baseball Fields - Dugouts	Ext.		Field	Baseball

Not connected to an accessible-route No accessible route to all areas of sport activity	- -	Provide an accessible route to the field. Install an accessible route between all areas of sports activity.	2

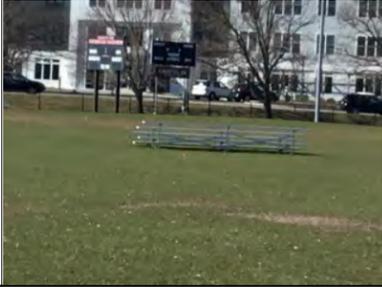
ID	Location	Floor	Room	Element	Type	Photo	Issues	Current Measure	Recommendations	Quantity	Notes
Bleachers											
17	North and South Side Baseball Fields and Football Field	Ext.		Bleachers	N/A

Min. # of designated wheelchair spaces not provided Seating spaces < 36" x 60" (side entry) (MAAB) Seats not connected by accessible route	- - -	Provide accessible wheelchair spaces with a stable and firm 36" by 60" clear floor space adjacent to each bleacher. Provide an accessible route to the seating area.	6	
Best Practice											
18	Picnic Area Near Concession Stand	Ext.

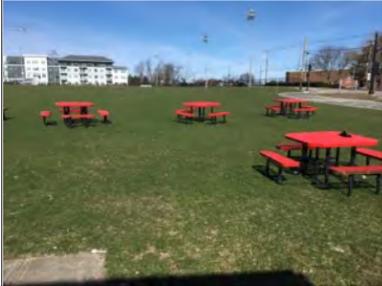
-	Recommend providing a 48" wide min. stable, firm and slip-resistant surface around the boundary of an accessible picnic table located on an accessible route. See Figure 1 in the narrative report for an example of the clear route around the picnic table.	1	
19	Benches Near Parking Lot	Ext.

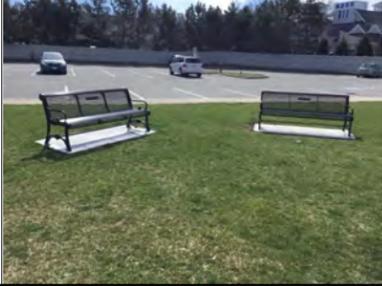
-	Recommend providing a 36" min. by 48" min. stable, firm and slip-resistant surface adjacent to at least one bench in the park in a manner that is substantially similar to what is shown in Figure 2 in the narrative report.	1

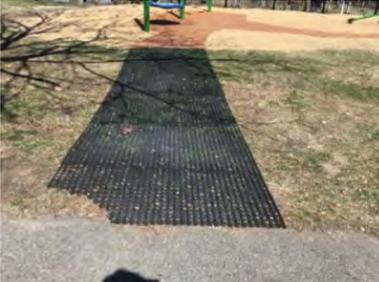
ID	Location	Floor	Room	Element	Type	Photo	Issues	Current Measure	Recommendations	Quantity	Notes
Approach and Entrance											
Exterior Access Route											
1	To Playground From Parking	Ext.		Exterior Access Route	Exterior

Surface openings > 1/2" Cross slope > 1:50 (2.00%)	- 5.8%	Repair surface. Reduce the cross slope to be no steeper than 1:50 (2.00%).	1	
2	From Playground to Parking	Ext.		Exterior Access Route	Exterior

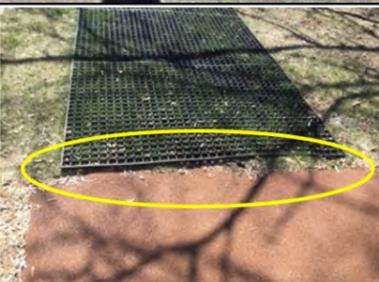
Level changes > 1/4"	1"	Alter the change in level to be 1/4" high max.	1	
3	Memorial Stone	Ext.		Exterior Access Route	Exterior

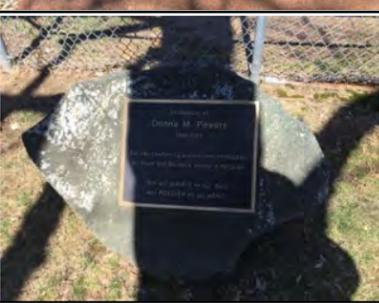
Accessible route not provided	-	Ensure an accessible route is provided.	1	
Off-Street Parking Lot or Garage											
4	Parking	Ext.		Off-Street Parking Lot or Garage	Visitor

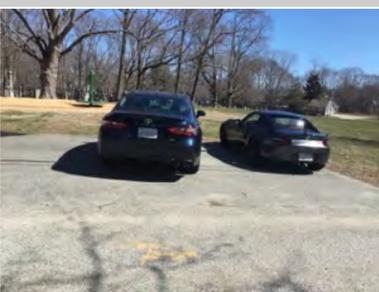
Total # of parking Total # of designated accessible parking spaces Total # of designated van accessible spaces	2 0 0	Provide a marked van accessible space that is at least 132" wide with a marked access aisle that is at least 60" wide. Add the designation "Van Accessible" to the sign located at the van accessible space. Ensure the bottom of the sign is 60" min. above the ground and the top 96" max. above the ground.	1

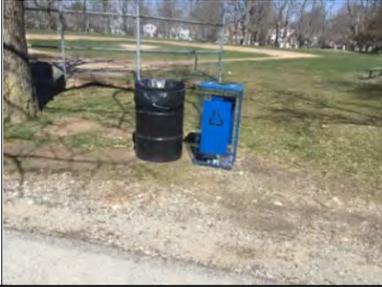
ID	Location	Floor	Room	Element	Type	Photo	Issues	Current Measure	Recommendations	Quantity	Notes
Trash / Recycling											
5	Trash Cans Near Softball Field	Ext.		Trash / Recycling	N/A

Trash container not connected to an accessible route	-	Ensure the trash container is located on an accessible route.	1	
Play and Sport Areas											
Play Areas											
6	Playground	Ext.		Play Areas	N/A

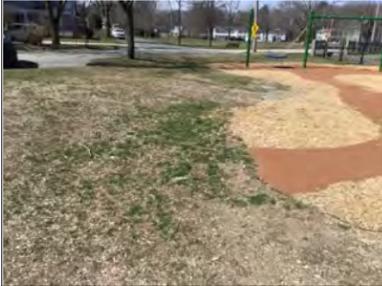
Accessible route not provided around playground	-	Install an accessible route to and around the playground perimeter.	1	
7	Playground	Ext.		Play Areas	N/A

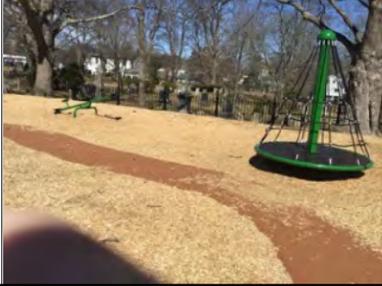
Accessible route not provided at play components	-	Install an accessible route to and around each unique play component the playground.	1	
8	Play Bar Near Playground	Ext.		Play Areas	N/A

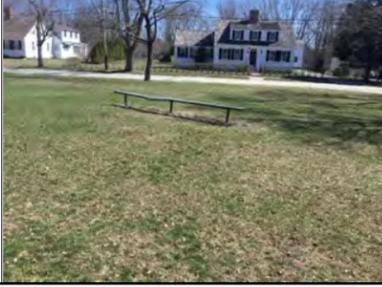
Accessible route not provided at play components Not connected to an accessible route	- -	Provide a compliant impact-attenuating surface under and around the play components. Provide an accessible route to play areas.	1

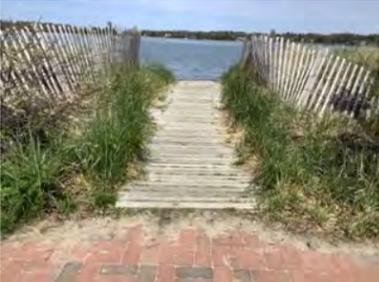
ID	Location	Floor	Room	Element	Type	Photo	Issues	Current Measure	Recommendations	Quantity	Notes
Approach and Entrance											
Exterior Access Route											
1	Northwest Beach Access Point With Wooden Ramp	Ext.		Exterior Access Route	Exterior

Level changes > 1/4"	1"	Alter the change in level to be 1/4" high max.	1	
2	Gazebo	Ext.		Exterior Access Route	Exterior

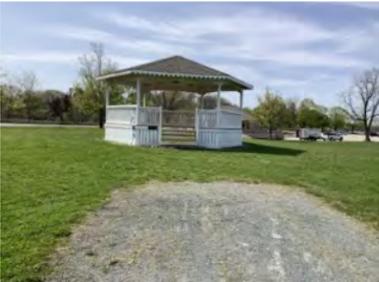
Accessible route not provided	-	Ensure an accessible route is provided to the gazebo.	1	
3	Near Gazebo	Ext.		Exterior Access Route	Exterior

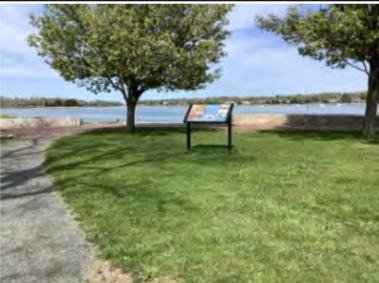
Accessible route not provided	-	Ensure an accessible route is provided to the wayside panel.	1	
Beach Access Routes											
4	By Parking and Gazebo	Ext.		Beach Access Routes	Removable

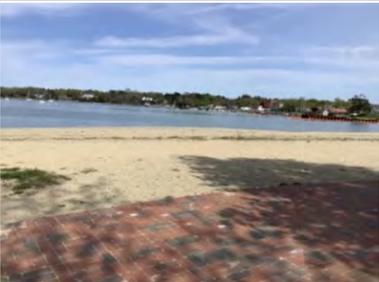
Beach route not provided Surface is not firm and stable	- -	Recommend providing a beach mat that is 60" wide min., and firm and stable. Ensure the mat extends to the high tide level. Ensure surface at the accessible route is firm and stable.	1

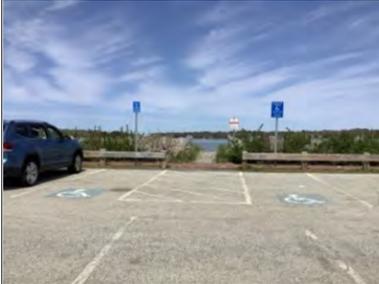
ID	Location	Floor	Room	Element	Type	Photo	Issues	Current Measure	Recommendations	Quantity	Notes
Off-Street Parking Lot or Garage											
5	Northeast Accessible Parking by Wooden Route to Beach	Ext.		Off-Street Parking Lot or Garage	Visitor

Total # of parking Total # of designated accessible parking spaces Total # of designated van accessible spaces Sign does not have the designation "Van Accessible" Sign top > 96" above finished grade	211 1 1 - 105"	Add the designation "Van Accessible" to the sign located at the van accessible space. Locate sign with the top of the sign 96" above the ground.	1	
6	Parking at Beach House and Snack Shack	Ext.		Off-Street Parking Lot or Garage	N/A

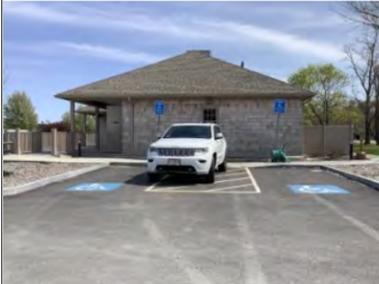
Total # of designated accessible parking spaces Total # of designated van accessible spaces Sign does not have the designation "Van Accessible"	1 1 -	Add the designation "Van Accessible" to the sign located at the van accessible space.	1

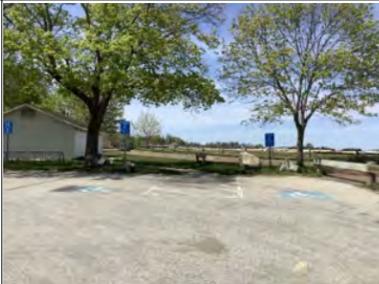
7	Accessible Parking, Northwest Corner of Parking Lot	Ext.		Off-Street Parking Lot or Garage	N/A

Total # of designated accessible parking spaces Sign bottom < 60" above finished grade	2 42"	Locate sign with the bottom of the sign 60" above the ground at the space on the right.	1	
Emergency Exit											
8	Community Room	1		Emergency Exit

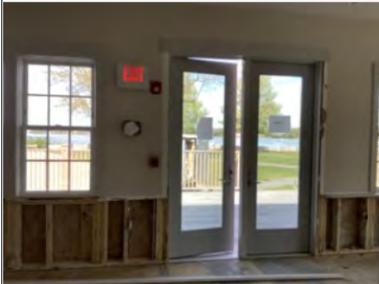
Tactile sign not provided at emergency exit Illuminated International Symbol of Acc. not provided (MAAB 2006)	- -	Provide a sign with raised characters and braille at the emergency exit. Mount signs between 48"-60" above the finished floor located on the latch side of the door. Where a tactile sign is provided at double doors with two active leaves, the sign shall be located to the right of the right hand door. Provide an illuminated sign with the International Symbol of Accessibility (ISA).	3	
9	East Facing 2nd Exit to Deck	1		Emergency Exit	167

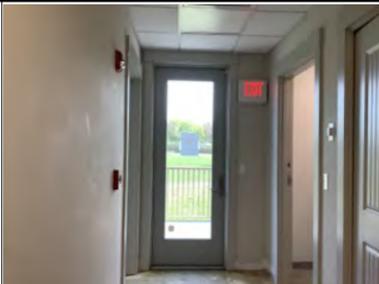
Tactile sign not provided at emergency exit Illuminated International Symbol of Acc. not provided (MAAB 2006)	- -	Provide a sign with raised characters and braille at the emergency exit. Mount signs between 48"-60" above the finished floor located on the latch side of the door. Provide an illuminated sign with the International Symbol of Accessibility (ISA).	1

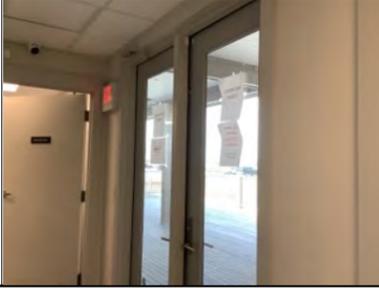
ID	Location	Floor	Room	Element	Type	Photo	Issues	Current Measure	Recommendations	Quantity	Notes
10	Main Entry by Kitchen	1		Emergency Exit

Tactile sign not provided at emergency exit Illuminated International Symbol of Acc. not provided (MAAB 2006)	- -	Provide a sign with raised characters and braille at the emergency exit. Mount signs between 48"-60" above the finished floor located on the latch side of the door. Where a tactile sign is provided at double doors with two active leaves, the sign shall be located to the right of the right hand door. Provide an illuminated sign with the International Symbol of Accessibility (ISA).	1	
Access to Goods and Services											
Doors, Doorways, & Gates											
11	Women's Toilet Room	1		Doors, Doorways, & Gates

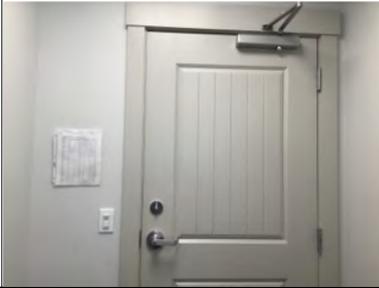
Door requires > 5 lbs of force to open	8 lbs	Adjust closers so doors do not require more than 5 pounds of force to open.	1	
Stairways

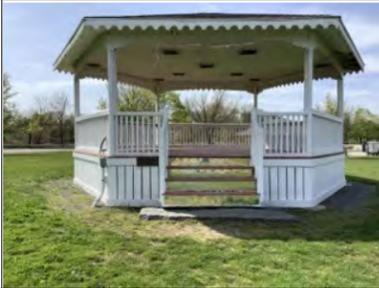
12	Gazebo	Ext.		Stairways	Exterior

Handrails do not extend 12" from stairs Handrails have non-compliant cross section	- -	Top: Ensure handrails extend horizontally above the landing for 12" min. beginning above the first riser nosing. Bottom: Ensure that the sloped bottom extension extends one tread depth minimum beyond last riser nosing in same direction as stair flight. Provide handrails with a 1 1/4" - 2" circular cross section.	1	
Signage											
13	Women's Toilet Room	1		Signage	Designation

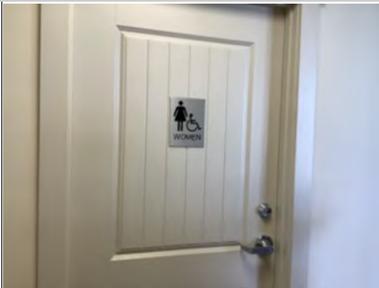
Raised characters < 48" or > 60" above ground Sign not located on the latch side of the door	63" -	Mount signs so that the baseline of the lowest tactile character is 48" min. above the finished floor and the baseline of the highest tactile character is 60" max. above the finished floor. Locate signs at permanent rooms alongside the door on the latch side.	1

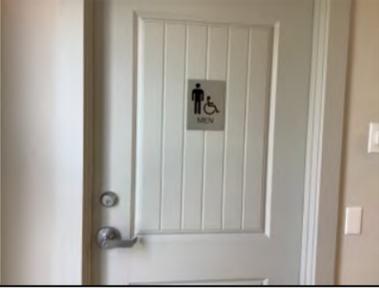
ID	Location	Floor	Room	Element	Type	Photo	Issues	Current Measure	Recommendations	Quantity	Notes
14	Men's Toilet Room	1		Signage	Designation

Sign not located on the latch side of the door	-	Locate signs at permanent rooms alongside the door on the latch side.	1	
15	Beach House Entrance	Ext.		Signage	Designation

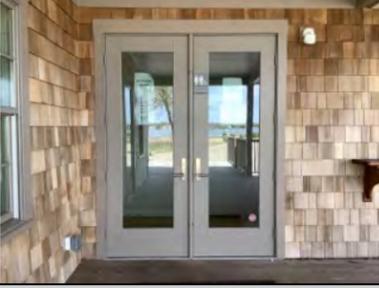
Sign not located on the latch side of the door	-	Locate signs at permanent rooms alongside the door on the latch side. At a set of double doors, locate the sign on the right side of the right door.	1	
Benches											
16	By Gazebo	Ext.		Benches	N/A

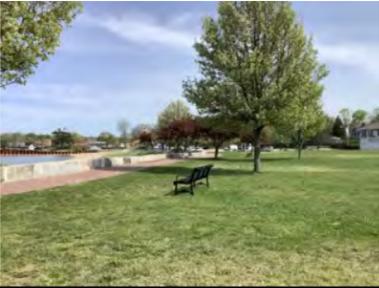
No accessible route to one bench in this area	-	Provide an accessible route to at least one bench in this area.	1	
Bike Racks											
17	By Beach Shack	Ext.		Bike Racks	N/A

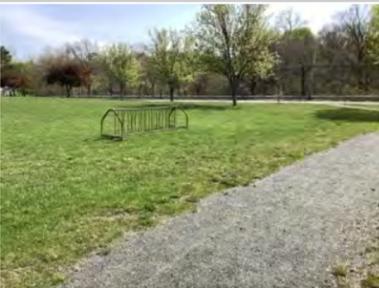
Bike rack is not connected to an accessible route	-	Ensure bike racks are connected to an accessible route.	1	
Toilet & Bathing Rooms

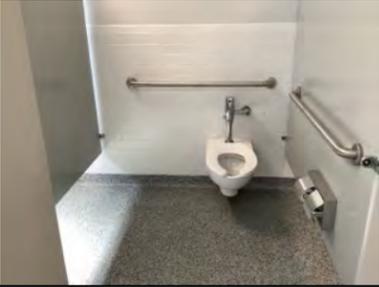
ID	Location	Floor	Room	Element	Type	Photo	Issues	Current Measure	Recommendations	Quantity	Notes
Toilet Compartment											
18	Men's Toilet Room	1		Toilet Compartment	Accessible Compartment

Door with malfunctioning self-closing hinge	-	Repair hinge.	1	
19	Women's Toilet Room	1		Toilet Compartment

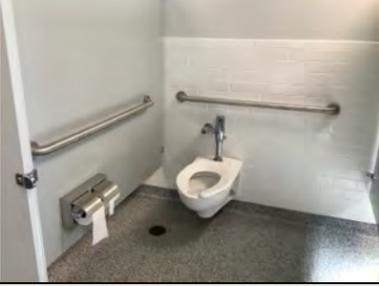
Door with malfunctioning self-closing hinge	-	Repair hinge.	1	
Best Practice											
20	Women's Toilet Room	1

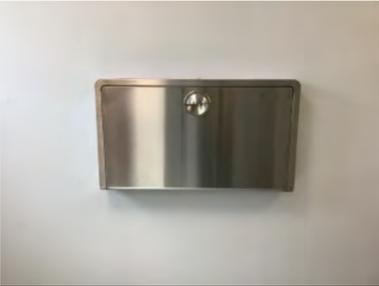
This is a good design for a dispenser that does not act as a protruding object. We recommend replicating this at other facilities.	1	
21	Accessible Parking, Northwest Corner of Parking Lot	Ext.

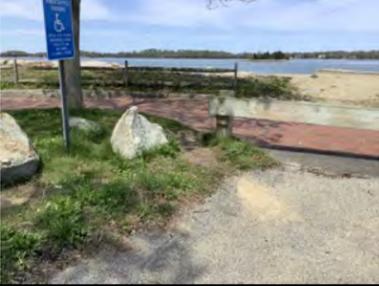
Recommend providing an accessible route from parking to the brick path which connects to beach access points.	1	
22	Northeast Accessible Parking by Wooden Route to Beach	Ext.

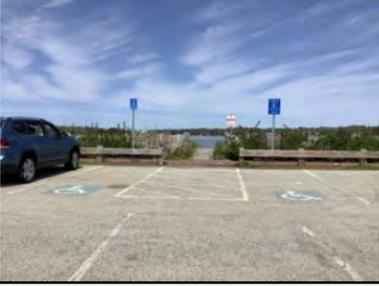
Recommend providing a sign indicating the location of the nearest accessible beach access point.	1

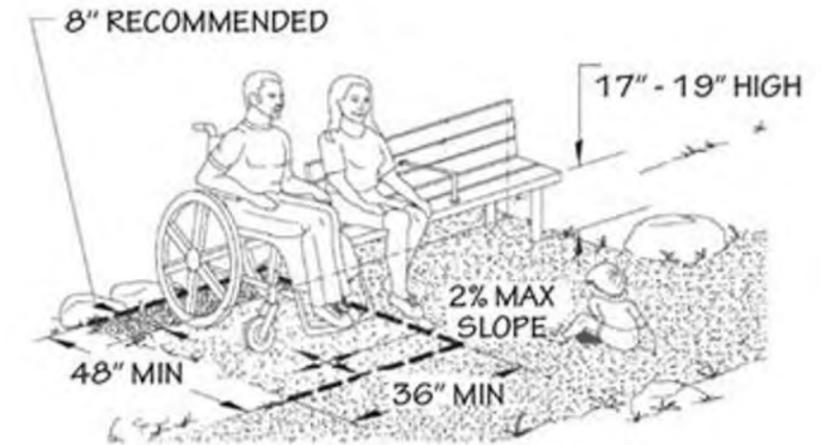
Figure 1 shows the recommended space adjacent to a bench positioned to allow a person in a wheeled mobility device and a person sitting on the bench to have their shoulders aligned:

- Recommend providing 36” wide by 48” deep clear floor space next to at least one bench in the courtyard so that a wheelchair user is able to sit shoulder-to-shoulder with a person seated on the bench.

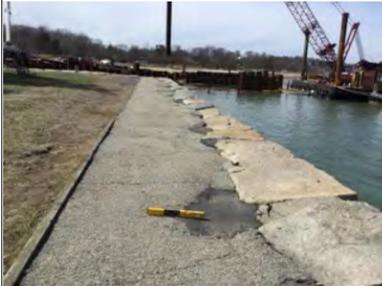
ID	Location	Floor	Room	Element	Type	Photo	Issues	Current Measure	Recommendations	Quantity	Notes
Approach and Entrance											
Exterior Access Route											
1	Towards Boat Launch	Ext.		Exterior Access Route	Walkway

Cross slope > 1:50 (2.00%)	7.4%	Reduce the cross slope to be no steeper than 1:50 (2.00%).	1	
2	Towards Boat Launch	Ext.		Exterior Access Route	Walkway

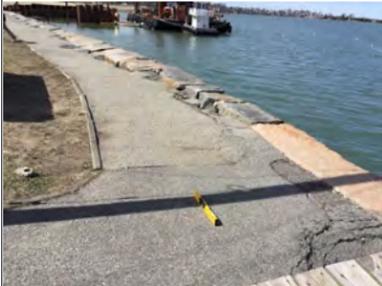
Running slope > 1:20 (5.00%)	6.8%	Reduce the running slope to be no steeper than 1:20 (5.00%).	1	
3	Hingham Veteran's Plaque and Statue	Ext.		Exterior Access Route	Exterior

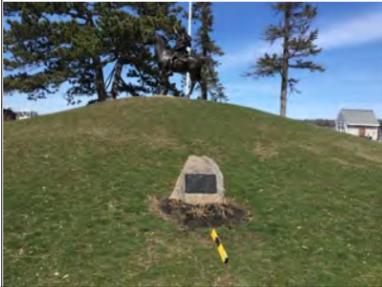
Running slope > 1:20 (5.00%) Accessible route not provided	13.9% -	Reduce the running slope to be no steeper than 1:20 (5.00%). Ensure an accessible route is provided to the plaque.	1	
4	Towards Boat Launch	Ext.		Exterior Access Route	Walkway

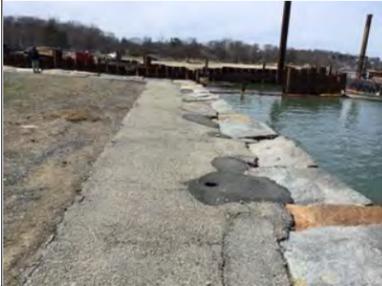
Route not maintained in operable working condition	-	Ensure that the accessible route is maintained in operable working condition.	1

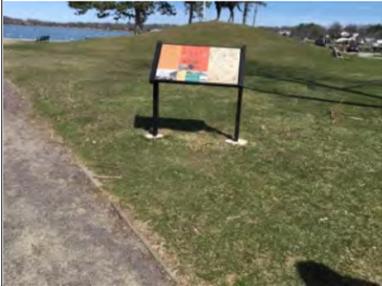
5	Wayside Sign	Ext.		Exterior Access Route	Exterior

Accessible route not provided	-	Ensure an accessible route is provided to the wayside sign.	1

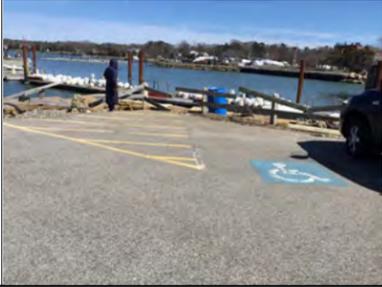
ID	Location	Floor	Room	Element	Type	Photo	Issues	Current Measure	Recommendations	Quantity	Notes
Off-Street Parking Lot or Garage											
8	Parking	Ext.		Off-Street Parking Lot or Garage	N/A

Total # of parking Total # of designated accessible parking spaces Access aisle < 96" wide at van space Sign not provided Sign does not have the designation "Van Accessible"	14 1 72" - -	Provide one van accessible parking space. Provide a marked access aisle that is at least 96" wide. Provide a sign with the bottom of the sign 60" min. above the ground and the top 96" max. above the ground. Add the designation "Van Accessible" to the sign located at the van accessible space.	1	
Entrance											
7	Old Harbormaster's Office	Ext.		Entrance	Main Entrance

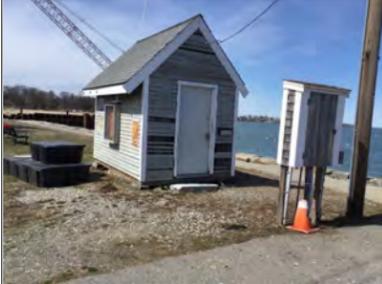
Entrance not on an accessible route		If still in use, provide an accessible route to the entry.	1	
Access to Goods and Services											
Ramps

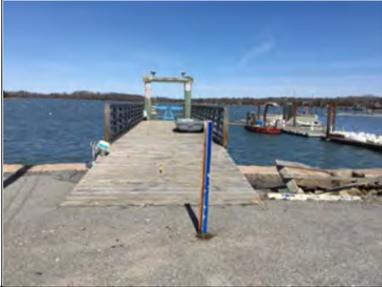
10	Slip Access in Summer	Ext.		Ramps	Exterior

Running slope >1:12 (8.33%) Level changes > 1/4" Edge protection < 4" high Handrails not provided	8.6% 1.5" - -	Alter the change in level to be 1/4" high max. Reduce running slope to be no steeper than 1:12 (8.33%). Provide edge protection that prevents the passage of a 4" diameter sphere, where any portion of the sphere is within 4" of the finished floor or ground surface. Provide handrails with a 1-1/4" to 1-1/2" circular cross section.	1	
Benches											
9	Benches	Ext.		Benches	N/A

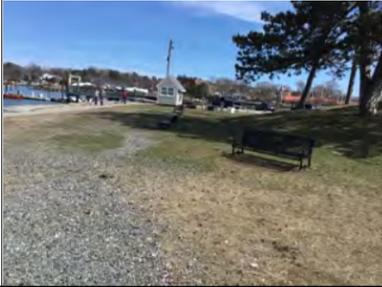
No accessible route to one bench in this area		Provide an accessible route to at least one bench in this area.	1	
Overall Review

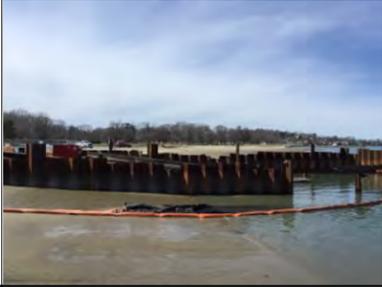
ID	Location	Floor	Room	Element	Type	Photo	Issues	Current Measure	Recommendations	Quantity	Notes
11	Town Boat Launch Under Construction	Ext.

Note: Town Boat Launch and large parking lot could not be assessed due to construction.	1	
13	Slip Access in Summer	Ext.

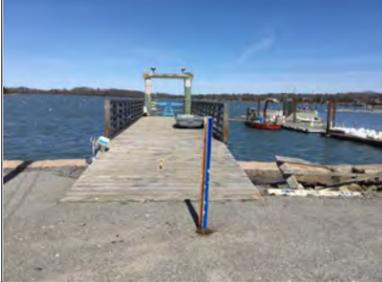
Note: The gangway and docks were not in the water on the day of survey and could not be assessed.	1	
Best Practice											
12	Benches	Ext.

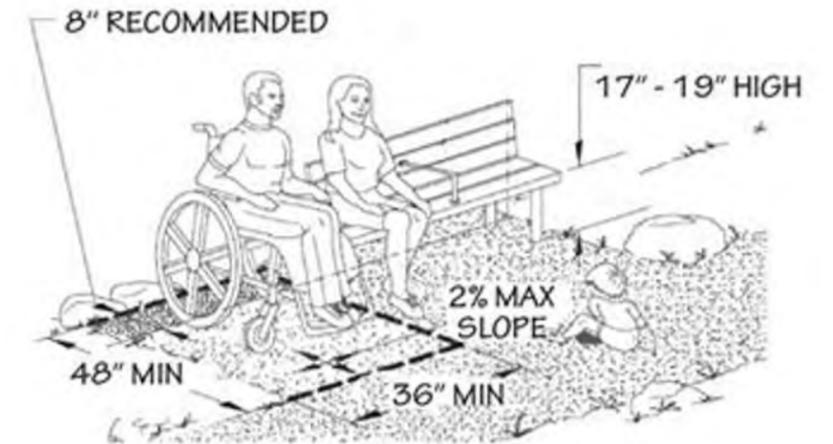
Figure 1 shows the recommended space adjacent to a bench positioned to allow a person in a wheeled mobility device and a person sitting on the bench to have their shoulders aligned:

- Recommend providing 36" wide by 48" deep clear floor space next to at least one bench in the courtyard so that a wheelchair user is able to sit shoulder-to-shoulder with a person seated on the bench.

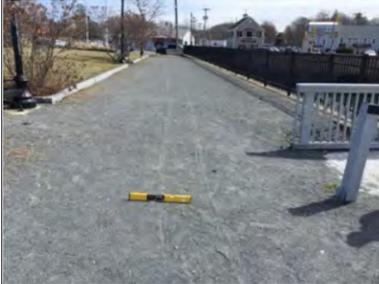
ID	Location	Floor	Room	Element	Type	Photo	Issues	Current Measure	Recommendations	Quantity	Notes
Approach and Entrance											
Exterior Access Route											
1	Walkway by the Ramp	1		Exterior Access Route	Walkway

Cross slope > 1:50 (2.00%)	5.9%	Reduce the cross slope to be no steeper than 1:50 (2.00%).	1	
2	Possible Route to Memorial Plaque	1		Exterior Access Route	Exterior

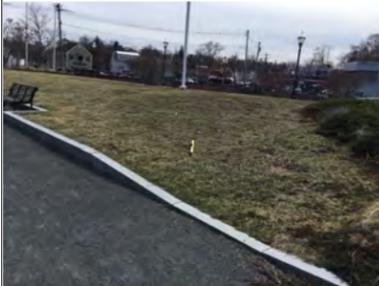
Running slope > 1:20 (5.00%) Level changes > 1/4"	14% 1.5"	Provide an accessible route to the memorial plaque. Reduce the running slope to be no steeper than 1:20 (5.00%). Alter the change in level to be 1/4" high max.	1	
3	Walkway	1		Exterior Access Route	Walkway

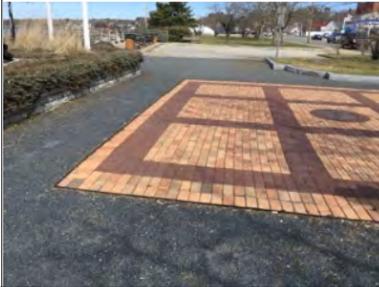
Level changes > 1/4"	1.5"	Alter the change in level to be 1/4" high max.	1	
4	Memorial	1		Exterior Access Route	Walkway

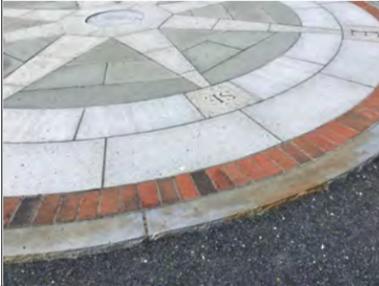
Level changes > 1/4"	2"	Alter the change in level to be 1/4" high max.	1	
5	Wayside Sign	1		Exterior Access Route	Walkway

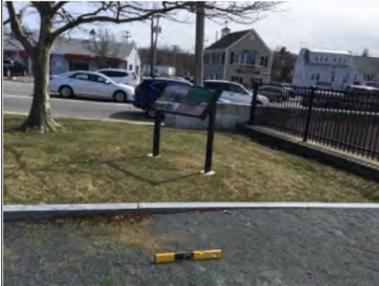
Accessible route not provided	4"	Ensure an accessible route is provided to the wayside sign.	1

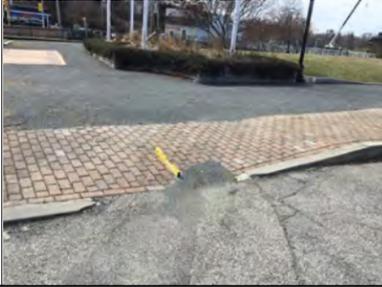
ID	Location	Floor	Room	Element	Type	Photo	Issues	Current Measure	Recommendations	Quantity	Notes
Curb Ramp											
6	Parking Lot Curb Ramp	1		Curb Ramp	N/A

Running slope > 1:12 (8.33%)	16%	Reduce the running slope to be no steeper than 1:12 (8.33%).	1	
Access to Goods and Services											
Ramps											
7	Ramp to Whitney Wharf	Ext.		Ramps	Exterior

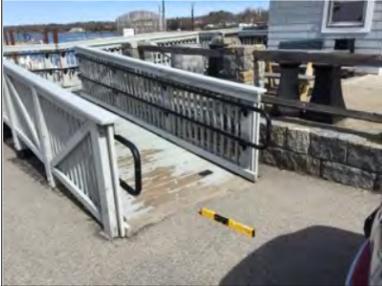
Landing has a slope > 1:50 (2.00%) (MAAB)	6%	Alter so that the slope in all directions is no greater than 1:50 (2.00%).	1	
8	Ramp to Whitney Wharf	1		Ramps	Exterior

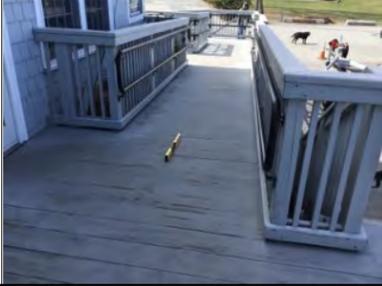
Landing has a slope > 1:50 (2.00%) (MAAB) Handrails do not extend 12" past top & bottom	- 4%	Alter handrails to extend horizontally above the landing for 12" min. beyond the top and bottom of ramp runs. Alter so that the slope in all directions is no greater than 1:50 (2.00%).	1	
Overall Review											
9	Parking Lot	1

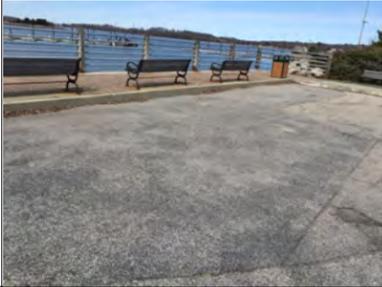
5	The parking lot east of Whitney Wharf is in the Whitney Wharf - Parking catalog and narrative report.	1

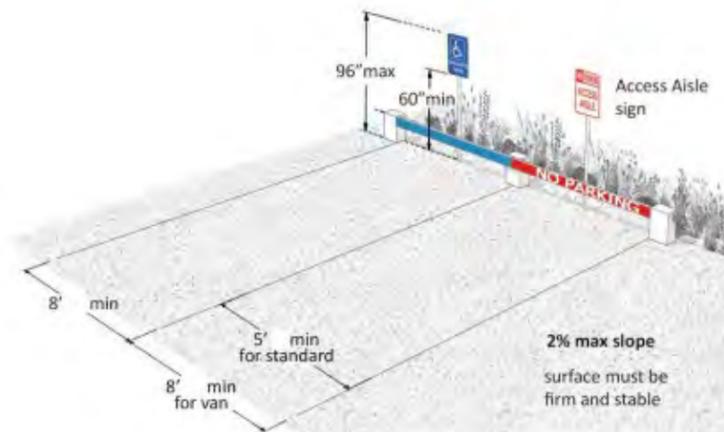
Accessibility issues include routes lack of a van accessible parking space in the parking lot.

Figure 1 shows one way to use posts, a painted wood rail and signs to designate a van accessible parking space and access aisle in an unpaved parking lot.

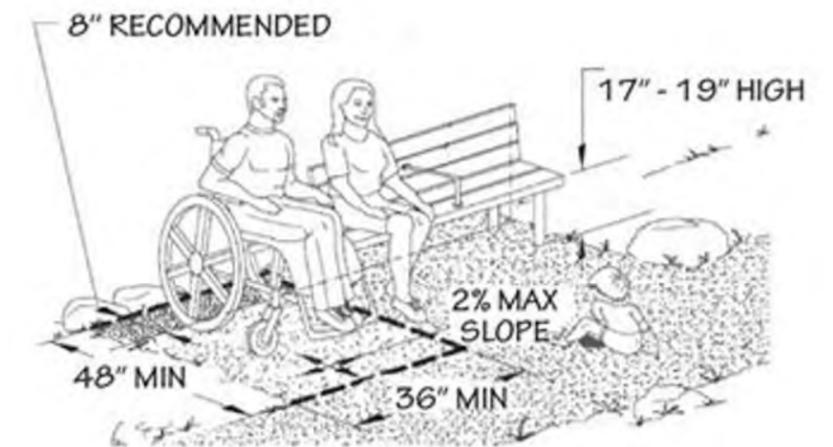
Figure 2 shows the recommended space adjacent to a bench positioned to allow a person in a wheeled mobility device and a person sitting on the bench to have their shoulders aligned:

- Recommend providing 36" wide by 48" deep clear floor space next to at least one bench in the courtyard so that a wheelchair user is able to sit shoulder-to-shoulder with a person seated on the bench.

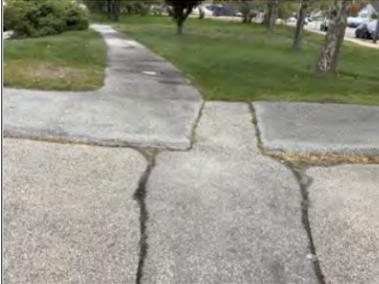
ID	Location	Floor	Room	Element	Type	Photo	Issues	Current Measure	Recommendations	Quantity	Notes
Approach and Entrance											
Exterior Access Route											
1	East Side of Parking Lot	Ext.		Exterior Access Route	Walkway

Route not maintained in operable working condition	-	Ensure that the accessible route is maintained in operable working condition.	1	
2	Wayside Sign in Park	Ext.		Exterior Access Route	Exterior

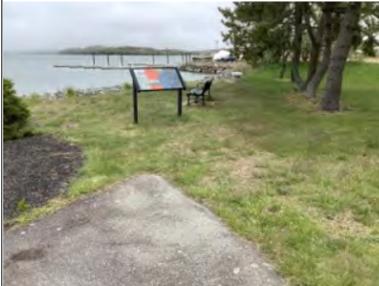
Surface is not stable, firm, and slip-resistant Accessible route not provided	- -	Ensure an accessible route is provided to the wayside.	1	
3	Walkway From Parking Towards Benches and Wayside	Ext.		Exterior Access Route	Walkway

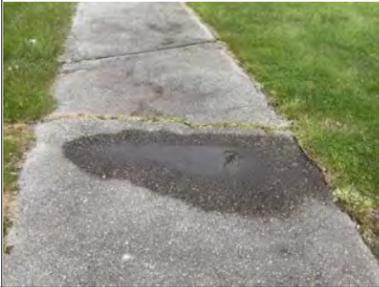
Does not prevent accumulation of water Route not maintained in operable working condition	- -	Repair the surface. Ensure that the accessible route is maintained in operable working condition.	1	
Curb Ramp											
4	West Side of Parking Lot	Ext.		Curb Ramp	N/A

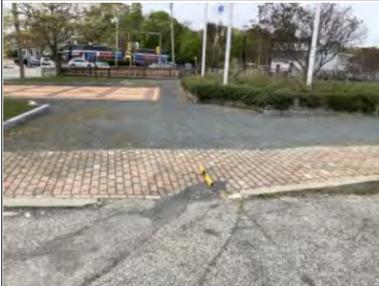
Accessibility issues include a curb ramp on the west side of the parking lot that has an excessive running slope.

Running slope > 1:12 (8.33%)	12.5%	Reduce the running slope to be no steeper than 1:12 (8.33%).	1

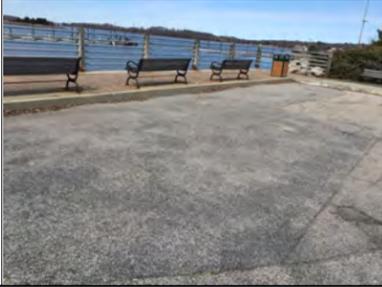
ID	Location	Floor	Room	Element	Type	Photo	Issues	Current Measure	Recommendations	Quantity	Notes
Off-Street Parking Lot or Garage											
5	Parking Lot East of Whitney Wharf	Ext.		Off-Street Parking Lot or Garage	N/A

Total # of parking Access aisle not provided Sign not provided Sign does not have the designation "Van Accessible" Total # of designated accessible parking spaces Total # of designated van accessible spaces	5 - - - -	Provide a compliant van accessible parking space and marked access aisle each at least 96" wide. Provide a sign with the International Symbol of Accessibility (ISA) with the bottom of the sign 60" min. above the ground and the top 96" max. above the ground. Add the designation "Van Accessible" to the sign located at the van accessible space.	1	
Access to Goods and Services											
Benches											
6	Benches in Park	Ext.		Benches	N/A

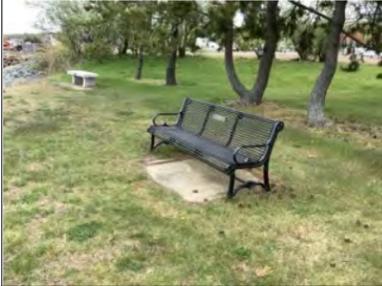
No accessible route to one bench in this area	-	Provide an accessible route to at least one bench in this area.	1
